Douglas Partners Pty Ltd ABN 75 053 980 117 www.douglaspartners.com.au 96 Hermitage Road West Ryde NSW 2114 PO Box 472 West Ryde NSW 1685 Phone (02) 9809 0666

Hanlon Industries Pty Ltd 22 Clevedon Street Botany, NSW 2019 224958.00 29 September 2023 223256.00.R.001.Rev1 AD:hb

Preliminary Geotechnical Assessment
Proposed Digital Billboard Structure
Sydney Park Road (near intersection of King Street, Erskineville

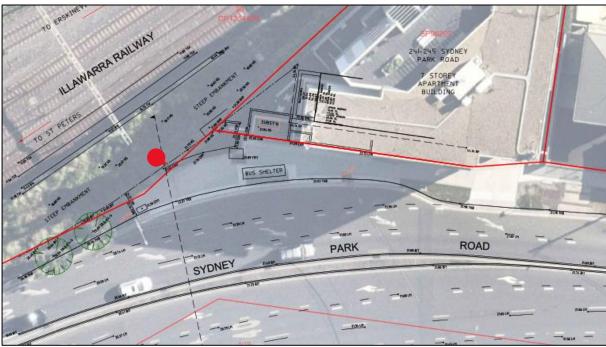
Figure 1: Photograph of the site area (red mark).

The proposed structure is to be constructed within the rail corridor along the southern side of the Illawarra Line and to the north of Sydney Park Road. The rail cutting at this location is about 10 m high (levels taken from survey drawings provided) with a steep 80 to 85° lower section and a shallower (30-35°) upper slope where the sign is proposed. The upper slope is vegetated with medium-dense low shrubs and several trees. The lower level of the slope is retained by a blockwork faced retaining wall with the upper section left exposed. An aerial photograph showing the indicative location is given in Figure 1.

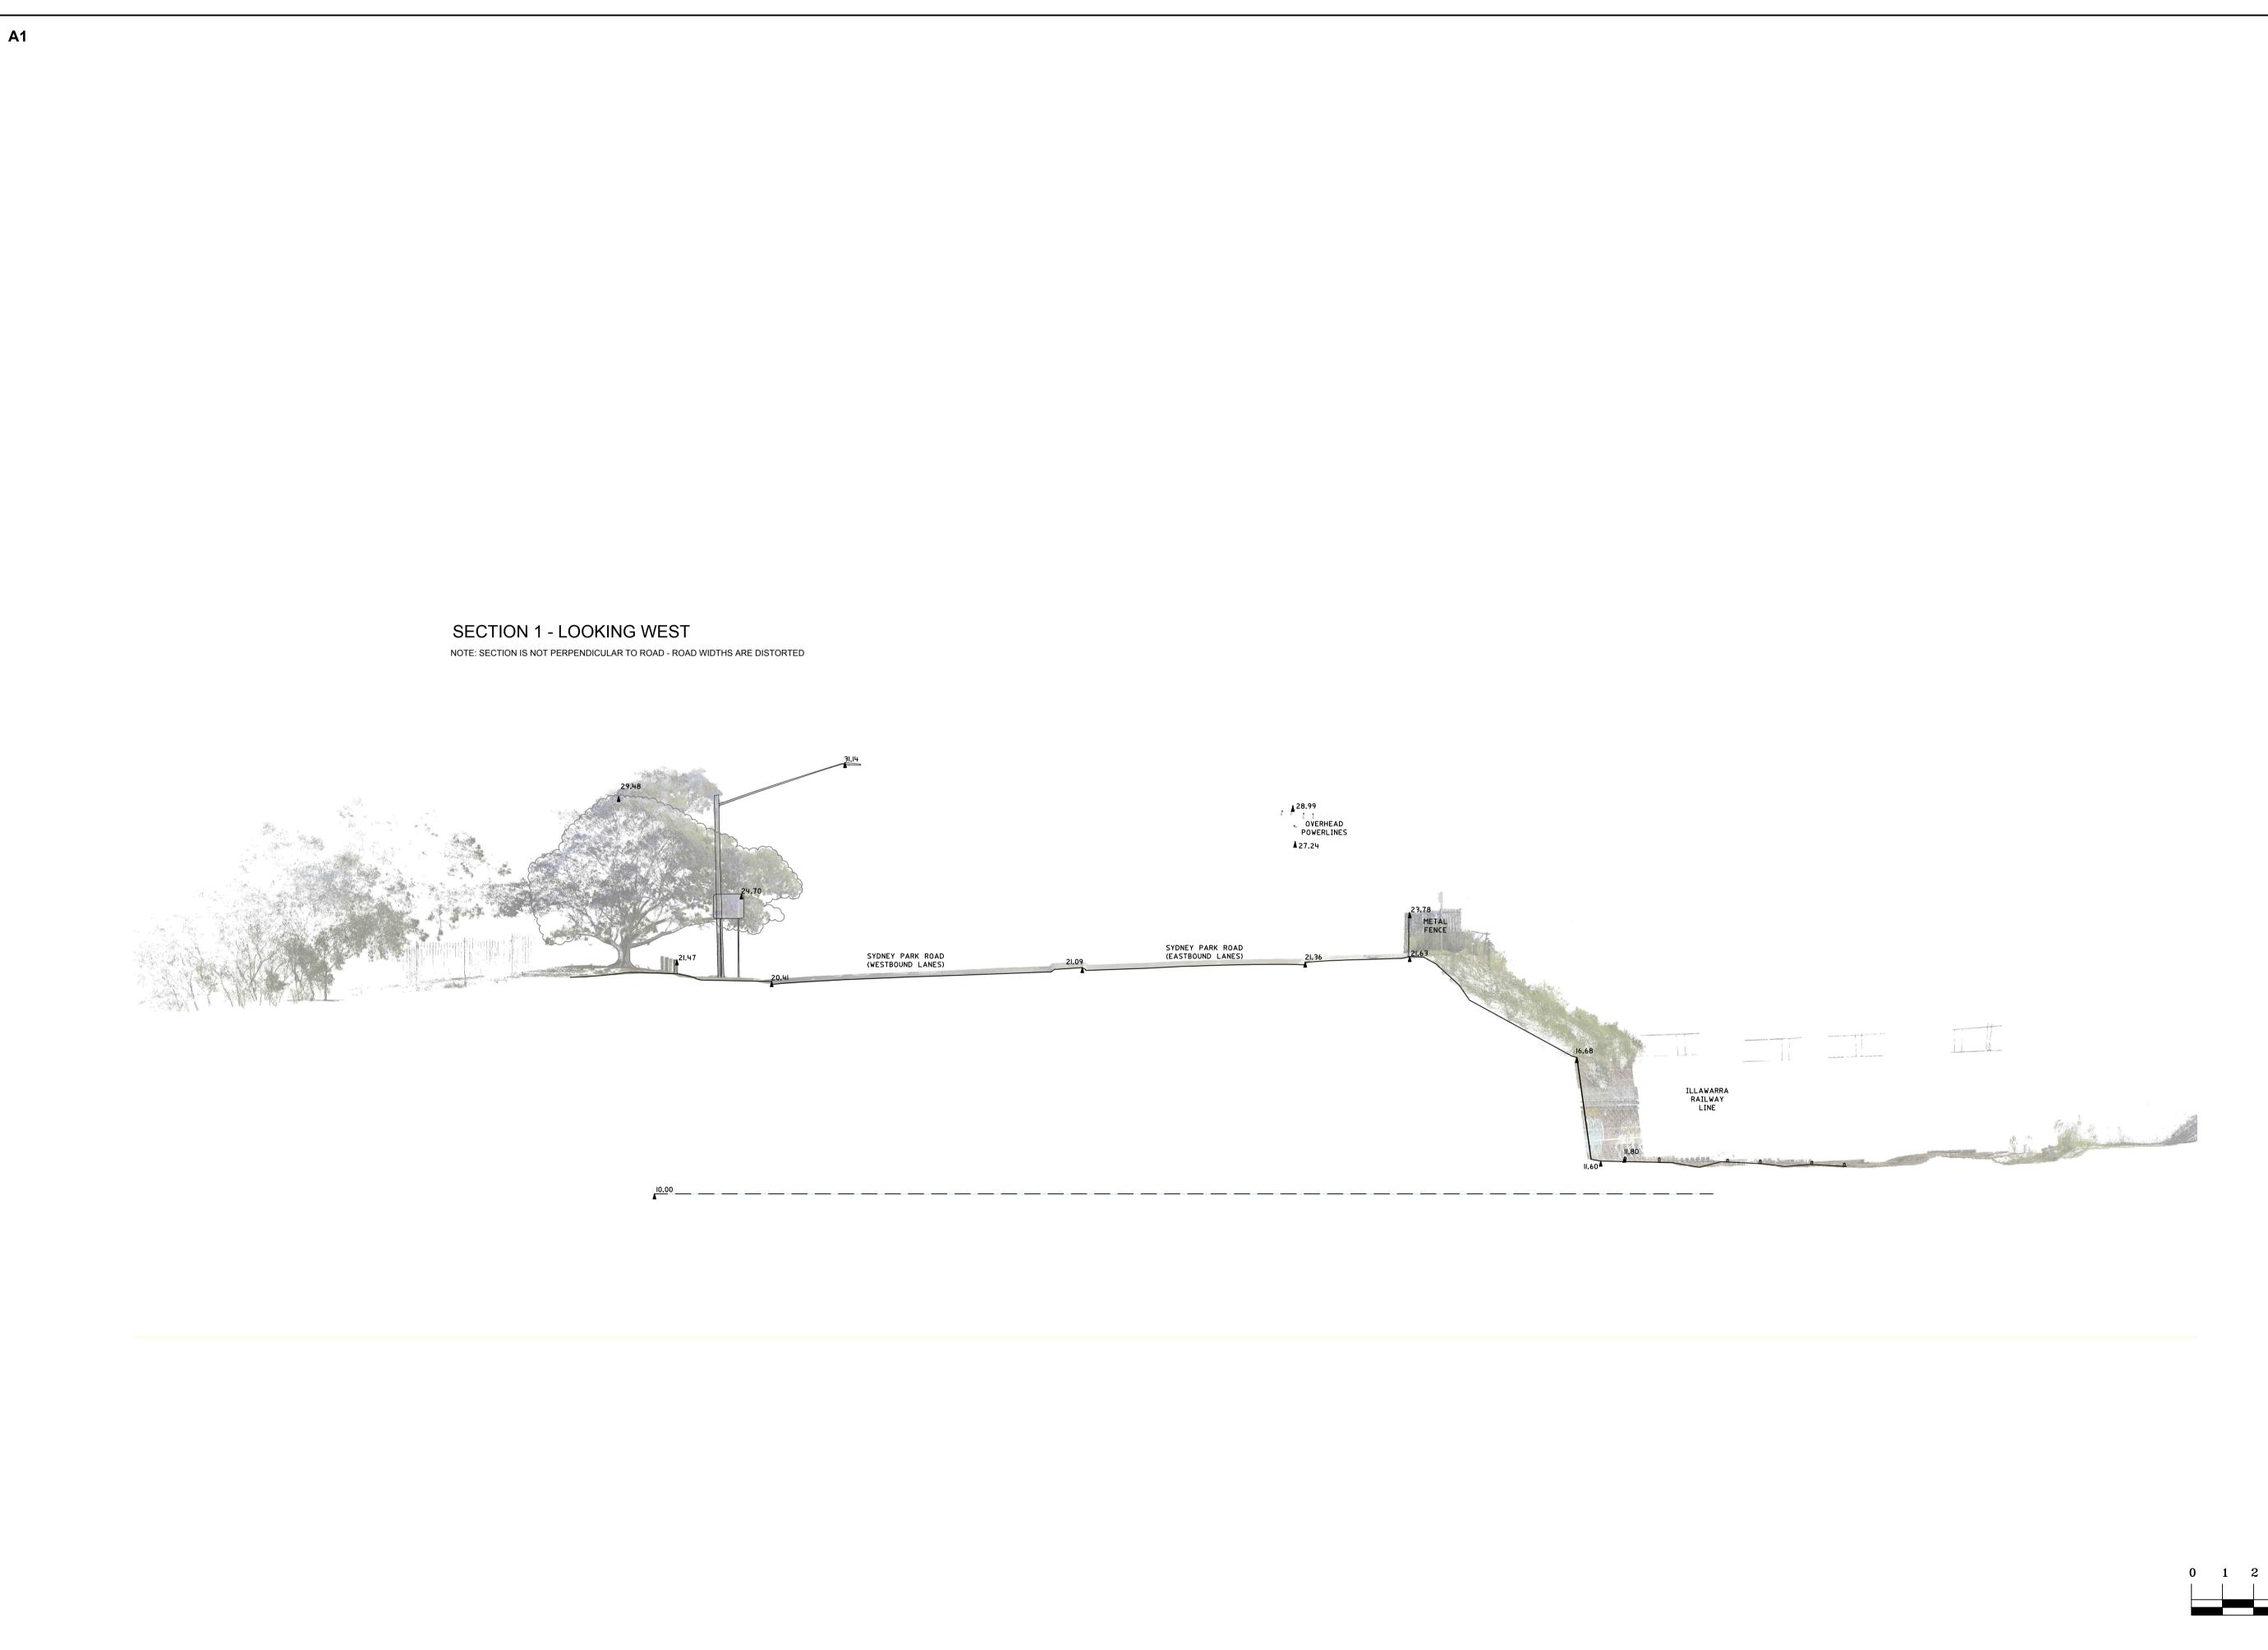
SCALE 1:100 APPROVED AS/PB SURVEY INSTRUCTION / SCALE DATE OF SURVEY 05/04/2023 / DRAWING NAME **22346sitePlan** SHEET 2 OF 2 CAD FILE 22346sitePlan 1.dwg

HORIZONTAL DATUM: CO-ORDINATE SYSTEM: MGA-GDA2020 MARKS ADOPTED: SSM 52690 - SSM 207965 VERTICAL DATUM: DATUM: AUSTRALIAN HEIGHT DATUM (AHD) B.M. ADOPTED: SSM 52690 R.L. 17.601 SOURCE: S.C.I.M.S. 31/03/2023 1 FIRST ISSUE 24/04/2023

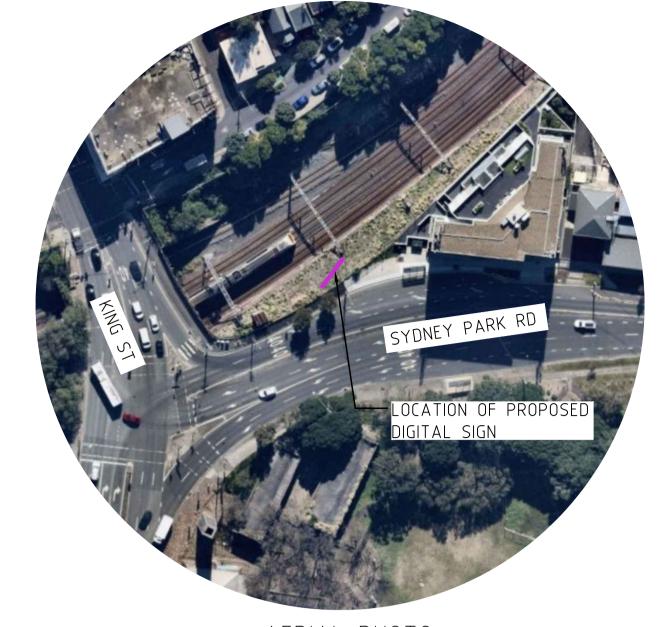
AERIAL PHOTO NTS
