## AS2870-2011 SITE CLASSIFICATION

H4 Living

Lot 68 No 53 McCrossin Ave  
Birrong NSW

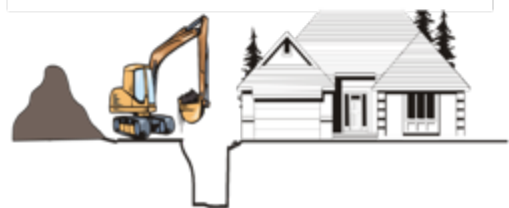
Fig. 11 De-stabilizing house foundations

- Ensuring that excavations are well supported or are dug to avoid collapses. (Fig. 11)
- Constructing well-compacted and retained 'soil aprons' around the building to stop erosion.

- Special considerations if any excavations are to be dug near adjoining structures. (Fig. 11)
- Sloping the soil and paths away from the building by the minimum amount required by the building regulations to prevent water flowing towards the building foundations. (Fig. 10 & 18)

- Running machinery over shallow drain pipes may break them causing leaks and subsequent foundation movements.
- Any excavations close to building footings can cause them to sink by disturbing the foundation material or by drying the foundation clay. (Fig 11)
