HI NOON SKI CLUB LTD, THREDBO NSW

BCA AND ACCESS PERFORMANCE SOLUTION REPORT

- ACCESS TO BUILDINGS
- CEILING HEIGHTS

REPORT NO ► 3430 REV B FINAL

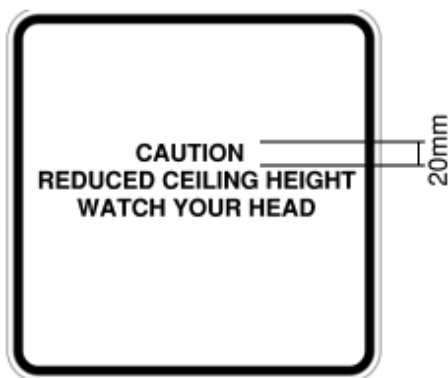
1. Signage similar to the below which notes “CAUTION – REDUCED CEILING HEIGHT – WATCH YOUR HEAD” shall be installed to the wall adjacent to the affected ceiling of the subject room. The sign should be colour contrasting to the background and be positioned in a readily apparent position (i.e. wall adjacent to the affected ceiling).
2. Cautionary tiger tape is to be provided at the wall-ceiling junction where the height is less than 2.1m.

Figure A - Proposed signage

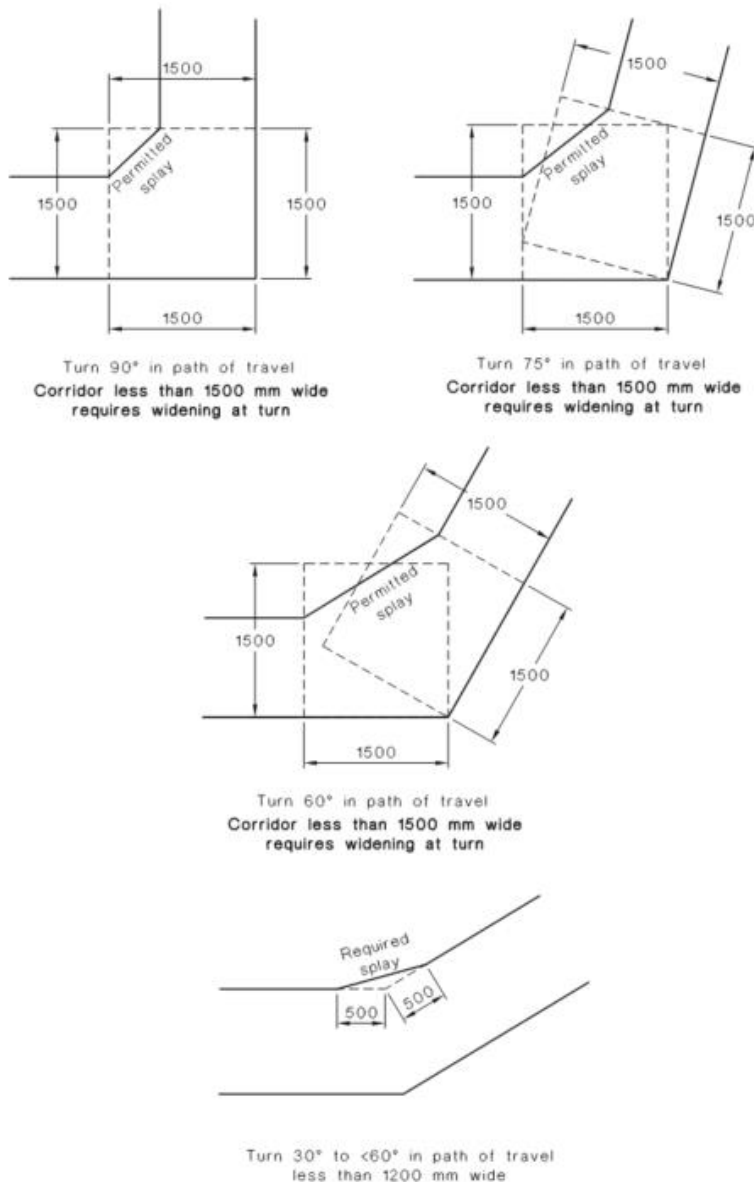
The space required for a wheelchair to make a 60° to 90° turn shall have a gradient no steeper than 1 in 40 and shall be not less than 1500mm wide and 1500mm long in the direction of travel. The space may be splayed across the internal corner as shown in Figure 4.

Where the angle of turn is 30° to <60° and the width of the path of travel is less than 1200mm, a splay of at least 500mm x 500mm shall be made on the internal corner, as shown in Figure 4.

Figure 1 – Extract from AS1428.1.-2009 – Space required for a 30° to 90° degree turn

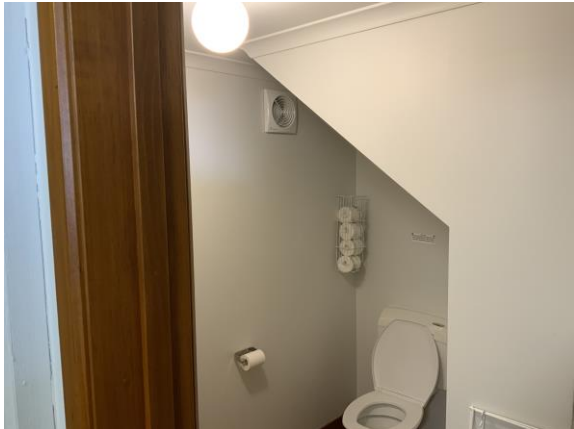
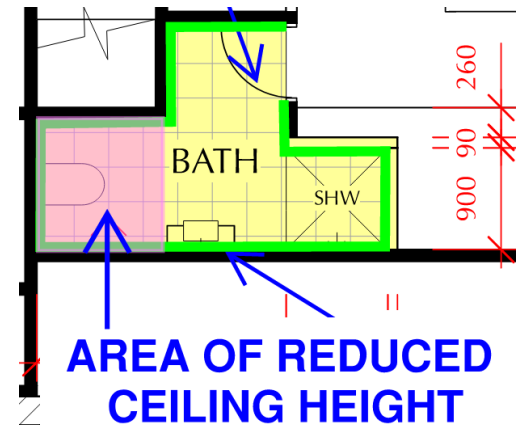
The proposed internal alterations to the existing Hi Noon Ski Club Ltd includes alterations to the existing sanitary compartment located off of the ski store on the lower level, part of which is located under the stair accessing the upper level of the building. Due to the toilet being located under the stair, the ceiling above the toilet is less than 2.1m and reduces in height from one side of the toilet to the other as a result of the stair above. The lowest part of the ceiling is approximately 1.6m in height.

Figure 3 and Figure 4 – Water Closet located under stair does not achieve ceiling height of at least 1.2m

If we consider the affected part of the sanitary facility and the activities that occur or that may be affected by the reduced ceiling height, it can be seen that the toilet fixture is located within the reduced ceiling height area, with a reduced ceiling height of 1600mm at the lowest part. The ceiling height reduces from 2.1m to 1.6m from the wall on one side of the toilet fixture to the other. A toilet compliant with AS1428.1 -2009 has a maximum width of 400mm (600mm for the cistern) and the typical/average dimension of a standing human body at the front of the toilet would typically occupy an area of 450mm (Metric Handbook Planning and Design Data – Sixth Edition edited by Pamela Buxton), which would place a

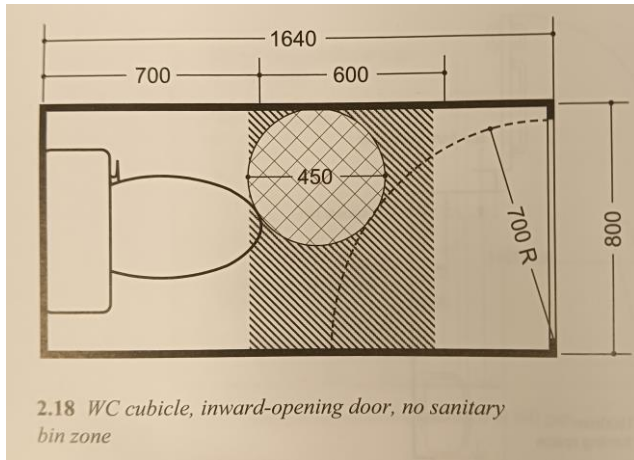
standing human body approximately 400mm-800mm from the side wall achieving a 2.1m height ceiling.

Figure 5- Typical Water Closet and human body dimensions – Metric Handbook Planning and Design Data – Sixth Edition

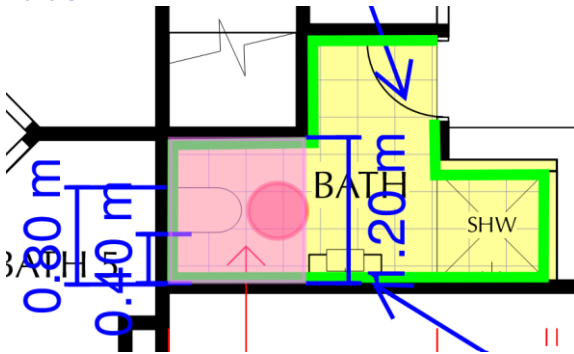
Figure 6 – Relative location of a human body within the reduced ceiling height area

If we use linear interpolation to determine the height of the ceiling under the toilet fixture itself, we obtain a ceiling height of between 1.9m and 1.8m.

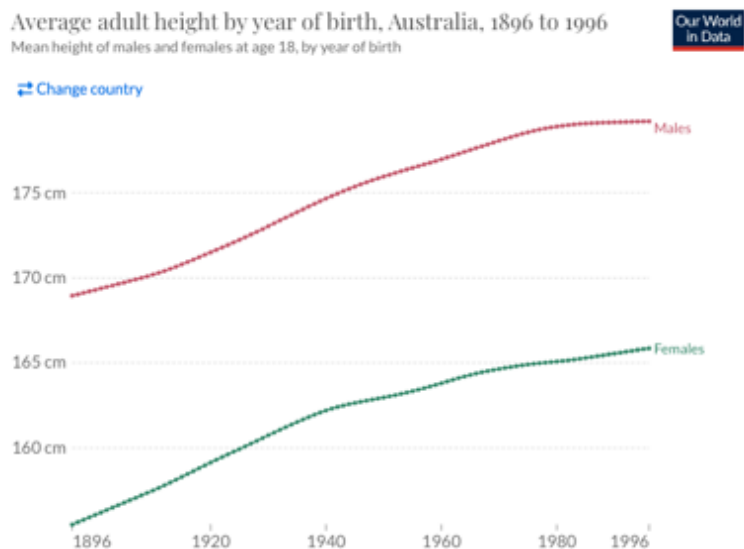
The Australian Bureau of Statistics (ABS) outlined that the highest average height were males in the 18-41 age group with an average height of 1778mm (1756mm overall), refer to graph below for average height of adults (Australia), by year of birth. This represents a 322mm difference from the required 2100mm ceiling height which is what is required.

Figure 9 – Average heights of adults by birth (Australia), Our World Data

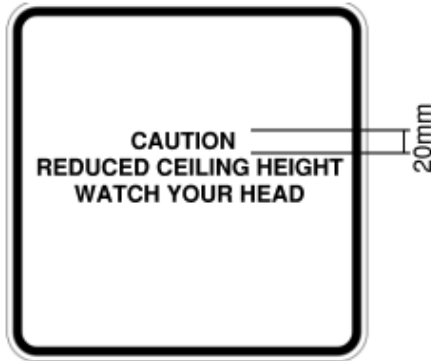
To offset the reduced ceiling height, it is proposed to alert occupants by the provision of cautionary tiger tape along the reduced ceiling height and signage, similar to the below:

Figure 10- Proposed signage

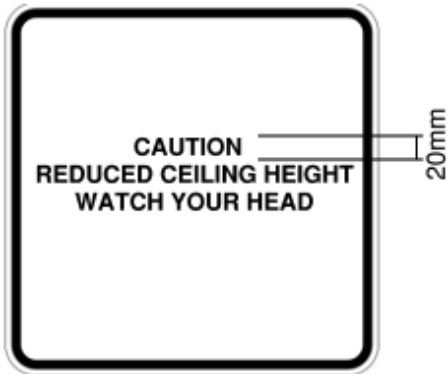
1. Signage similar to the below which notes "CAUTION – REDUCED CEILING HEIGHT – WATCH YOUR HEAD" shall be installed to the wall adjacent to the affected ceiling of the subject room. The sign should be colour contrasting to the background and be positioned in a readily apparent position (i.e. wall adjacent to the affected ceiling).
2. Cautionary tiger tape is to be provided at the wall-ceiling junction where the height is less than 2.1m.

Figure 11 – Proposed signage
