# GEOTECHNICAL INVESTIGATION REPORT

Project Title – 67-75 Lawford St, Greenacre NSW

Project Type – Proposed Industrial Development

Project No. – GR24232

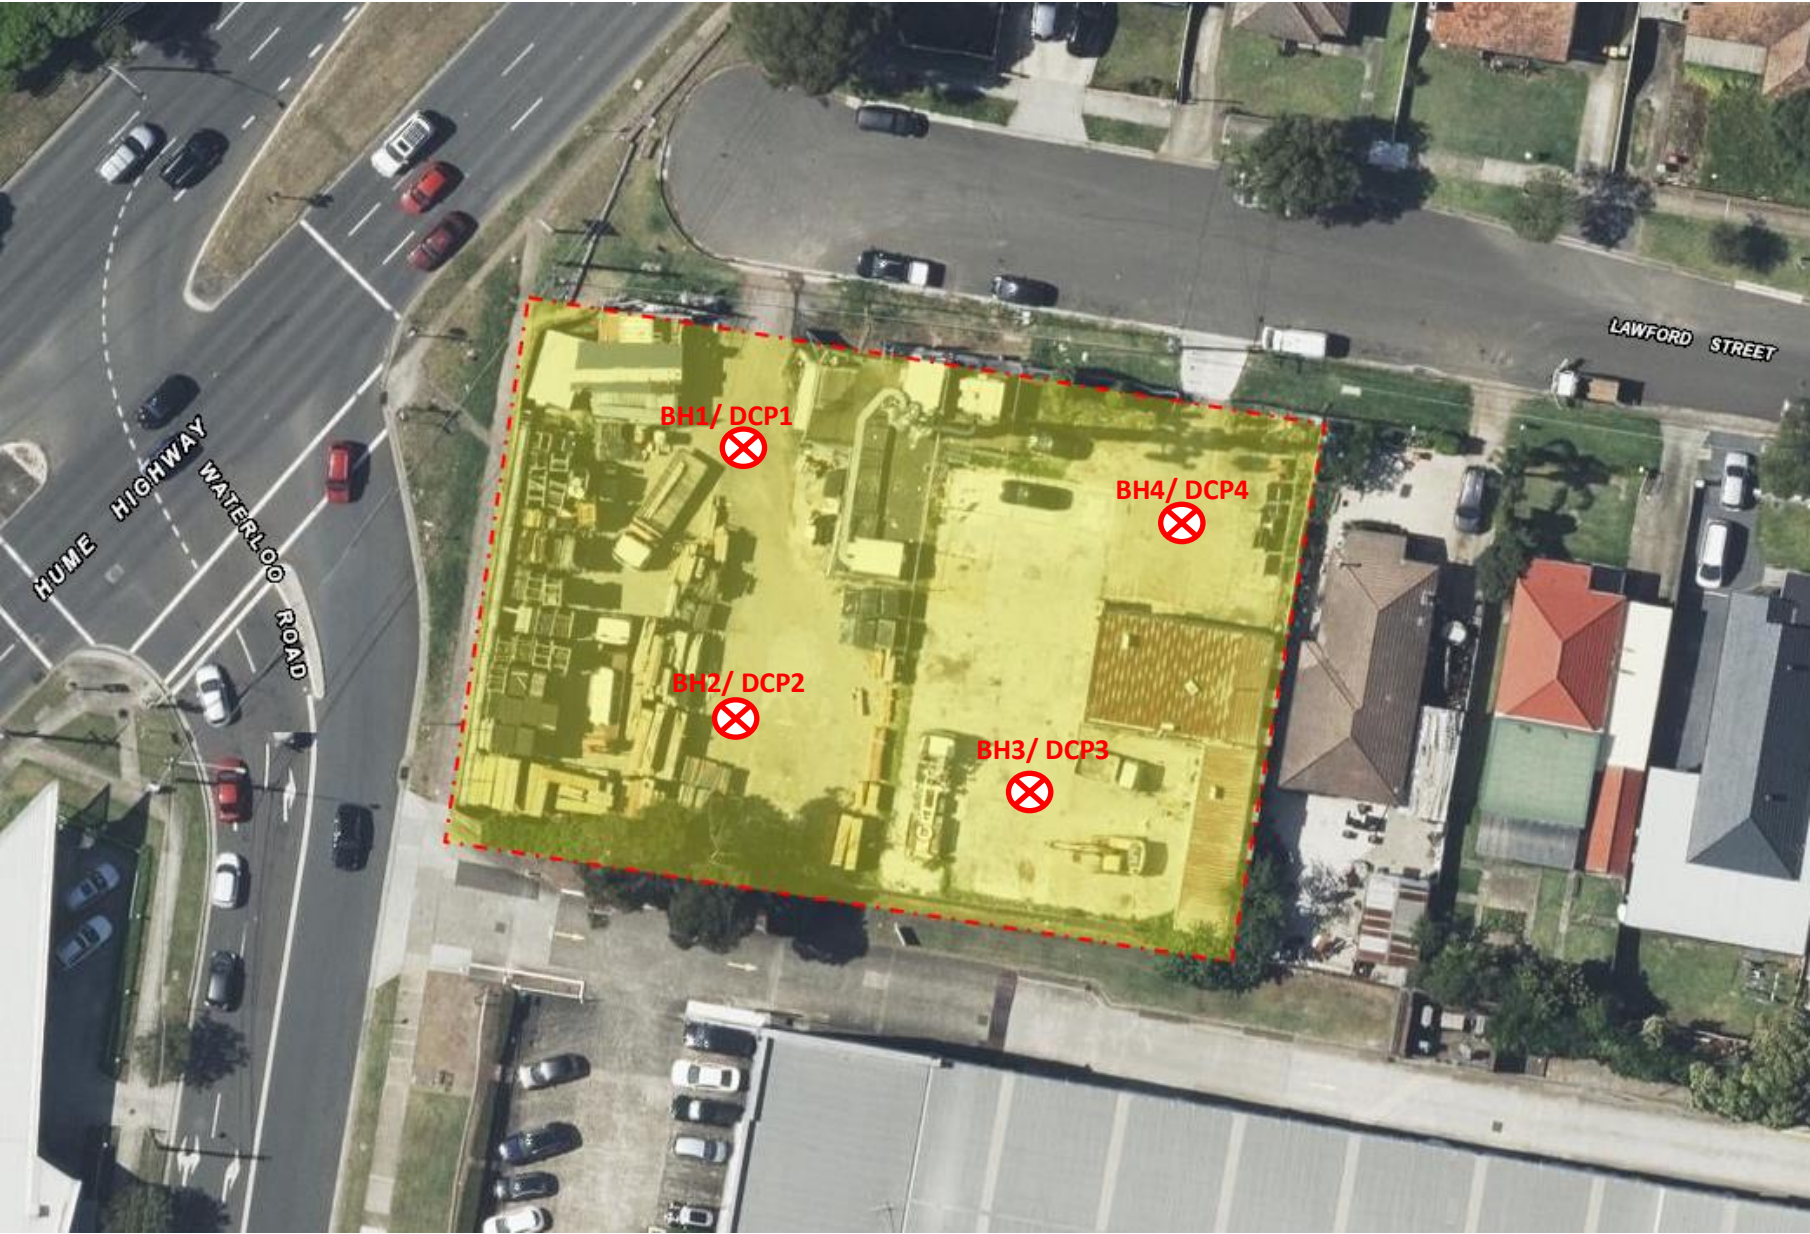
## APPENDIX A – Site Plan

Drawn	AS	CLIENT: ALLAMCORP PTY LTD SITE ADDRESS: 67-75 LAWFORD ST, GREENACRE	Figure	1
Checked	AE		Title	Site Plan
Date	18/10/2024		Job No	GR24232
Scale @ A3	NTS

The results of the investigation indicate that the subsurface profile comprises silty/sandy CLAY underlain by IRONSTONE/SANDSTONE bedrock. Based on the borehole information, a summary of subsurface conditions is presented below. The location of each borehole can be found in Appendix A and more detailed logs can be found in Appendix B.
