# **Demolition of Matong Hall**

## 26-28 Matong Street, Matong

Statement of Environmental Effects

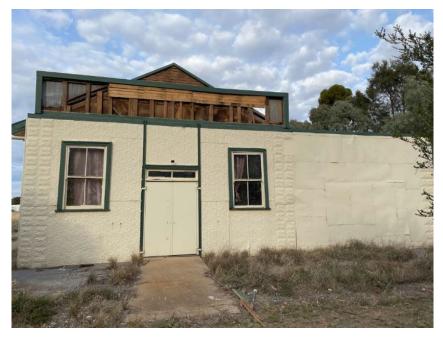
Figure 3-4 View of Building (north elevation)

A locality figures are provided in Figure 3-1 and Figure 3-2, an aerial view of the lot and surrounding area is provided in Figure 3-3 and photographs of the building are provided in Figure 3-4 to Figure 3-7.

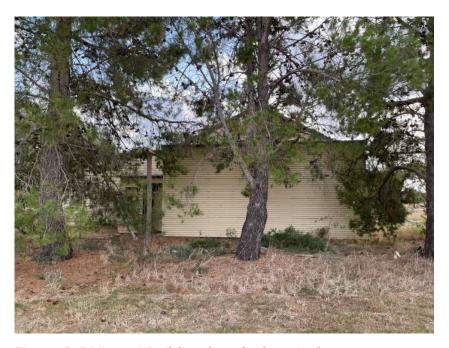
Figure 3-5 View of Building (south elevation)

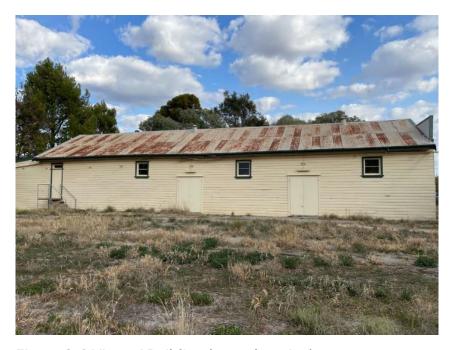
Figure 3-6 View of Building (east elevation)

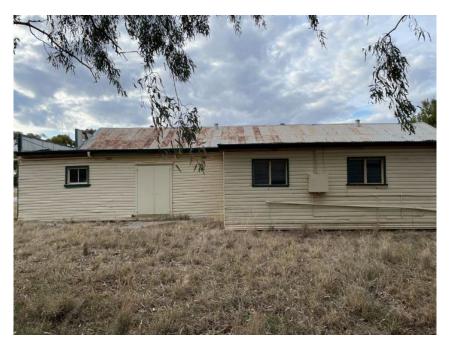
Figure 3-7 View of Building (west elevation)

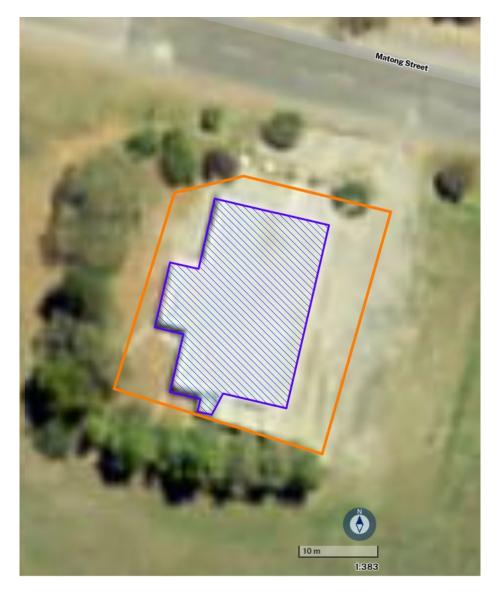
Figure 4-1 Approximate demolition disturbance area shown as the purple hatched outline, approximate hoarding/fenced area in orange

The objective of the demolition program is to facilitate the safe removal of the structures with minimal disturbance to the area and impact on the environment. An approximate disturbance area is shown in Figure 4-1. The scope of works include:

<sup>&</sup>lt;sup>1</sup> Crown Lands are yet to engage a construction contractor. As such a site and hoarding plan is not available. The site and hoarding plans would be included in the DEMP. A basic markup of the site is included in Figure 4-1

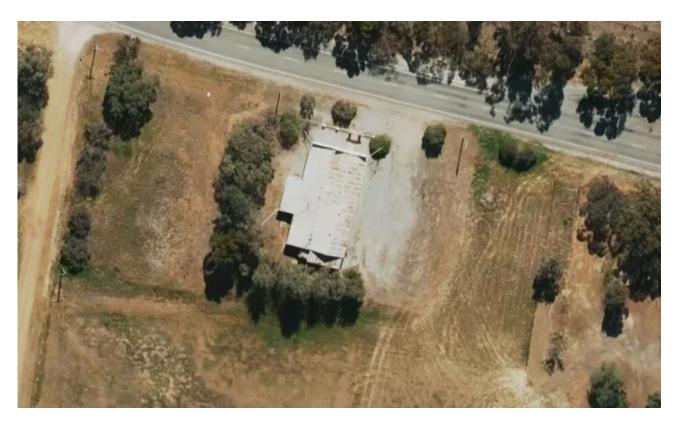
Figure 0-1 Matong Hall

Figure 0-1 provides an overview of the Matong Hall:

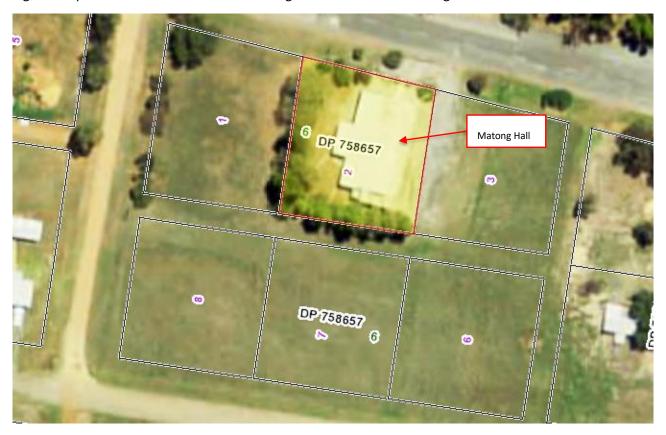
Figure 0-2 Matong Hall Boundaries

Figure 0-2 provides an overview of the Matong Hall boundaries according to its Lot and DP number.

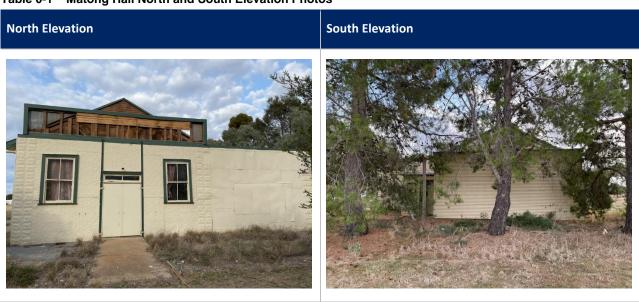
Table 0-1 Matong Hall North and South Elevation Photos

Table 0-1 and Table 0-2 comprise photographs of the North, South, East, and West elevations of the Matong Hall on this site:

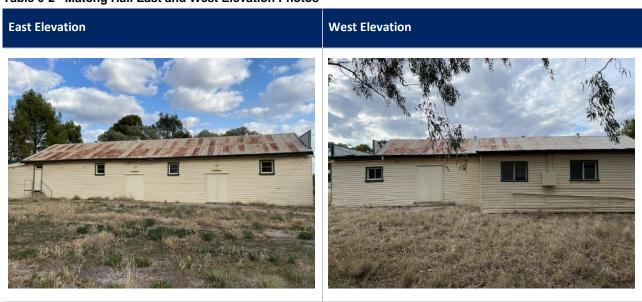
Table 0-2 Matong Hall East and West Elevation Photos

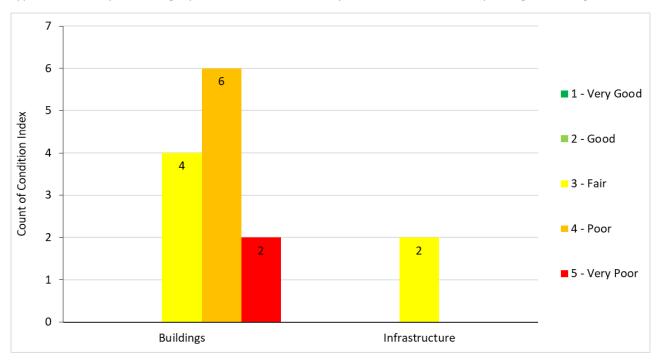
Figure 0-3 Condition Index Count by Asset Type

A condition score was assigned with a 1 to 5 rating as detailed in the Condition Index Table in the Condition Assessment Guide. The condition profile for the Matong Hall is shown in Figure 0-3. As illustrated in this figure, there were no assets with condition ratings of 1, indicating that none of the assets on this site were in a Very Good condition.

Most assets within this site (12 by count or 86%) were in a 3-fair or 4-Poor condition. Figure 0-3 illustrates that of these, 10 assets including 4 assets with 3-Fair condition and 6 assets with 4-Poor condition were categorized under building asset type and 2 assets with 3-Fair condition were under infrastructure asset type. The subsequent category includes assets in 5-Very Poor condition, encompassing 2 building assets.

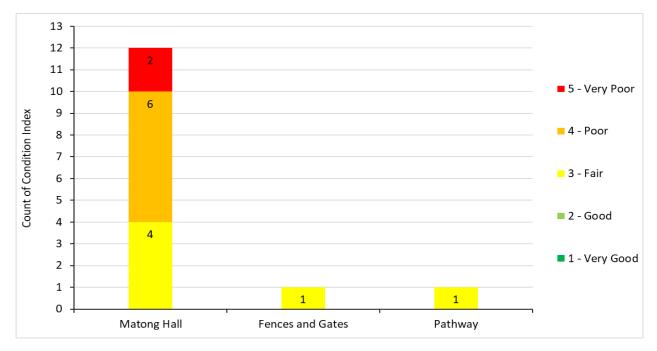
Figure 0-4 Distribution of Condition Index Across Assets

Figure 0-4 illustrates the distribution of condition indexes across various assets. Notably, many assets with a condition rating of 4-poor were in the Matong Hall building. Following that, four assets rated as 3-Fair and two assets with condition rating of 5-Very Poor were also situated in the Matong Hall.

Assets with a condition rating of 3-Fair were scattered across the Fences and Gates and the Pathway.

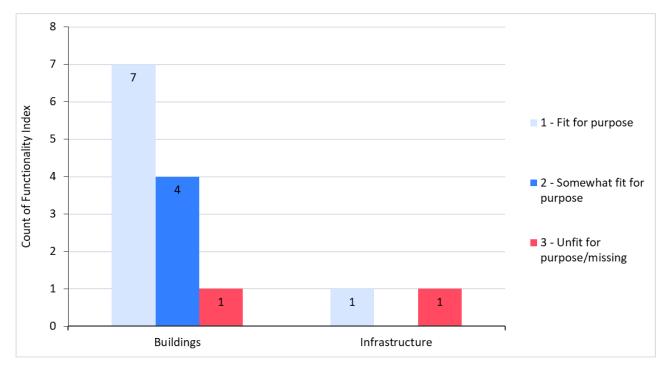
Figure 0-5 Functionality Index Count by Asset Type

A Functionality score was assigned with a 1 to 3 rating as detailed in the Functionality Index Table in the Condition Assessment Guide. From the total of 14 assets, 8 or 57% of assets had functionality score of 1 and were fit for purpose. The Functionality profile for the Matong Hall is shown in Figure 0-5.

It indicates that most assets within the Buildings asset type were deemed fit for purpose (assuming they were in a good condition). The next group includes four assets in Buildings assets that were categorized as somewhat fit for purpose. Additionally, the figure notes that there are 2 assets which were either unfit for purpose or missing; this includes 1 asset in the buildings and 1 in infrastructure asset types.

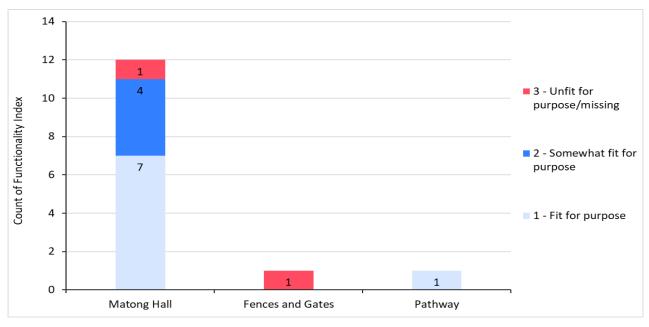
Figure 0-6 Distribution of Functionality Index Across Assets

Figure 0-6 illustrates the distribution of functionality indexes across various assets. Notably, four assets with a functionality rating of 2 (Somewhat fir for purpose) were part of the Matong Hall building. These Assets included the following:

Subsequently, two assets as part of Matong Hall and Fences and Gates assets were deemed unfit for purpose (functionality index 3). The list of these assets is as below:

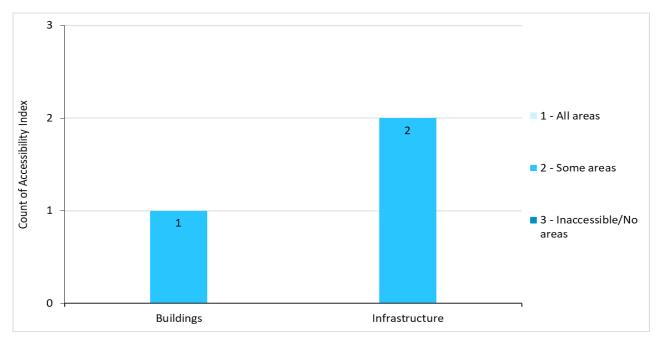
Figure 0-7 Accessibility Index Count by Asset Type

Out of a total of 3 assets, 1 asset from Buildings asset type and 2 assets from Infrastructure asset type some accessibility provisions for individuals with disabilities. Importantly, no building on this site provided full accessibility. These findings are visually represented in Figure 0-7.

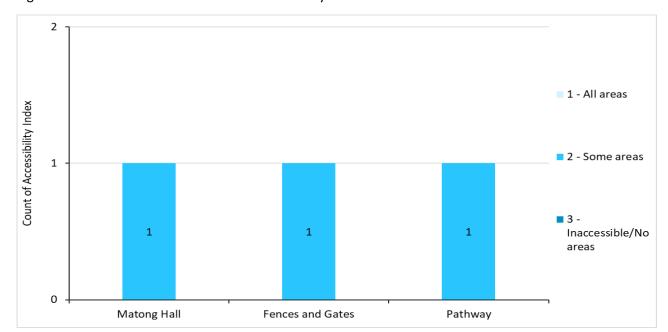
Figure 0-8 Distribution of Accessibility Index Across Assets

Figure 0-8 illustrates the distribution of Accessibility indexes across various assets.

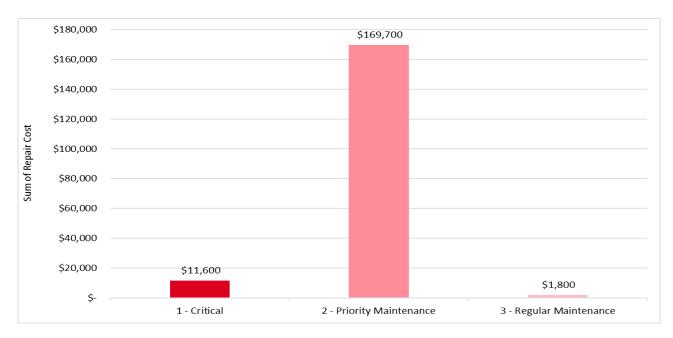
Figure 0-9 Projected Repair Costs

The forecasted defect costs are shown in Figure 0-9. Notably, there are significant expenditures projected for rectification of defects with rating of 2. The second group of costs are primarily due to rectification of defects with rating of 1. The last group of defect rectification costs are related to the defects with rating of 3.

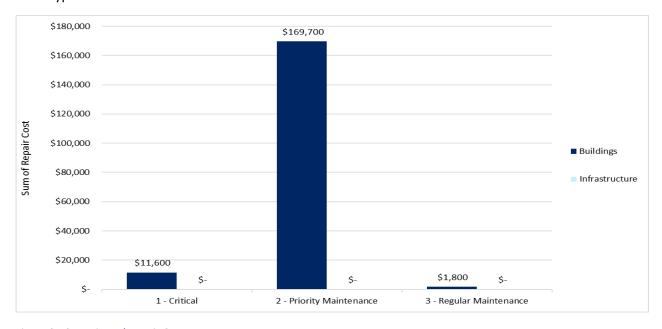
Figure 0-10 Projected Repair Costs per Asset Type

The forecasted defect rectification expenditure per asset type is shown in Figure 0-10. The graph illustrates that all costs related to rectification of defects with ratings 2, 1 and 3 are projected to be spent on Buildings asset types.

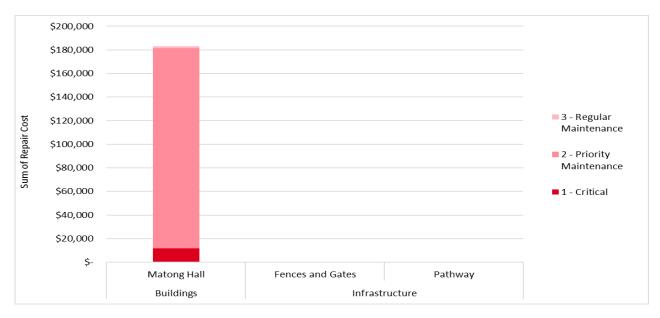
Figure 0-11 Projected Repair Costs per Asset

The projected defect rectification costs to be addressed for each asset are shown in Figure 0-11. In the Buildings asset category, there are defects that need to be repaired within the next month which are part of the Matong Hall.

Within the next 6 to 12 months, most costs will be spent on Matong Hall assets. Finally, a smaller portion of defects withing the Matong Hall need to be repaired after the next year.

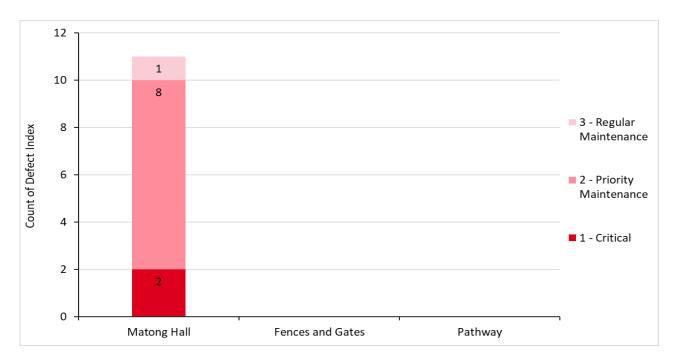
Figure 0-12 Defects Distribution Across Assets

Figure 0-12 presents an overview of defect distribution across the 14 assets inspected on this site. As seen from the figure, all defects were found in the Matong Hall building. Conversely, the fences and gates and the Pathway did not have any defects.

It is crucial to consider the number of defects in conjunction with the defect rating and criticality. For instance, even though all defects were in the Matong Hall, only two of them were critical defects that require immediate attention.

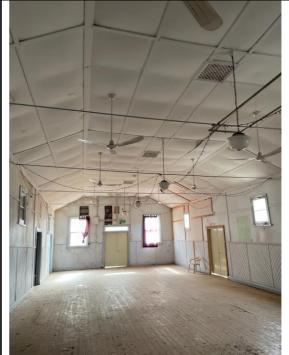
Plan and add additional light fittings. (This is an improvement activity). Allow cost for a nominal eight (8) additional fittings.

**Asset Name** Matong Hall Defect ID SW01\_MA\_A01\_C11\_D01 Subtype Hydraulic Services Defect Rating 1 - Critical Description Gutters and Downpipes Repair Cost \$1,600.00 Repair Required
Clean out all gutters around the building. Defect Description Gutters blocked and need to be cleaned

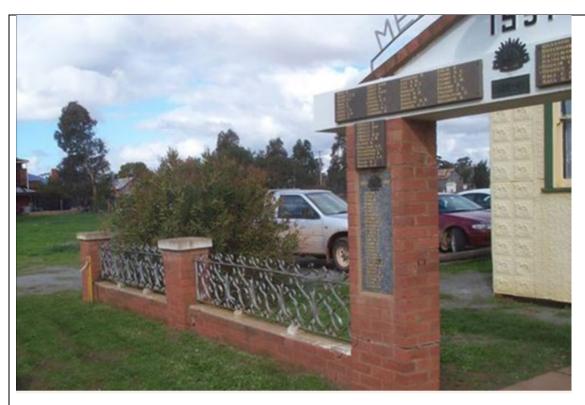
Figure 2-9: Matong Memorial Gates in Original Position at Matong Hall 2021. (Source: NSW War Memorials Register Website.)

The memorial is in the form of a brick fence about 115 feet along the frontage of the Mechanics' Institute Hall, and is surmounted with grille work. At the small entrance gate the pillars are of brick, and are joined with a massive concrete flat arch, on which are the words in raised letters "Memorial Gates." The two sets of gates are the gift of Messrs. H. V. McKay. On each of the pillars is a granite tablet each bearing the names of 27 men who enlisted from Matong. The fence was erected by Mr. G. S. Baker, of Ganmain, who made a very good job of his contract.

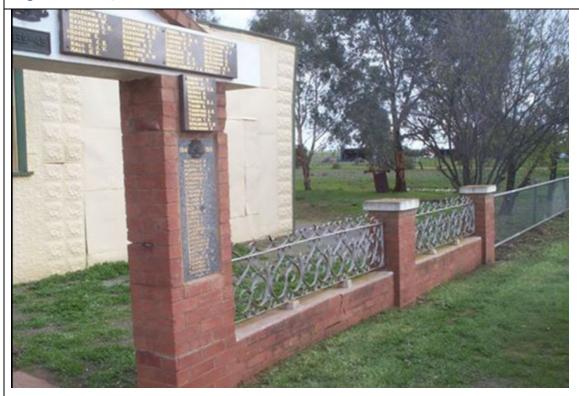
Figure 2-10: Matong Memorial Gates in Original Position at Matong Hall 2021. (Source: NSW War Memorials Register Website.)

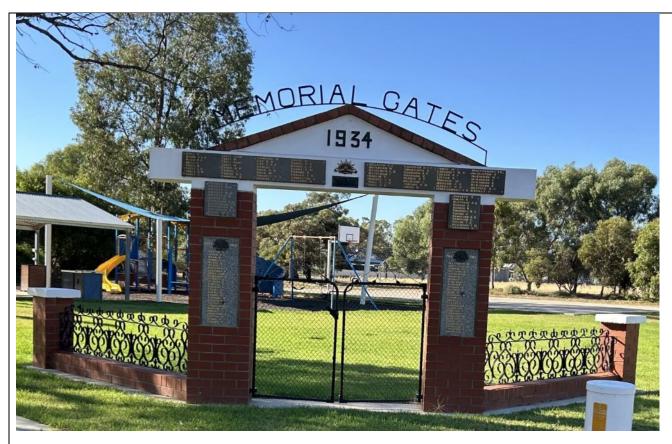
Figure 2-11: Matong Memorial Gates, relocated to Matong Park.

The Memorial Gates were re-located to Matong Park in 2023, on the southeast corner of Matong Street and Deepwater Road, see Figure 2-11. At that time, a plaque was installed on the gates, as seen in Figure 2-12 marking their relocation from the hall to the park. The Matong Memorial Gates are listed on the NSW War Memorials Register, although they are still shown on that register as being located in front of the hall.<sup>5</sup>

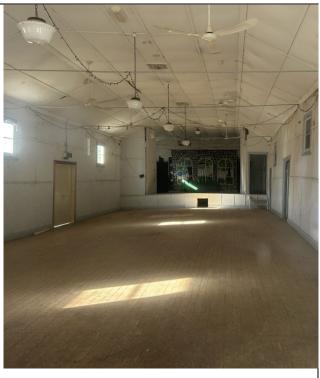
Figure 2-24: Interior looking towards stage at the rear.

Internally, the original hall space has timber lining boards to dado height and a solid timber floor. There is a raised stage, seen in Figure 2-24, at the south end with basic timber framed screens and a fire exit in the east wall. Walls in general are fibro lined, and the ceiling is either Gyproc or sheet metal with a central ceiling grill. There are pairs of timber framed batten doors leading to the dining space.

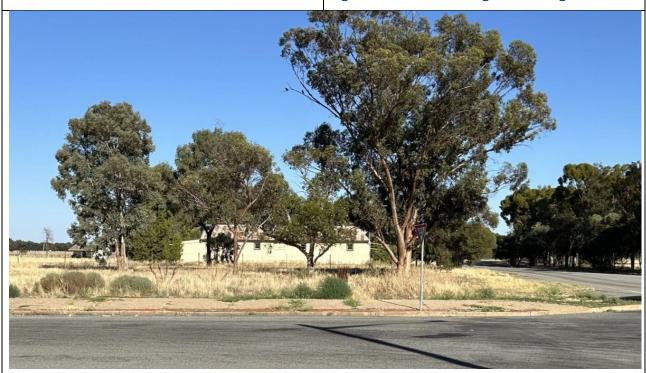
Figure 2-25: View of east elevation from Matong Park.

The Matong Hall, seen from Matong Park across Deepwater Road in Figure 2-25, is a rectangular single-story timber-framed building with weatherboard siding and corrugated iron roofing. The building has a western annex (dining area), also weatherboard clad with skillion roof, running the full length of the hall. Off that western extension is a smaller kitchen annex near the southern end. There is another double extension (one part being toilets, the other a backstage area) at the south end.

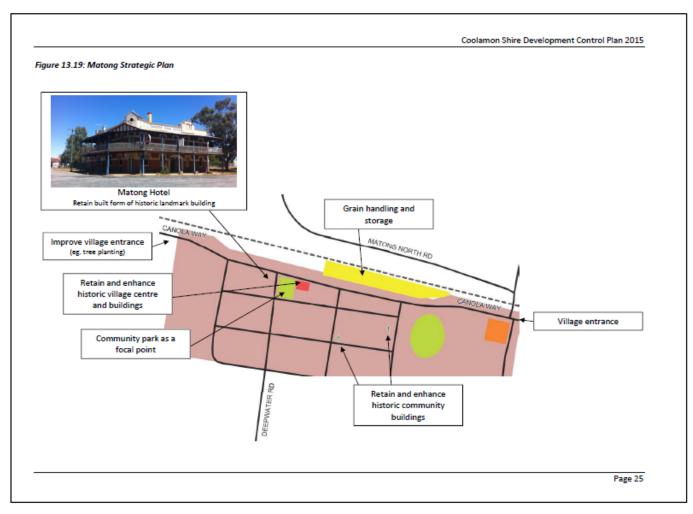
Figure 3-1: Matong Strategic Plan within the DCP. (Source: Coolamon Shire Council Website.)

The diagram at Figure 3-1, is provided within the DCP to inform future development within Matong, however it is outdated, as it calls for the historic landmark building, the Matong Hotel (Farmer's Home Hotel) to be retained, although it was demolished following a fire in 2018.
