BOREHOLE & LABORATORY TEST REPORT

LOT 2 59 LUCAS ROAD EAST HILLS

Prepared by RafZan Consulting Engineers

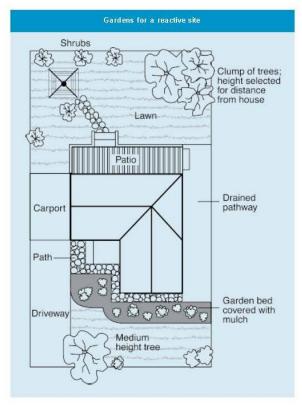
For this reason, particularly where problems exist or are likely to occur, it is recommended that an apron of paving be installed around as much of the building perimeter as necessary. This paving

should extend outwards a minimum of 900 mm (more in highly reactive soil) and should have a minimum fall away from the building of 1:60. The finished paving should be no less than 100 mm below brick vent bases.
