# Limited Site Classification

Lot 20 No.69 Durham Rd, East Gresford NSW

Project: P20067-WR-18006

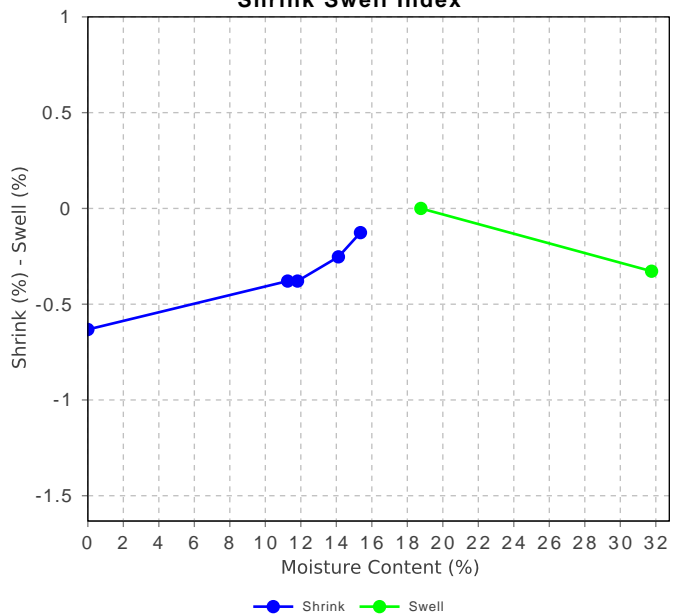
## Shrink Swell Index

Initial Pocket Penetrometer (kPa)	250
Final Pocket Penetrometer (kPa)	175
Initial Moisture Content (%)	18.8
Final Moisture Content (%)	31.8
<b>Swell (%)</b>	<b>-0.3</b>
