Landcom

Remedial Action Plan

Stage 5 and Stage 6
Claymore Renewal Project
Claymore, NSW

17 November 2022

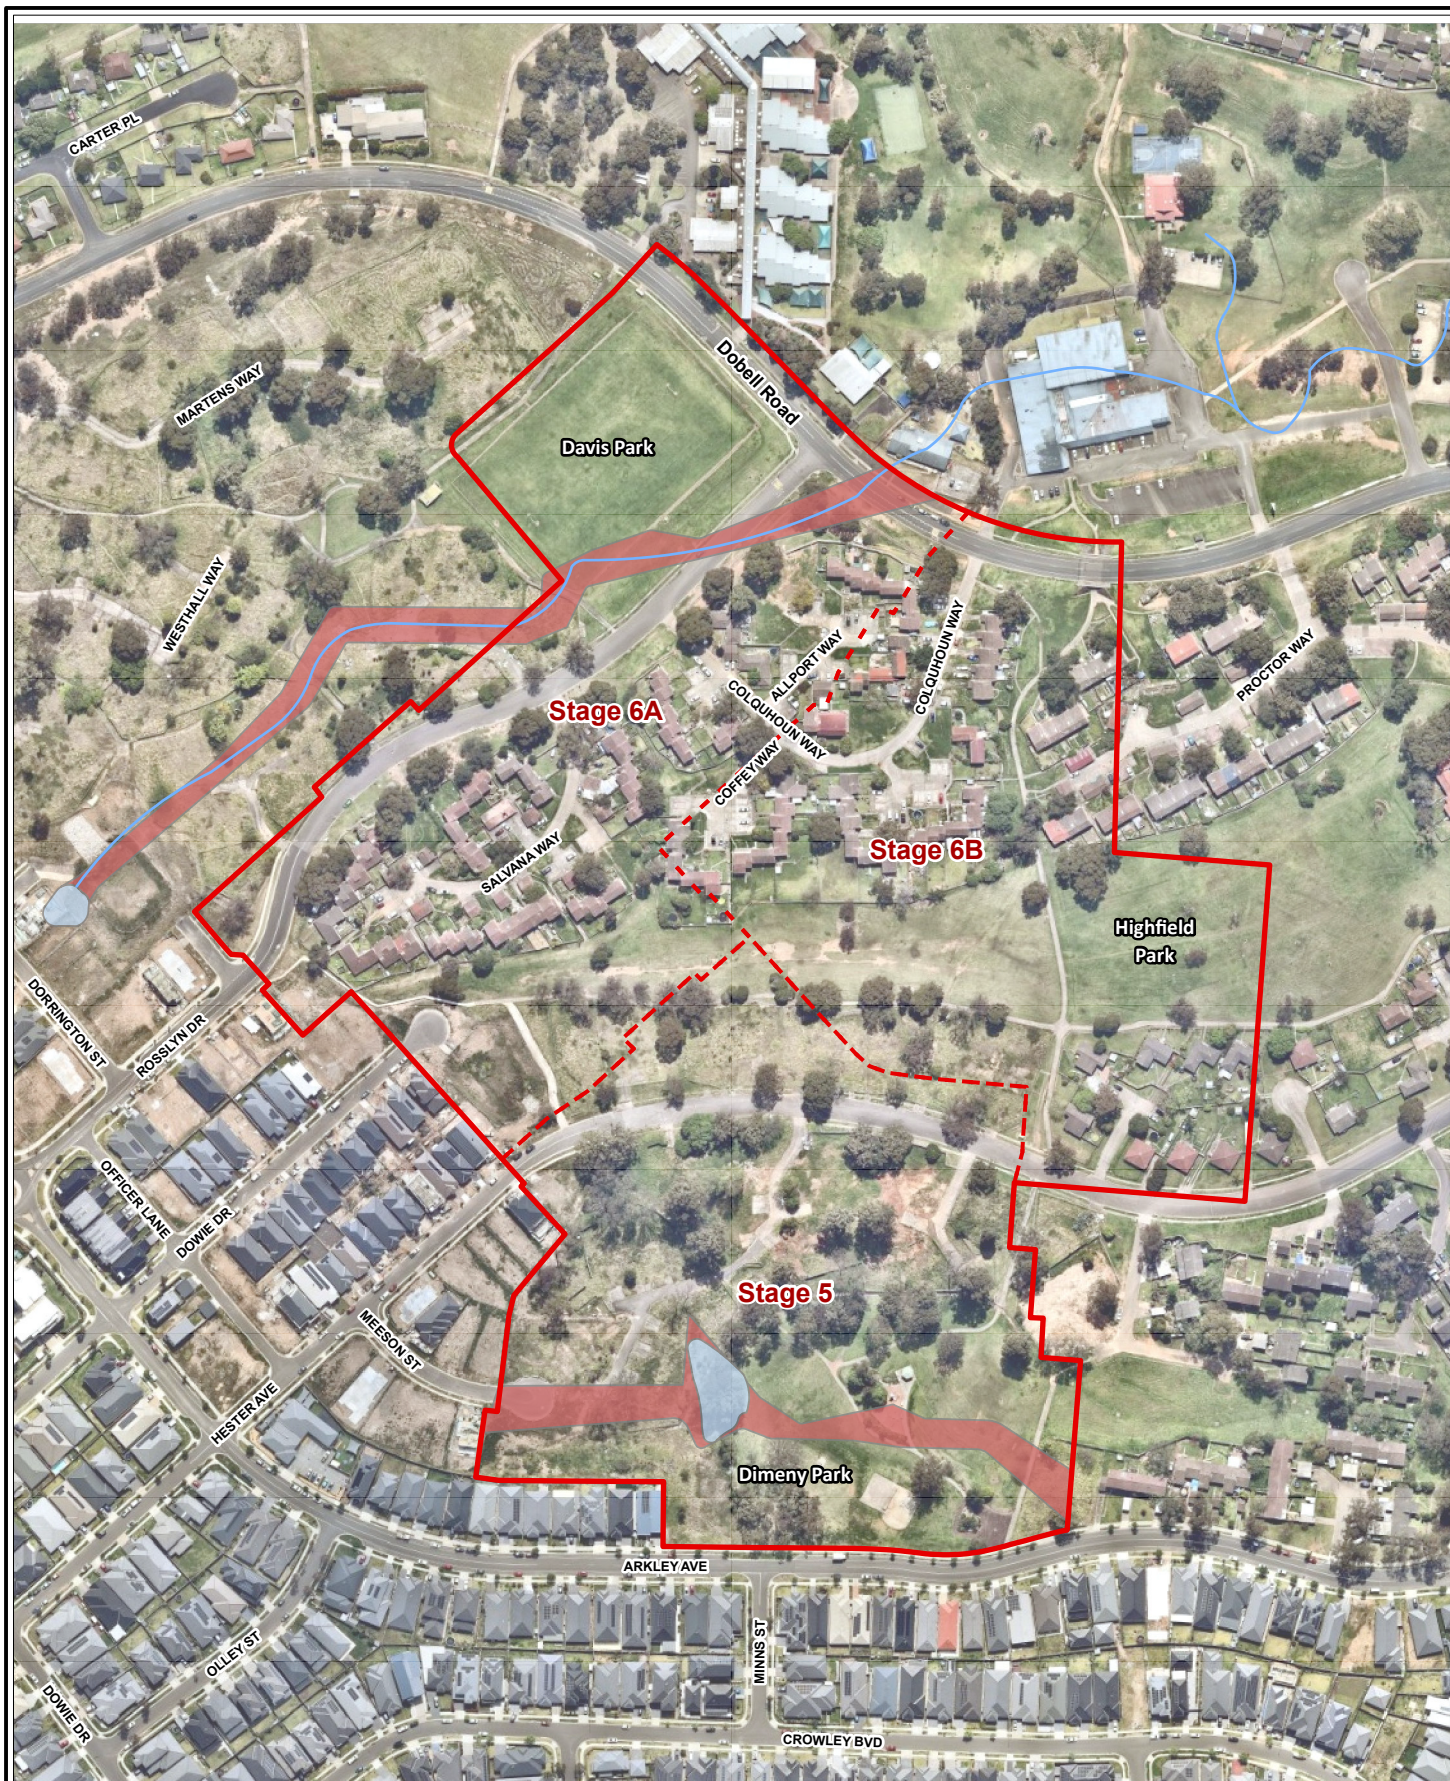
FIGURE 2

- Approximate Site Boundary
- - - Stage Boundary
- Site Features (Douglas Partners, 2020)
- Approximate Gully and Dam Fill Area
- Approximate Historical Dam Locations
- Approximate Historical Creek Line

The site location is shown on **Figure 1**. The site layout is shown in **Figure 2** and **Figure 3**, shows the numerous cadastral lots that legally define the site, as identified in **Section 2.1**.

The following site condition and surrounding environment is based on review of DP (2020). The location of the sites is shown in **Figure 1**. The layout of the site and the cadastral boundaries are shown respectively in **Figure 2** and **Figure 3**. The site details are summarised in **Table 2.1** and described in detail in the following sections.

The site layout is shown on **Figure 2**.

The current land use of adjacent properties and across adjacent roads is shown in **Figure 2** and summarised below.

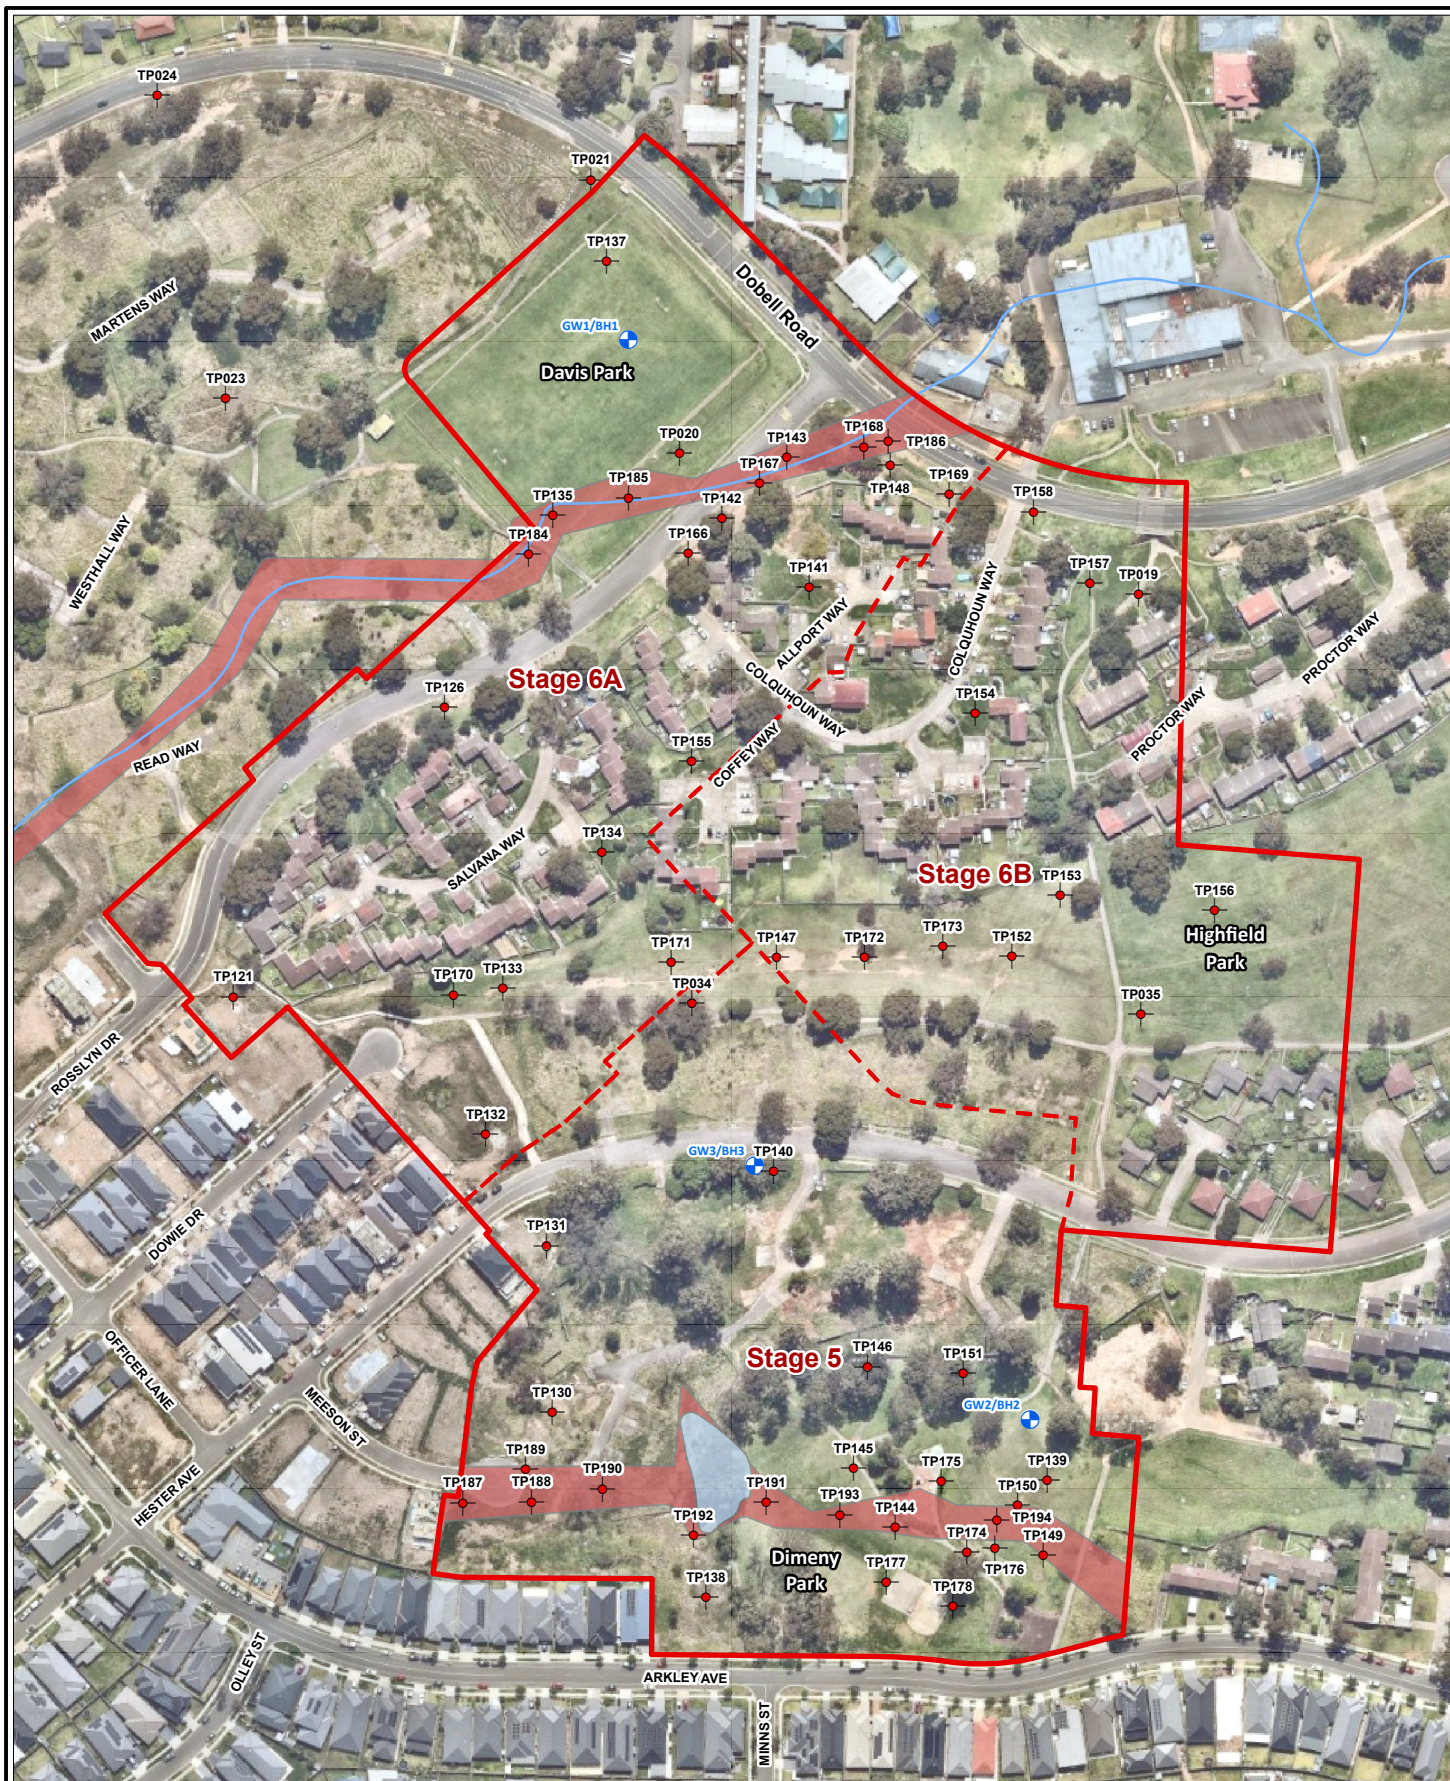
FIGURE 4

- Legend**
- Approximate Site Boundary
 - - - Stage Boundary
 - Site Features (Douglas Partners, 2020)
 - Approximate Gully and Dam Fill Area
 - Approximate Historical Dam Locations
 - Approximate Historical Creek Line
 - Historical Sample Locations (Douglas Partners, 2020)
 - Test Pit Location
 - ⊕ Monitoring Well/Borhole Location

The DSI investigation included excavation of 54 testpits and associated soil sampling through the various stages, including 24 testpits within Stage 5, 21 testpits within Stage 6A and 9 testpits within Stage 6B. Test pit locations are shown on **Figure 4**. The investigation also included three soil bores (one Stage 6A and two Stage 5) and installation and groundwater assessment of one monitoring well (in Stage 6A). Summary Tables are provided as **Appendix A** and borelogs are provided as **Appendix B**.

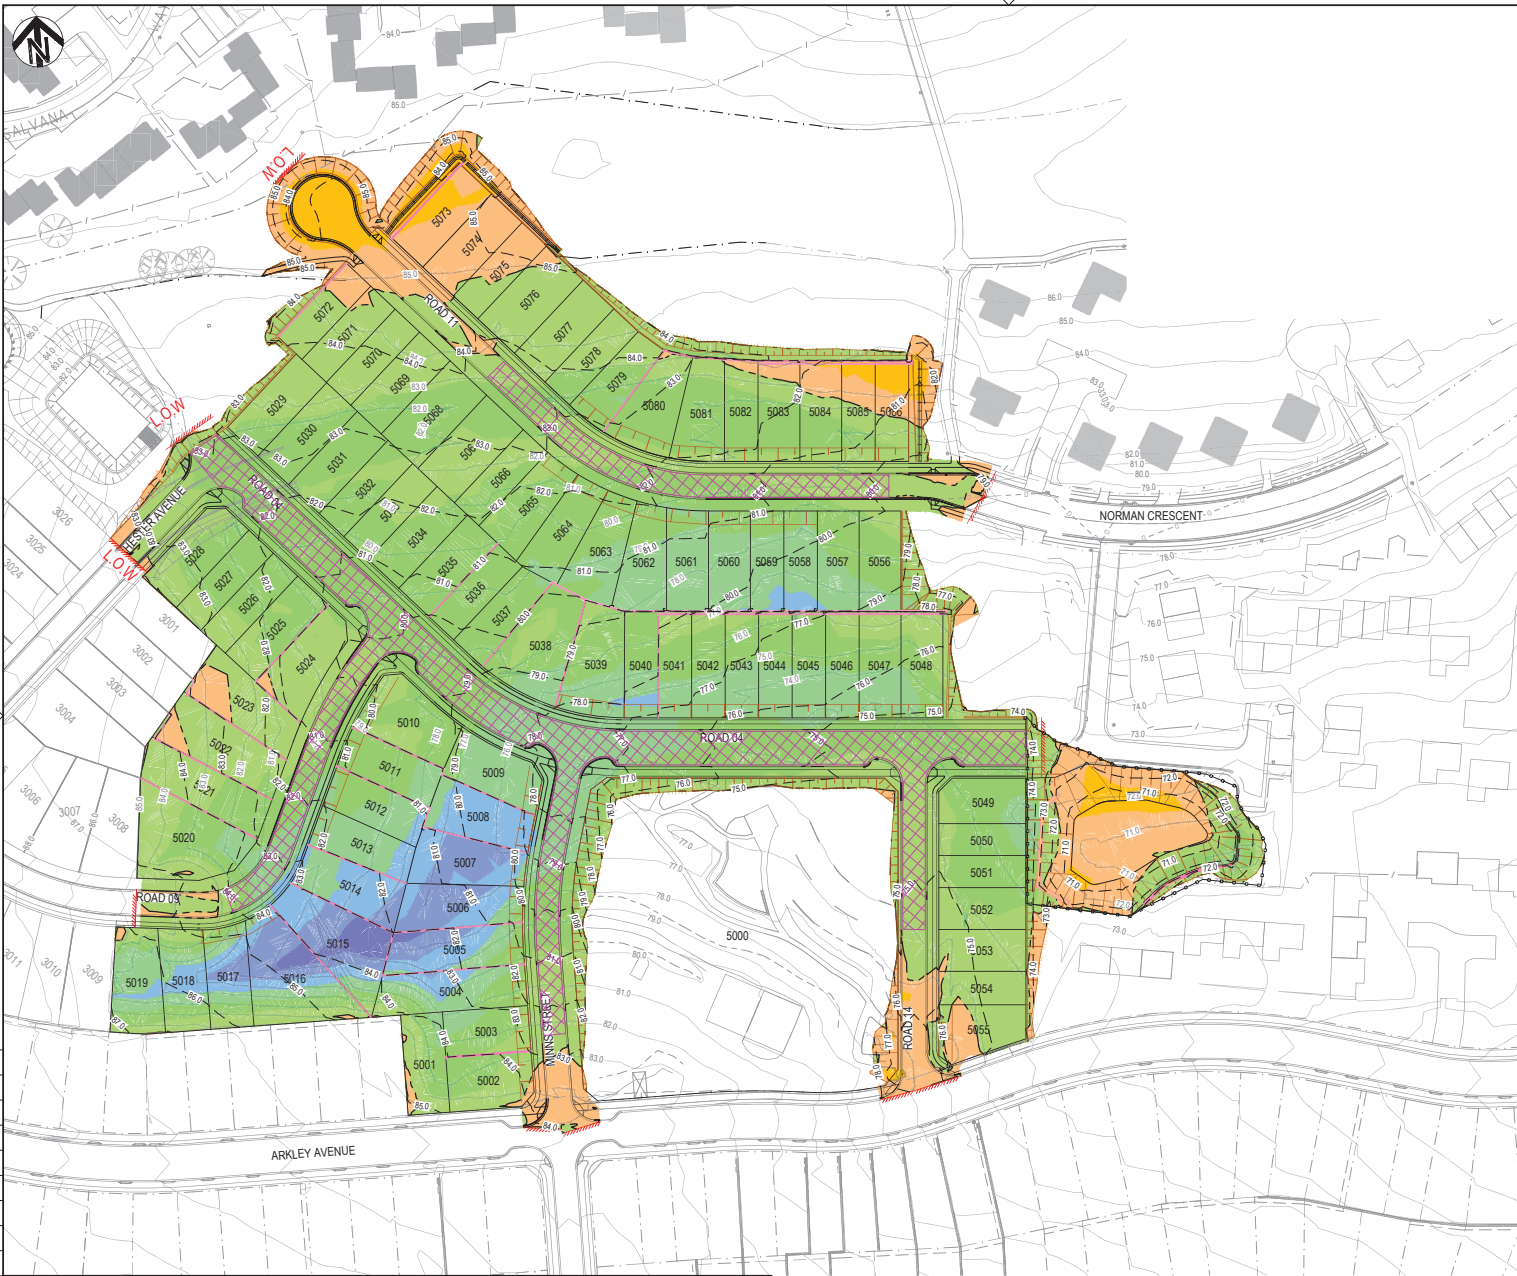
Appendix D Containment Cell Plans

- EXISTING CADASTRAL BOUNDARY
- ROAD BOUNDARY
- LOT BOUNDARY
- RETAINING WALL
- BATTER (1:4 MAX)
- CUT/FILL LINE
- LIMIT OF WORKS
- EXISTING CONTOUR
- DESIGN CONTOUR
- CONTAMINATED MATERIAL BURIAL CELLS
