## AS2870-2011 SITE CLASSIFICATION

CLIENT:  
**Hunter Homes NSW**

SITE ADDRESS:  
**Lot 33, No 2 Olax Place  
Diamond Beach NSW**

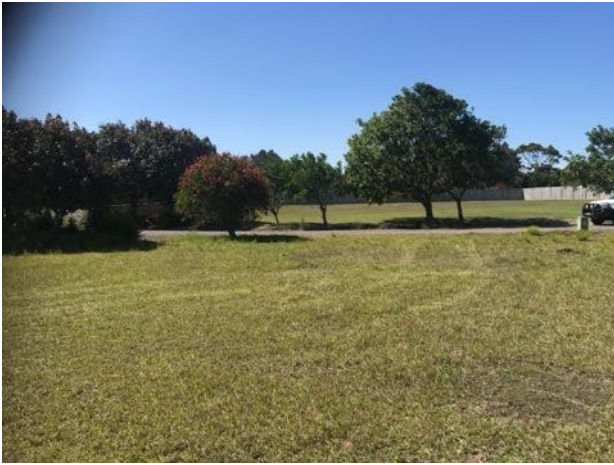
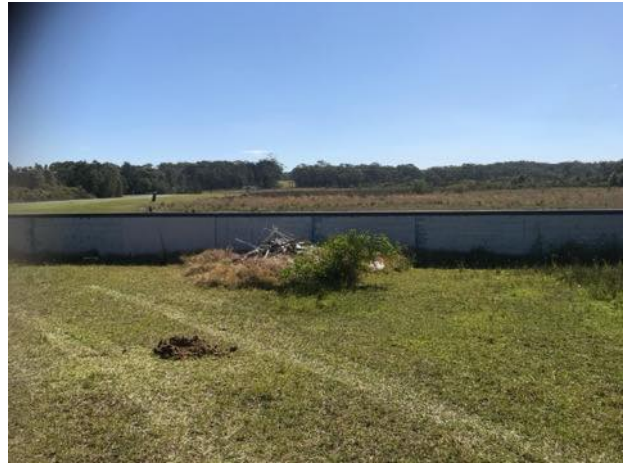
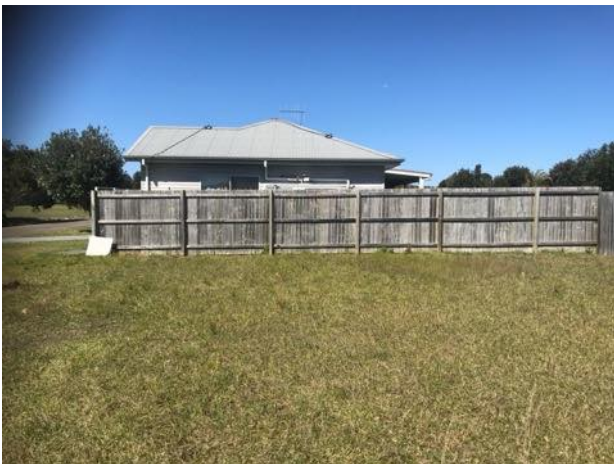
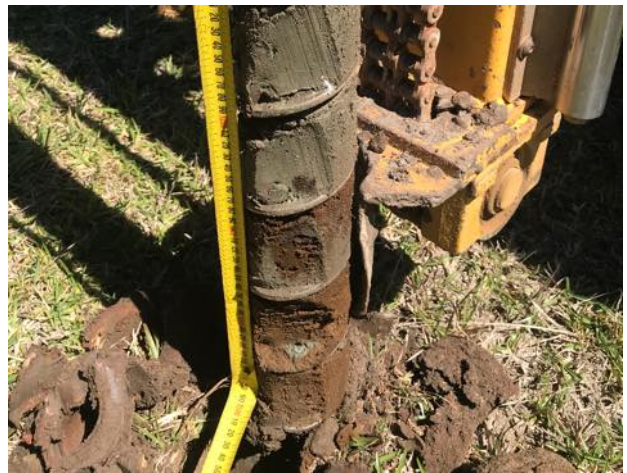
SITE PHOTOGRAPHS

| Site Features: | Vacant Site with grass & adjoining trees |
| Site Drainage: | Fair (At time of testing) |
| Ground Slope | Gentle |
