## **Geotechnical Investigation Report**

### **Proposed Dual Occupancy Dwelling**

**24 Saurine Street, Bankstown NSW**

**Report No. R26138. Rev0**

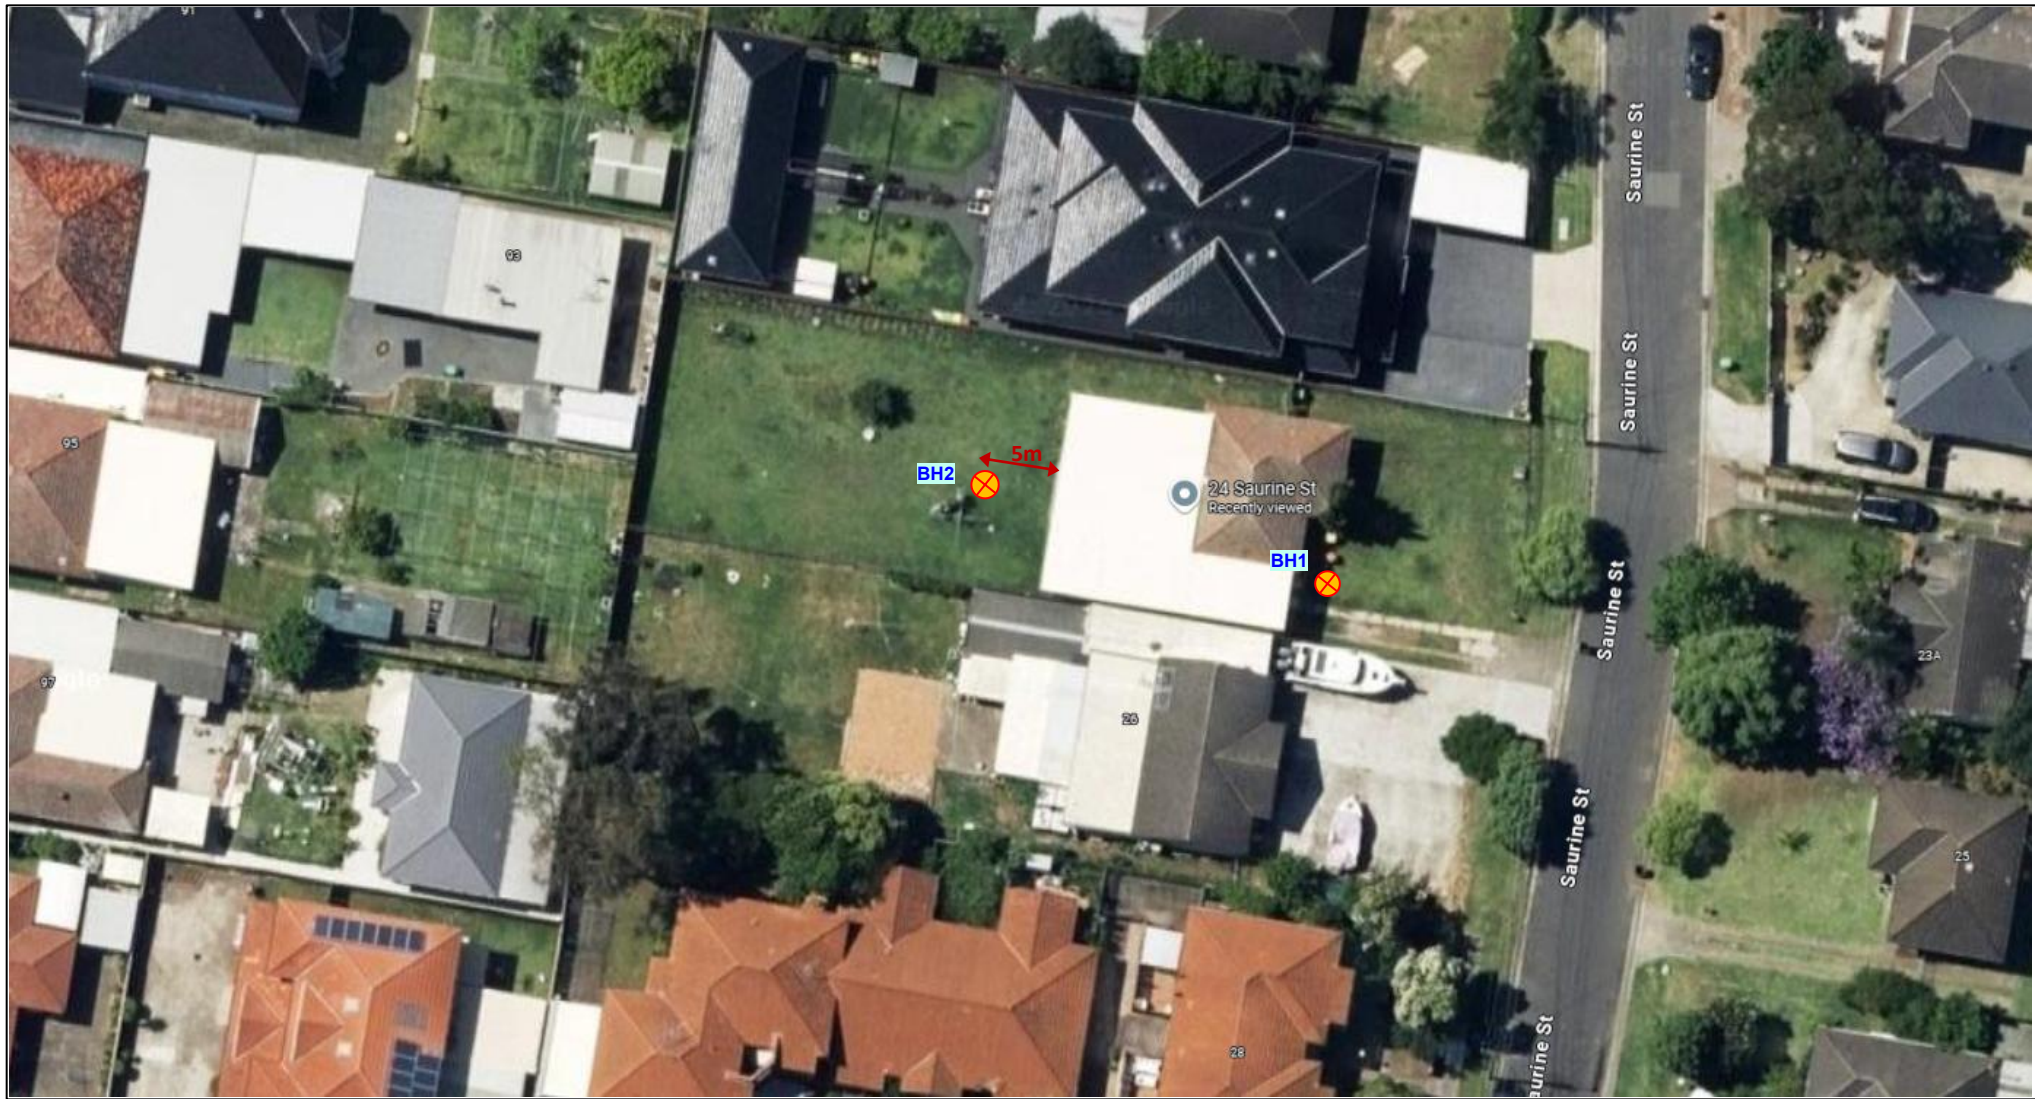
Approximate Borehole Locations

| Appendix A | Approximate Borehole Locations |

Subsurface investigation involved drilling two boreholes (BH1 and BH2) across the allotment. BH1 at the front was drilled using a Hilux mounted Christie Engineering drilling rig equipped with solid flight augers. Due to restricted vehicular access to the rear, BH2 was drilled using hand portable augers.

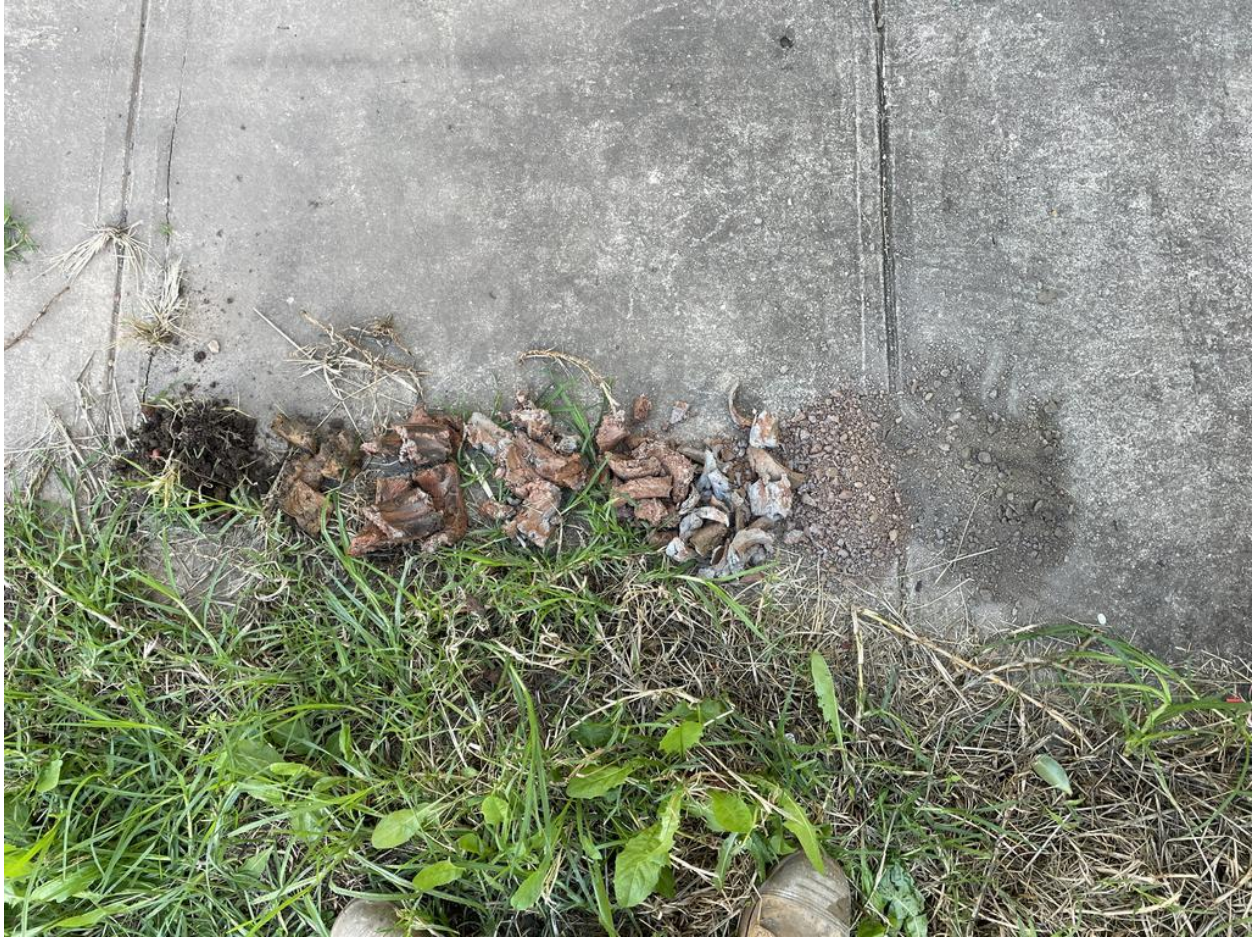
Subsurface Material - BH1

Rig: Ute Mounted Christie Rig

Water Observations: N/A

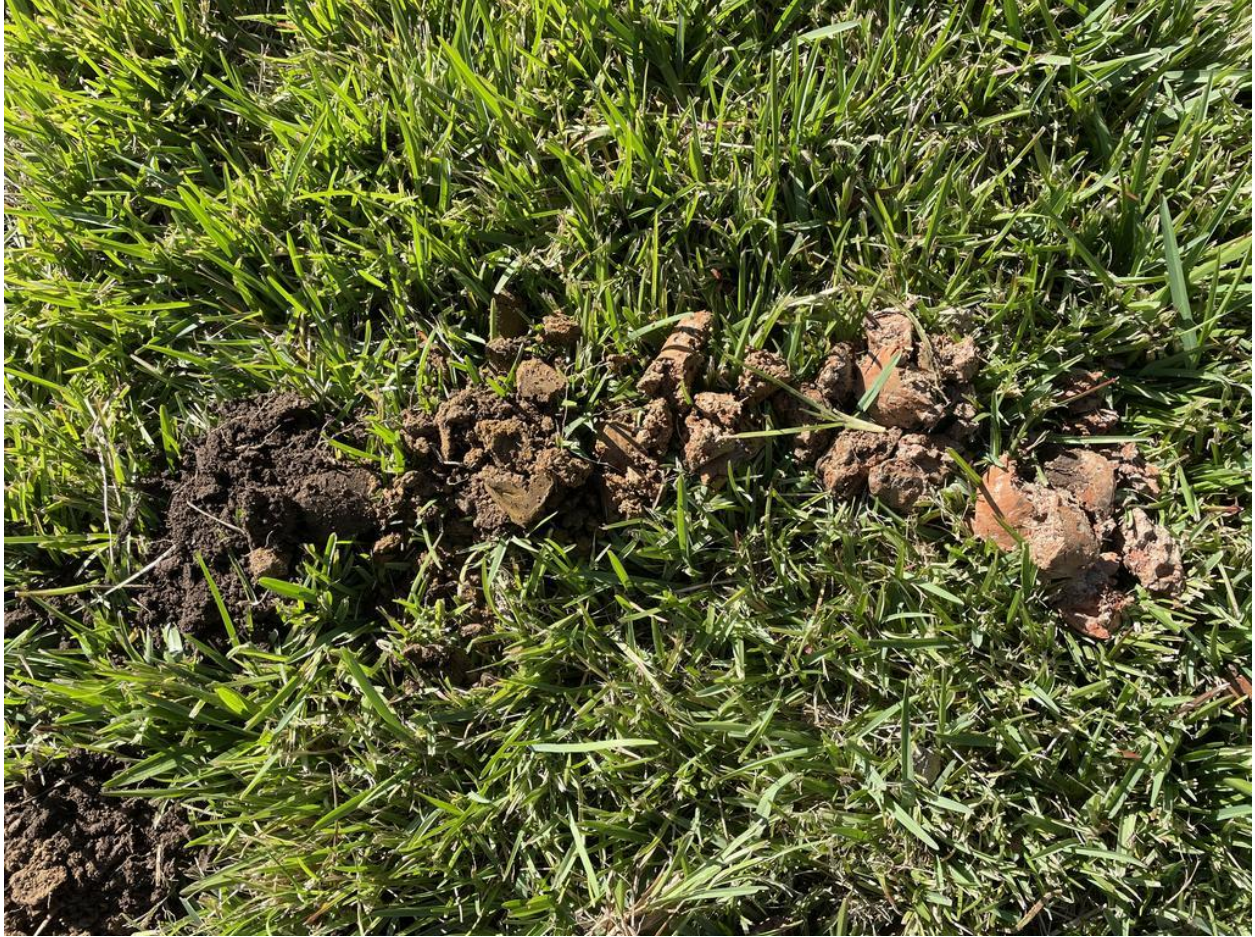
Subsurface Material – BH2

Equipment: Hand Auger

Water Observations: N/A
