## GEOTECHNICAL SITE INVESTIGATION

5 Kinlyside Close, Young, NSW 2594.

H26-625.

Re: Proposed Residential Development at 5 Kinlyside Close, Young, NSW 2594.

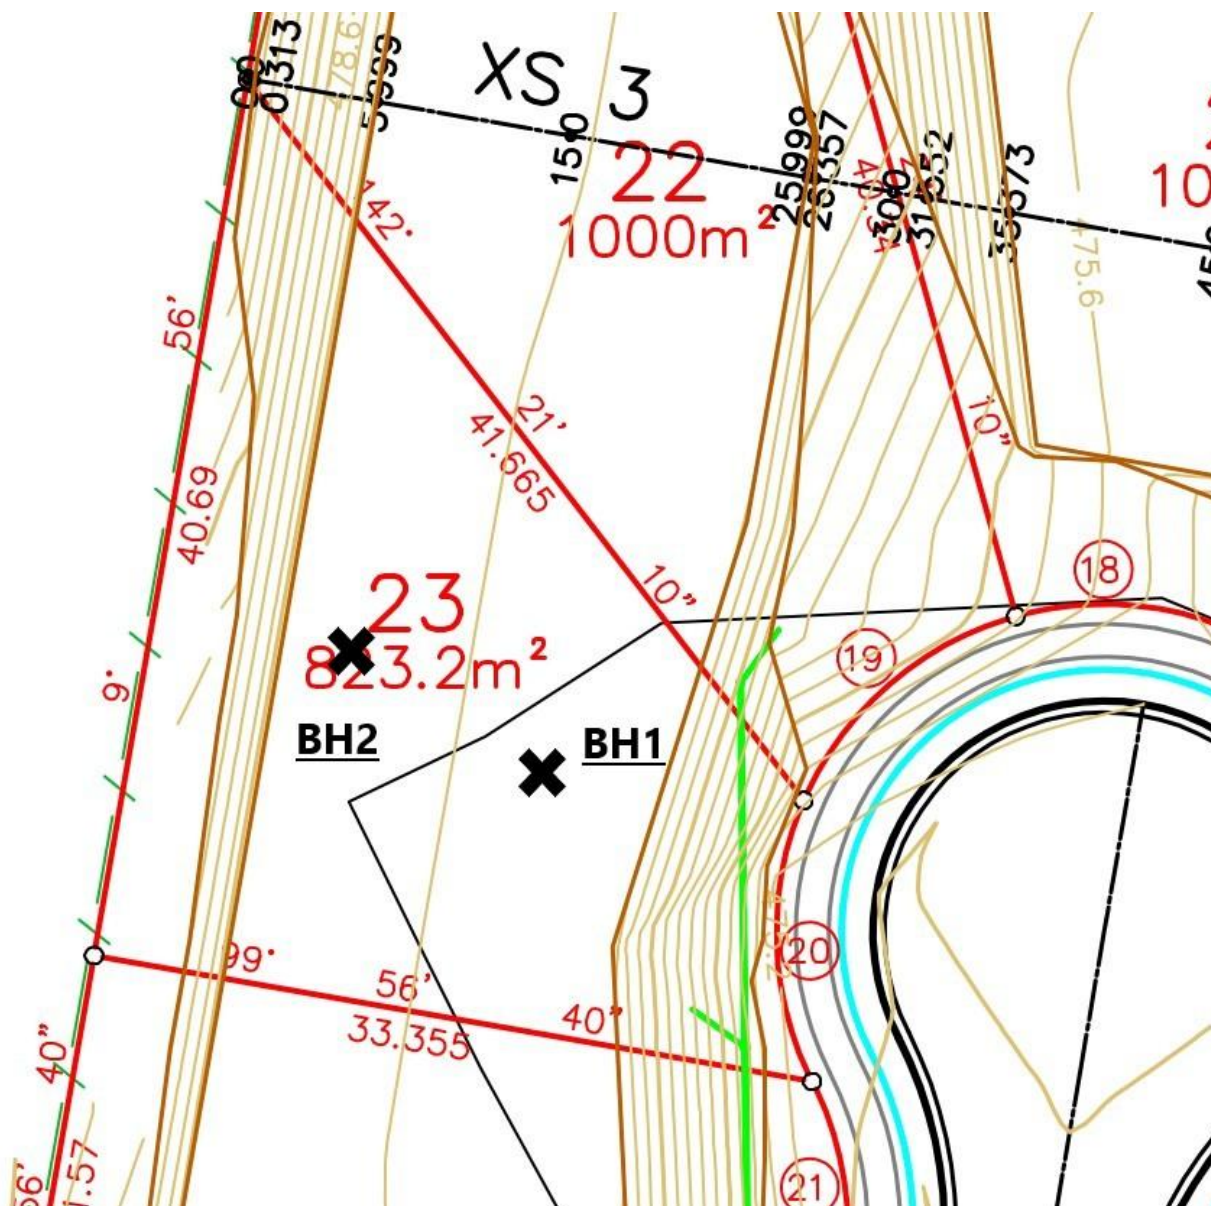
Lot Plan of the site with ASCT approximate test positions.

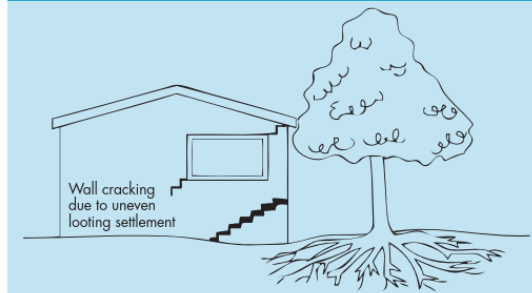
#### Trees can cause shrinkage and damage

As the weather pattern changes and the soil begins to dry out, the external footings will be first affected, beginning with the locations where the sun's effect is strongest. This has the effect of lowering the

external footings. The doming is accentuated and cracking reduces or disappears where it occurred because of dishing, but other cracks open up. The roof lines may become convex.

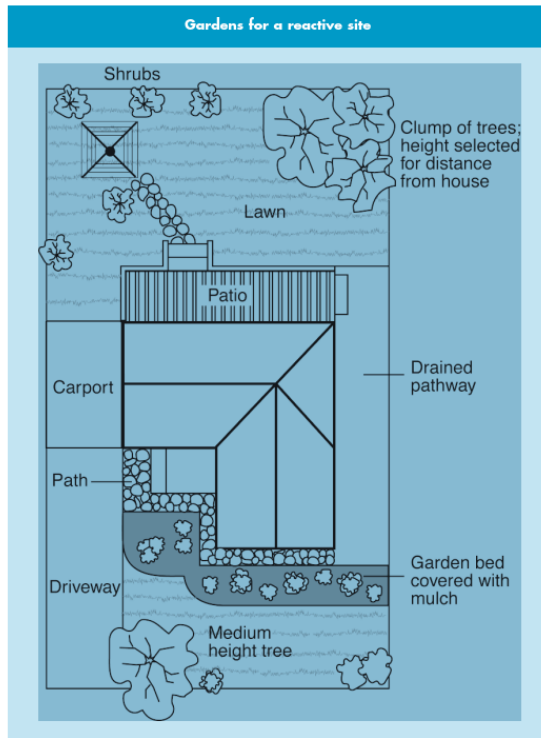
extend outwards a minimum of 900 mm (more in highly reactive soil) and should have a minimum fall away from the building of 1:60. The finished paving should be no less than 100 mm below brick vent bases.
