Reference: 7787-4-R1 Rev2  
25 August 2026

Kosciuszko Thredbo Pty Ltd  
By email: chris\_byrnes@evt.com

## **Proposed Installation of Snowmaking Unit No 2, Friday Flat, Thredbo NSW Geotechnical Assessment**

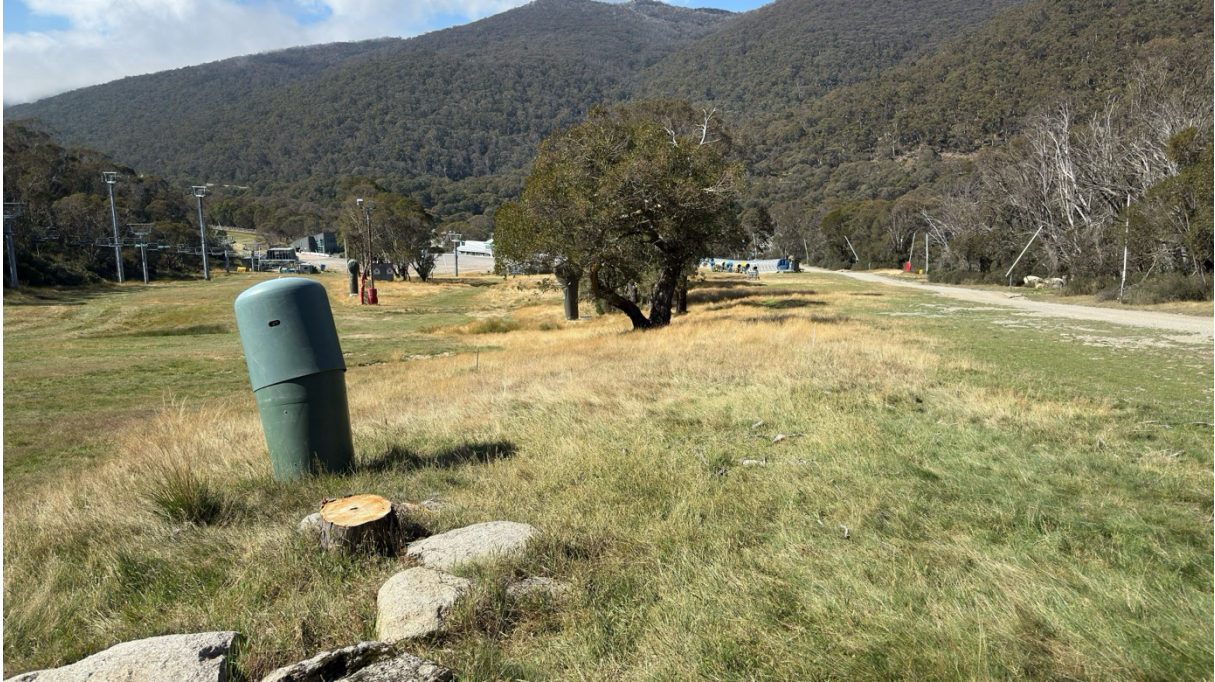
**Photo 1 – View of proposed Unit 2 location looking southeast towards Unit 1 location**

The proposed installation site is located about 79m northwest of Unit No 1 in Friday Flats. The Site is located on gently undulating terrain that generally slopes down to the southwest at about 7° to 10° towards Friday Drive. Photo 1 shows a view of the proposed installation. The Site is bounded to the east by Gunbarrel Express Bottom Station and elsewhere by grass land.
