Report on Pavement Investigation

East Seaham Road, Stage 5
East Seaham

82218013

Prepared for
Port Stephens Council

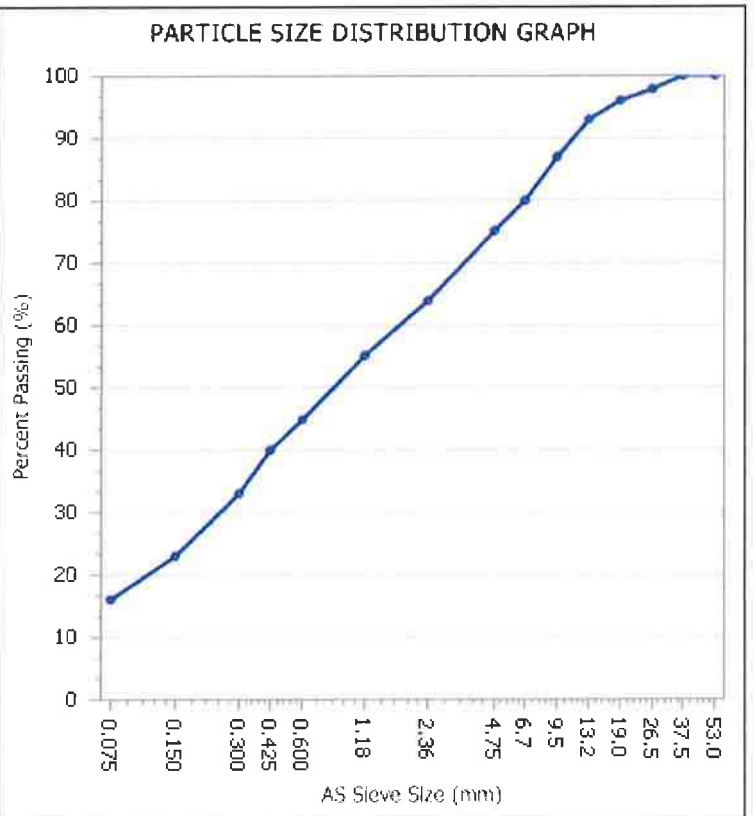
| AS Sieve (mm) | Specification Minimum | Percent Passing (%) | Specification Maximum |
|---|---|---|---|
| 0.150 | | 23 | |
| 0.075 | | 16 | |

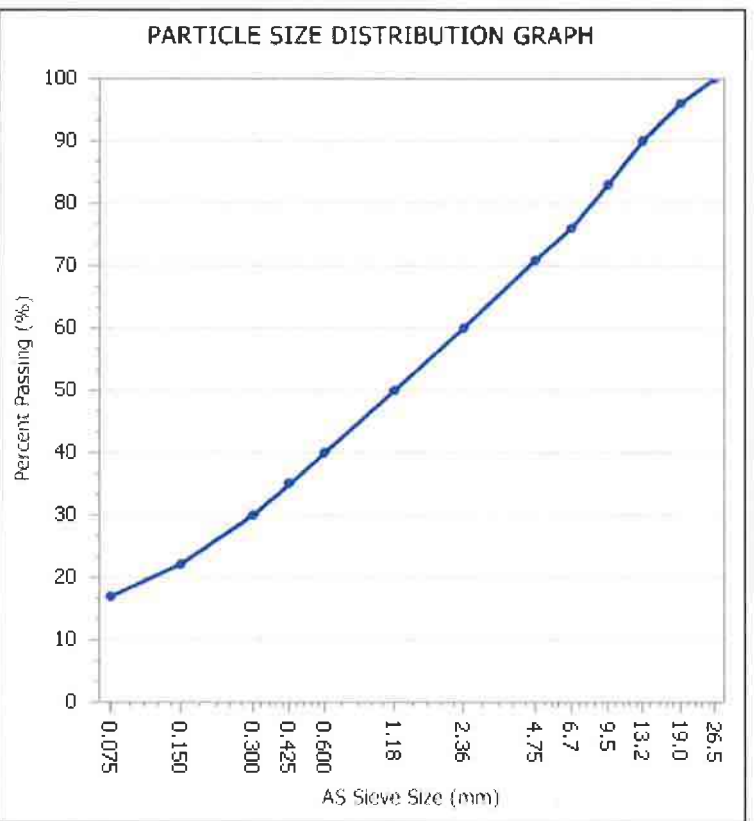
| AS Sieve (mm) | Specification Minimum | Percent Passing (%) | Specification Maximum |
|---|---|---|---|
| 0.150 | | 22 | |
| 0.075 | | 17 | |

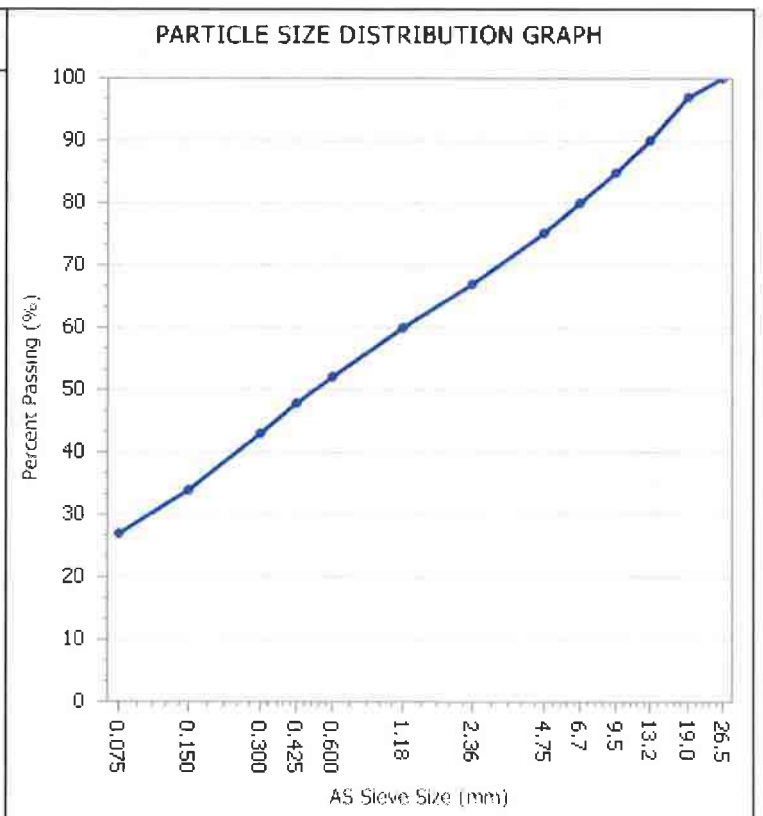
| AS Sieve (mm) | Specification Minimum | Percent Passing (%) | Specification Maximum |
|---|---|---|---|
| 0.150 | | 34 | |
| 0.075 | | 27 | |

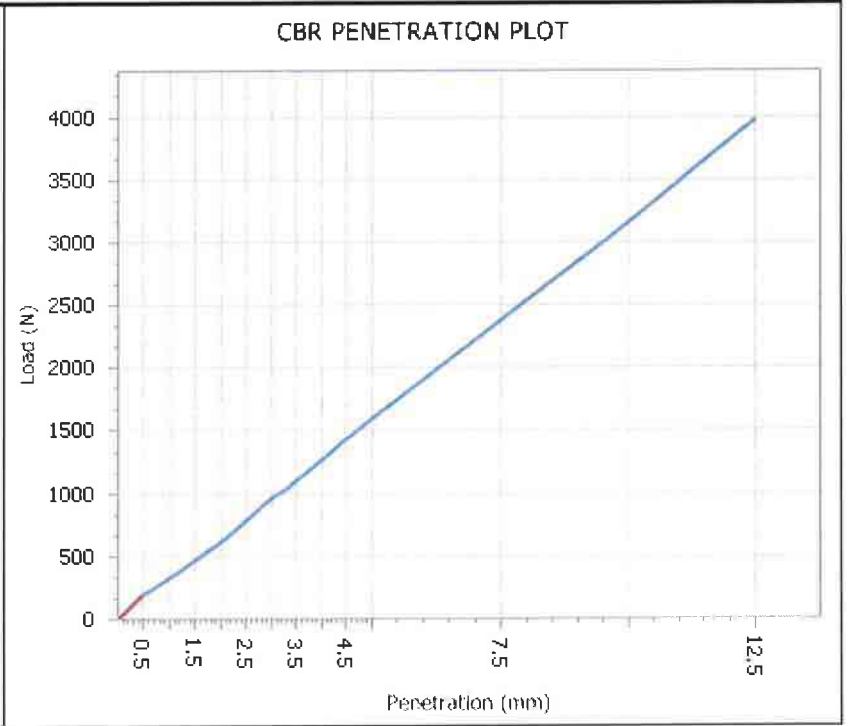
| Minimum CBR Specification (%): | - |
| CBR Value @ 5.0mm (%): | 8 |
