**Report on
Mine Subsidence Assessment**

**Proposed Industrial Subdivision
Lot 1131, DP1057179, Black Hill**

**Prepared for
F & F Properties**

**Project 91148.00
September 2017**

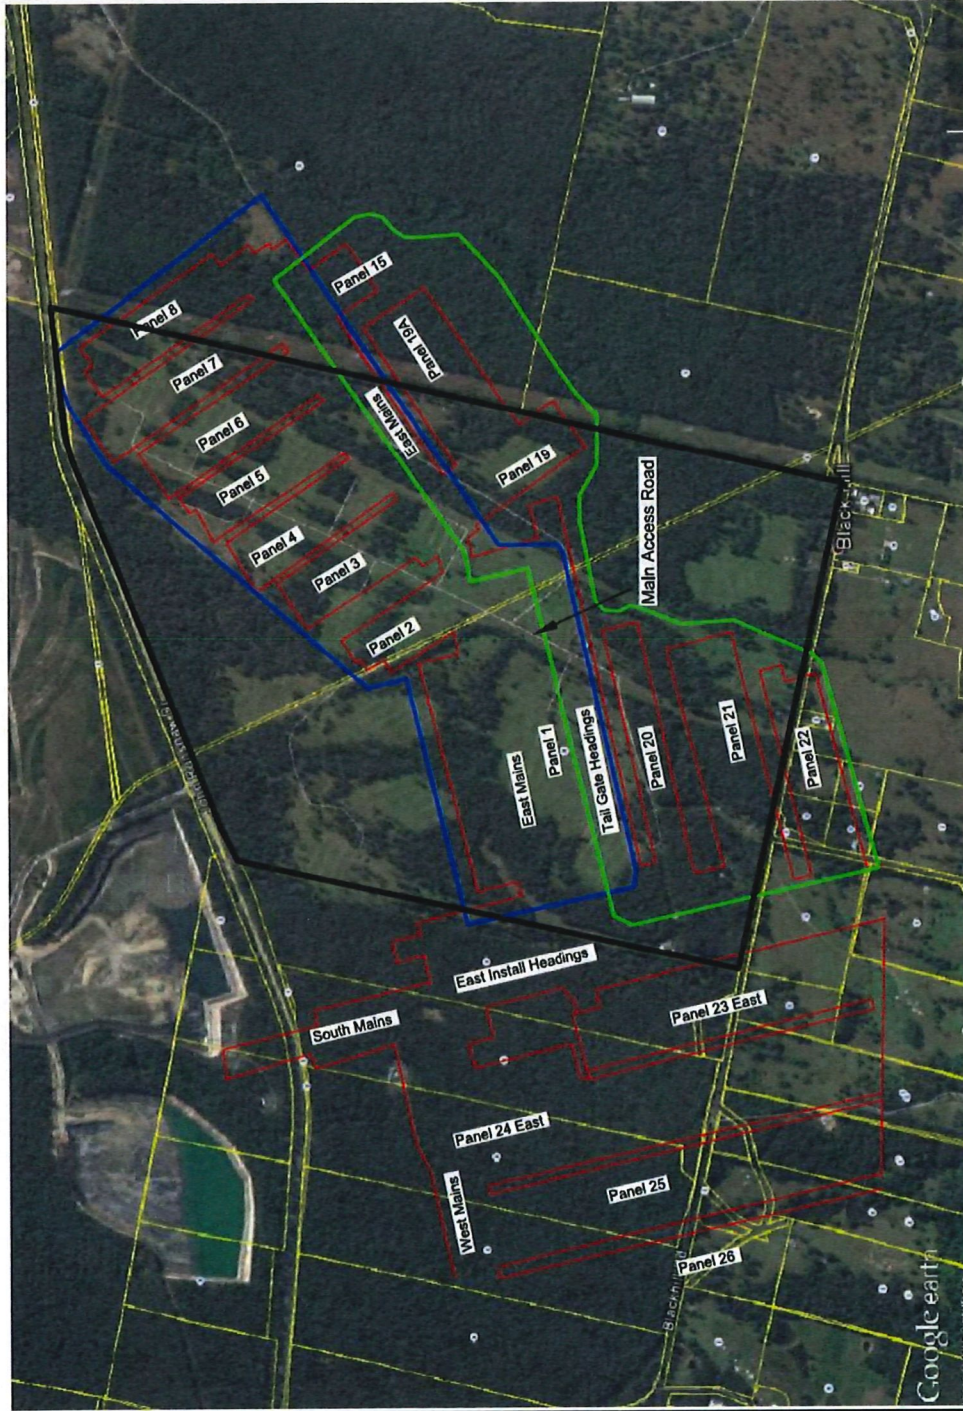
- LEGEND**
- Underground Mine Workings
 - SMP Area 1 Boundary
 - SMP Area 2 Boundary
 - Property Boundary
