### 3.4 Description of the Building Exterior

The subject building presents as a group of two-storey red textured brick and tile-roofed components arranged along an approximately north-south axis (though some components have an additional lower ground level or second floor and one component, Stage 5, is single-storey). The main entry is from the eastern side at a level between the ground and first floors, but the primary facade must be said to be the western facade facing a view over the golf links.

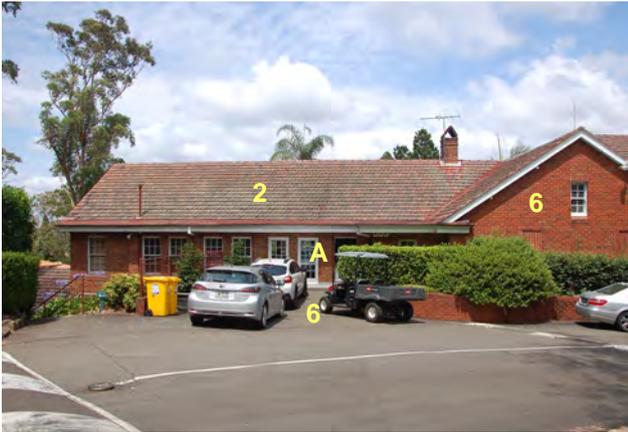
Figure 3.25 Eastern facade: southern wing. In Stage 6 the driveway was extended to provide delivery access. The window in the gable was reused from the first floor kitchen (see Figure 3.33). Three Stage 2 windows were converted to doors (marked 'A') as part of the 1982 internal works.

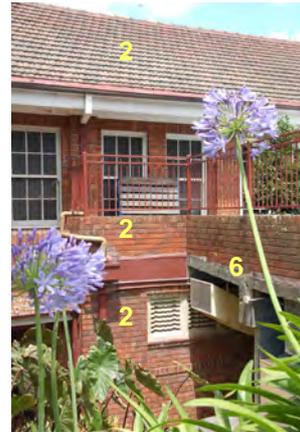
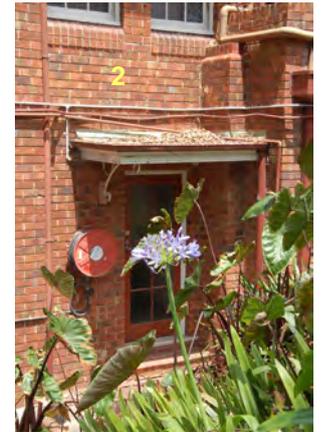
Figure 3.26 Eastern facade: Left: view of Billiard Room (above) and squash courts (below). The concrete vents are original from Stage 2. Right: view of lower ground level doorway from Card Rooms (now Archives). The awning and its ornate metal bracket are original from Stage 2.

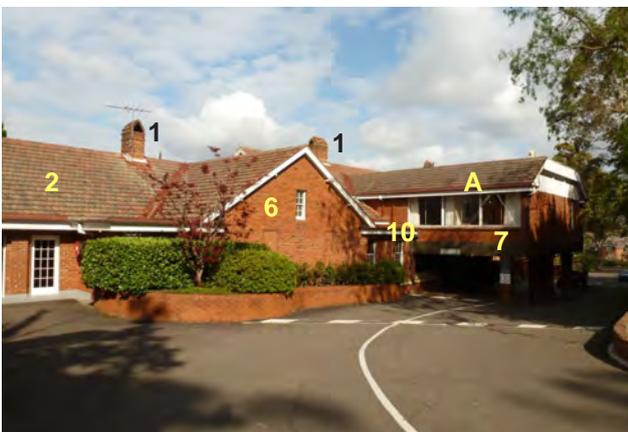
Figure 3.27 Eastern facade: partial view from south-east. The two chimneys and small surrounding areas of roof are the only Stage 1 elements visible. The tiles and window on this side of the *porte cochere* roof, marked A, were reused in Stage 7 from the south half of stage 4.

Figure 3.33  
Eastern facade: junction of *porte cochere* and original building, to right of main entrance. 'A' indicates evidence of repairs after removal in Stage 4 of the Stage 1 flat *porte cochere* roof. 'B' shows one of two windows bricked up in Stage 6, one of which was reused in the Stage 6 gable (see Figure 3.27).

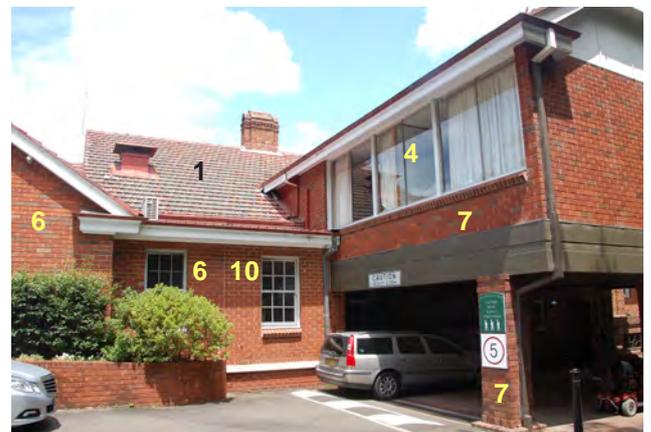
Figure 3.28 Eastern facade: view to left of main entrance. Part of the Stage 1 roof remains intact though the vent is a later addition. Both double-hung windows have been reused from Stage 1 and the large *porte cochere* window has been reused from Stage 4.

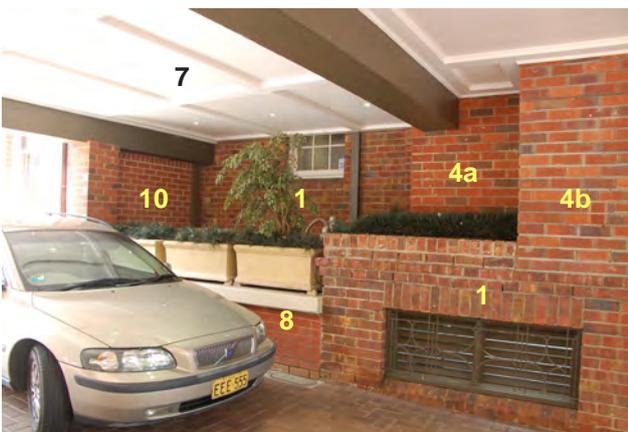
Figure 3.29 Eastern facade: view to left of main entrance. In Stage 4 the wall marked '4a' was rebuilt in the same location as a Stage 1 wall, but '4b' was added on top of the Stage 1 planter wall. In Stage 8 the wall and slab over the lower ground level Laundry were added.

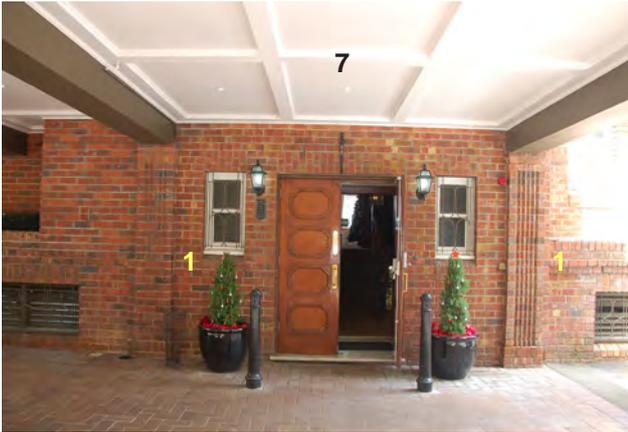
Figure 3.30  
Eastern facade: main entrance. The brick facade including fluted pilasters and low level vents are Stage 1 elements but the *porte cochere* structure is Stage 7.

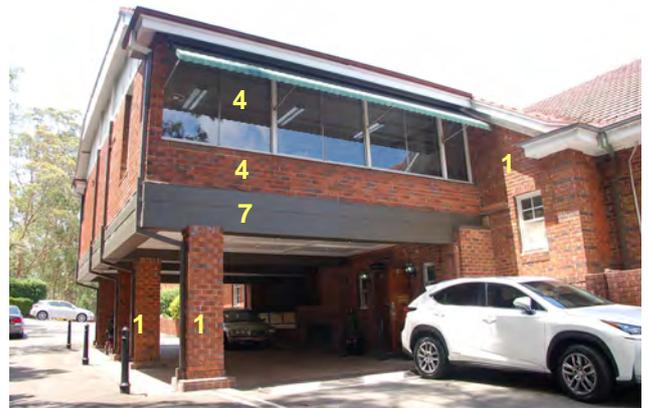
Figure 3.31  
Eastern facade: northern wall of *porte-cochere*. The two northern piers are from Stage 1. The brickwork, window and tiled roof on this side are from Stage 4 but the sub-structure and two southern piers are from Stage 7.

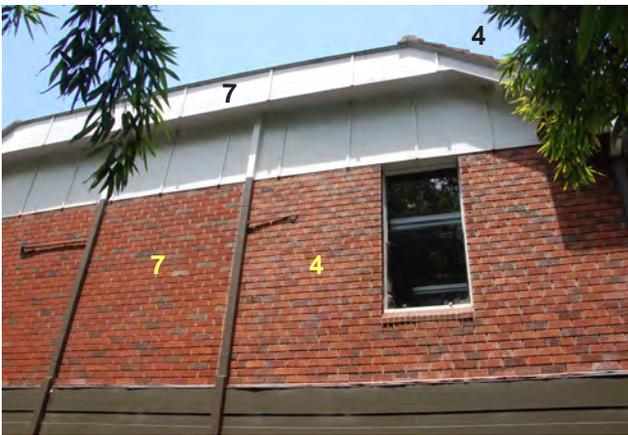
Figure 3.32  
Eastern facade: eastern wall of *porte cochere*. Some of the brickwork remains from Stage 4.

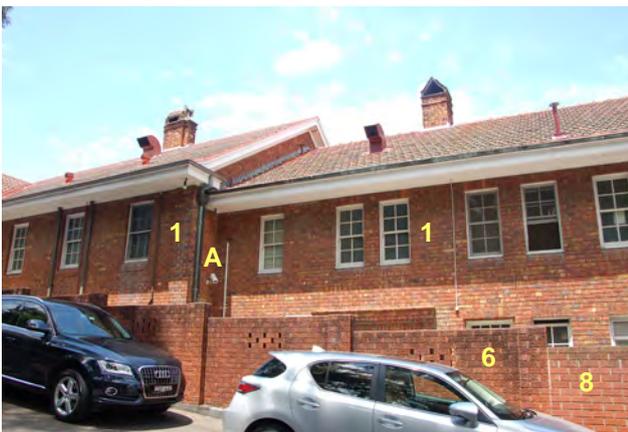
Figure 3.34  
Eastern facade: northern wing. The chimneys are original from Stage 1 but the vents are later additions. 'A' denotes the second of two windows bricked up in Stage 6. The Stage 6 service yard wall was extended in Stage 8.

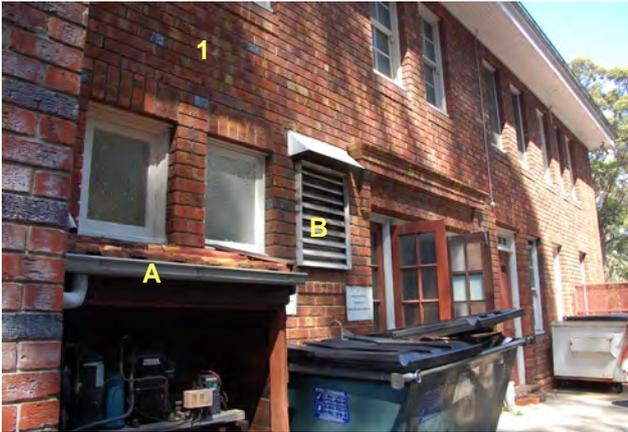
Figure 3.35  
Eastern facade: northward view of northern wing. The lean-to marked 'A' was added at an unknown time. The grille at 'B' may be circa Stage 6.

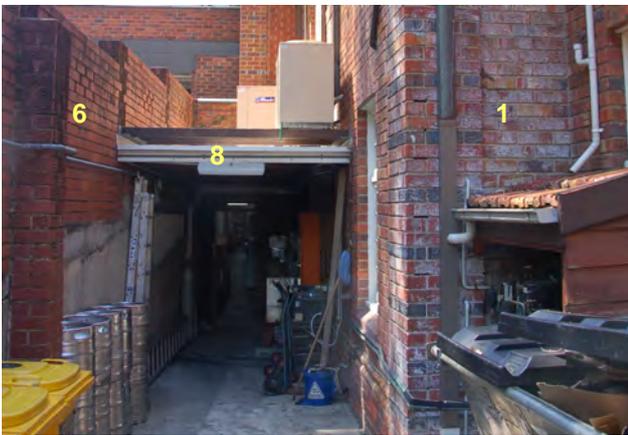
Figure 3.37  
Eastern facade: view south along eastern wall. A metal roof over part of the service area was added in Stage 8.

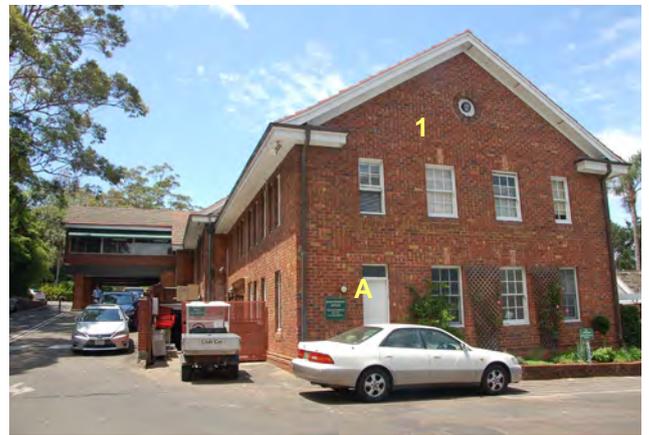
Figure 3.38  
Northern facade: 'A' denotes a door converted from a Stage 1 window as part of the 1982 works.

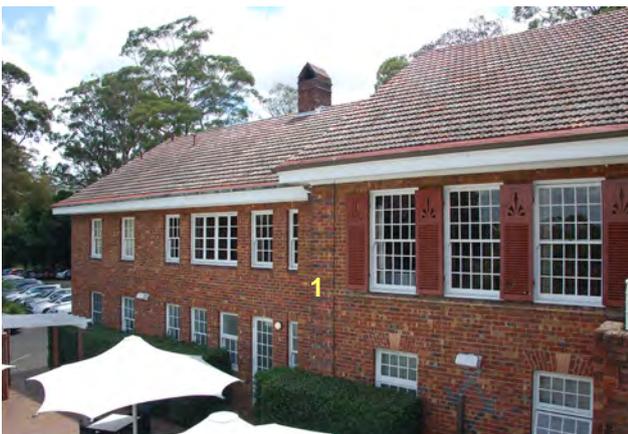
Figure 3.39  
Western facade: Northward view of northern wing, virtually intact from Stage 1.

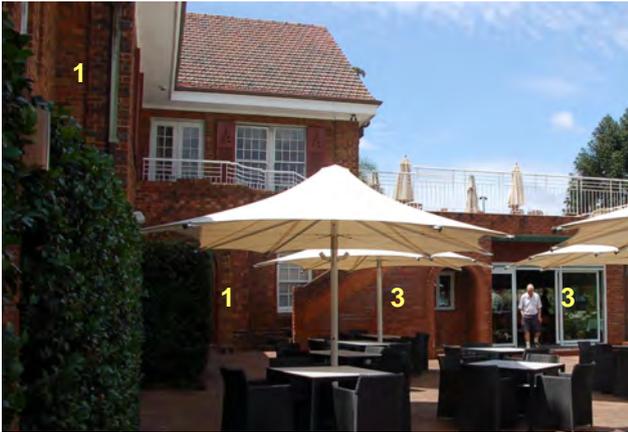
Figure 3.40  
Western facade: Southward view with Stage 1 at left and Stage 3 at right

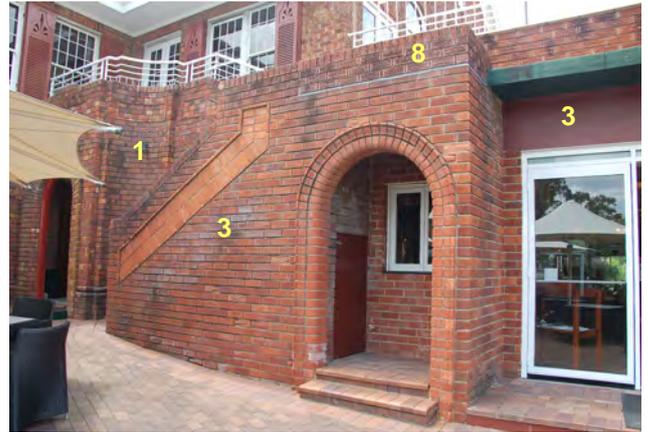
Figure 3.41  
Western facade: Northern facade of Lower Lounge. In Stage 3 the top flight of the Stage 1 stairs were retained and a new bottom flight added. In Stage 8 a new flight to the upper terrace was added.

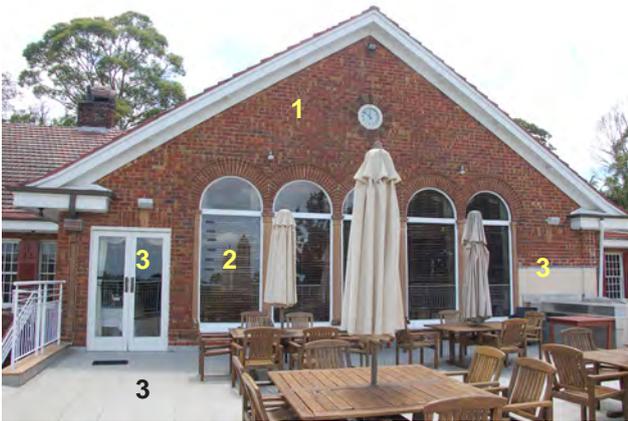
Figure 3.45  
Western facade: The original Veranda and Stage 3 terrace. The arches were glazed in Stage 2. A window to the left of the arches was replaced by a door in Stage 3. A window to the right of the arches was partly bricked up and partly covered by the top of a stairwell in Stage 3. The gable clock is not original.

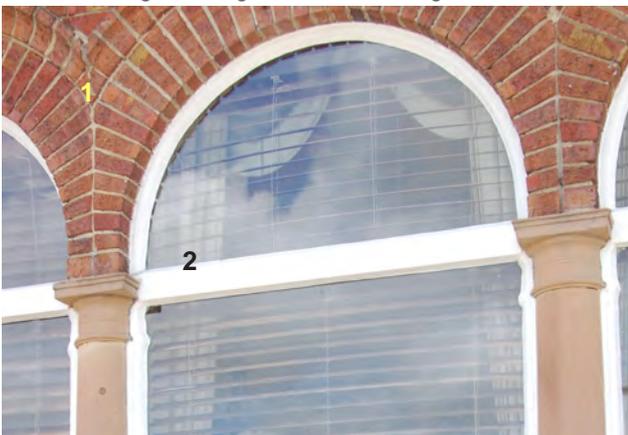
Figure 3.47  
Western facade: Detail of Veranda arch, glazed in Stage 2.

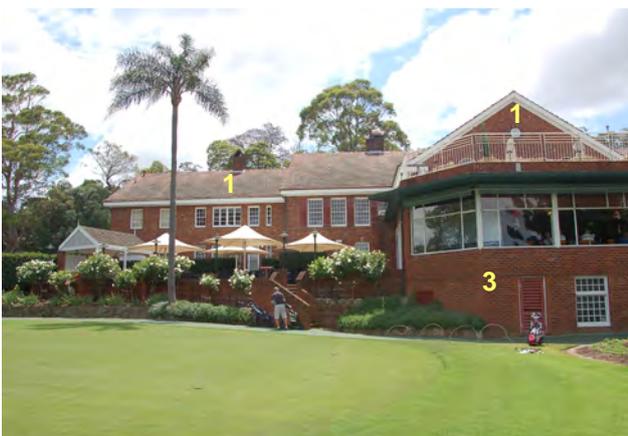
Figure 3.49  
Western facade: Eastward view of southern wing with Stage 3 addition at right.

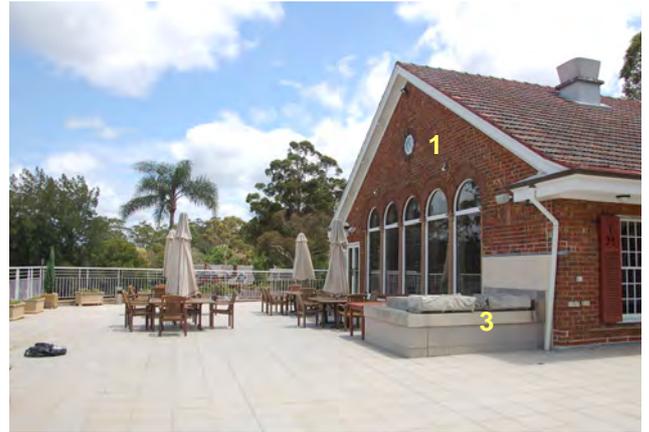
Figure 3.46  
Western facade: Northward view of upper terrace over Lower Lounge. The Stage 3 stairwell housing, visible at right, has been modified since installation.

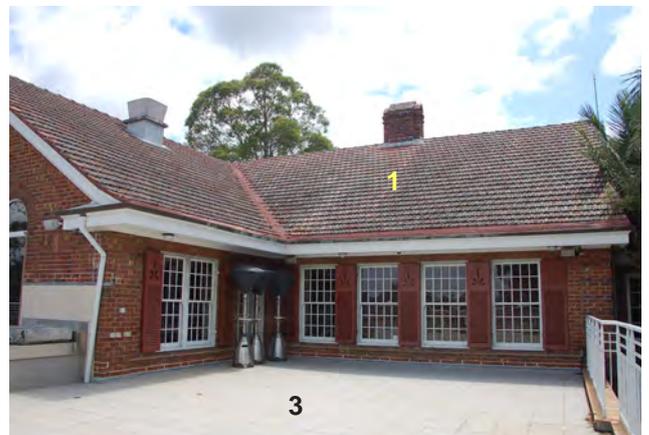
Figure 3.48  
Western facade: southern section of upper terrace. The air duct is a later component.

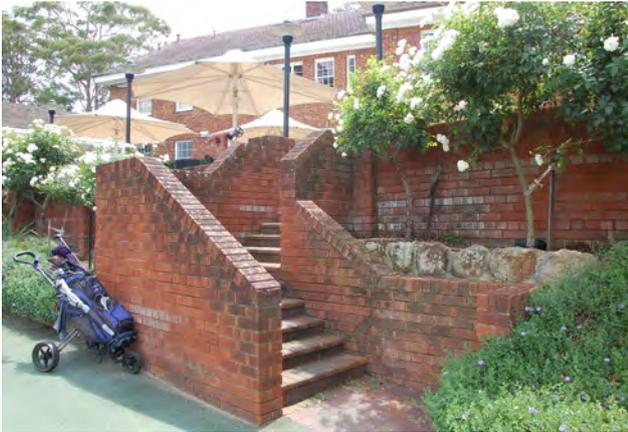
Figure 3.50  
Western facade: stairs from terrace. This configuration postdates the 1990s but the bricks appear to date from Stage 1. A similarly configured stair was removed from the site of the Stage 8 Lower Lounge extension in 1996, and may have been rebuilt here.

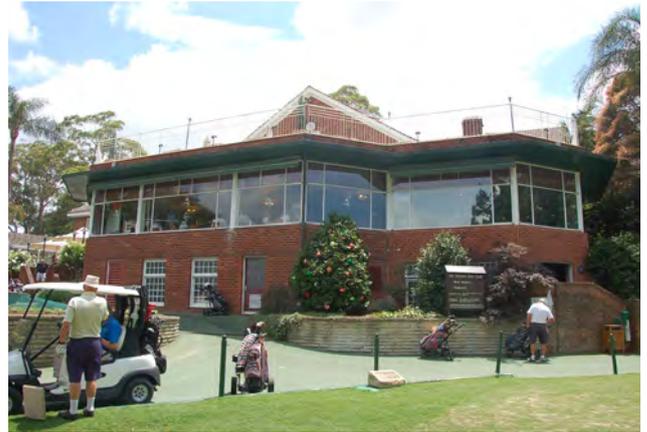
Figure 3.51  
Western facade: view of Stage 3.

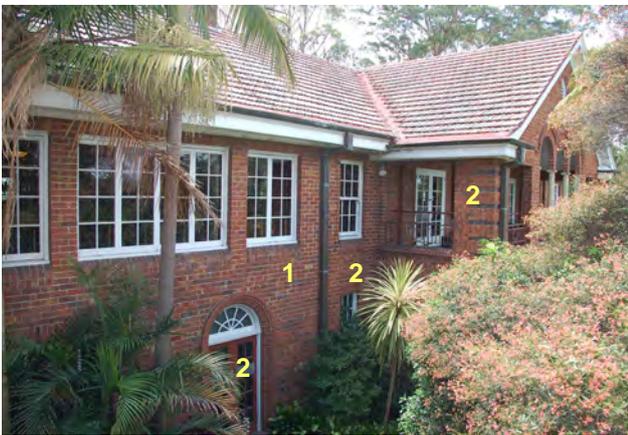
Figure 3.52  
Western facade: southern wing. In Stage 2 the arched door replaced a Stage 1 window.

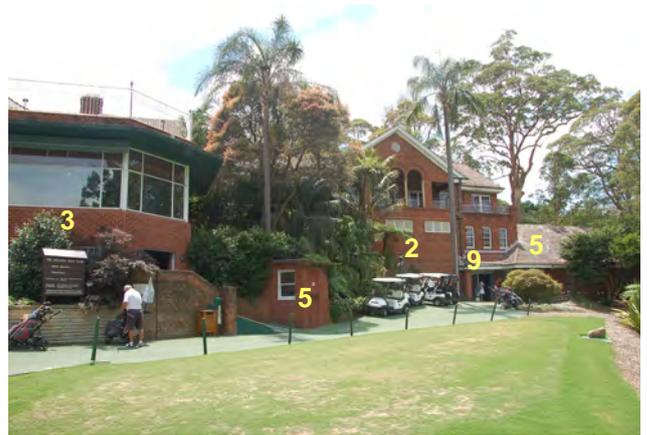
Figure 3.53  
Western facade: view to south-east showing several stages including the Buggy Store, Starter's Box and Pro Shop roof extension.

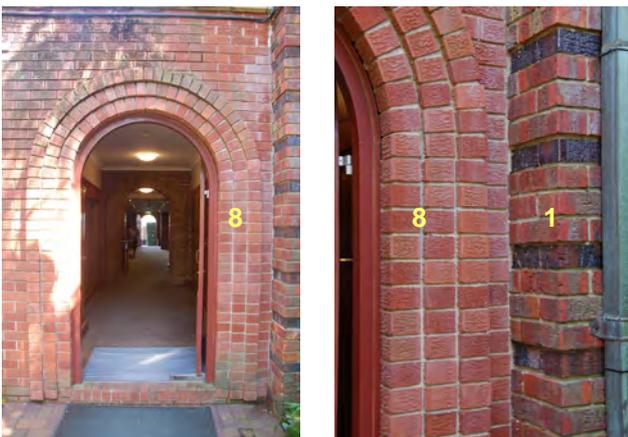
Figure 3.54  
Western facade: Northward view of south entrance to Golfer's Foyer showing Stage 8 brick arch copying Stage 1 arch, which remains intact inside; and detail of junction with original building.

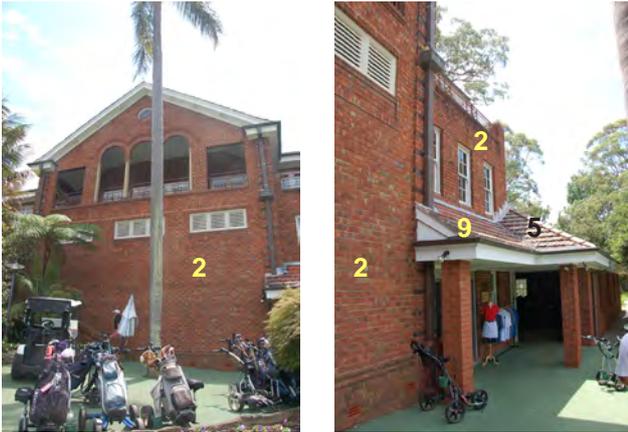
Figure 3.55  
Western facade: Left: Stage 2 gabled Veranda over Squash Courts showing original concrete grilles. Right: Entrance to Buggy Store with Pro Shop on left.

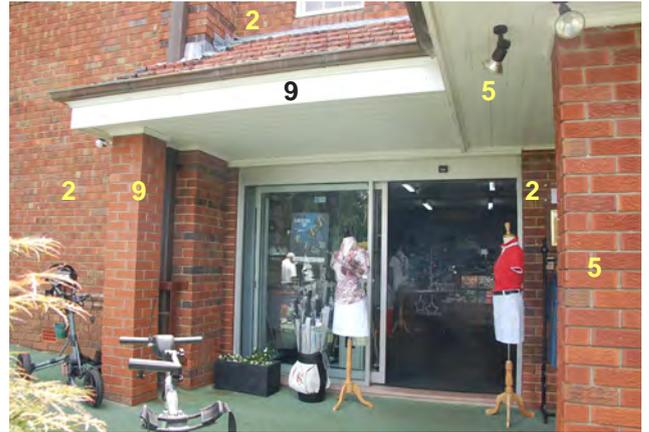
Figure 3.56  
Western facade: Entrance to Pro Shop. The sliding glass doors were installed as part of Stage 5 and the roof in Stage 9.

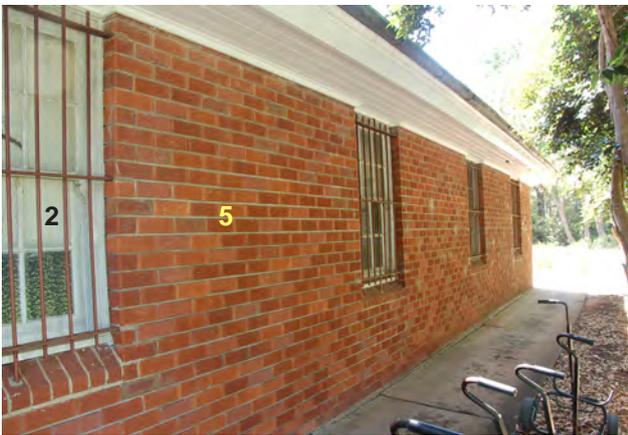
Figure 3.57  
Western facade: Western facade of Buggy Store. Some of the windows were reused from the Stage 2 southern wing.

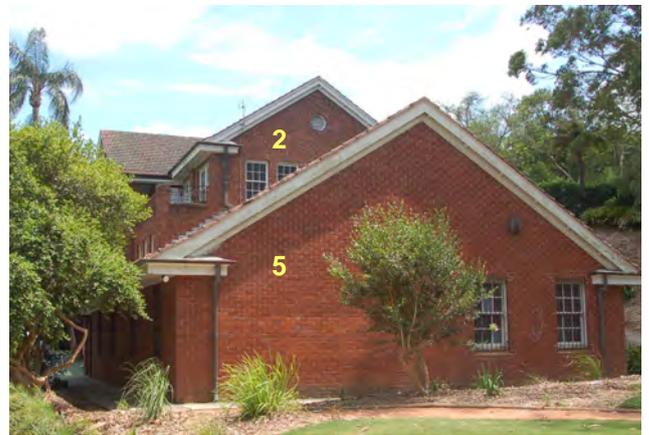
Figure 3.58  
Southern facade: Buggy Store in foreground with Billiard Room beyond.

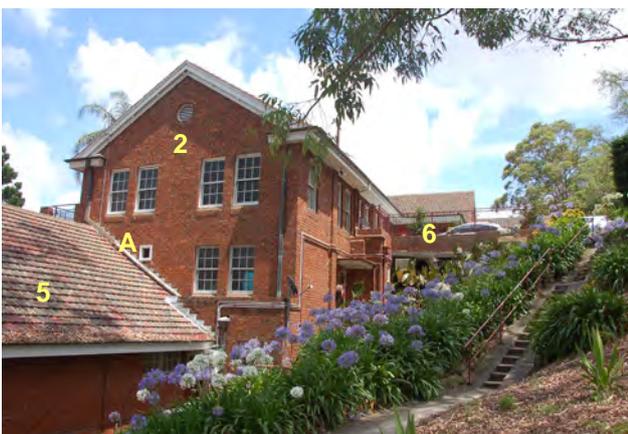
Figure 3.59  
Southern facade: northward view showing southern facade of Stage 2. 'A' denotes the location of two windows removed when Stage 5 was added (a small vent has since been installed). Stage 2 windows at lower ground floor level, where the Buggy Store abuts Stage 2, were also removed and reused in the Buggy Store.

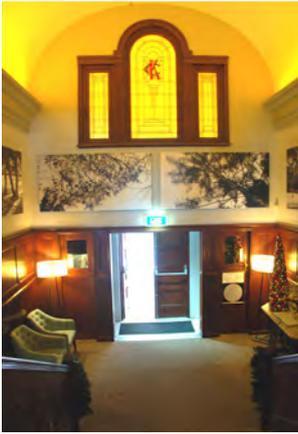
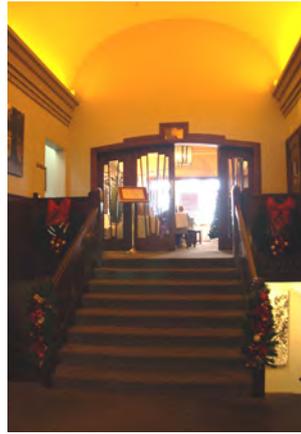
Figure 3.60  
Main entry foyer, Stage 1. Left: eastwards view showing original windows over *porte cochere*, enclosed on other side by stage 4, now covered on other side and illuminated electrically. Right: westwards view.

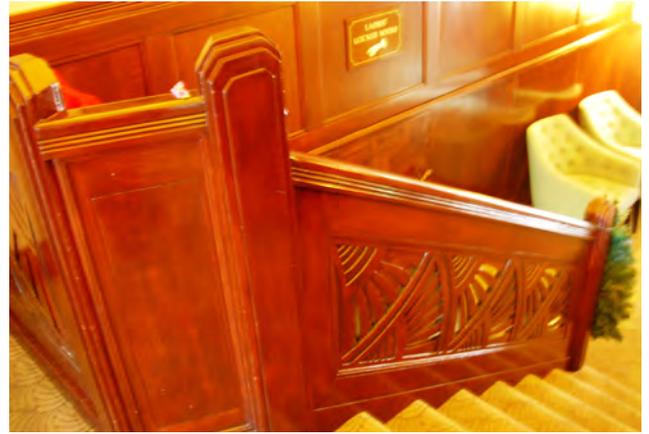
Figure 3.61  
Main entry foyer, Stage 1: detail of balustrading.

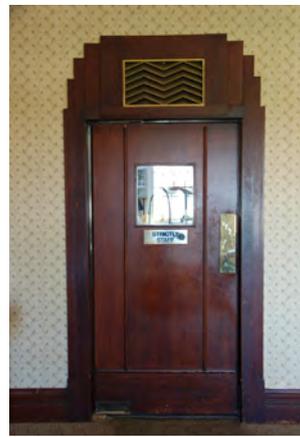
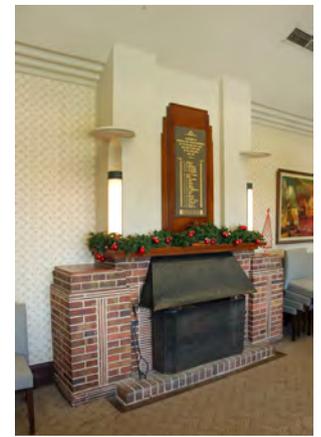
Figure 3.63  
First floor, Stage 1: Left: doorway from Dining Room to Kitchen. Right: original Dining Room fireplace and chimney breast with corner lighting. Compare to Figures 2.50 and 2.48.

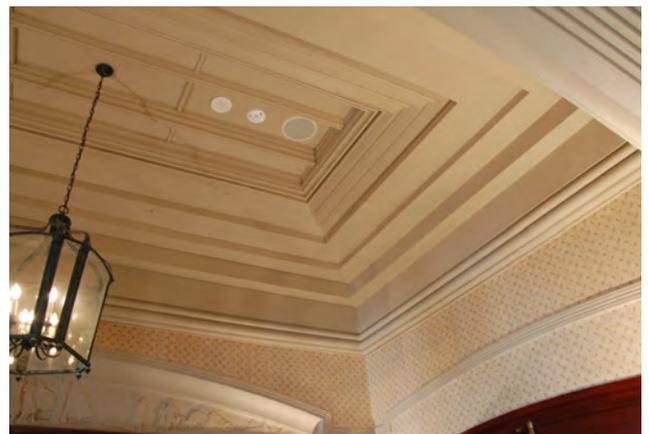
Figure 3.65  
First floor, Stage 1: Ceiling in lobby between Lounge and Dining Room.

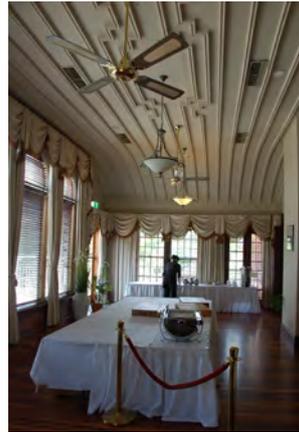
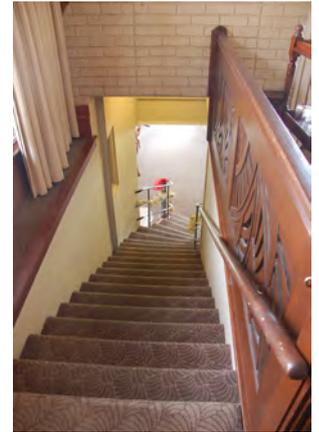
Figure 3.67  
First floor: Left: Northwards view in Stage 1 Verandah. Right: View down Stage 3 stairs from Verandah to Lower Lounge, showing timber balustrading. Outline of infilled window is visible above stairs.

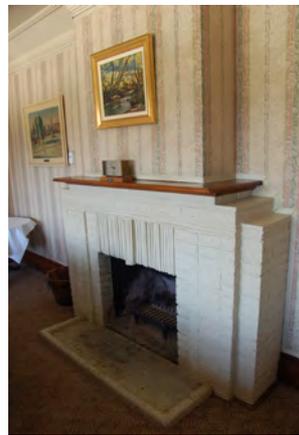
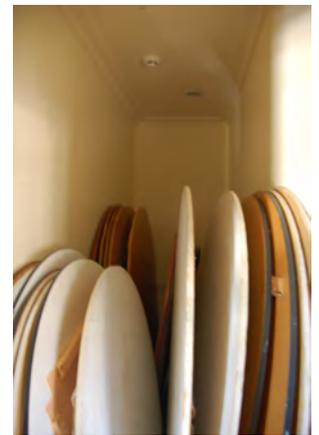
Figure 3.69  
First floor, Stage 1: Left: fireplace and chimney breast in erstwhile Ladies' Lounge (compare to Figure 2.49). Right: stairwell off Ladies Lounge, now table store after post-1990s blocking up of stairwell.

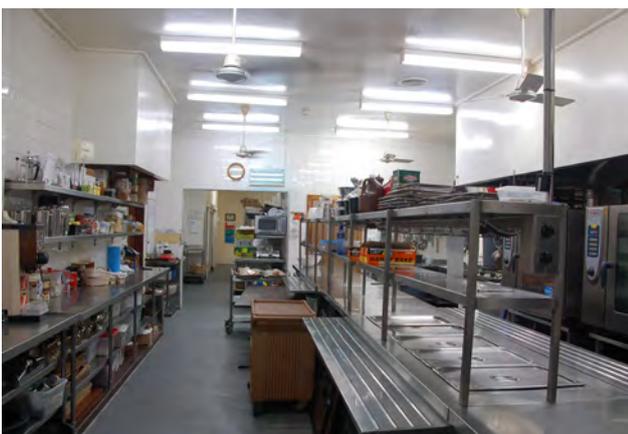
Figure 3.70  
First floor, Stage 1: northwards view in kitchen. The opening to the washup area at the far end was widened as part of 1958 internal alterations.

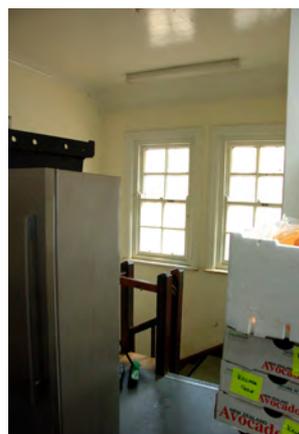
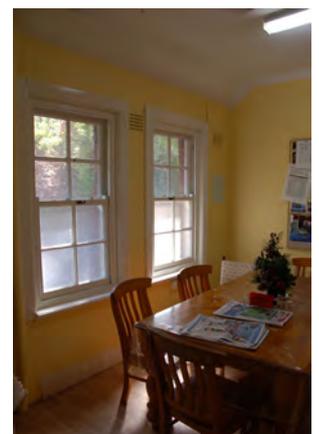
Figure 3.71  
First floor, Stage 1: Left: original stairs, north wing, east side. Right: original servant's room and bathroom on east side, combined as staff room c.1982.

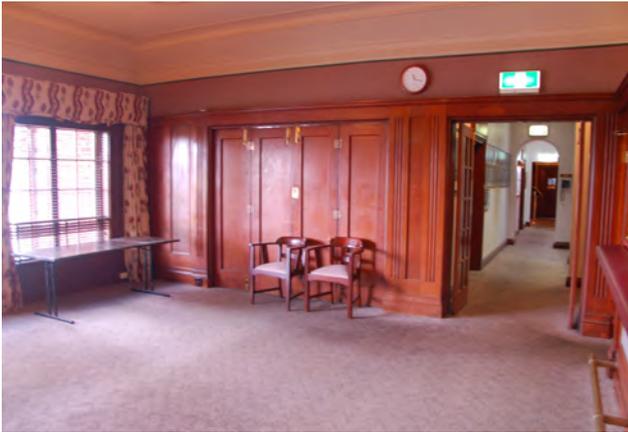
Figure 3.72  
First floor, Stage 1: northwards view in Smoking Room. In Stage 1 the wall to the right of the corridor opened into the Bar.

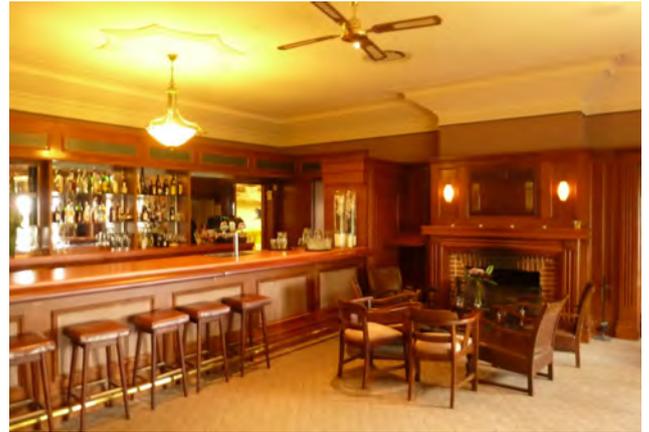
Figure 3.73  
First floor: southwards view in Stage 1 Smoking Room with original fireplace. The bar was added in Stage 2 and the Bar Store beyond in Stage 6.

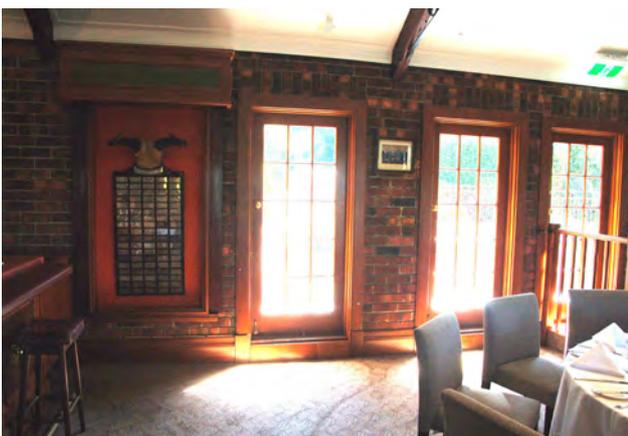
Figure 3.76  
First floor: eastwards view in Billiards Room showing four Stage 2 windows, the left-most blocked up and the other three converted to doorways in 1982.

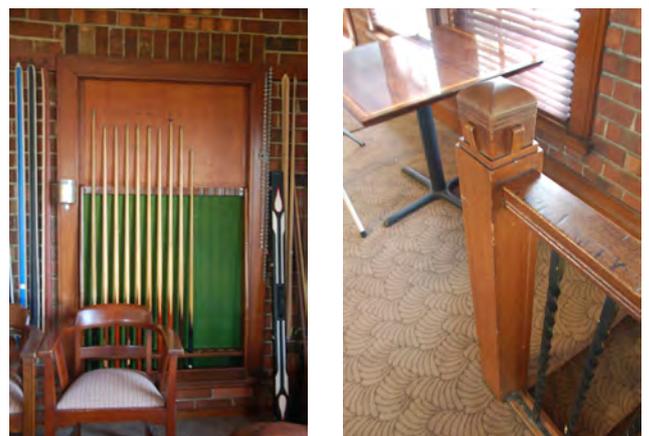
Figure 3.77  
First floor: Left: southernmost window in Stage 2 Billiard Room eastern wall, blocked up in 1982. Right: original Stage 2 well post on stairs from Billiard Room to ground floor.

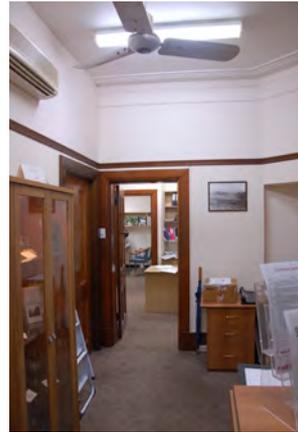
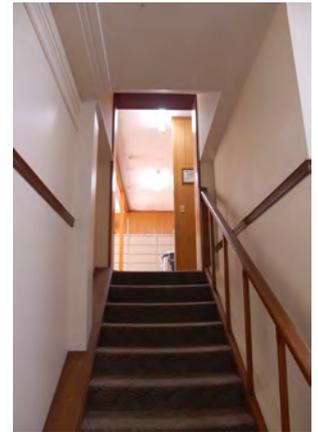
Figure 3.79  
First floor: Left: administration area composed of sections from Stages 1 (foreground), 6 and 9. Right: Stage 4 stairs from Stage 1 administration area up to Stages 4 and 7 *porte cochere* offices.

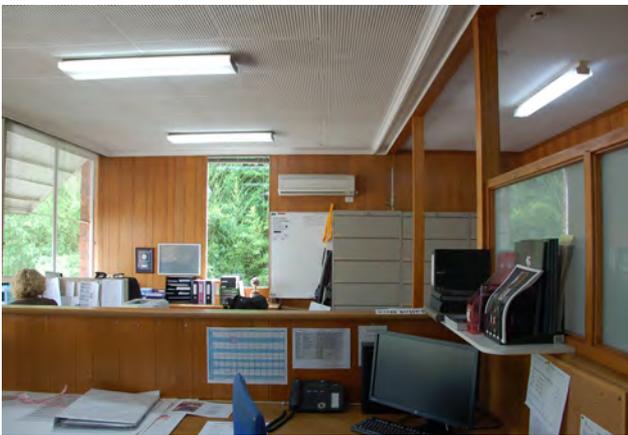
Figure 3.80  
Second floor: eastwards view in *porte cochere* office. Stage 4 ceiling is on the left, Stage 7 on the right.

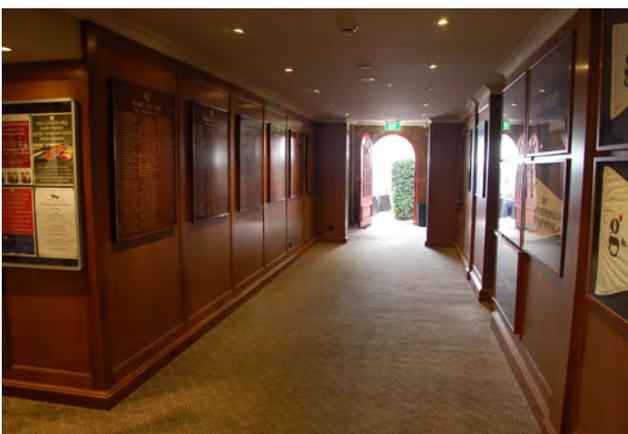
Figure 3.82  
Ground floor: northward view along Stage 8 Golfer's Foyer, originally part of Stage 1 men's locker area (foreground) and entrance to women's locker area, showing Stage 1 brick arch beyond.

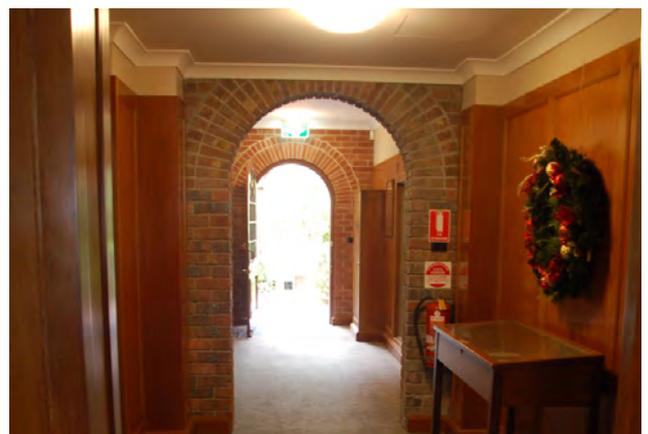
Figure 3.83  
Ground floor: southward view along Stage 8 Golfer's Foyer showing Stage 1 brick arch in foreground and Stage 8 brick arch beyond.

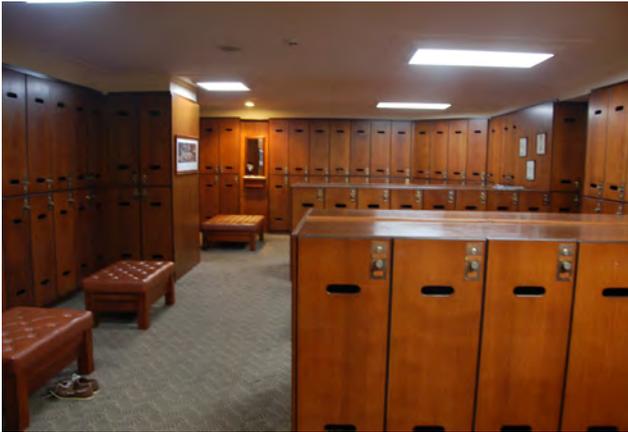
Figure 3.84  
Ground floor: northward view in men's locker area. The wall on the left dates only from Stage 8 and the lockers have been reconfigured several times over the years.

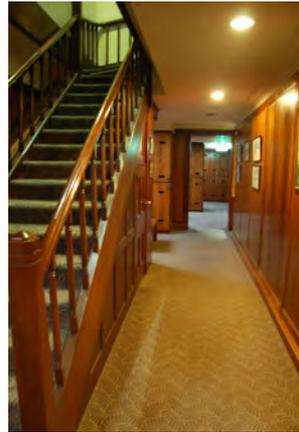
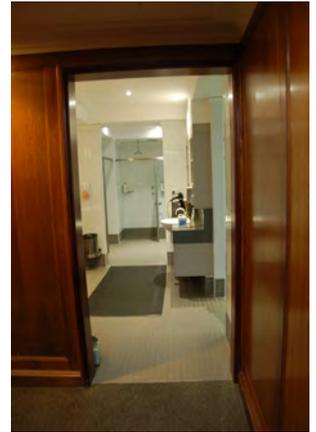
Figure 3.85  
Ground floor: Left: southwards view in men's locker area with Stage 1 stairs on left. Right: northwards view into shower area in men's locker area, dating from 1988.

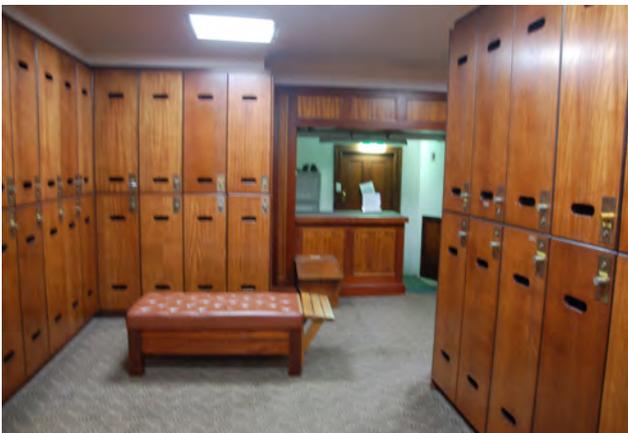
Figure 3.86  
Ground floor: northward view in men's locker area. The area behind the counter, now the shoe cleaning area, was in Stage 1 the men's bar.

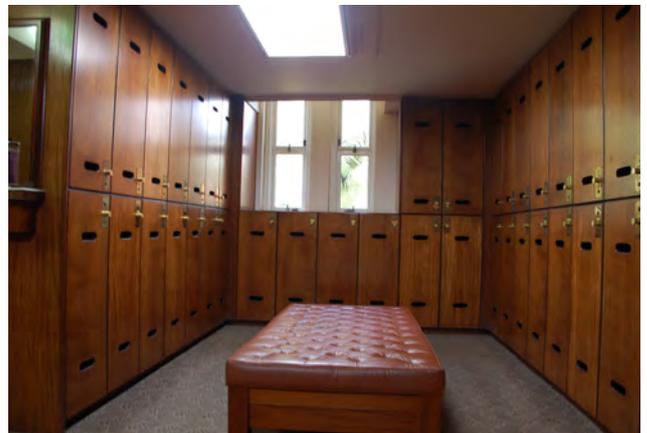
Figure 3.87  
Ground floor: westward view in southern section of men's locker area, converted from men's WCs in 1988.

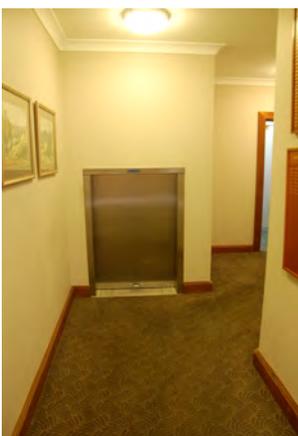
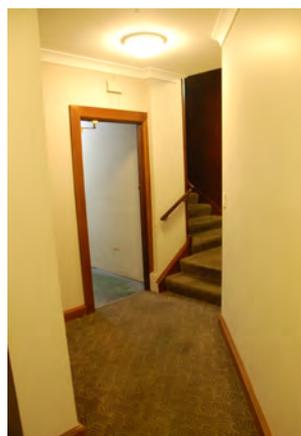
Figure 3.88  
Ground floor: Left: eastward view along Stage 8 corridor to stage 8 electric hoist from Kitchen above. Right: Stage 8 diagonal wall to corner of men's locker room area and Stage 1 stairs to main entry foyer beyond.

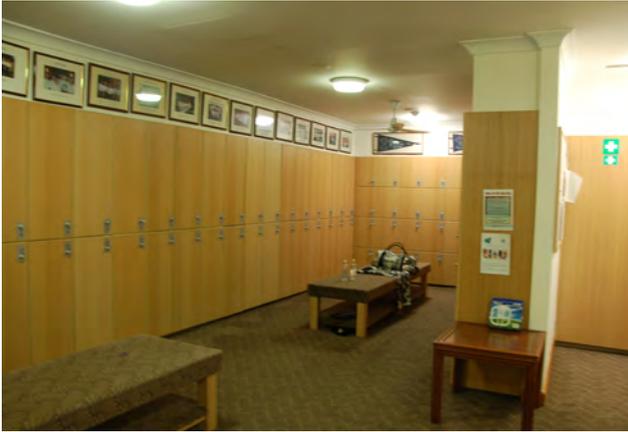
Figure 3.90  
Ground floor: southward view in women's locker area, reconfigured in Stage 8.

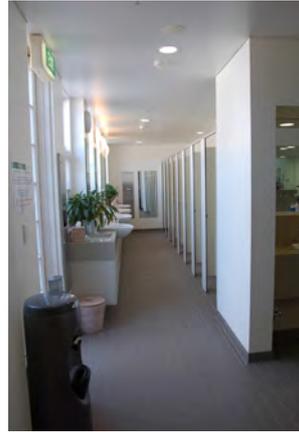
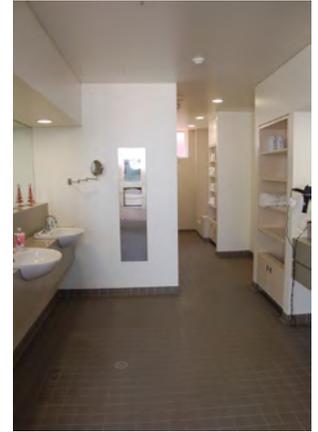
Figure 3.91  
Ground floor: views of women's ablutions area, formerly part of stage 1 servants' quarters, reconfigured in 1982.

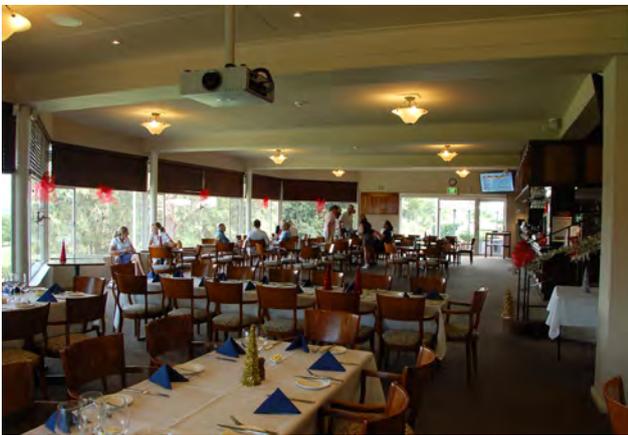
Figure 3.92  
Ground floor: northward view in Lower Lounge (Stage 3).

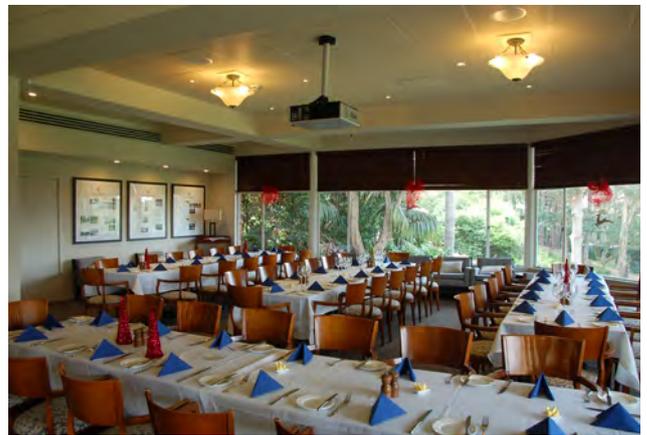
Figure 3.93  
Ground floor: southward view of Stage 8 addition to Lower Lounge, with post-1990s storeroom at left.

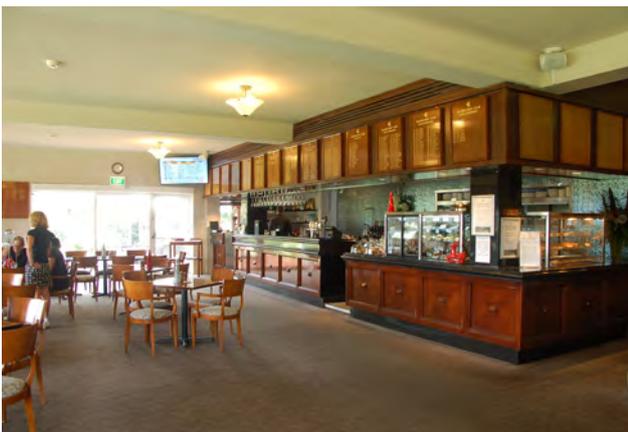
Figure 3.94  
Ground floor: northward view in Lower Lounge showing Stage 3 bar/servery, reconfigured several times since construction.

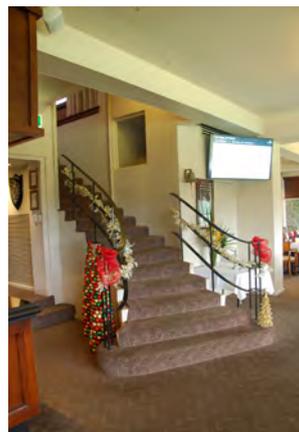
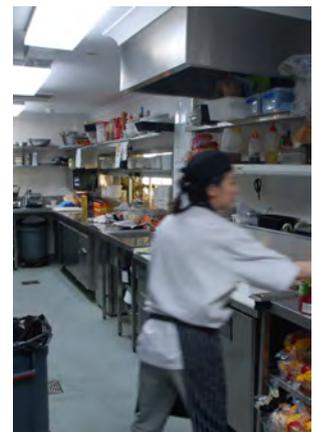
Figure 3.95  
Ground floor: Left: Stage 3 stairs up to Verandah. Right: kitchen behind Lower Lounge bar; the wall at right was the western external wall of Stage 1.

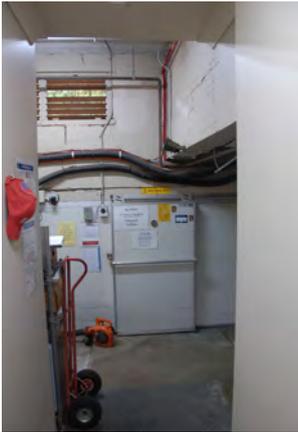
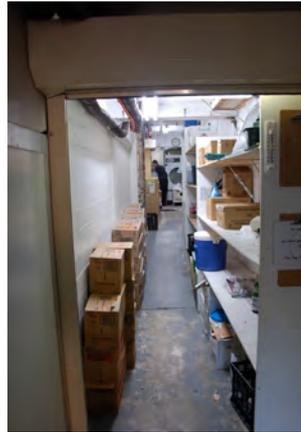
Figure 3.96  
Ground floor: Left: eastward view to door of Stage 1 cellar, now cool room, on eastern side of building. Right: southward view through Linen area to Stage 8 Laundry.

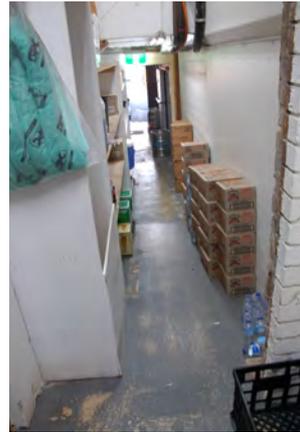
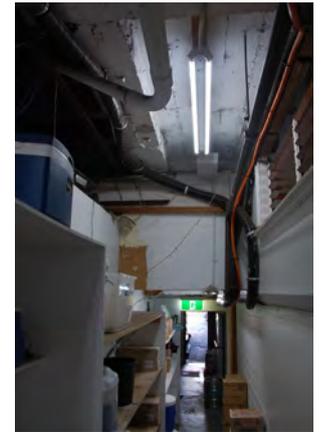
Figure 3.97  
Ground floor: Left: northward view from Linen area to service yard. Right: ceiling of Laundry/Linen area showing timber under-floor structure at left and later concrete roof at right.

The building's condition ranges from fair in areas such as the Stage 6 ground floor Chair Store through good in most secondary sections to very good in main areas such as the Lounge, Dining Room and Verandah and relatively recently refurbished spaces such as the ground floor locker areas. Some less visible alterations, for example the junction of the Stage 8 Laundry roof with the Stage 1 building (see Figure 3.97), have been roughly or incompletely finished.

Some less visible alterations, for example the junction of the Stage 8 Laundry roof with the Stage 1 building (see Figure 3.97), have been roughly or incompletely finished.

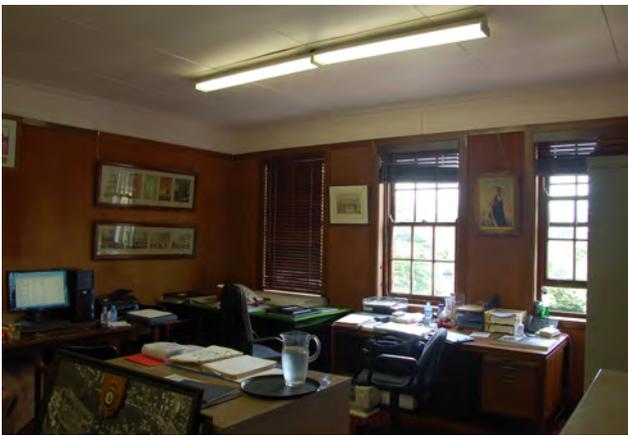
Figure 3.98  
Ground floor: westward view in Stage 2 Card Room, now Archives. Windows in the southern wall were blocked up with the addition of the Buggy Store in Stage 5.

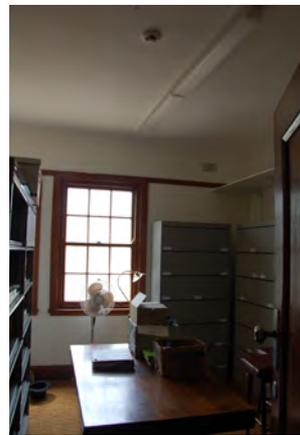
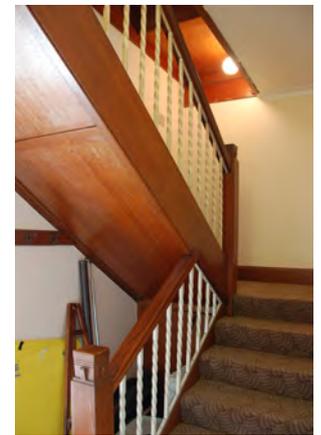
Figure 3.99  
Ground floor: Left: southward view in second Card Room, now Archives. Right: Stage 2 stairs up to Billiard Room.

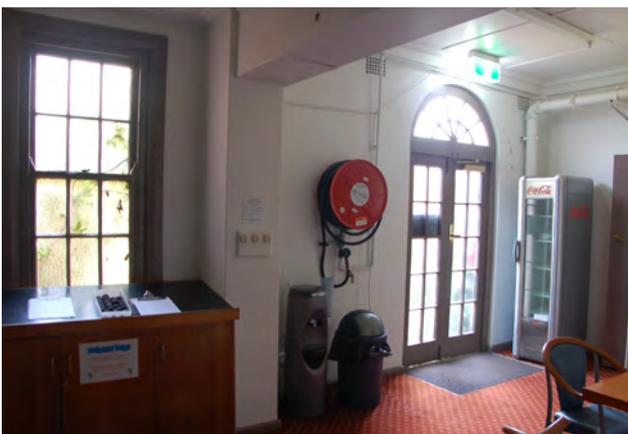
Figure 3.100  
Ground floor: westward view in Squash Courts foyer, showing beam above, supporting original southern external Stage 1 wall, and Stage 2 arched doorway replacing window in Stage 1 wall.

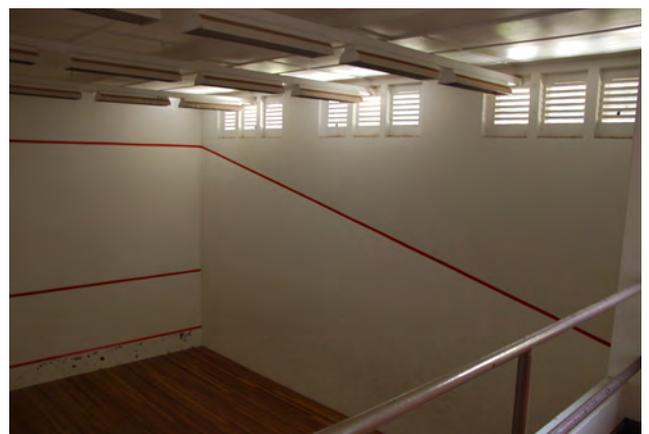
Figure 3.101  
Ground floor: westward view in Stage 2 squash court showing original air grilles.

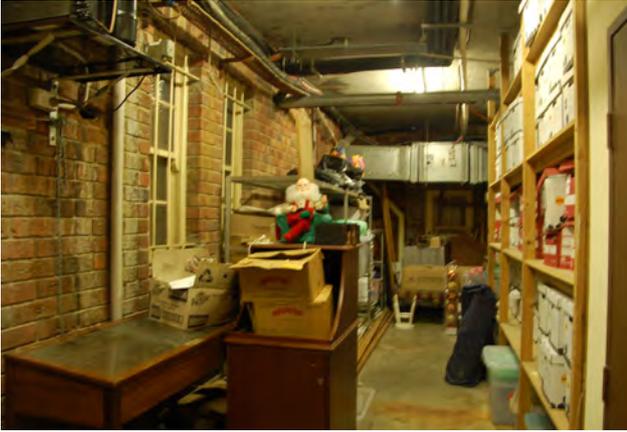
Figure 3.102  
Ground floor: northward view in Stage 6 Chair Store (below Bar Store) showing original Stage 1 wall and windows at left,

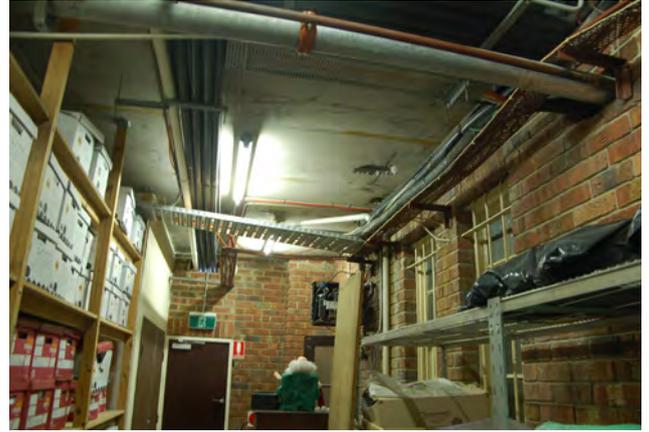
Figure 3.103  
Ground floor: southward view in Stage 6 Chair Store. The windows at right are Stage 1 but the doorway at the far end on the right is Stage 2 and the far wall is Stage 6.

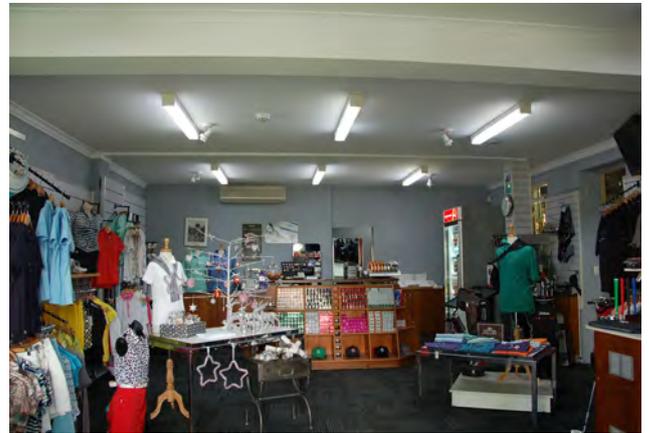
Figure 3.105  
Lower ground floor: eastward view in Stage 2 Professional's area. The beam in the foreground was the location of the original western external wall. The Professionals' workshop and showroom were united in 1982.

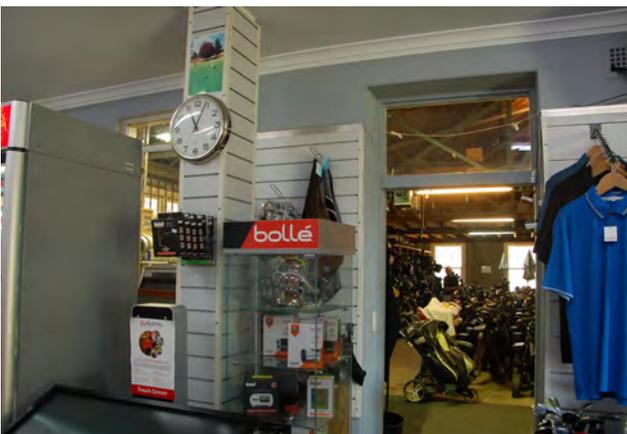
Figure 3.106  
Lower ground floor: southward view in Pro Shop showing two Stage 2 windows, the one on the right converted to a doorway in Stage 5.

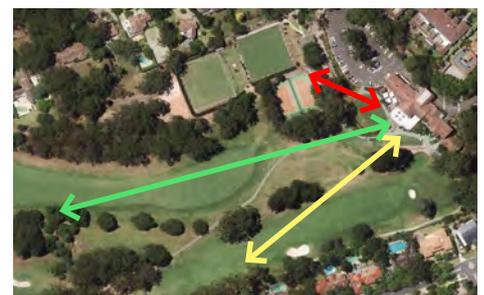
Figure 4.7  
Views from/to Clubhouse building. Primary views are indicated by the green arrow, secondary by yellow and tertiary by red.

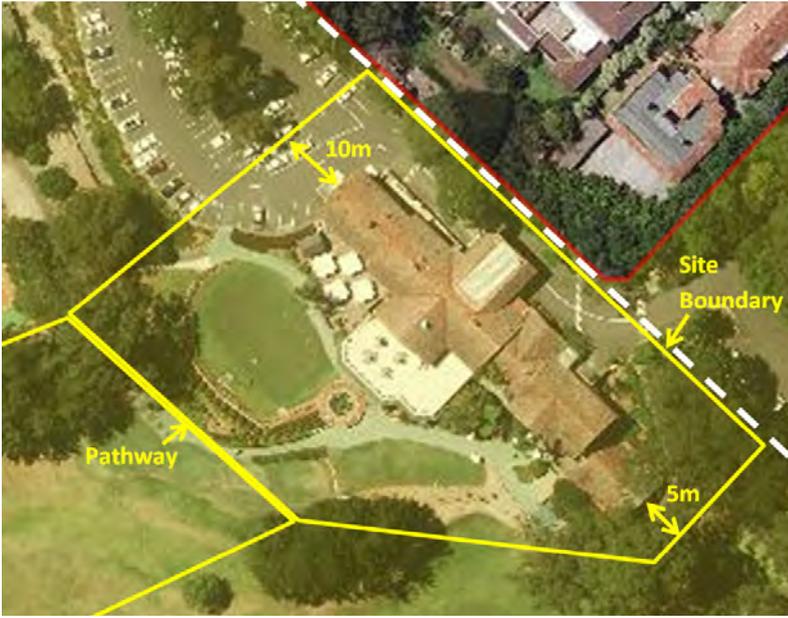
Figure 4.9  
Aerial view showing subject building and proposed essential curtilage boundaries. North is at the top. Not to scale.

The minimum spatial curtilage considered essential in order to protect the significance of the Clubhouse building is therefore as shown in Figure 4.9.
