### 3.4 Description of the Building Exterior

The subject building presents as a group of two-storey red textured brick and tile-roofed components arranged along an approximately north-south axis (though some components have an additional lower ground level or second floor and one component, Stage 5, is single-storey). The main entry is from the eastern side at a level between the ground and first floors, but the primary facade must be said to be the western facade facing a view over the golf links.

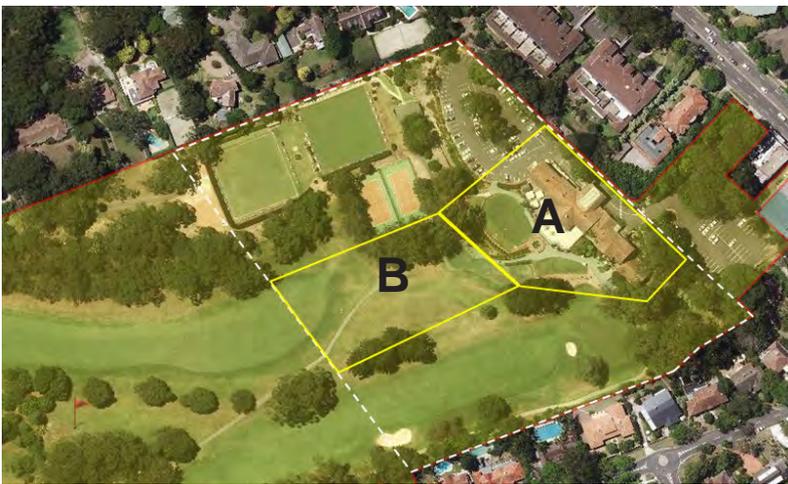
Figure 4.10  
Aerial view showing the Clubhouse building, the whole property shaded in yellow, Deferred Area 15 outlined in dashed line and proposed curtilage outlined in yellow: the proposed spatial curtilage is labelled A, and the proposed visual curtilage B. North is at the top. Not to scale.

An additional element with which the building has an important relationship is the golf links themselves. Both the 1909 and 1933 Clubhouses were sited, oriented and designed to address westward views over the links - views which (as shown in Figures 2.14-2.18) also influenced the development of Killara - and to present a suitably impressive prospect from the links. This view (which can be graded according to significance, as shown in Figure 4.7) is therefore considered contributory to the significance of the Clubhouse building and should be maintained. A minimum visual curtilage based on the primary views is shown in Figure 4.10 and is proposed to be included in the Clubhouse building's legal heritage curtilage.

The heritage significance of the Clubhouse building relies in part on its visual connection to the golf links. A minimum visual curtilage protecting primary views (Area B in Figure 4.10) shall be kept open and undeveloped, in accord with the policies in this *CMP*, to ensure the retention of historical primary views between the building and the links.

For the purposes of this Section, “the setting” refers to the heritage curtilage identified in Section 4.7, comprising Areas A and B as shown in Figure 4.10.

Rights of way are permitted within the spatial curtilage (Area A as shown in Figure 4.10) in order to provide necessary access. Rights of way are not permitted within the visual curtilage (Area B).

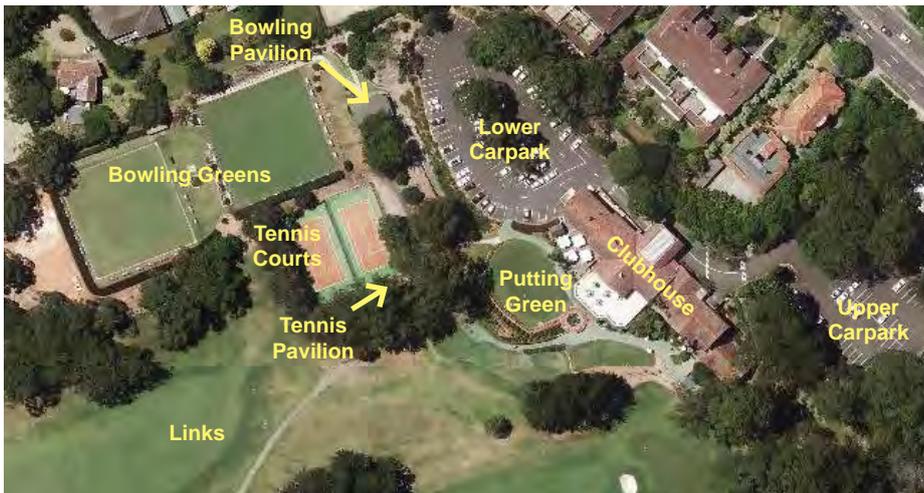
Figure 4.11  
Aerial view showing main site elements. North is at the top.

The elements of the site and its context are shown in the aerial view below, and graded in Table 4.1 below.

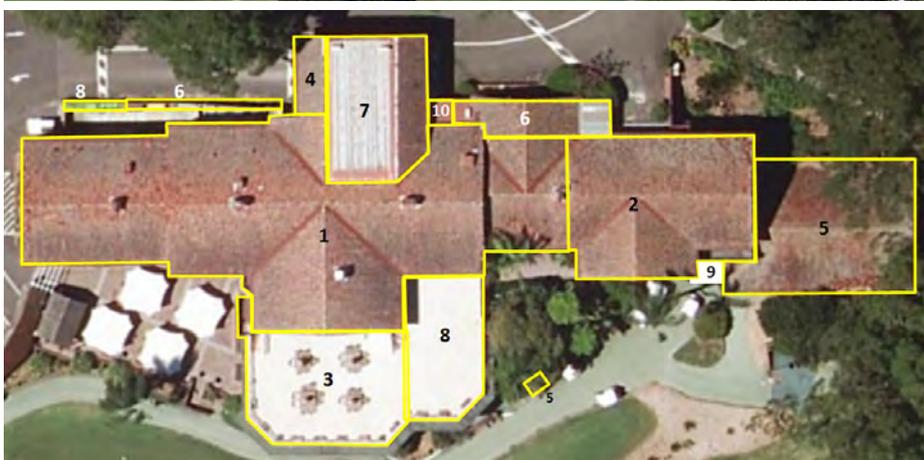
Figure 4.12  
Aerial view of Clubhouse building showing identified stages of development.

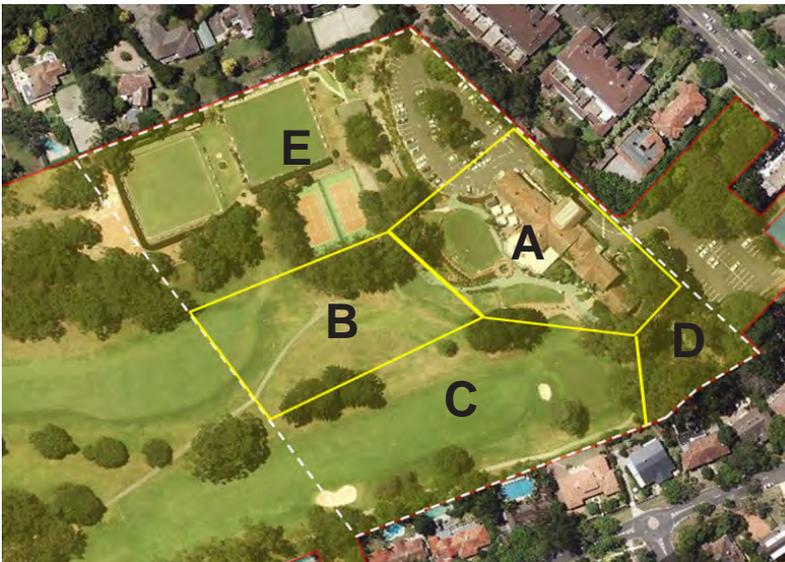
Figure 4.13  
Aerial view showing gradings of sensitivity in Deferred Area 15 (outlined in dashed line). North is at the top.

Given the proposed building curtilage and view corridor and the grading of significance of the primary site elements, the area described as Deferred Area 15 can be divided into zones of High, Moderate or Low sensitivity. Development within these areas would have High, Moderate or Low impact, respectively, on the heritage significance of the Clubhouse building and its setting.

Any new buildings within Areas C-E as shown in Figure 4.13 shall take into account the degrees of sensitivity and impact described in Table 4.2. Table 4.6 shows the implications of the sensitivity gradings for potential development.

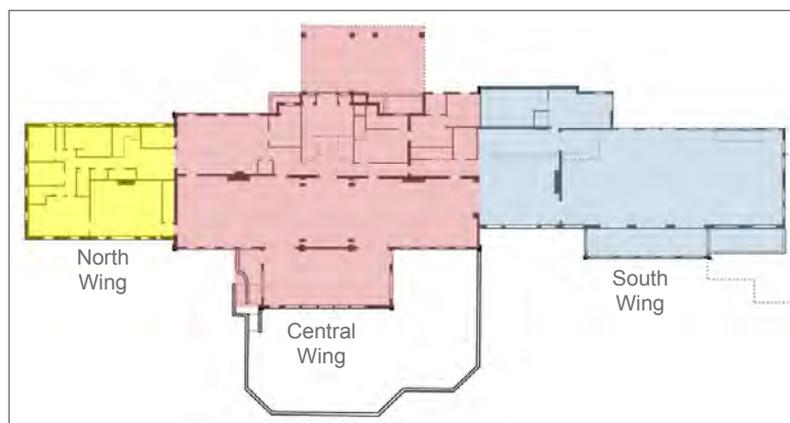
Figure 4.14 Designated Clubhouse 'wings', for purposes of grading only. The plan shown is of the First Floor.

For the purpose of grading the significance of internal elements, Stages 1 and 2 are divided into three 'wings'; the north, central and south, as shown below.

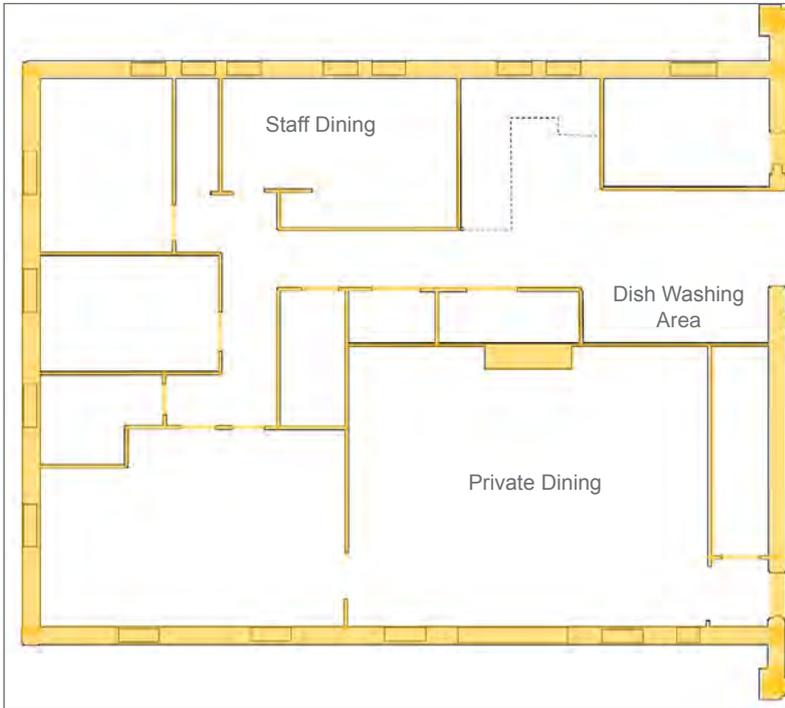
Figure 4.15  
Plan of First Floor, north wing. Stage 1 elements are shown in orange.

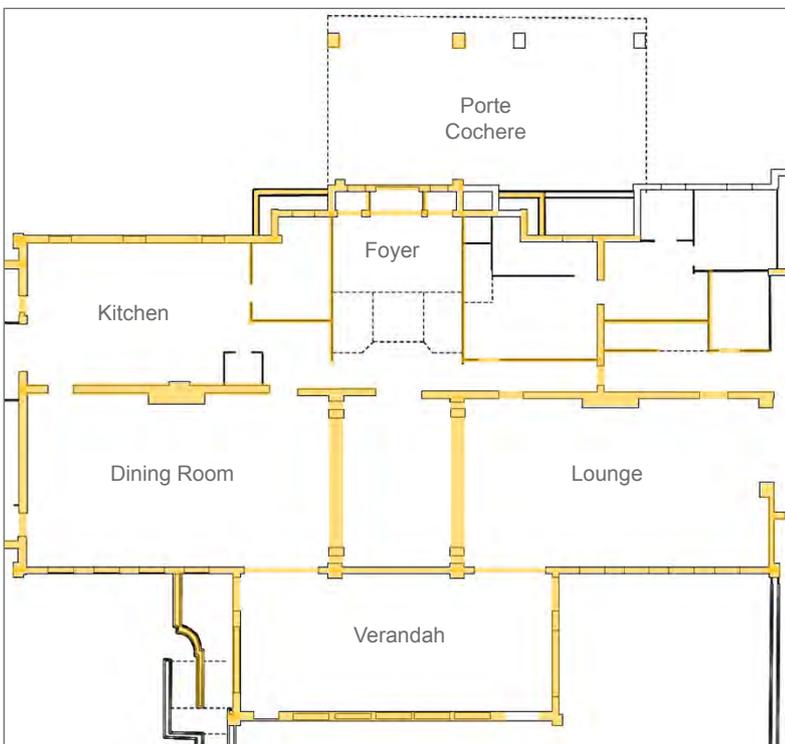
Figure 4.16  
Plan of First Floor, central wing. Stage 1 elements are shown in orange.

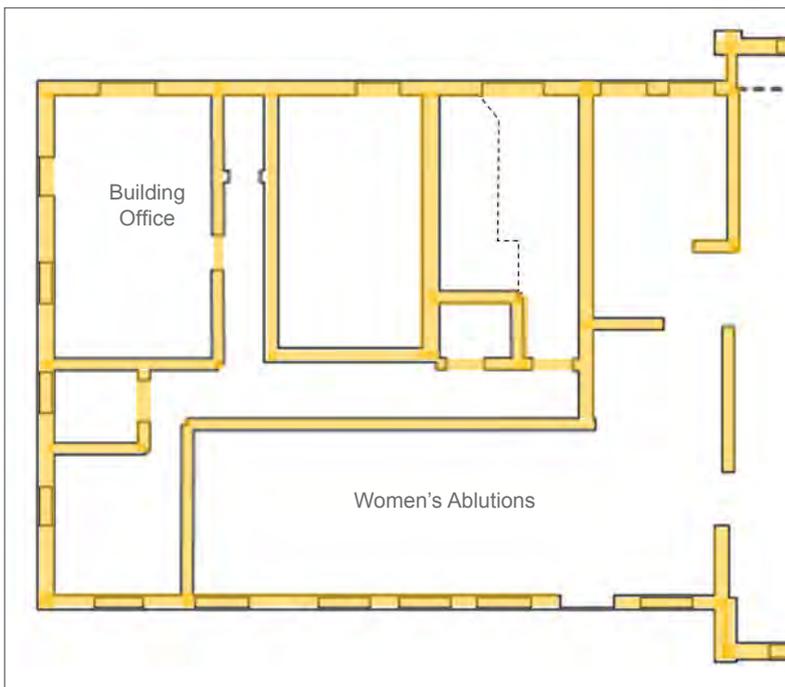
Figure 4.18  
 Plan of Ground Floor, north wing. Stage 1 elements are shown in orange.  
 Source: GBA Heritage. Schematic only; not to scale.

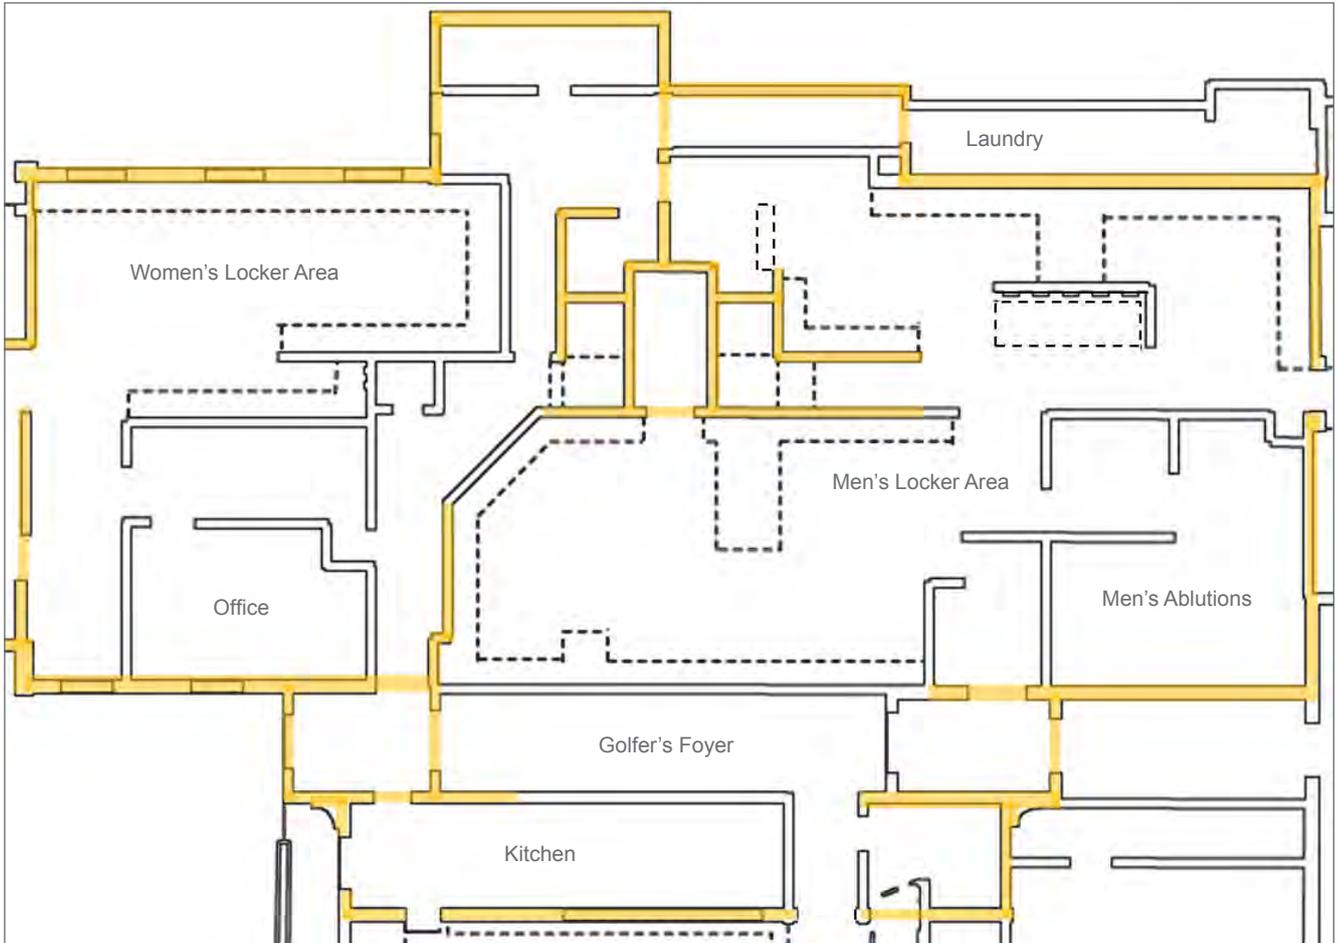
Figure 4.19  
Plan of Ground Floor, central wing. Stage 1 elements are shown in orange.

Source: GBA Heritage. Schematic only; not to scale.

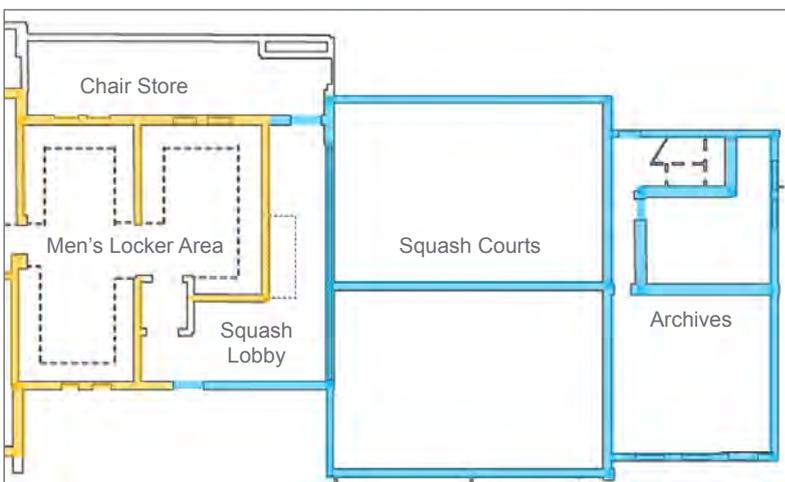
Figure 4.20  
Plan of Ground Floor, south wing. Stage 1 elements are shown in orange and Stage 2 elements in blue.

Source: GBA Heritage. Schematic only; not to scale.

All openings			
		Bricked up windows (two) in Kitchen			
		All internal walls/spaces/stairs			
Ground floor	Central	Original external walls and openings excepting sections near current Cool Room as shown in Figure 4.17	High		
				Golfer's Foyer	Brick arched doorway between Stages 1 and 2 (originally external)
					Stairwells to First Floor, including stairs, walls, balustrading.
				Stairwells to First Floor, including stairs, walls, balustrading.	
	Stairwells to First Floor, including stairs, walls, balustrading.	Stairs from men's locker area to corridor			
		South	All spaces and components	Little	
	North

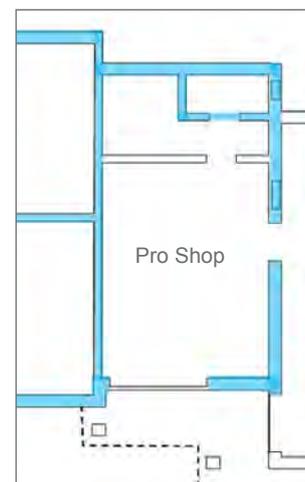
Figure 4.21  
Plan of Lower Ground Floor, south wing. Stage 2 elements are shown in blue.

Source: GBA Heritage. Schematic only; not to scale.

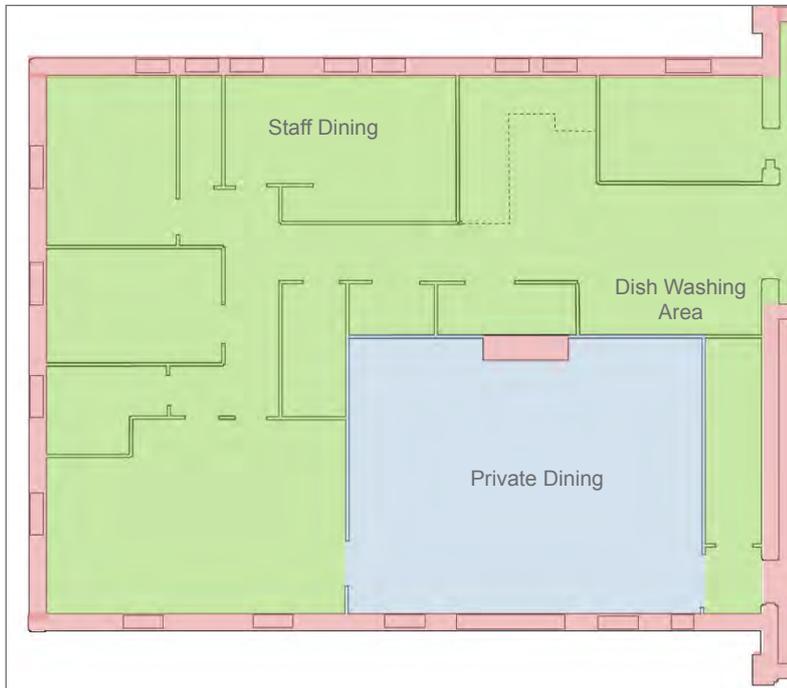
Figure 4.22  
Plan of First Floor, north wing, showing gradings of significance.

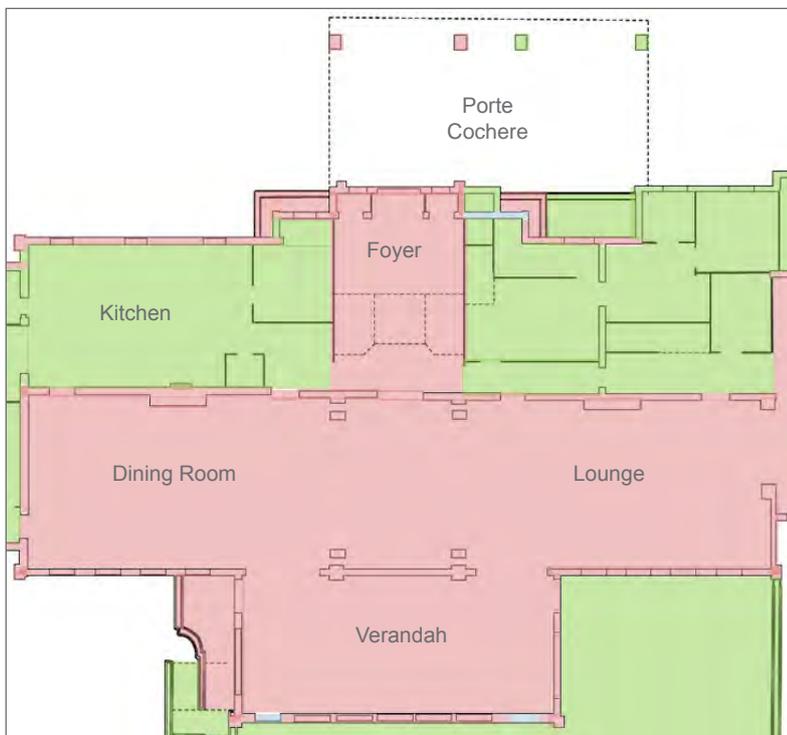
Figure 4.23  
Plan of First Floor, central wing, showing gradings of significance.

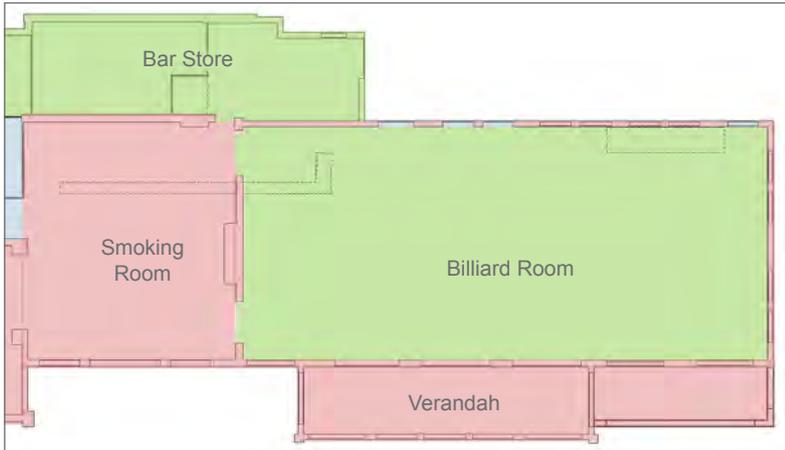
Figure 4.24  
Plan of First Floor, south wing, showing gradings of significance.

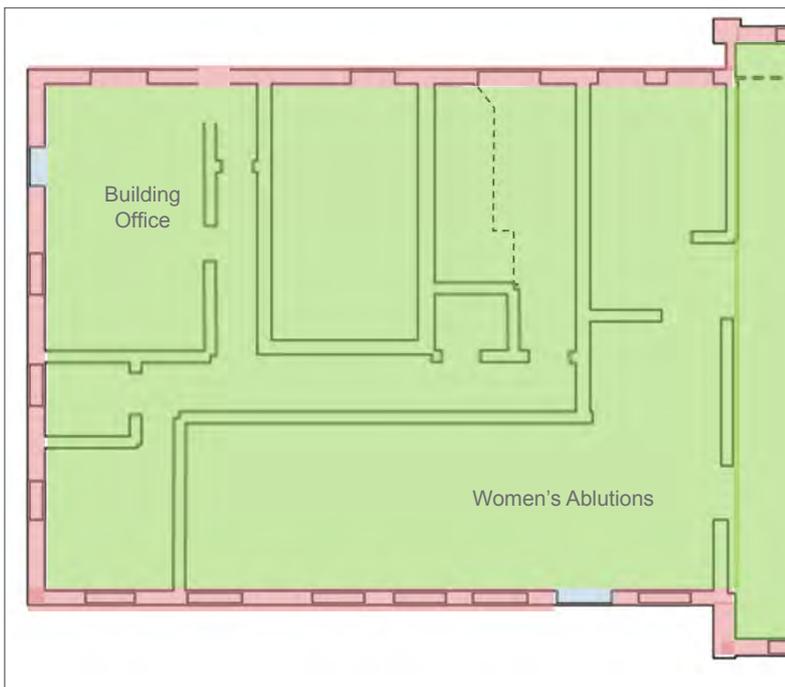
Figure 4.25  
Plan of Ground Floor, north wing, showing gradings of significance.

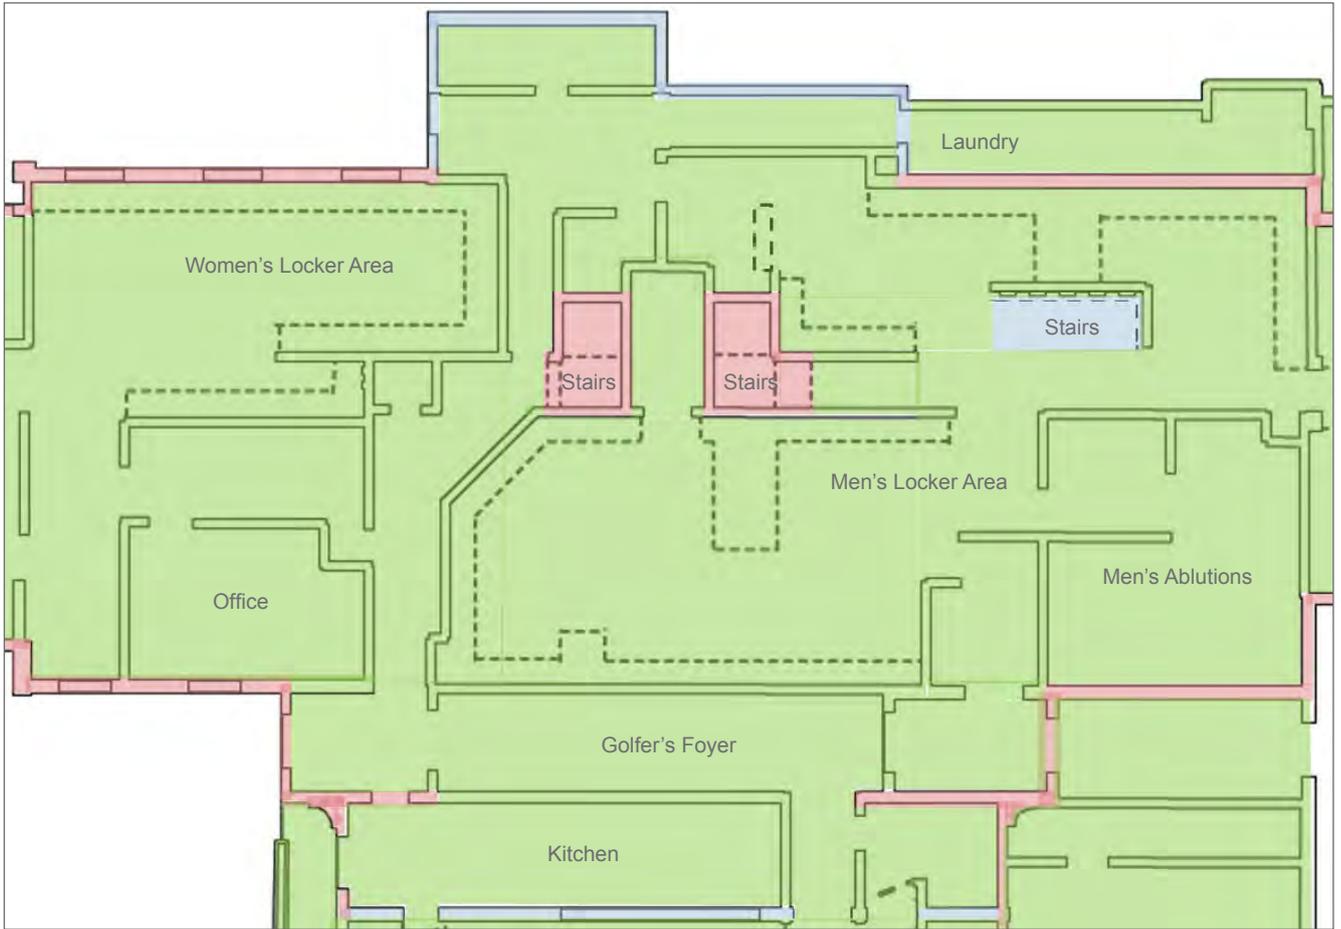
Figure 4.26  
Plan of Ground Floor, central wing, showing gradings of significance.

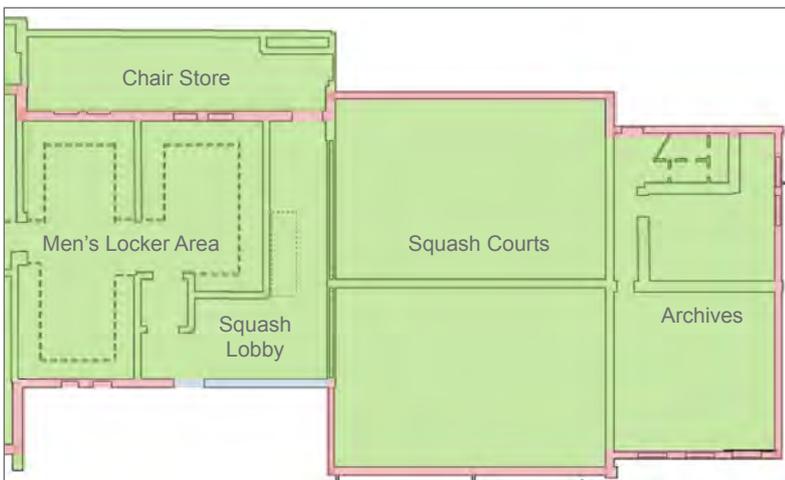
Figure 4.27  
Plan of Ground Floor, south wing, showing gradings of significance.

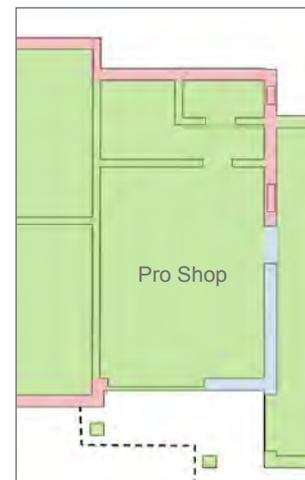
Figure 4.28  
Plan of Lower Ground Floor, south wing, showing gradings of significance.
