PHASE 1 CONTAMINATION ASSESSMENT AND  
SALINITY ASSESSMENT

PART LOT 24 DP1086823, 10 CRASE PLACE,  
GRASMERE, NSW

Report Date: 25 November 2013

Reference: ENAUWOLL04150AA-R01 (Rev. 1)

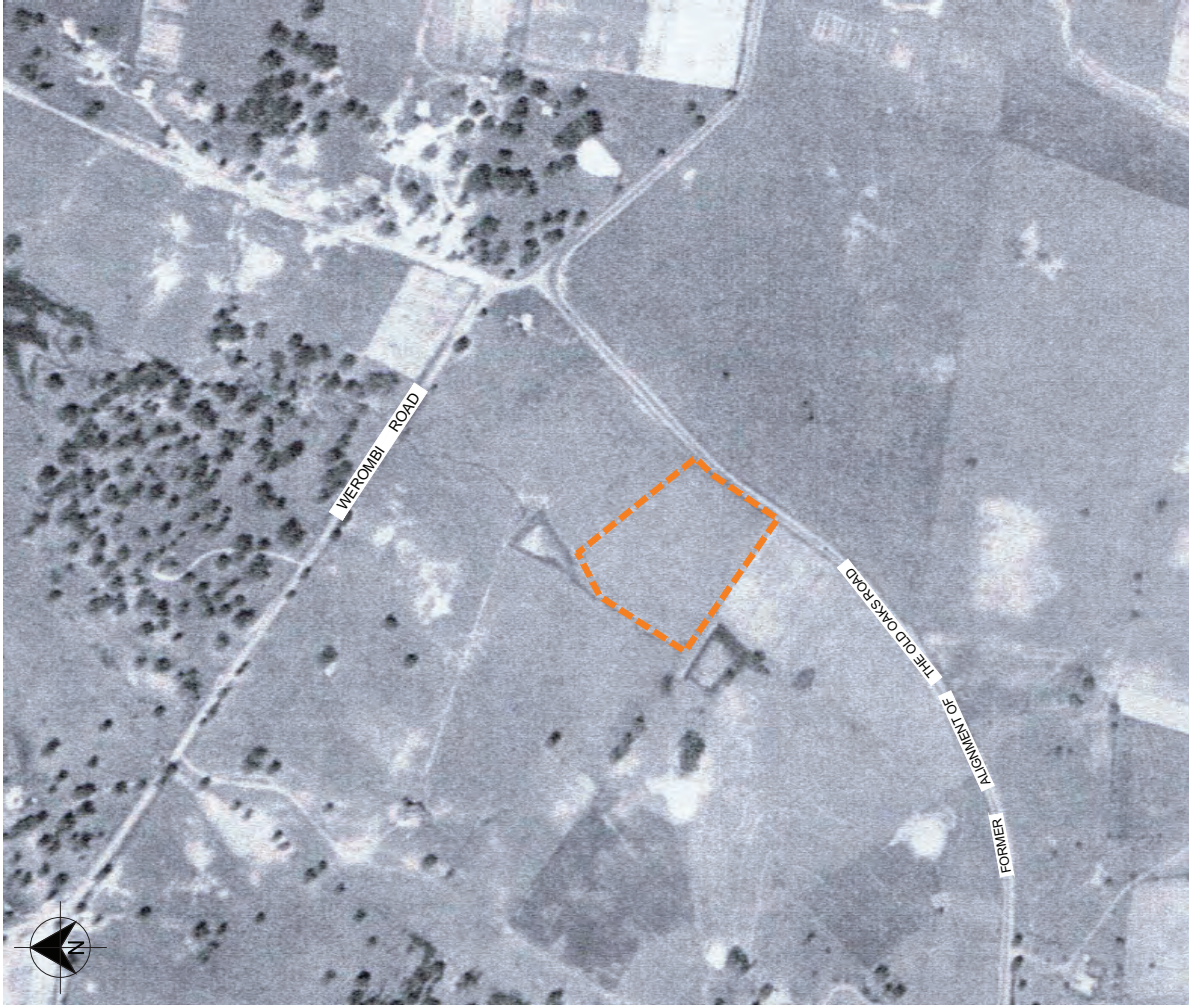
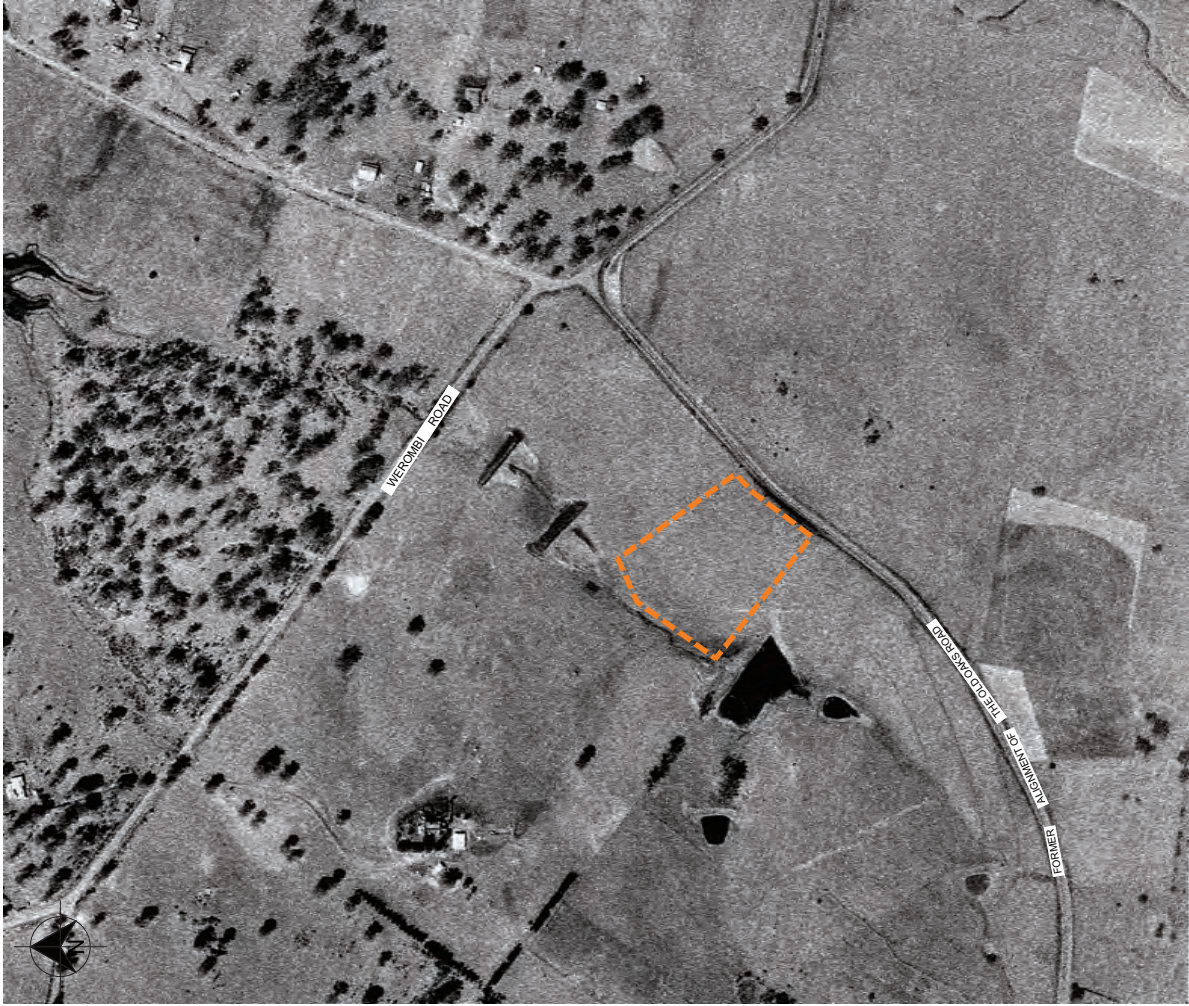
| revision | | description | | drawn | approved | date | | | | | | drawn | LZ | | | | client: | |
|---|--|---|--|---|---|---|--|--|--|--|--|---|---|---|---|---|---|--|
| | | | | | | | | | | | | | | | | | AERIAL PHOTOGRAPHS - 1954 AND 1965 | |

AERIAL PHOTOGRAPH 1954

AERIAL PHOTOGRAPH 1965

In the 1954 aerial photograph, a structure and driveway was evident in the northeastern corner of Lot 24, but had been removed by 1965. Other evidence of activities on the remaining parts of Lot 24 was not observed until 2007. In 2007, two patches of exposed soils were observed north of the site. Although some grass cover has re-established across these areas since 2007, exposed soil is still evident.

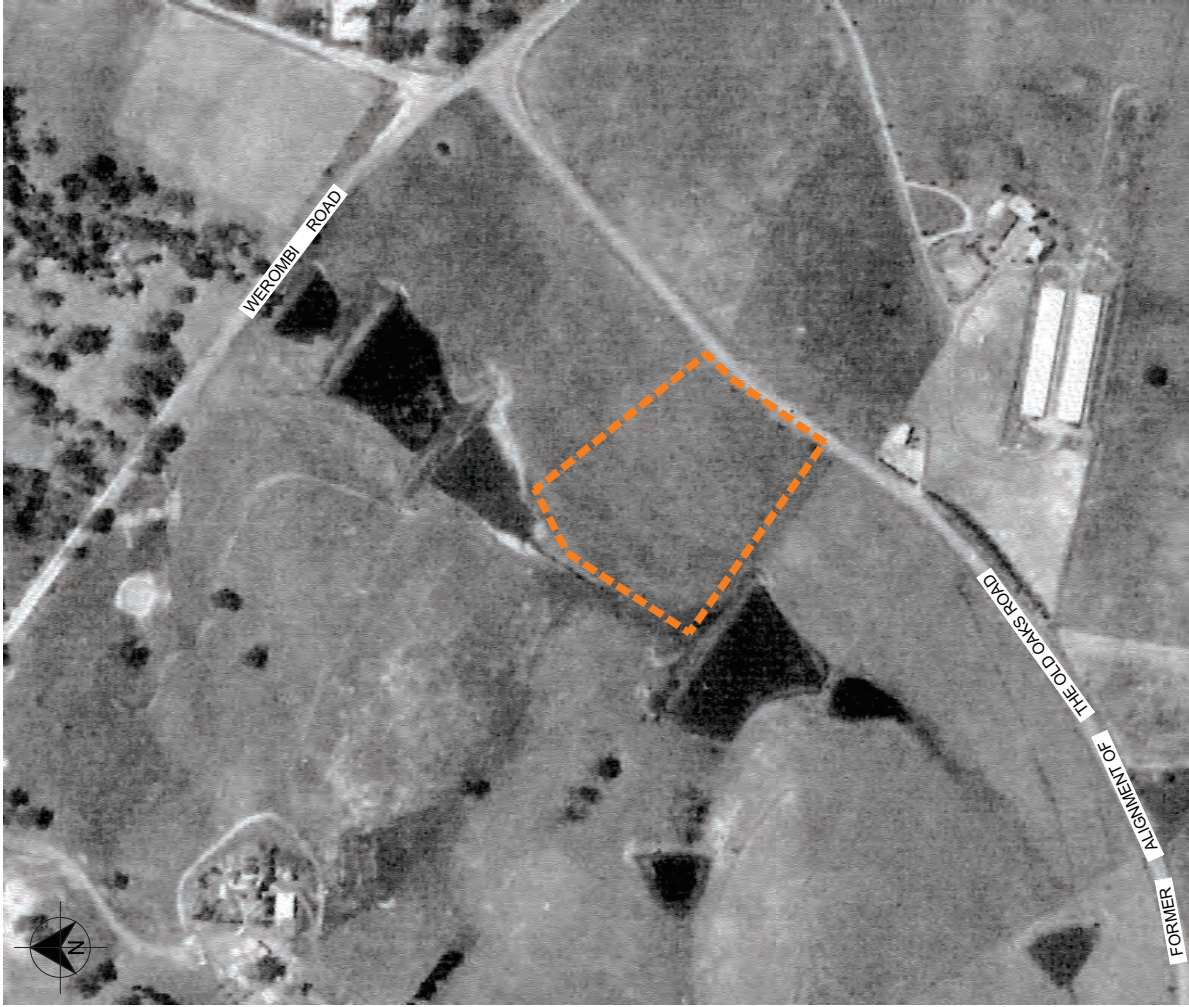
AERIAL PHOTOGRAPHY 1974

AERIAL PHOTOGRAPHY 1984

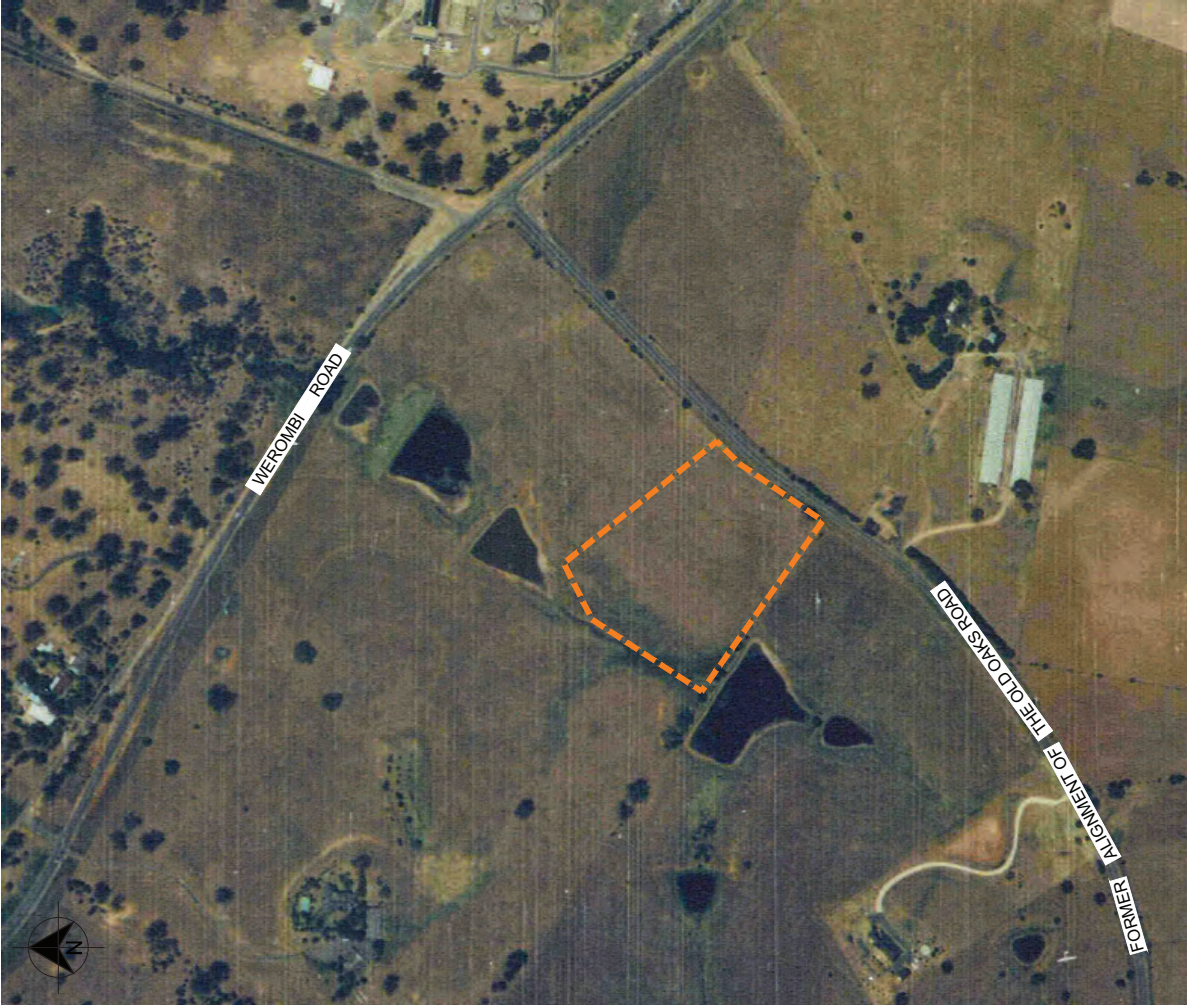
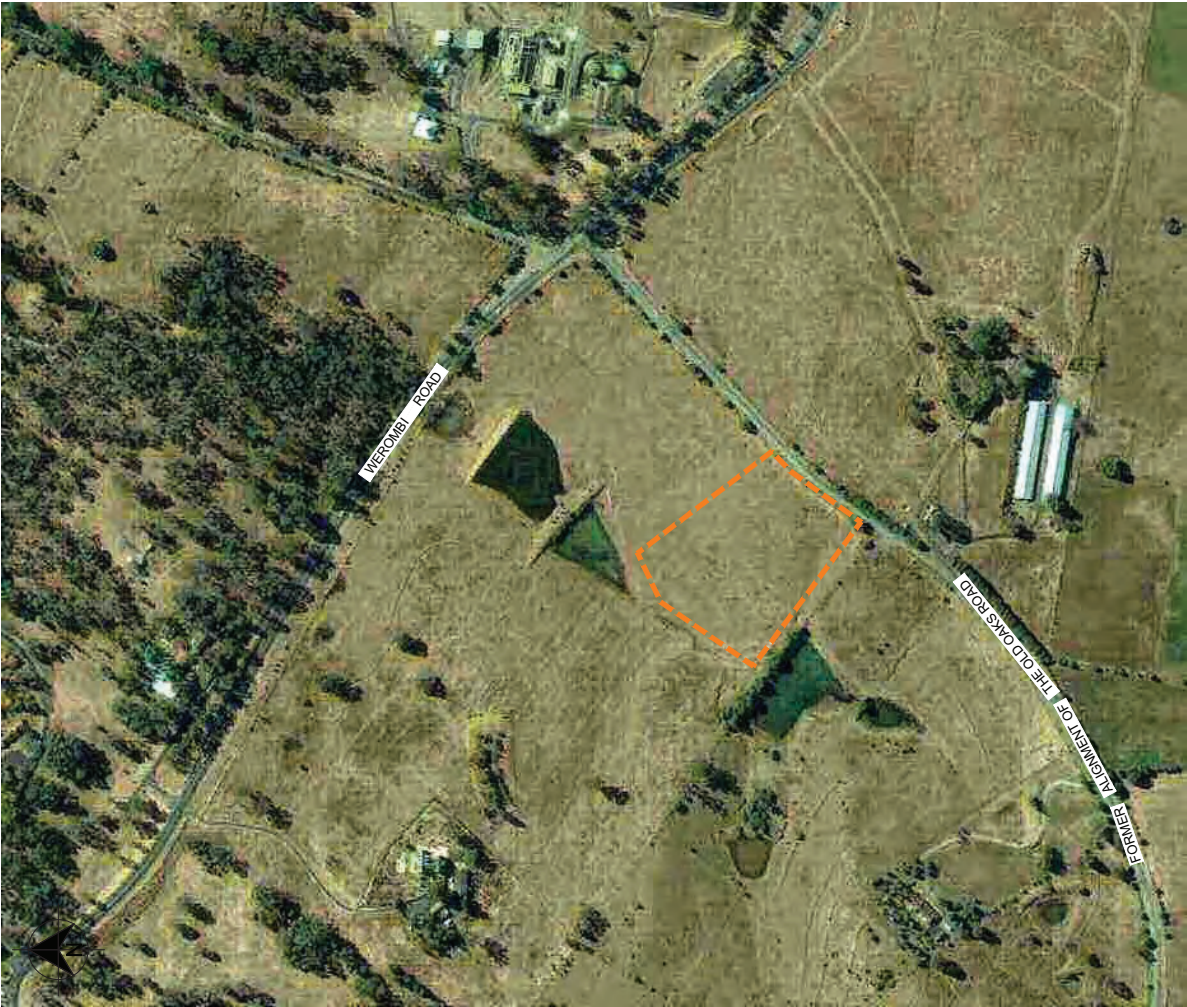
AERIAL PHOTOGRAPH 1994

AERIAL PHOTOGRAPH 2002  
AERIAL IMAGE SOURCE: GOOGLE EARTH PRO 6.0.1  
AERIAL IMAGE © SINCLAIR KNIGHT MERZ 2013

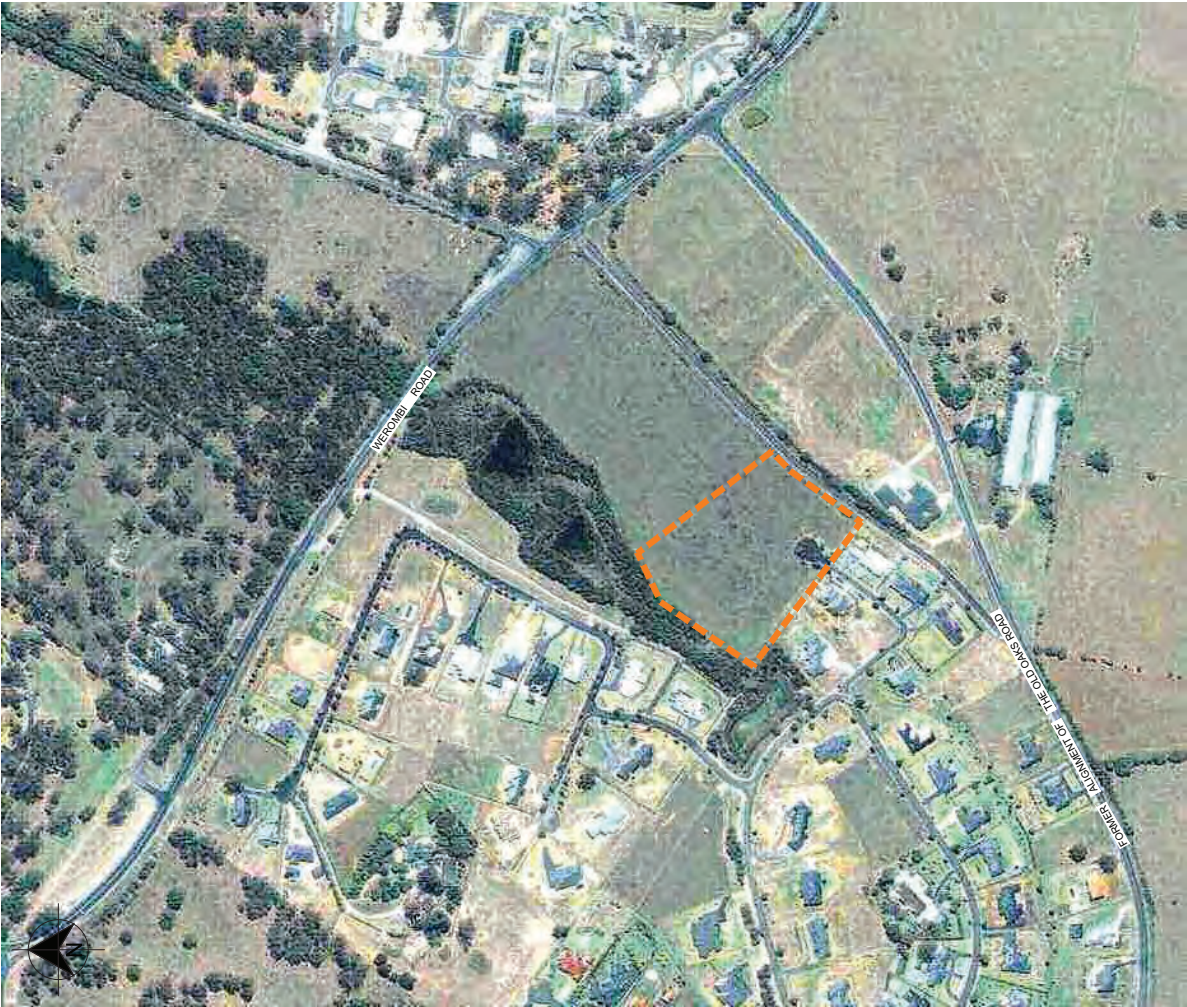
| DATE | OBSERVATIONS |
|---|---|
| <p>11/3/2007<br/>(Colour)<br/><br/>Google<br/>Earth Image</p> | <p><b>On Site:</b> A cul-de-sac extending from the southern boundary into the site has been constructed (Crane Place). An access track extends north from the cul-de-sac through the site where it appears to terminate, offsite, at a circular area which appears to be a slight depression or higher moisture content. A second feature extending from the cul-de-sac appears to be a storm water drain that directs water west from the road towards the watercourse. Three small objects positioned along the length of this drain are also evident. This corresponds to a drainage easement marked on title diagrams.</p> <p><b>Off Site:</b> Exposed ground is evident in areas north of the site. Near these areas are either slight depressions or high moisture content (as previously discussed). These areas are located adjacent to the dams. White efflorescence was observed in areas immediately surrounding dams located west of the site. This white feature may also be associated with hydromulching as vegetation growth substantially increases in later years. The third dam located northwest of the site and adjacent to Werombi Road is no longer evident. A network of roads servicing a new subdivision is evident in areas south and west of the site. The realignment of The Old Oaks Road appears under construction.</p> |
| <p>2/11/2012<br/>(Colour)<br/><br/>Google<br/>Earth Image</p> | <p><b>On Site:</b> Except for the cul-de-sac, the site continues to remain undeveloped. The remaining features observed in the previous aerial photograph have faded. Sporadic growth of trees and/or shrubs is evident throughout and north of the site.</p> <p><b>Off Site:</b> The exposed ground and access track extending north of the cul-de-sac are no longer evident. Extensive growth of tree and/or shrubs is evident in along the watercourse and areas surrounding the dams located west and north of the site. Residential developments continue in areas surrounding the site. The former alignment of The Old Oaks Road has been blocked with a fill mound at the intersection with Werombi Road. The realignment of The Old Oaks Road appears complete.</p> |

Evidence of a slight depression was observed between the cul-de-sac and watercourses west of the site. This depression is consistent with that observed in the 2007 aerial photograph and appears to be associated with the stormwater drainage system. This depression is also consistent with the drainage easement shown on title diagrams (Appendix E). The drainage appears to capture water accumulated within the cul-de-sac and directs it towards the watercourses located west of the site. No other structures or infrastructure was observed on the site. A building once occupied the northeastern corner of Lot 24 (offsite) circa 1954. Evidence of this former structure was not apparent during the site walkover however the long grass may have obscured any remnants.
