Report on
Assessment of Geotechnical Conditions

Proposed Rezoning
1 Crescent Street, Holroyd

Prepared for
Tiberius (Parramatta) Pty Ltd

Project 84770.00
May 2015

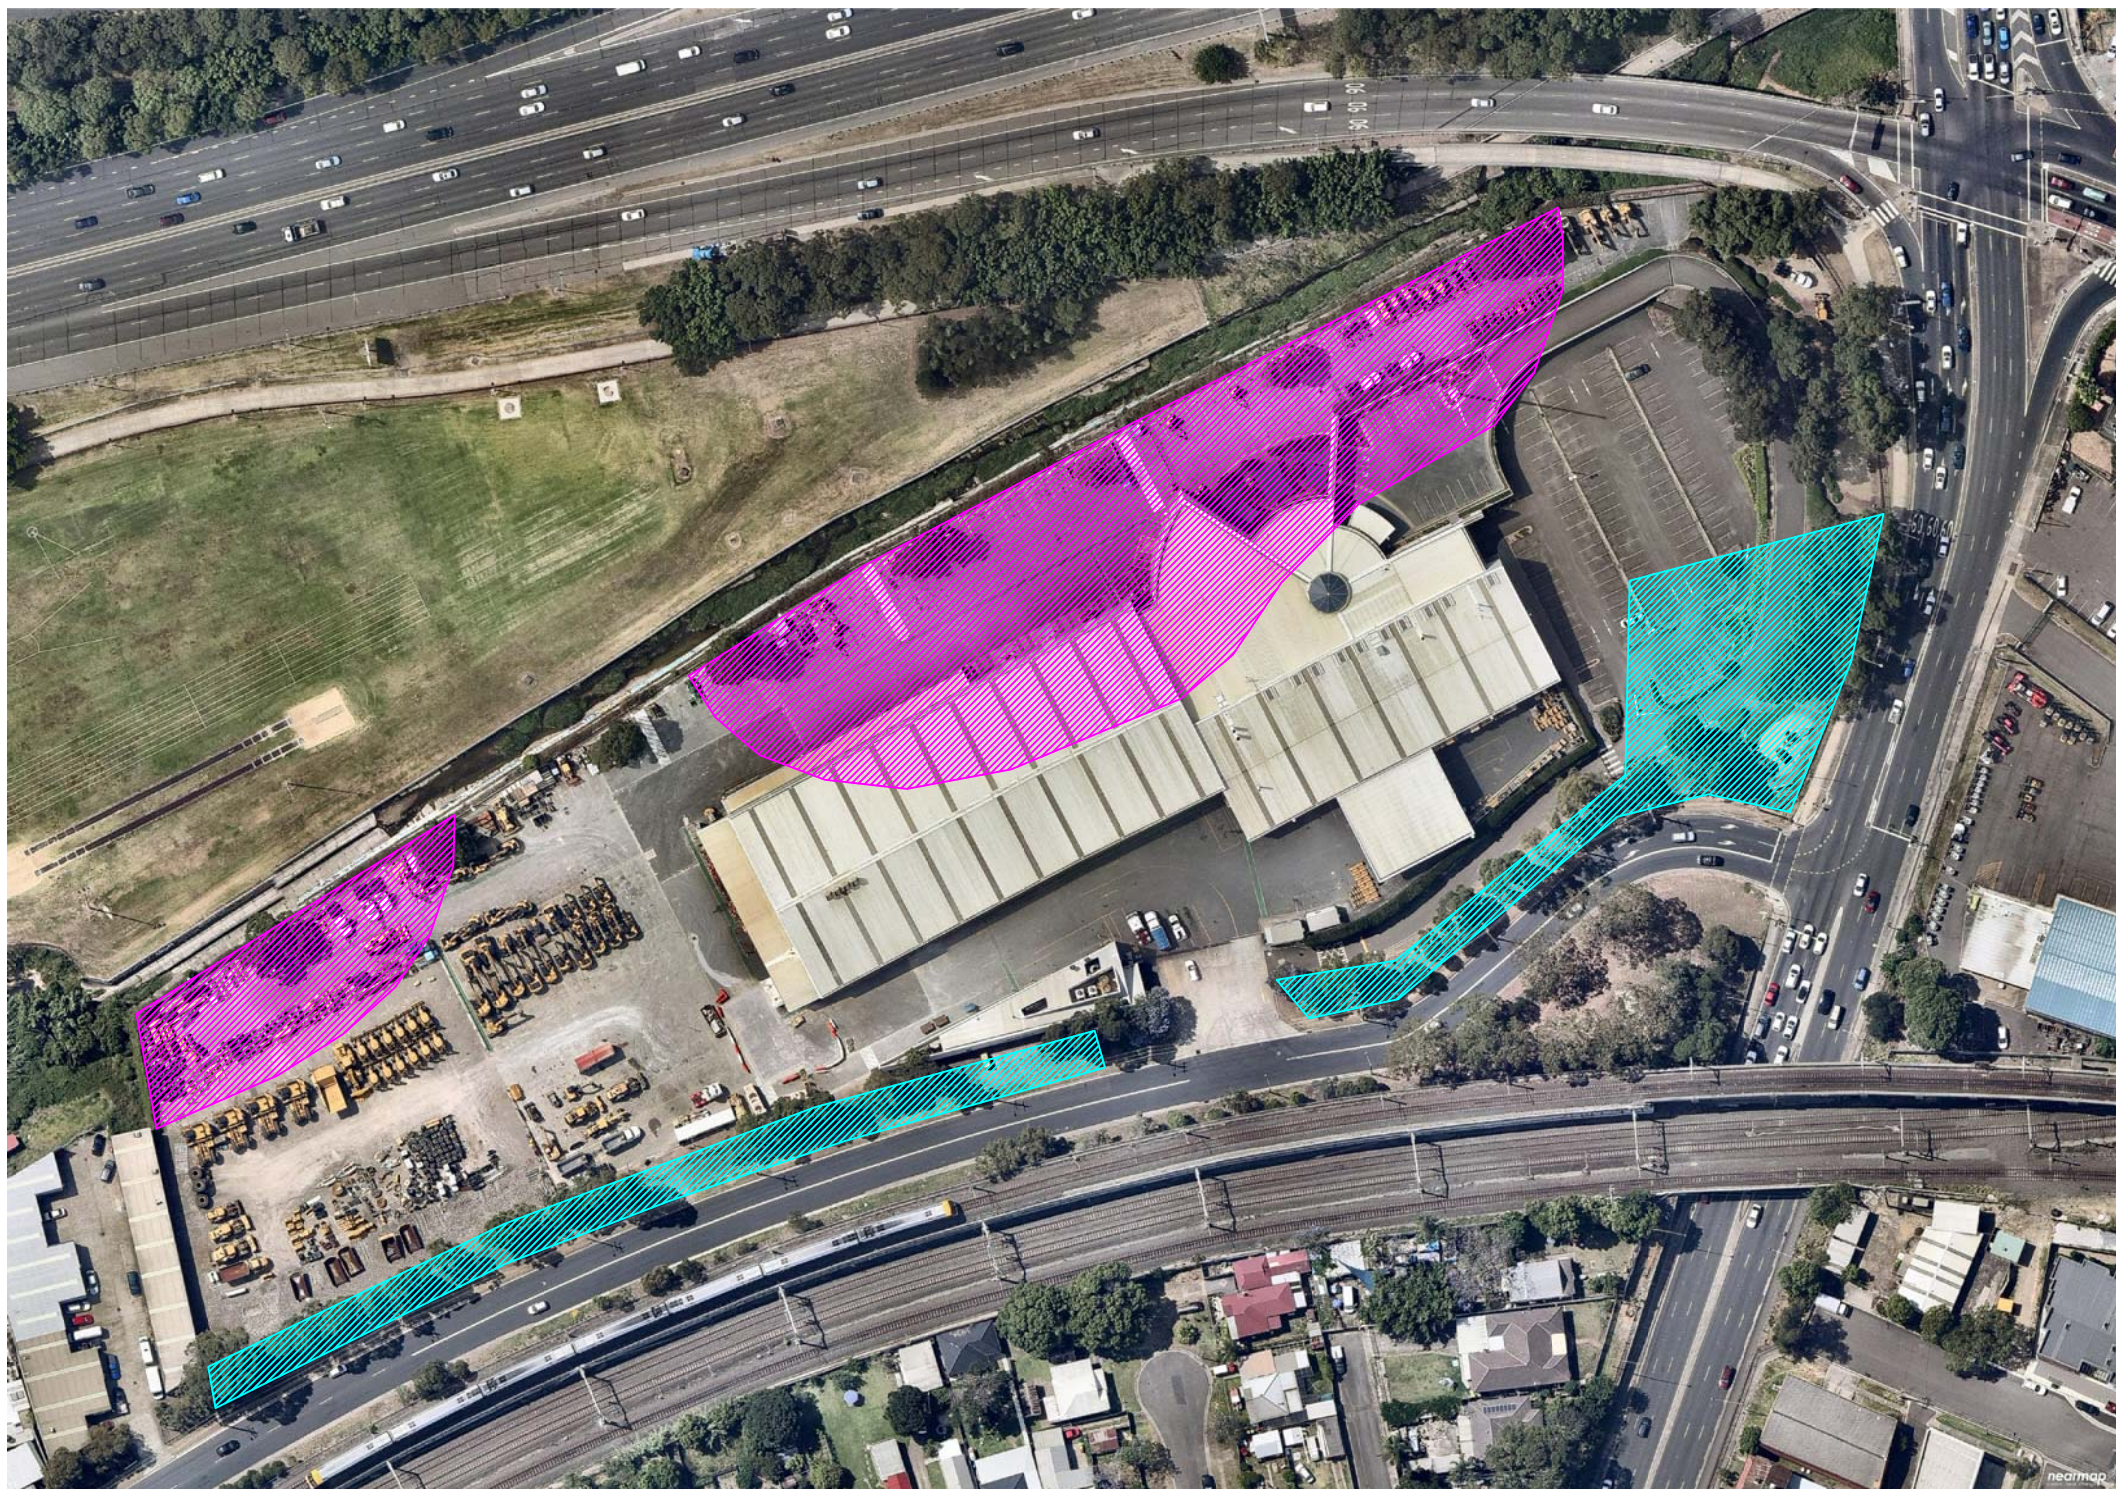
NOTE:
1. Base drawing from Nearmap.com

It is unclear whether the site was partially or wholly remediated prior to or during the development of the current site improvements. Selected test pit logs from our previous work are attached in Appendix C and their approximate locations are shown on Drawing 1 in Appendix B. These pits were selected as they were measured relative to AHD at the time of the field work, however it is not known whether the pits remain representative of current subsurface conditions.
