357 Glebe Point Road, Glebe

Conservation Management Plan

September 2015

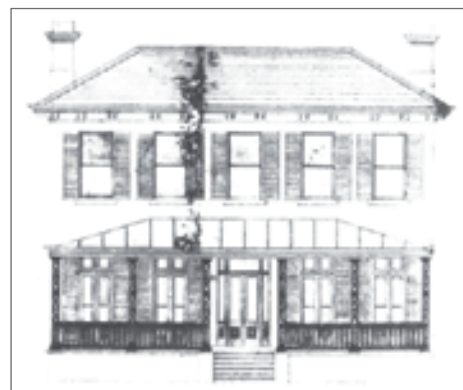
Figure 2.3
Blacket's drawing of the Glebe Road residence, front elevation, c.1857, by ET Blacket.

The first *Sands Directory*, of 1858, shows Blacket residing in Glebe Road. The house in Blacket's own drawings is recognisable as the existing building (see Figures 2.3 and 2.4), and even more so are family sketches, probably by Blacket's artistically talented daughter Edith, dated 1865 (Figure 2.5) and notated 'Our House'. The building was known during his residency only as 'Mr Blacket's House',¹⁶ and was described as having 'four upstairs rooms, four more below and several kitchens. There were fireplaces in some of the rooms as the house had at least four chimneys.' The site

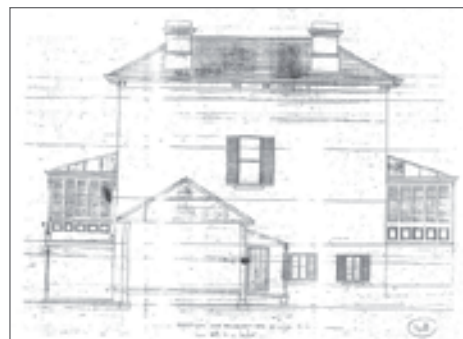
Figure 2.4
Blacket's drawing of the Glebe Road residence, apparently the north-west elevation with section through adjoining annex.

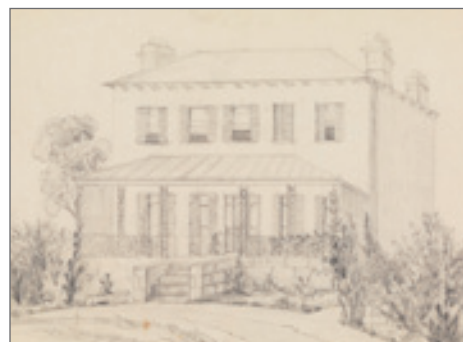
Figure 2.5
Drawing of the Glebe Road residence, dated 1865, probably by Edith Blacket.

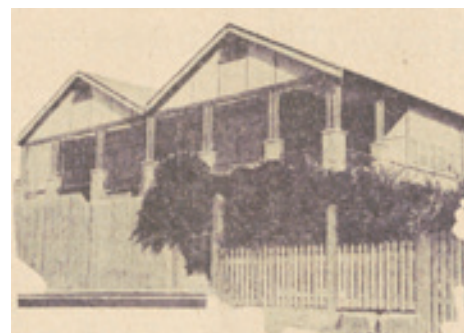
Figure 2.8
The Avon Street facade of the Metropolitan Girls' Shelter, 1931

In 1925, soon after creation of the Child Welfare Department, a large new building was erected in the eastern corner of the site fronting onto Avon Street, to house the Metropolitan Girls' Shelter.⁴² This was a single-storey structure plus basement, with twin half-timbered gables and front and rear verandas (see Figure 2.8), providing bedrooms, dormitories and associated facilities for girls awaiting hearings. A 'record plan' dated 1941 (Figure A3.2 in Appendix 3) shows the layout, and that of a 'shed' to the rear, which may have been the 'two bedrooms' described in the 1876 advertisement (labelled 'BR' in Figure 2.16 and 'MS' in aerial photographs). From at least 1943 a fence ran across the site to the south-west of the 'shed', creating a separate area at the rear of the site for the Metropolitan Girls' Shelter.

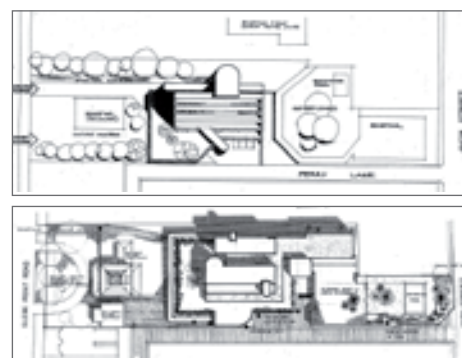
Figure 2.14
Sketch plans for proposed Remand Centre by Government Architect, 1977 (top) and 1978 (bottom).

Source: Drawings CW20-277 (top) and CW20-286 (bottom), Plan Services, NSW Finance & Services

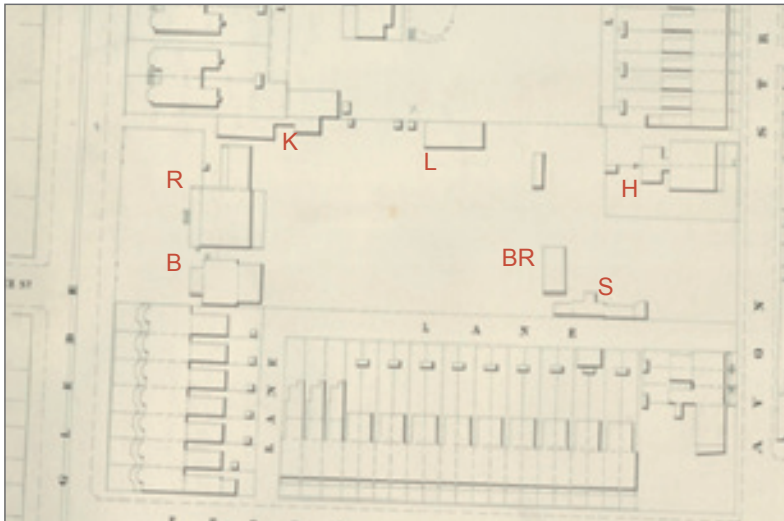
Figure 2.16

Plan of subject site, 1889, showing main residence and other buildings. Note the houses (H) in the northern corner of the site.

R	Original residence including annex
B	Ballroom and rear addition
K	Kitchen
L	Laundry
S	Possible stables
BR	Possible bedrooms
H	Apparent houses

Bidura's purchaser in 1877 was Frederick John Perks, a merchant and Justice of the Peace, who shared the house with his son, also named Frederick John Perks, a solicitor. A plan dated 1889, when both were still in residence, shows several buildings on the site (see Figure 2.16):

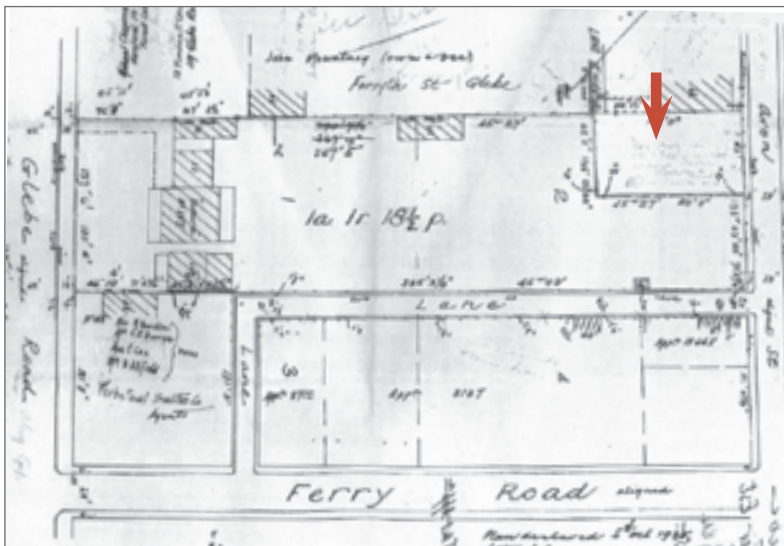
Figure 2.17

Survey plan, 1905, showing 1904 subdivision, formally excising northern corner of Lot 2 of the Boissier Estate (with excised lot indicated by arrow). Note that the semi-detached houses visible in Figure 2.16 are not shown.

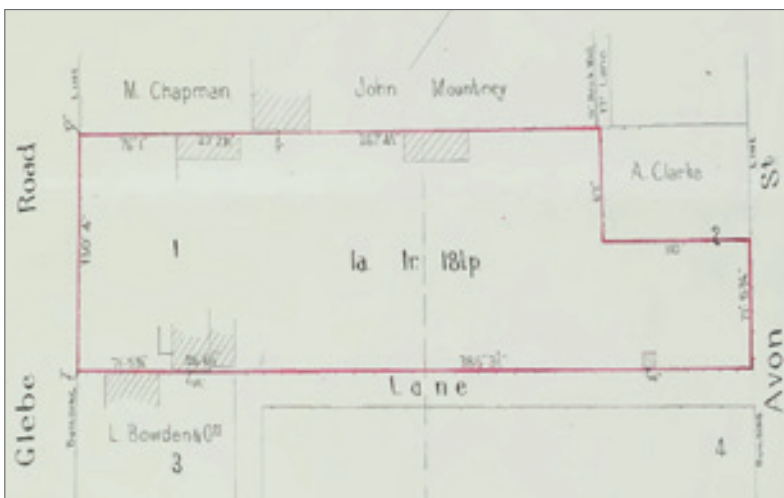
Figure 2.18

Plan of subject site as shown on Certificate of Title, Vol. 1674, Folio 158, 1906, with northern portion of original site labelled 'A Clarke'.

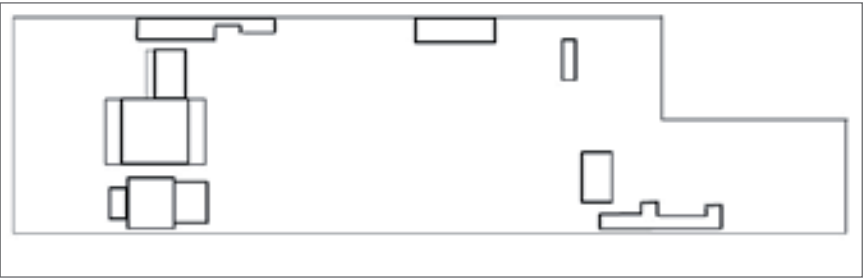
Figure 2.19
Schematic plan showing buildings on site c.1889, including Bidura House group, kitchen block, laundry block, stables and presumed bedroom block.

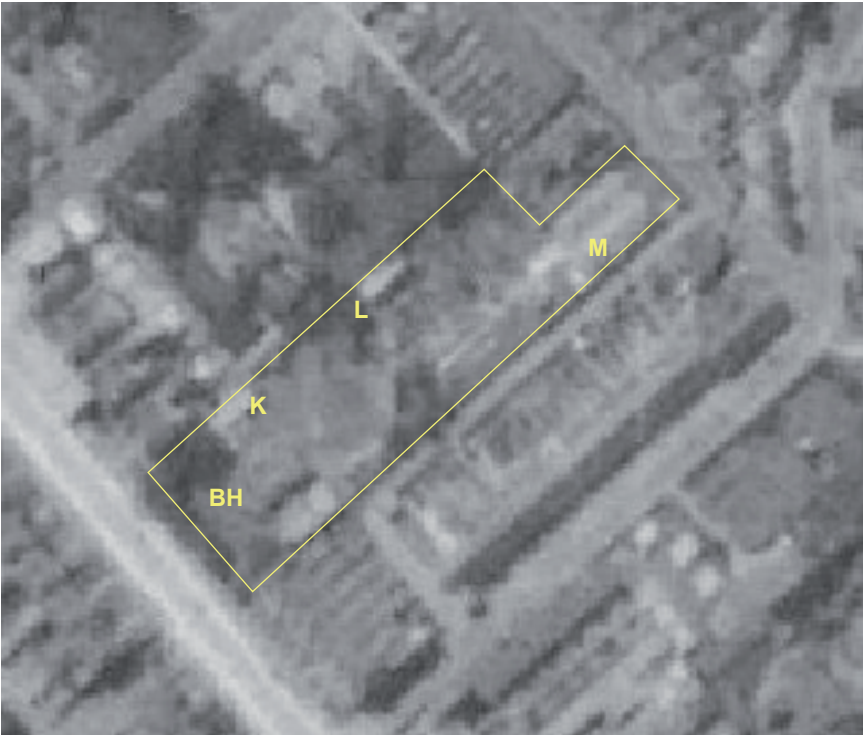
Key to aerial views	
BH	Bidura House group including residence and Annex (c.1860) and Ballroom (c.1870s)
K	Kitchen (c.1860s)
L	Laundry (c.1860s)
M	Metropolitan Girls' Shelter (c.1925)
MS	Shed linked to Girls Shelter, possibly same as building labelled BR in Figure 2.16 (c.1870s)
NS	New store (c.1930s-40s)
A	Air raid shelter (c.1940s)
S	School (c.1950s)
C	New classrooms (c.1970s)
RC	Remand Centre (1980-83)

Figure 2.20
Aerial view of subject site (outlined), 1930. Only Bidura House (R), the Kitchen block (K), Laundry block (L) and the Metropolitan Girls' Shelter (M) are clearly visible.

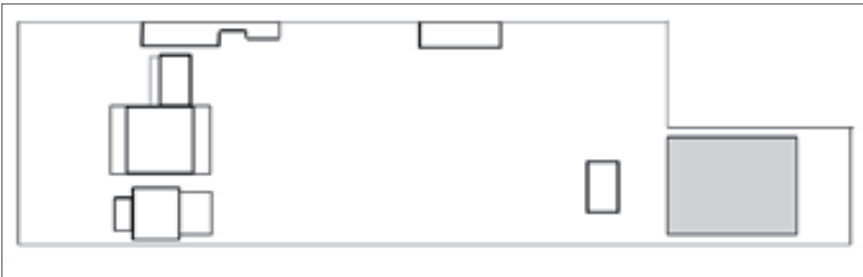
Figure 2.21
Schematic plan showing buildings on site c.1930, with Metropolitan Girls' Shelter, constructed 1925, shaded.

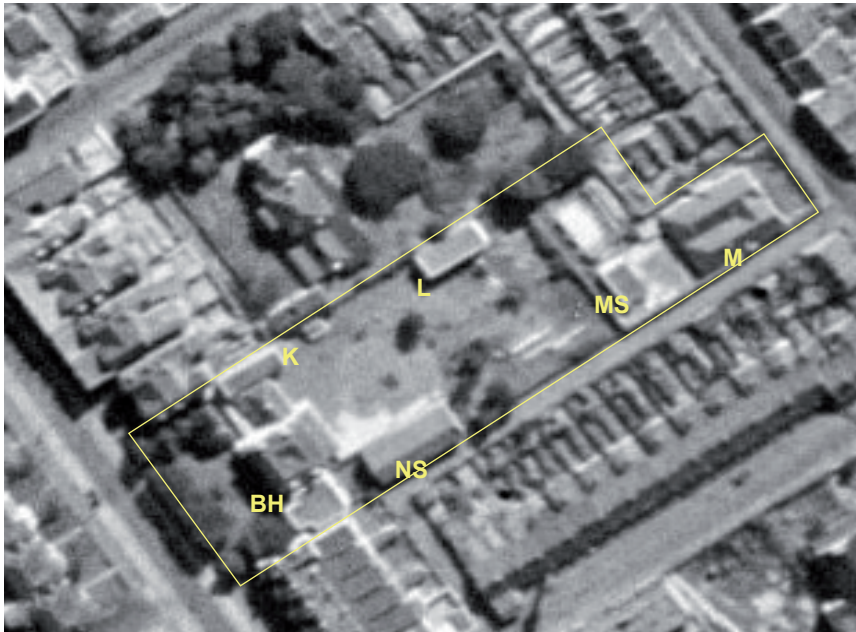
BH	Bidura House group including residence and Annex (c.1860) and Ballroom (c.1870s)
K	Kitchen (c.1860s)
L	Laundry (c.1860s)
M	Metropolitan Girls' Shelter (c.1925)
MS	Shed linked to Girls Shelter, possibly same as building labelled BR in Figure 2.16 (c.1870s)
NS	New store (c.1930s-40s)
A	Air raid shelter (c.1940s)
S	School (c.1950s)
C	New classrooms (c.1970s)
RC	Remand Centre (1980-83)

Aerial view of subject site (outlined), 1943. The two-bedroom 'shed' behind the Metropolitan Girls' Shelter (MS) and the new Store (NS) are clearly visible.

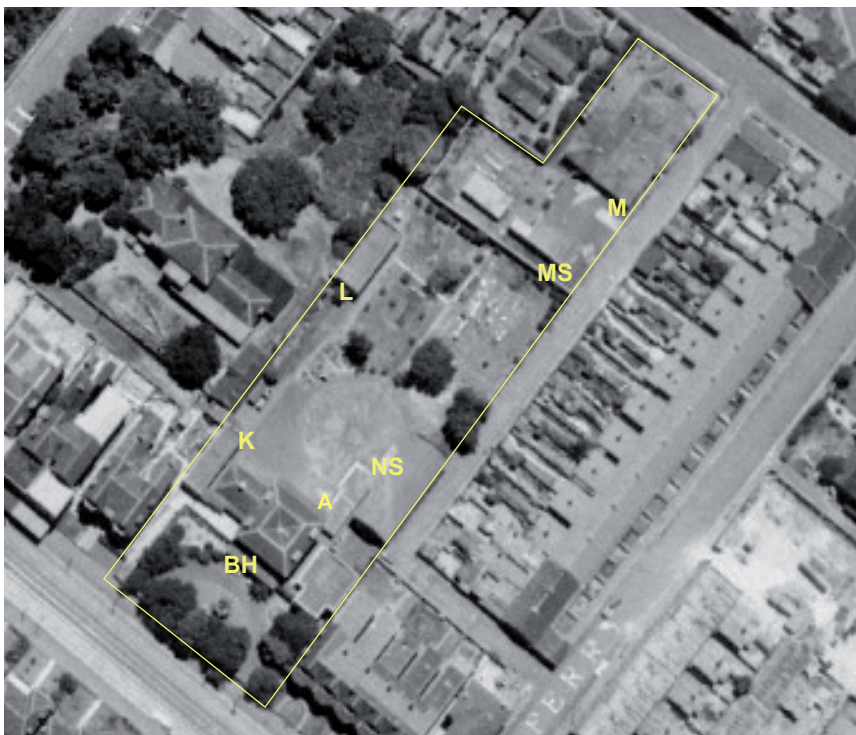
Figure 2.23

Aerial view of subject site (outlined), 1949. The Air Raid shelter (A) has been added by this time.

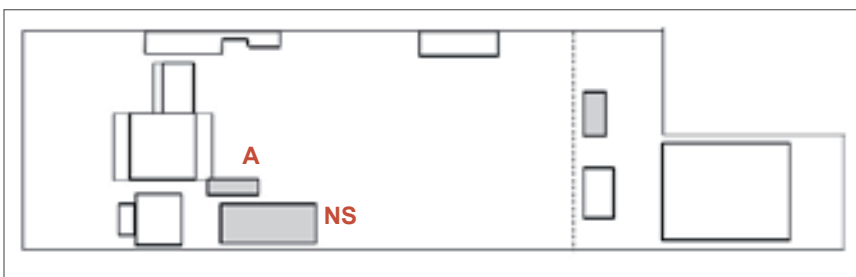
Figure 2.24

Schematic plan showing buildings on site c. 1949, with new Store (S) and Air Raid Shelter (A), both constructed c.1940s, and unidentified structure, shaded. The rear addition to the Ballroom and the presumed Stables have been demolished.

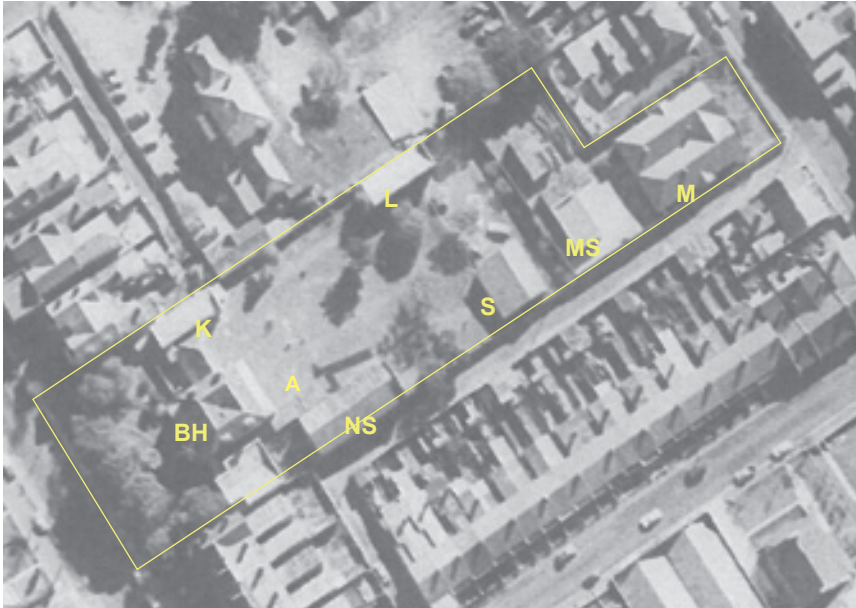
BH	Bidura House group including residence and Annex (c.1860) and Ballroom (c.1870s)
K	Kitchen (c.1860s)
L	Laundry (c.1860s)
M	Metropolitan Girls' Shelter (c.1925)
MS	Shed linked to Girls Shelter, possibly same as building labelled BR in Figure 2.16 (c.1870s)
NS	New store (c.1930s-40s)
A	Air raid shelter (c.1940s)
S	School (c.1950s)
C	New classrooms (c.1970s)
RC	Remand Centre (1980-83)

Figure 2.25
Aerial view of subject site (outlined), 1961.
The new School (S) is now visible.

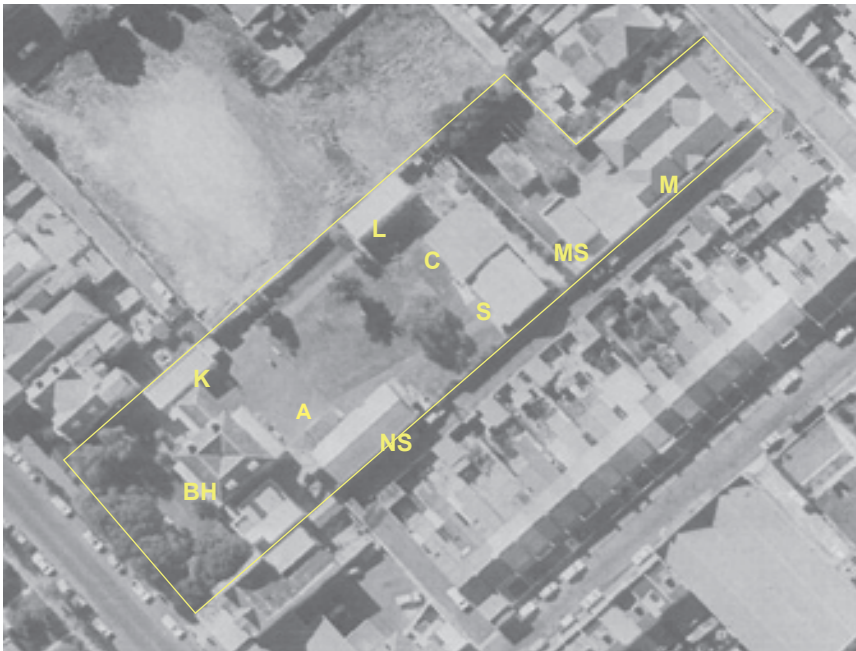
Figure 2.26
Aerial view of subject site (outlined), 1972.
The new classroom building (C) has been added.

Responding to the growing need for accommodation, the 1956 drawing also shows further alterations to the residence; conversion of the ballroom, now a school, to a 'new dormitory'; and construction of a 'new wooden classroom' - in fact a three-room school building with a covered veranda facing the residence - located south-west of the 'shed' near the Ferry Lane boundary (see Figures 2.11 and A3.5 in Appendix 3) and visible in a 1961 aerial photograph. A 1970 drawing⁴⁶ shows a new timber building to be added alongside the school, housing a classroom, office and staff room, and this is visible in 1972 aerial photographs (see Figure 2.26).

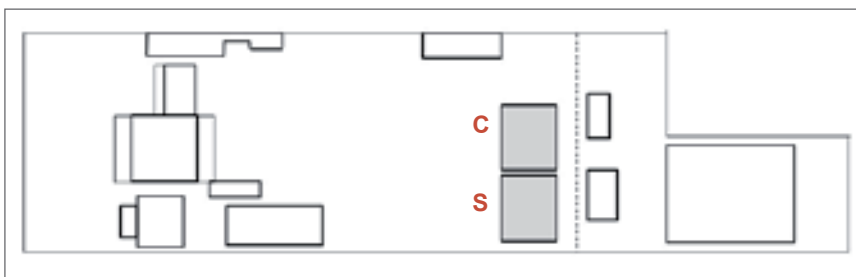
Figure 2.27
Schematic plan showing buildings on site c.1972, with School (S), constructed late 1950s, and new classroom block (C), constructed c.1971, shaded.

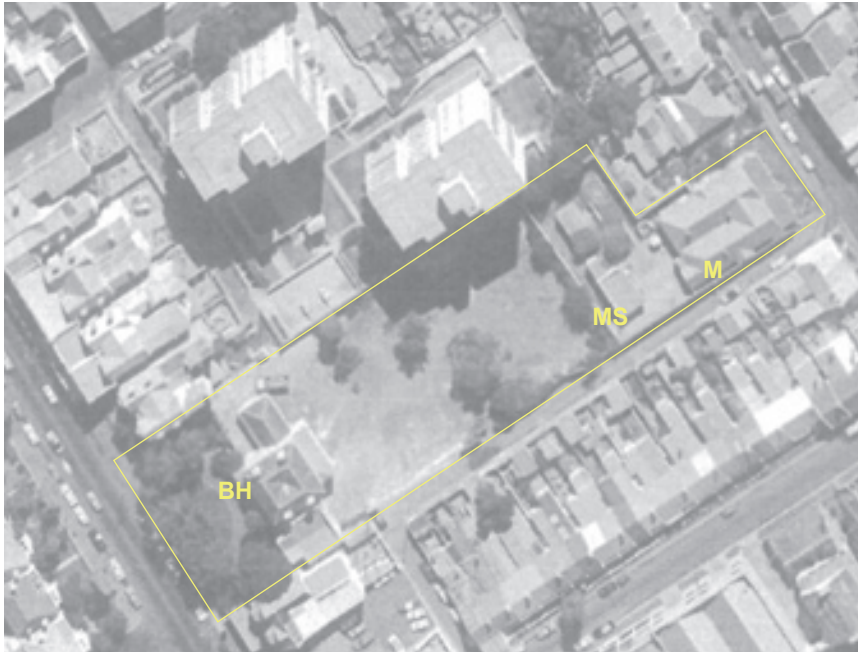
BH	Bidura House group including residence and Annex (c.1860) and Ballroom (c.1870s)
K	Kitchen (c.1860s)
L	Laundry (c.1860s)
M	Metropolitan Girls' Shelter (c.1925)
MS	Shed linked to Girls Shelter, possibly same as building labelled BR in Figure 2.16 (c.1870s)
NS	New store (c.1930s-40s)
A	Air raid shelter (c.1940s)
S	School (c.1950s)
C	New classrooms (c.1970s)
RC	Remand Centre (1980-83)

Figure 2.28
Aerial view of subject site (outlined), 1978. The Kitchen, Laundry, New Store, School, Classrooms and Air Raid Shelter have been demolished. The Metropolitan Girls' Shelter (M) and associated buildings were demolished soon afterwards.

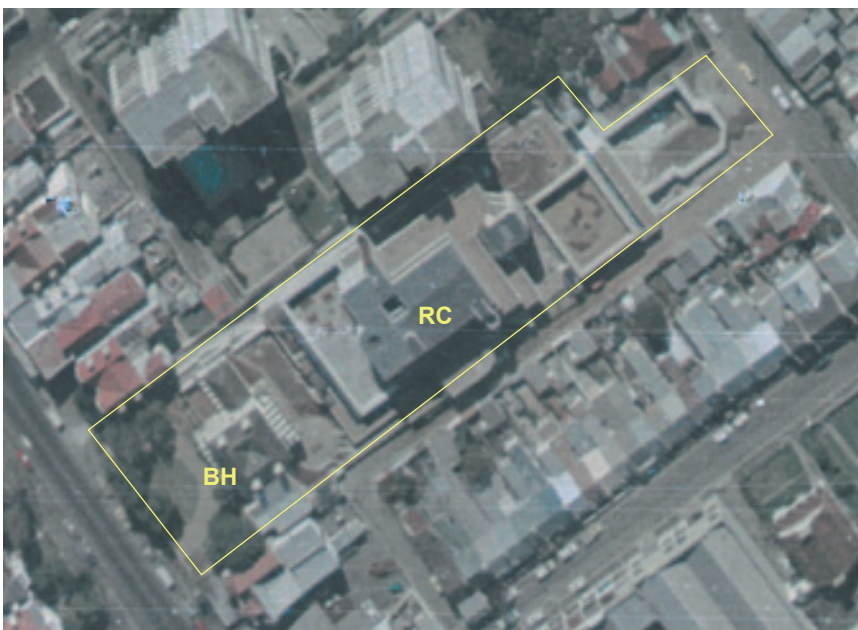
Figure 2.29
Aerial view of subject site (outlined), 1982. The new Remand Centre (RC) and associated structures are in place.

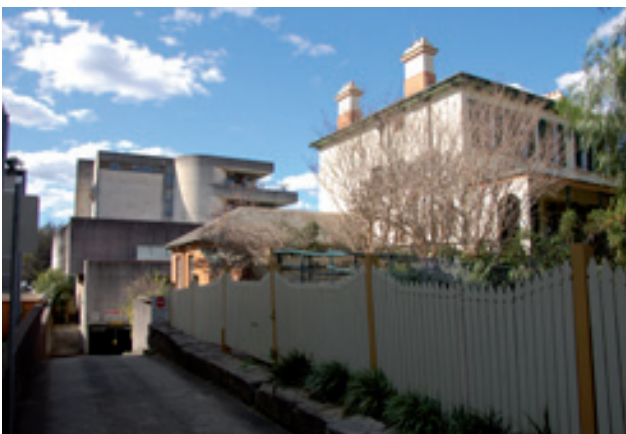
Figure 3.3
View to east from Glebe Point Road along Remand Centre driveway, showing Remand Centre at left and Bidura House at right.

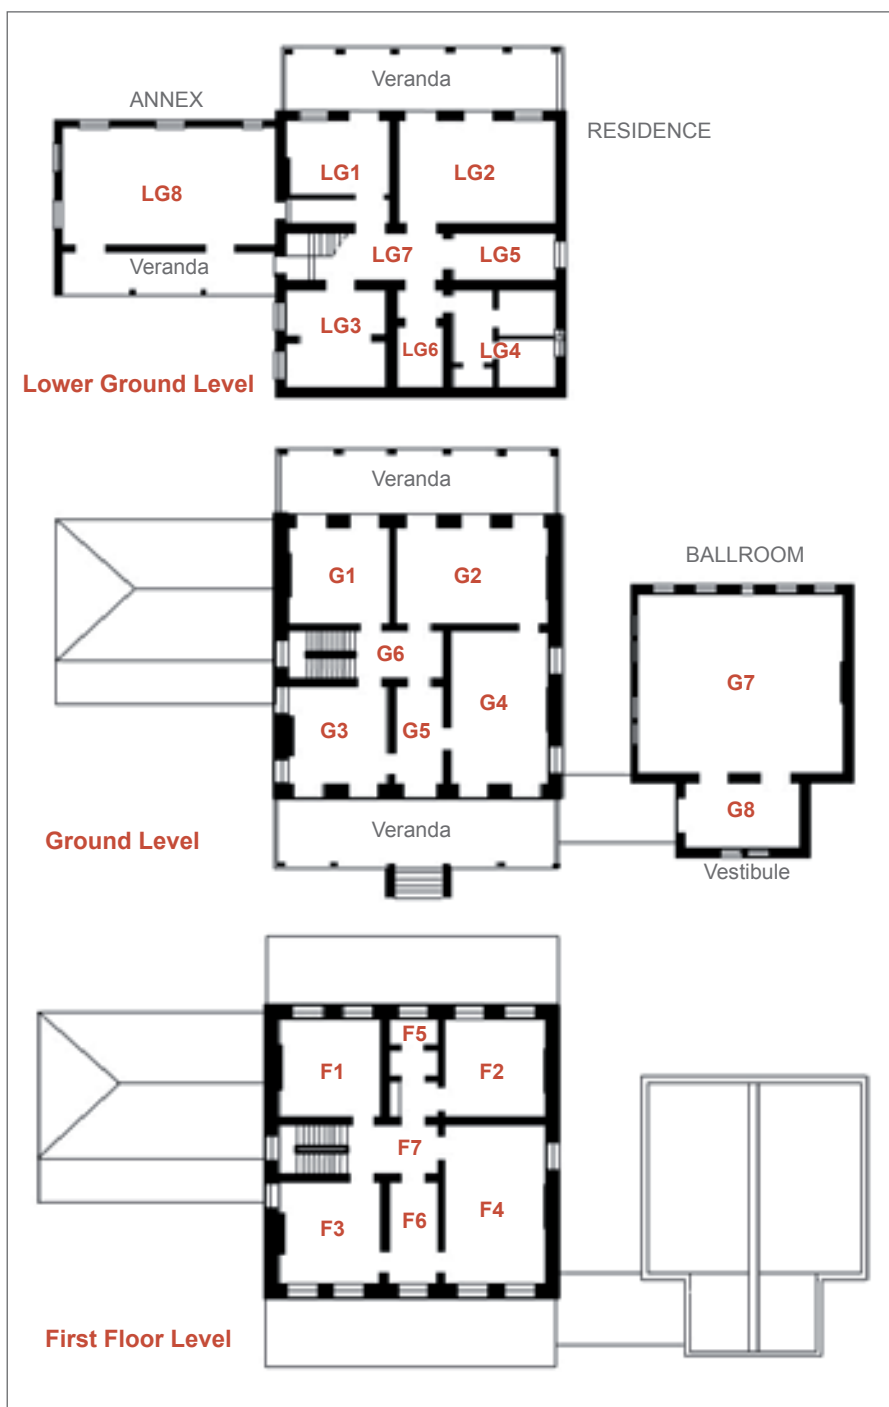
Figure 3.7
Floor plans of Bidura House group,
showing layout as at August 2015. Room
numbers are allocated for purposes of
reference within this report.

Plans are schematic only and not to scale.

Up-to-date drawings of the Bidura House group were not available at the time of writing. Plans representing the current layout are shown in Figure 3.7 below. Room or area numbers used below refer to these plans.

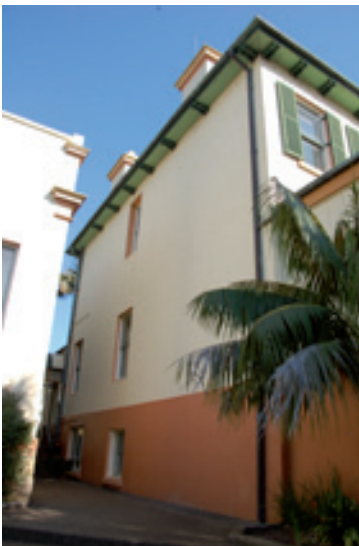
Figure 3.10
Residence south-east facade viewed from east. Lower ground floor windows are original; others added c.1950s

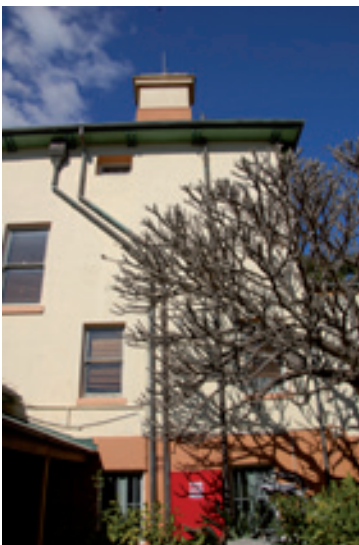
Figure 3.12
Partial view of residence north-west facade. Stairwell window (left) is original; two ground floor windows added c.1950s

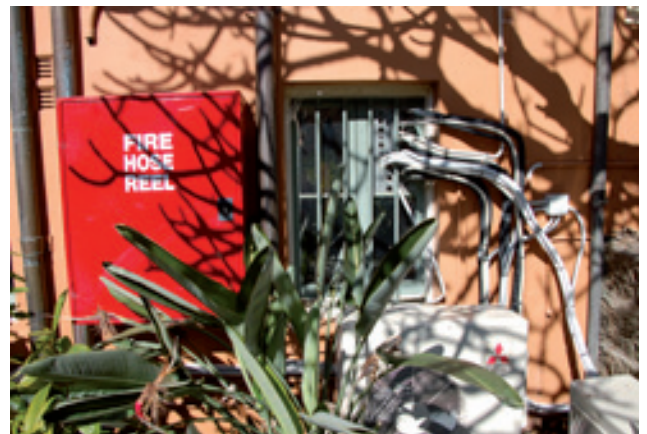
Figure 3.13
Residence north-west facade at lower ground floor, showing fire hose reel box and cabling fixed to wall and penetrating window

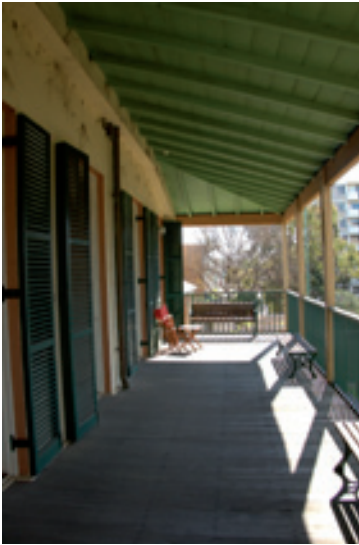
Figure 3.14
View to north-west along first floor rear veranda of residence. The roof is original but the rest of the veranda was reconstructed in the early 1980s

At the front a ground floor single-storey veranda takes up the width of the house, featuring marble and slate flooring and ornate cast metal columns and balustrading. At the rear is a two-storey timber veranda/balcony with stone flagging at lower ground level. Both have striped corrugated metal roofs.

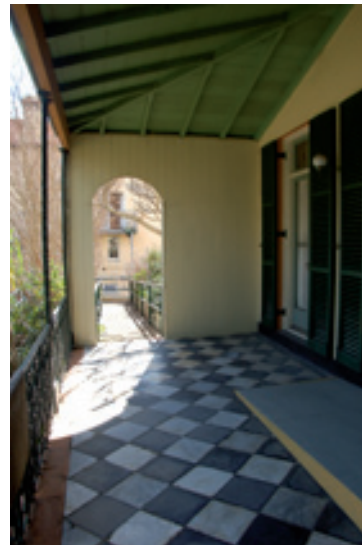
Figure 3.15
View to north-west along ground floor front veranda of residence. The roof is original but some of the cast metal work and flooring were replaced in the early 1980s. The access ramp is a later, reversible addition.

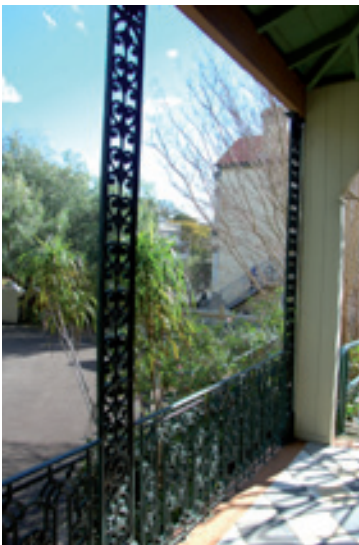
Figure 3.16
Detail of cast iron columns and balustrading

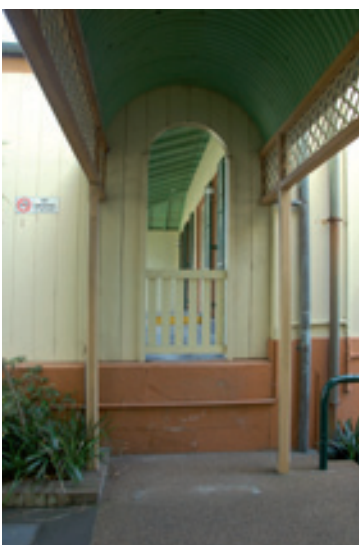
Figure 3.18
View to north-west from link to Ballroom, showing south-east end of residence ground floor front veranda, where original steps from veranda have been removed

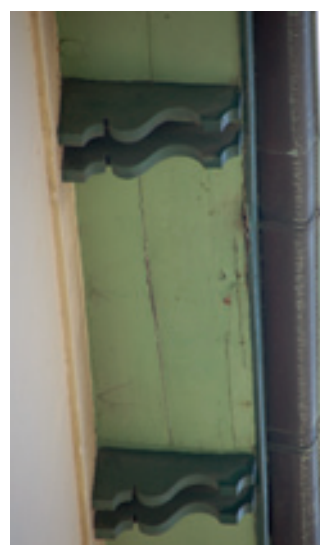
Figure 3.19
Detail of Bidura House eaves brackets and timber soffits

The external walls are of rendered, coursed and painted brick. The double-hung windows are timber, with external timber louvred shutters. The roof is clad in slate with decorative eaves brackets and patinated copper gutters, and features a central valley which appears to spill into a rainwater head on the north-western facade. On either side of the house stand two tall chimneys with corbelled cornices and metal chimney pots.

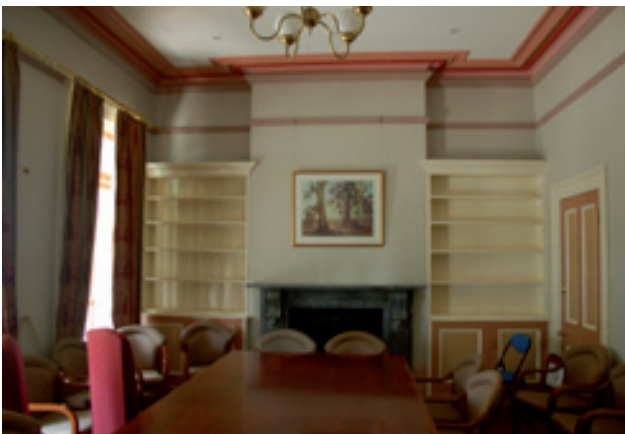
Figure 3.22
Room G2 (see plans, Figure 3.7), Residence ground floor, looking
south-east. Cupboards were reconstructed in early 1980s.

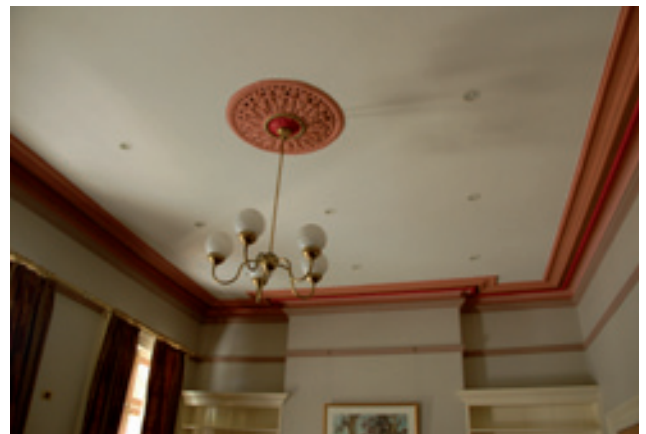
Figure 3.23
Ceiling in Room G2, showing typical ceiling rose, cornices and
ceiling/downlights

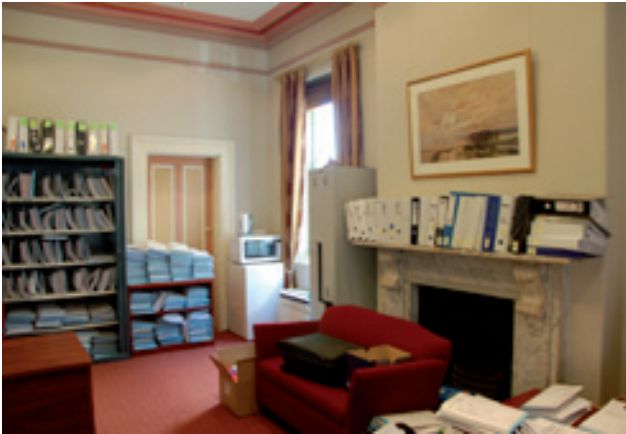
Figure 3.24
Room G4, Residence ground floor, looking north-east. Fireplace mantels were relocated from one fireplace to another within the building in the early 1980s restorations.

- Ground floor: replacement of timber floors; relocation of marble fireplace mantels; bricking up of one fireplace; new ceilings and lighting;
- First floor: largely intact: new wall between WC and handwashing area; bricking up of one fireplace; relocation of marble fireplace mantels;
- Basement: subdivision of areas LG1 and LG4 and tiling of floor in latter; bricking up of doorways between rooms LG1 and LG2, and between LG4 and LG6; removal of most of wall dividing western corner area; and
- Installation throughout of new mechanical and electrical services, including ventilation, power, lighting, security and data.

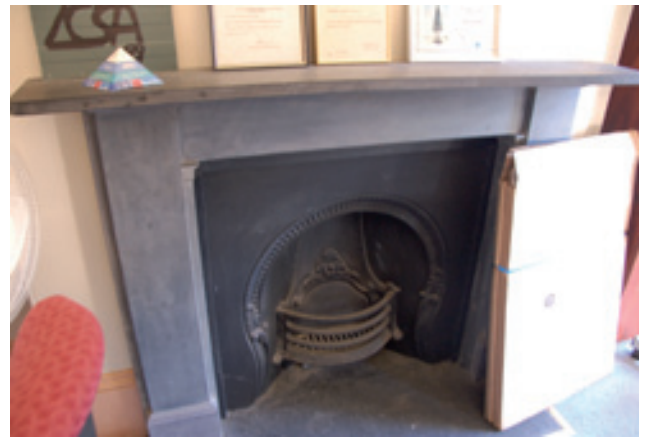
Figure 3.27
Fireplace, room F1, Residence first floor.

The rooms have plastered walls and chimney breasts and, excepting the front north-west room where the chimney has been bricked up, metal fireplaces with marble mantels and slate hearths. All have ornate cornices, picture rails, high skirting boards with moulded tops, wide architraves and four-panel doors. Although high ceilings with ornate ceiling roses are found in every room, the ceilings themselves are contemporary and plain, with inset downlights. The western corner room has a non-original polished timber floor; the other three rooms are carpeted. The current colour scheme uses shades in the pink-orange spectrum for detailing as well as green in the cornices, with a softer beige for the walls.

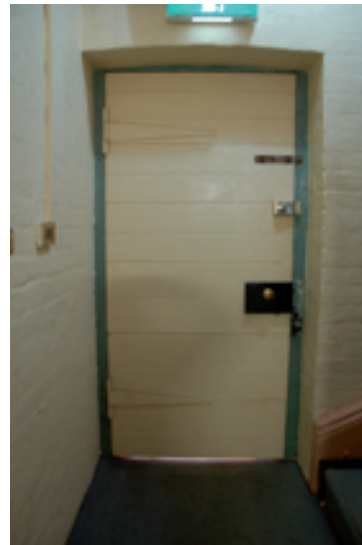
Figure 3.31
Tongue and groove door
from hallway, Residence
lower ground floor, to
courtyard, probably
original.

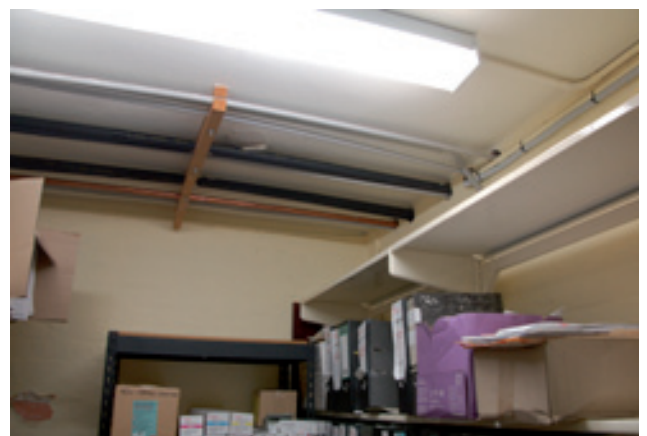
Figure 3.35
Detail of ceiling in Store (LG6), showing cabling penetrating brick
wall.

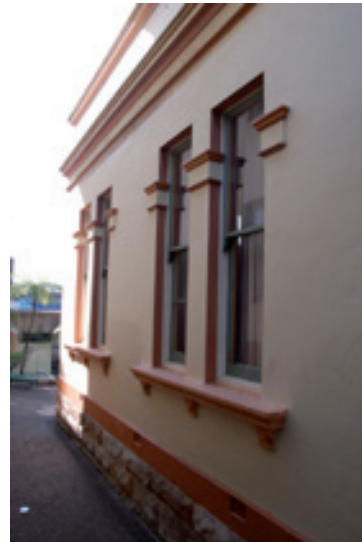
Figure 3.43
North-eastwards view of north-western facade of Ballroom showing original windows

At the front (south-western) facade is a Vestibule annex (G8) with double timber panelled entrance doors at the north-west and two double-hung windows to the south-west. The main building has two (original) pairs of double-hung windows to the north-west and four (non-original) double-hung windows and a small highly-placed central window to the north-east.

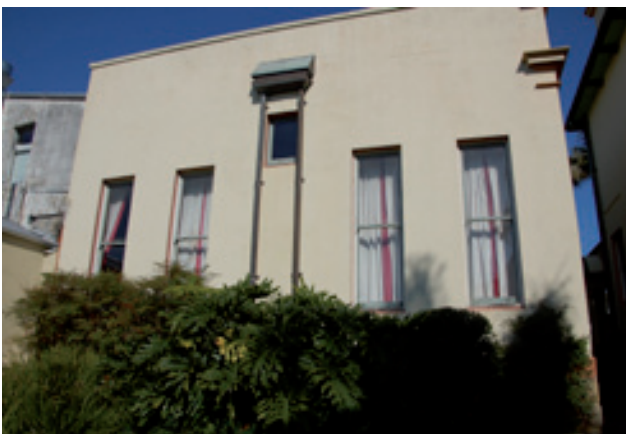
Figure 3.44
Rear facade of Ballroom showing non-original windows

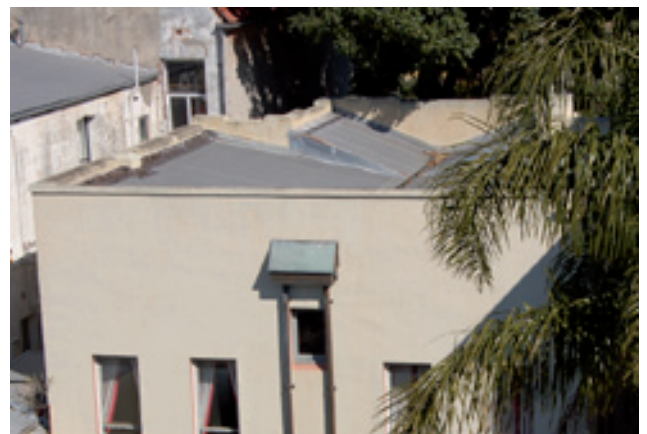
Figure 3.45
View of Ballroom showing double butterfly roof and central box gutter

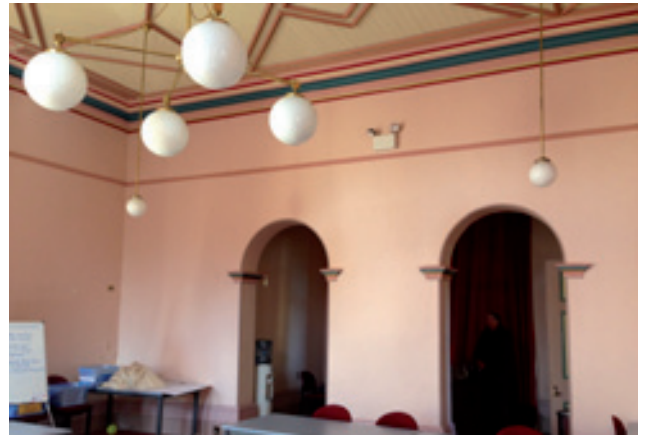
Figure 3.47
South-west wall of Ballroom, showing archways to Vestibule

The Vestibule has been treated similarly, though the floor finish is vinyl. Two tall arches between the Vestibule and Ballroom spaces have cornices at springing point. Some original ventilation grilles are evident.

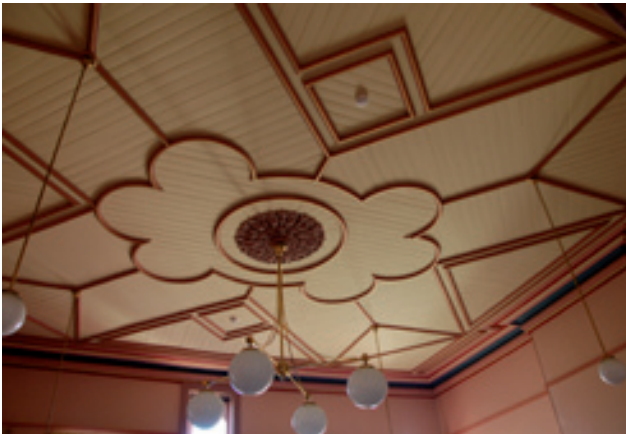
Figure 3.48
Ceiling of Ballroom

The Ballroom (G7) interior consists of a large single space with a high, timbered and decorated ceiling including an ornate ceiling rose and highly ornate cornices. The walls are plastered and painted, with a simple picture rail and double-height skirting boards with moulded tops. The fireplace in the chimney breast on the south-eastern wall has been bricked up. Timber floors may be partly original and have been carpeted.

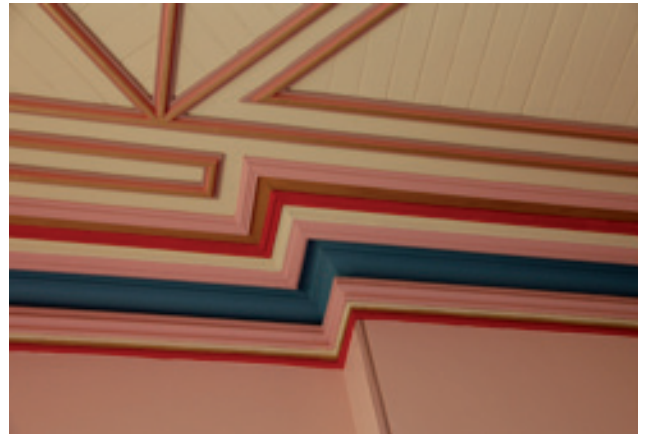
Figure 3.49
Detail of cornices and ceiling decoration in Ballroom

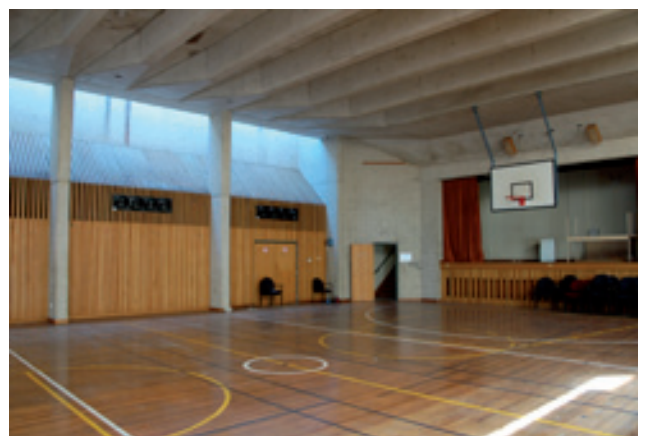
Figure 3.61
The auditorium / recreation area

Other than the auditorium and service areas, the interior is a mixture of office, classroom and some disused residential space. Circulation areas such as lobbies and stairwells feature exposed aggregate concrete walls. Other areas present plastered walls, suspended ceilings and carpeted floors in a typically contemporary functional style. The large auditorium features a coffered concrete ceiling.

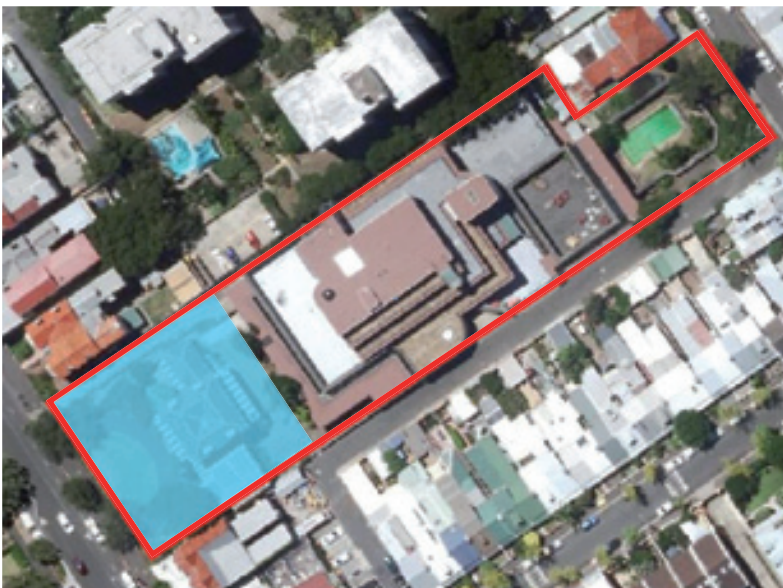
Figure 4.12
Aerial photograph marked up to show the identified curtilage for the Bidura House group coloured in blue and the boundaries of the subject site marked in red.

The existing curtilage, defined above and illustrated in Figure 4.12 provides views and appreciation of Bidura House, its Ballroom and garden, from the public realm. As such, it is considered to be the appropriate Reduced Curtilage for the listed heritage item.

- New buildings within the curtilage identified in Figure 4.12 should be limited to small ancillary or service structures located at the rear of the main house. There should be no new structures or additions to the front of the house.

New structures within the curtilage identified in Figure 4.12 shall be limited to small ancillary or service structures located at the rear of the Bidura House group. There shall be no new structures or additions in front of the group.

New development outside the curtilage identified in Figure 4.12 shall be volumetrically modeled to the maximum permissible height of 27 metres from the scale of the Bidura House group and should be largely within the view shadow of the group. New development shall not challenge the legibility of the Bidura House group as seen from any location in Glebe Point Road.

Potential future subdivision of the site shall retain the minimum site area for the Bidura House group identified in Figure 4.12.

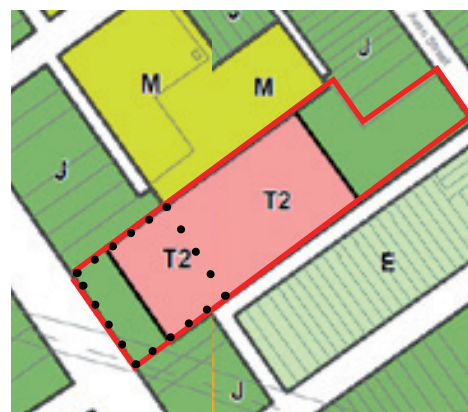
Figure 5.2
Composite of extracts from the *Sydney LEP 2012* Height of Buildings Maps 1 and 8 showing the minimum curtilage identified for "Bidura" house marked with a dotted line and the boundaries of the subject site marked with a solid line.

The dark green colour code indicates a maximum permissible height limit of 9 metres and the pink T2 code indicates a maximum height limit of 27 metres

The current owners have purchased the site with the expectation that it can be developed in accordance with *Sydney LEP 2012*. Under this LEP development at the Glebe Point Road and Avon Street frontages is restricted to a height of nine (9) metres and development in the central portion of the site is subject to a twenty seven (27) metre maximum height limit, as shown in Figure 5.1.

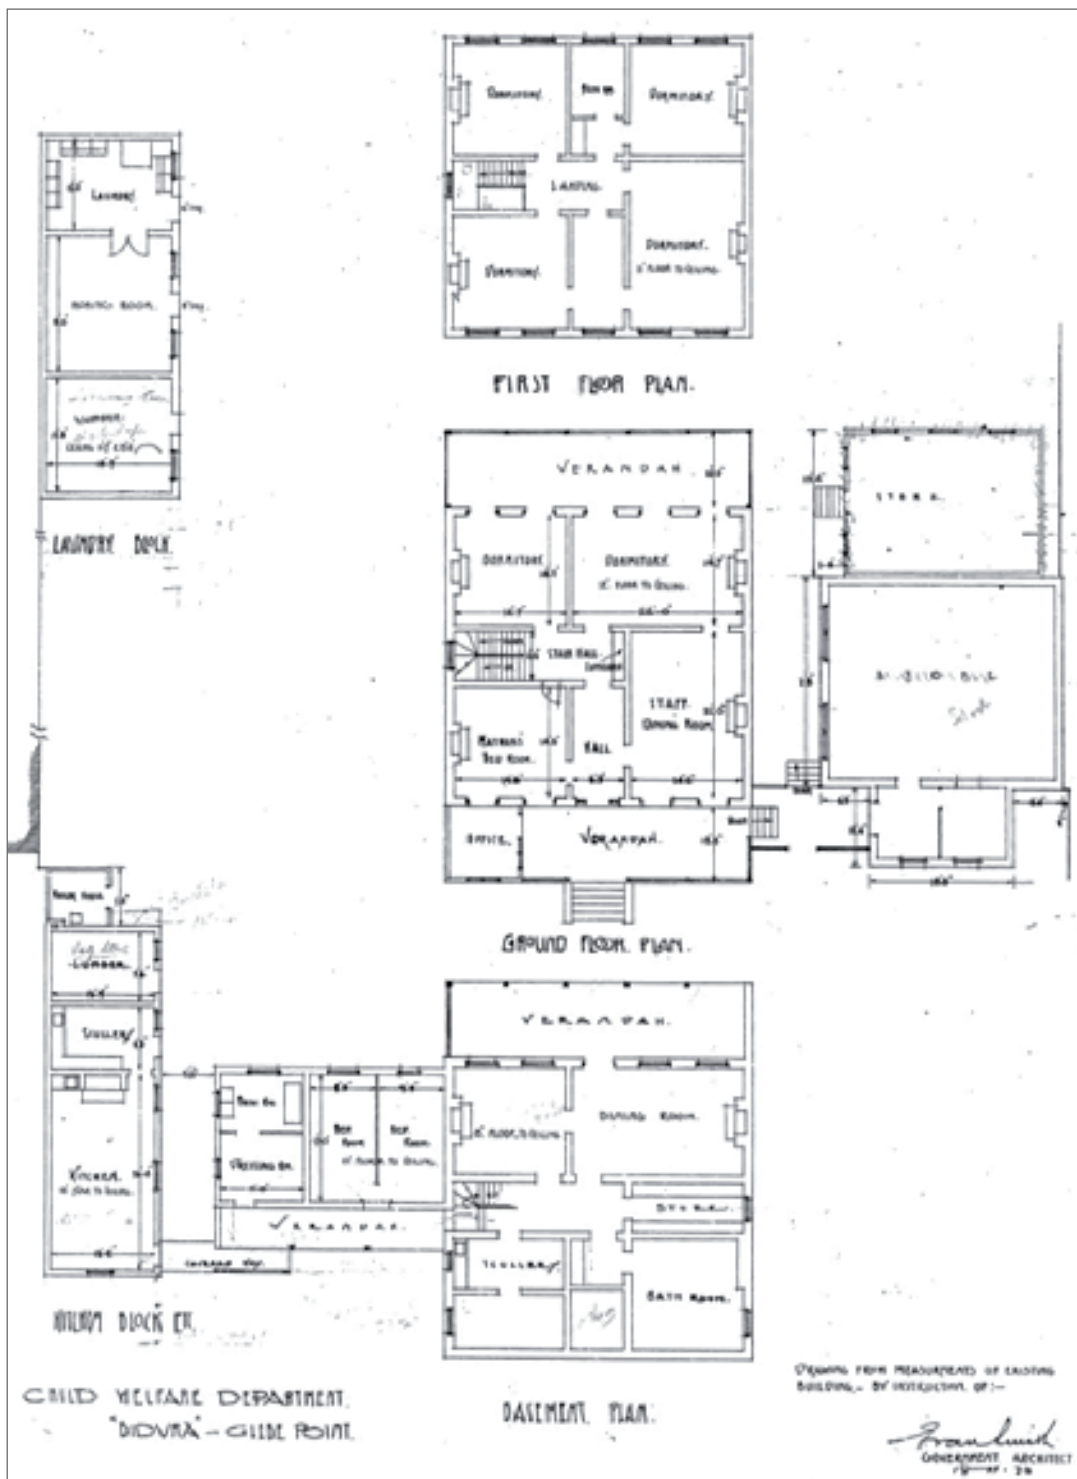
Figure A3.1
Plans of Bidura by Government Architect for Child Welfare Department, 1930

Source: Plan Services, NSW Finance & Services (Drawing CW20-1)

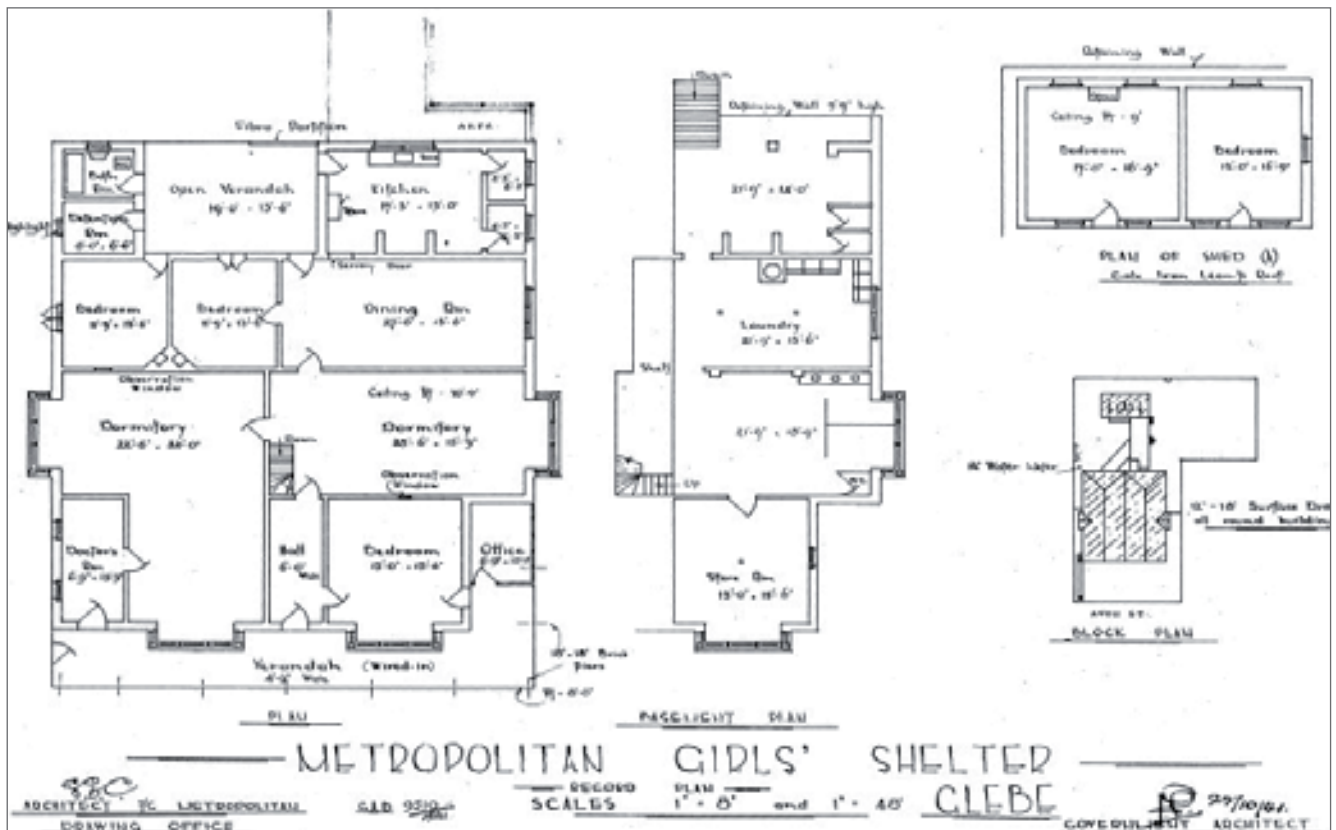
Figure A3.2
Plans of Metropolitan Girls' Shelter and shed, by Government Architect, 1941, showing location at rear of subject site. The building was completed c.1925 and is visible in 1930 aerial photography.

Source: Plan Services, NSW Finance & Services (Drawing CW20-23)
