357 Glebe Point Road, Glebe

Conservation Management Plan

September 2015

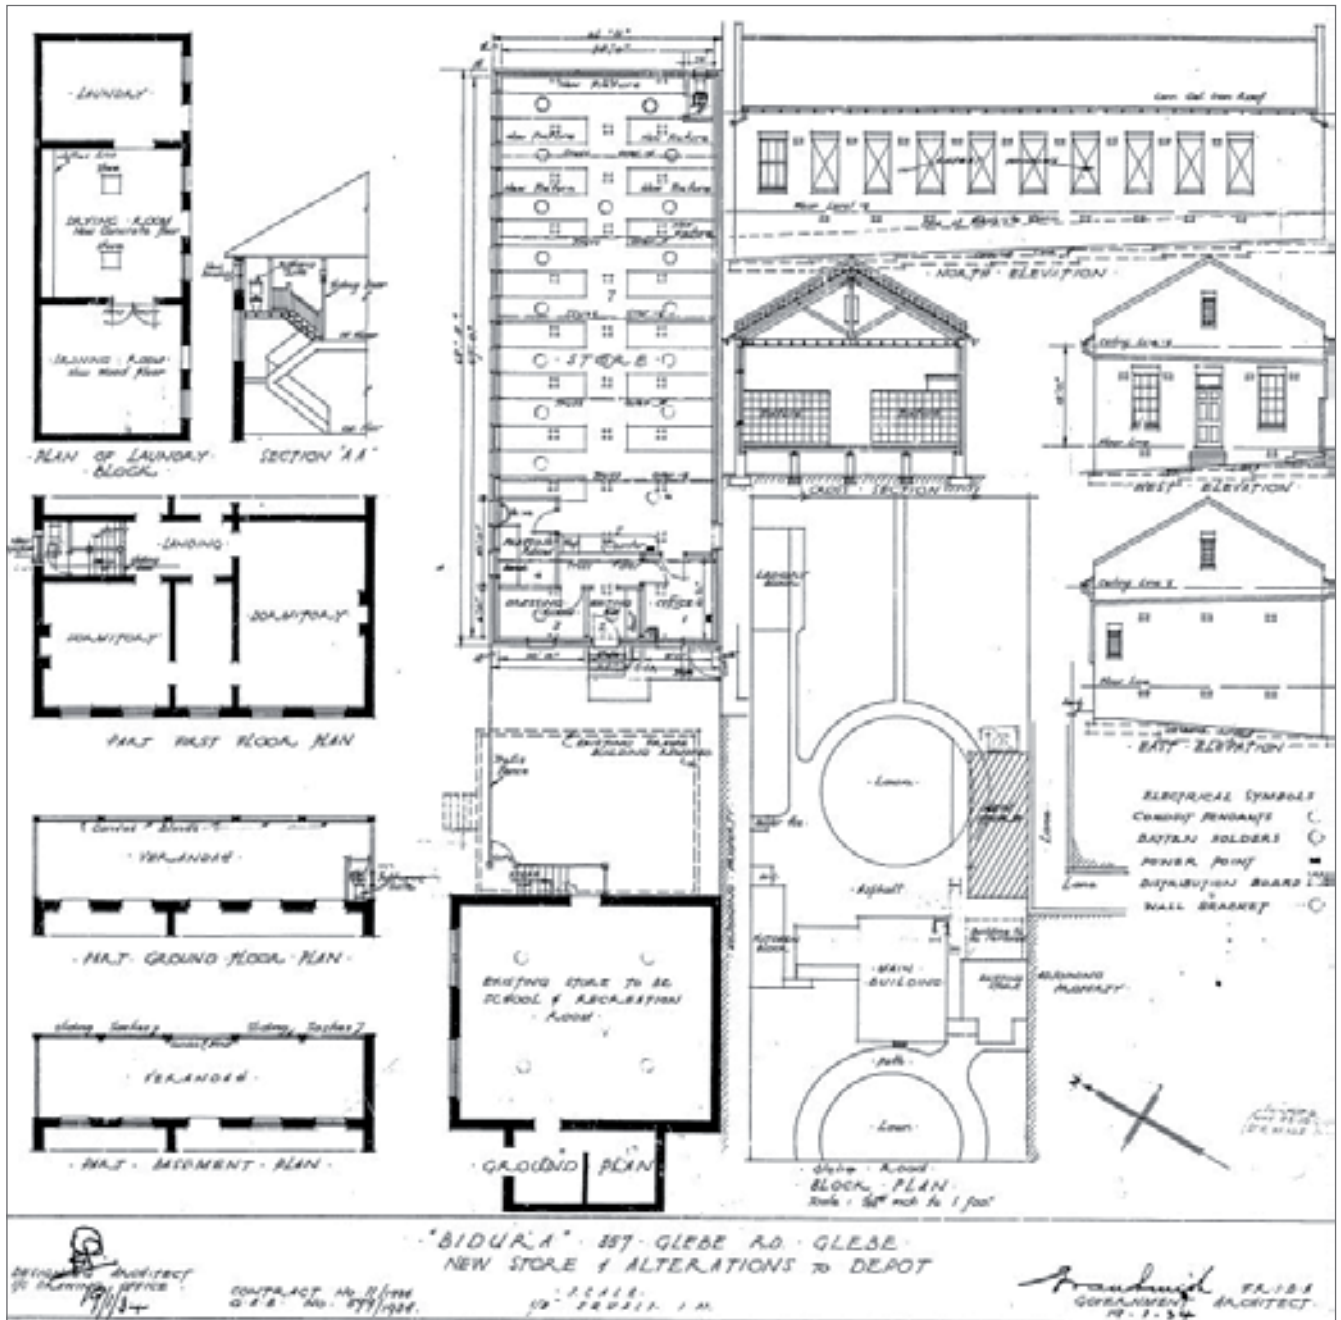
Figure A3.3

Plans for proposed new Store, demolition of rear addition to ballroom and minor alterations to residence, by Government Architect, 1934. Note installation of new stairs and WC at first floor of residence.

Source: Plan Services, NSW Finance & Services (Drawing CW20-2)

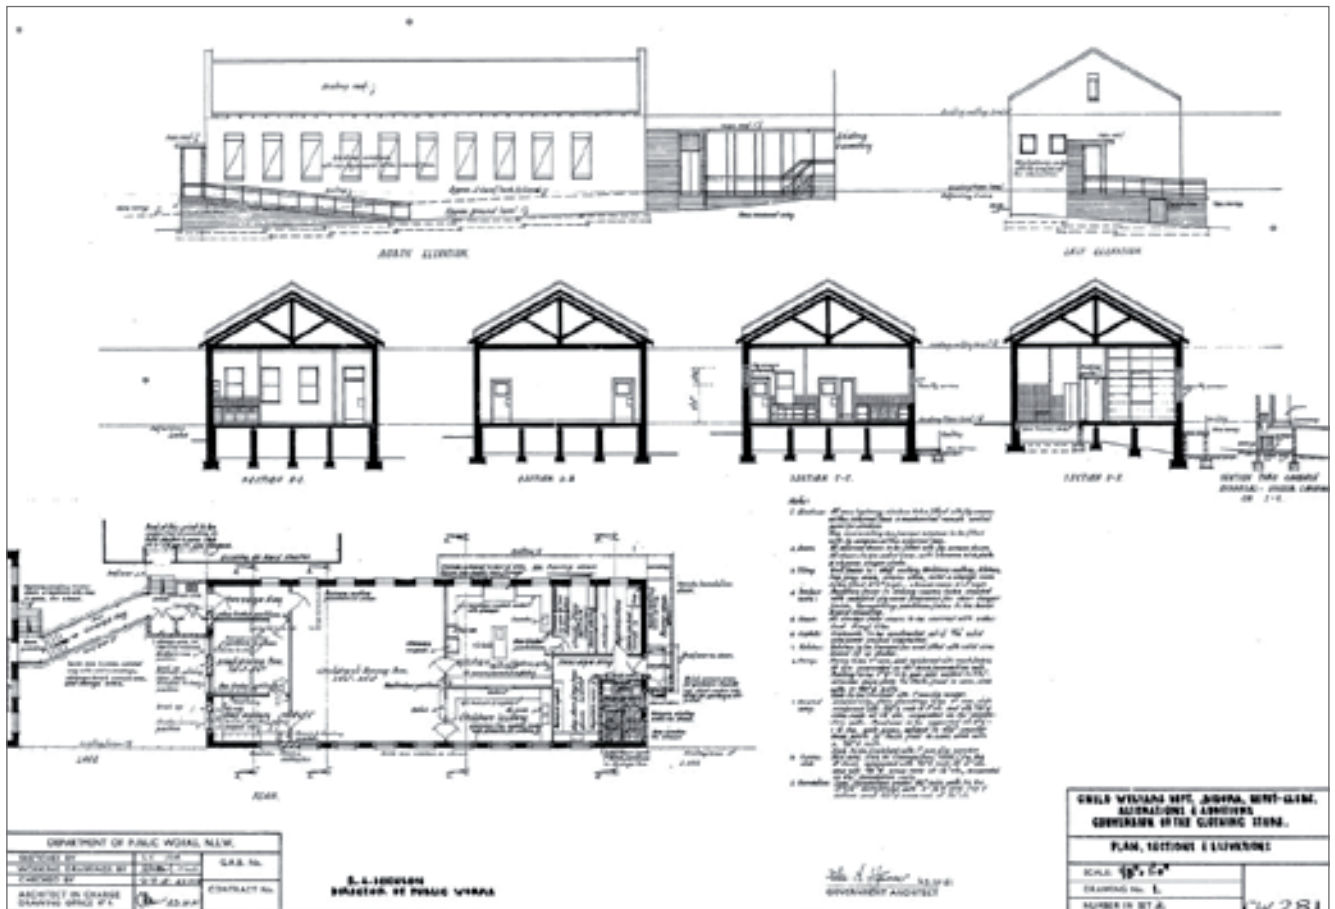
Figure A3.4
Plans for conversion of the Store to dining facilities, by Department of Public Works, 1961.

Source: Plan Services, NSW Finance & Services (Drawing CW20-7)

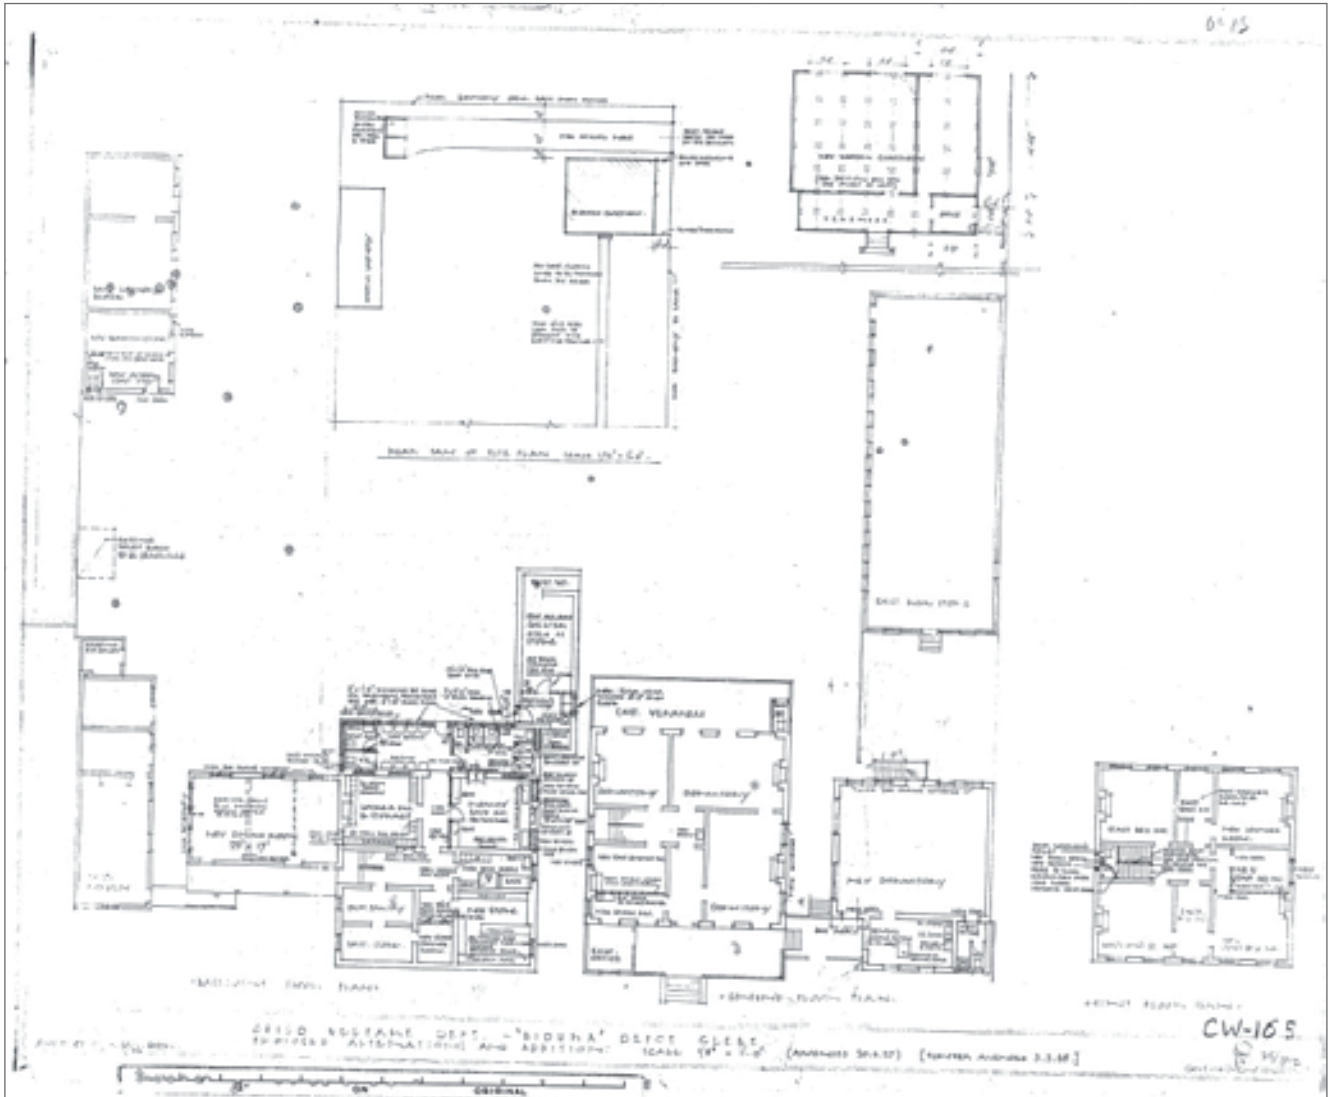
Figure A3.5
Plans for alterations and additions to residence, conversion of ballroom to dormitory and construction of school ('new timber classroom'), by Government Architect, 1956. Details of this drawing follow below, with main alterations identified.

Source: Plan Services, NSW Finance & Services (Drawing CW20-6)

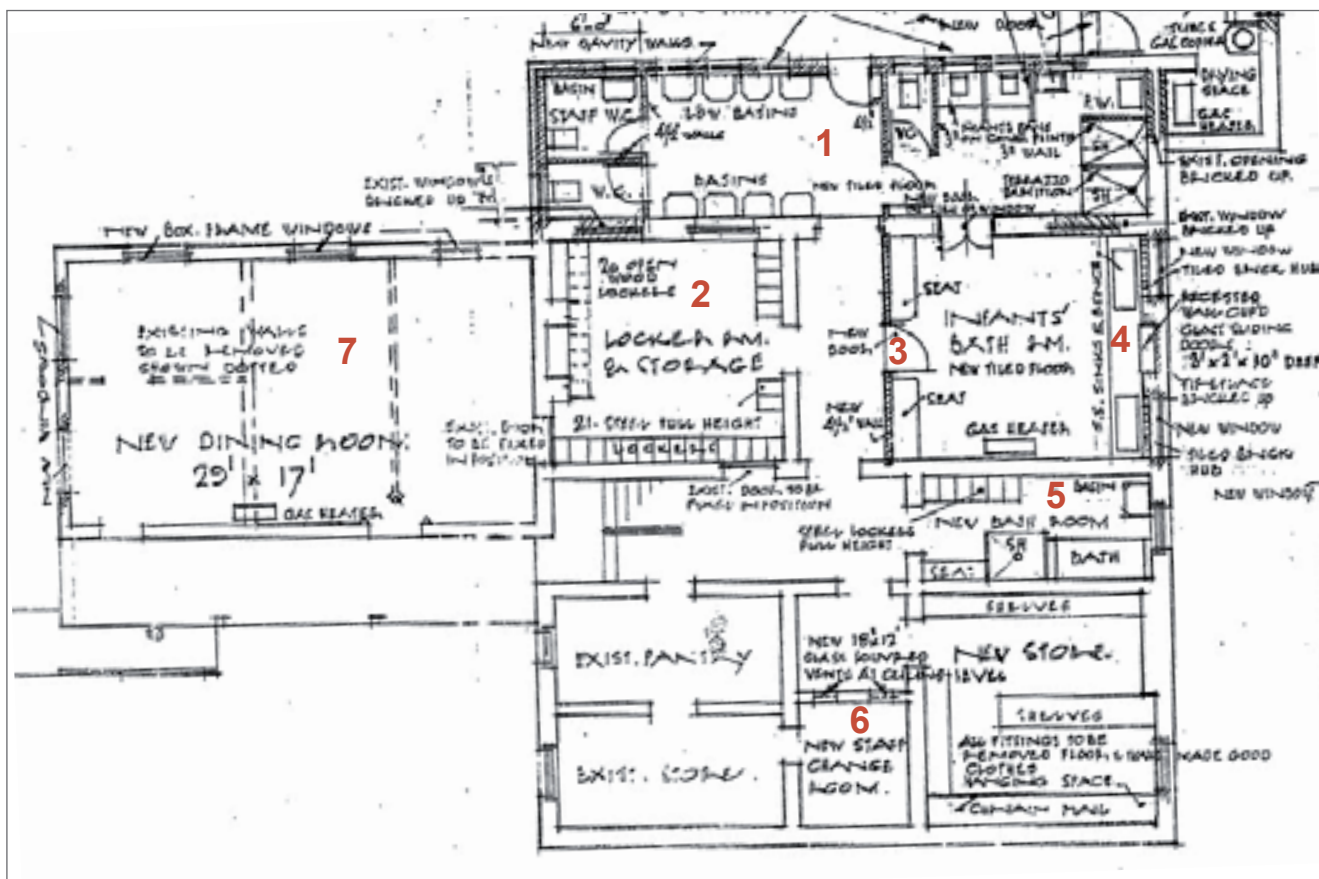
Figure A3.6
Detail of Figure A3.5, showing basement level of Bidura House. Numbers in red refer to Table X below.

TABLE A3.1 : ALTERATIONS SHOWN ON DRAWING CW20-6, BASEMENT LEVEL	
Item	Description
1	Back veranda: new cavity brick enclosing walls with windows, new internal brick walls, terrazzo partitions and WC equipment, 3 windows on house rear wall bricked up, 4th converted to doorway, new tiled floor
2	Lockers installed
3	New brick wall with doorway
4	Fireplace bricked up and recessed cupboard installed, new windows either side of chimney, new sinks, gas heater and new tiled floor
5	New bathroom fittings
6	New glass-louvered vent at ceiling level
7	Internal walls removed, new window frames

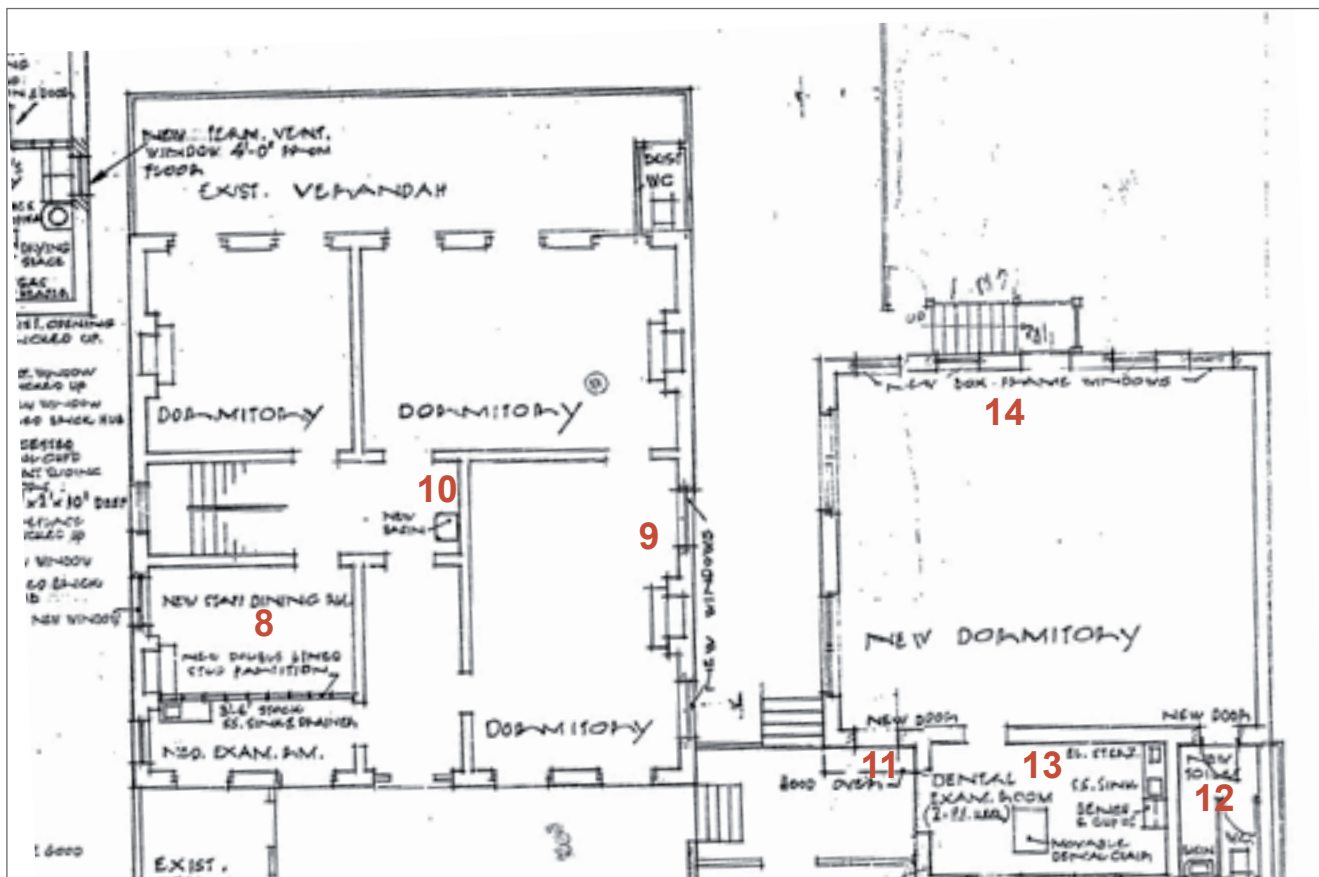
Figure A3.7
Detail of Figure A3.5, showing ground level of residence and ballroom. Numbers in red refer to Table X below.

TABLE A3.2 : ALTERATIONS SHOWN ON DRAWING CW20-6, GROUND LEVEL	
Item	Description
8	New stud wall dividing room, new window in house side wall, new sink
9	Two new windows in house side wall
10	New basin
11	New door with external hood over
12	New toilet addition, new door into ballroom/dormitory
13	New sink and dental surgery equipment
14	New windows to rear wall

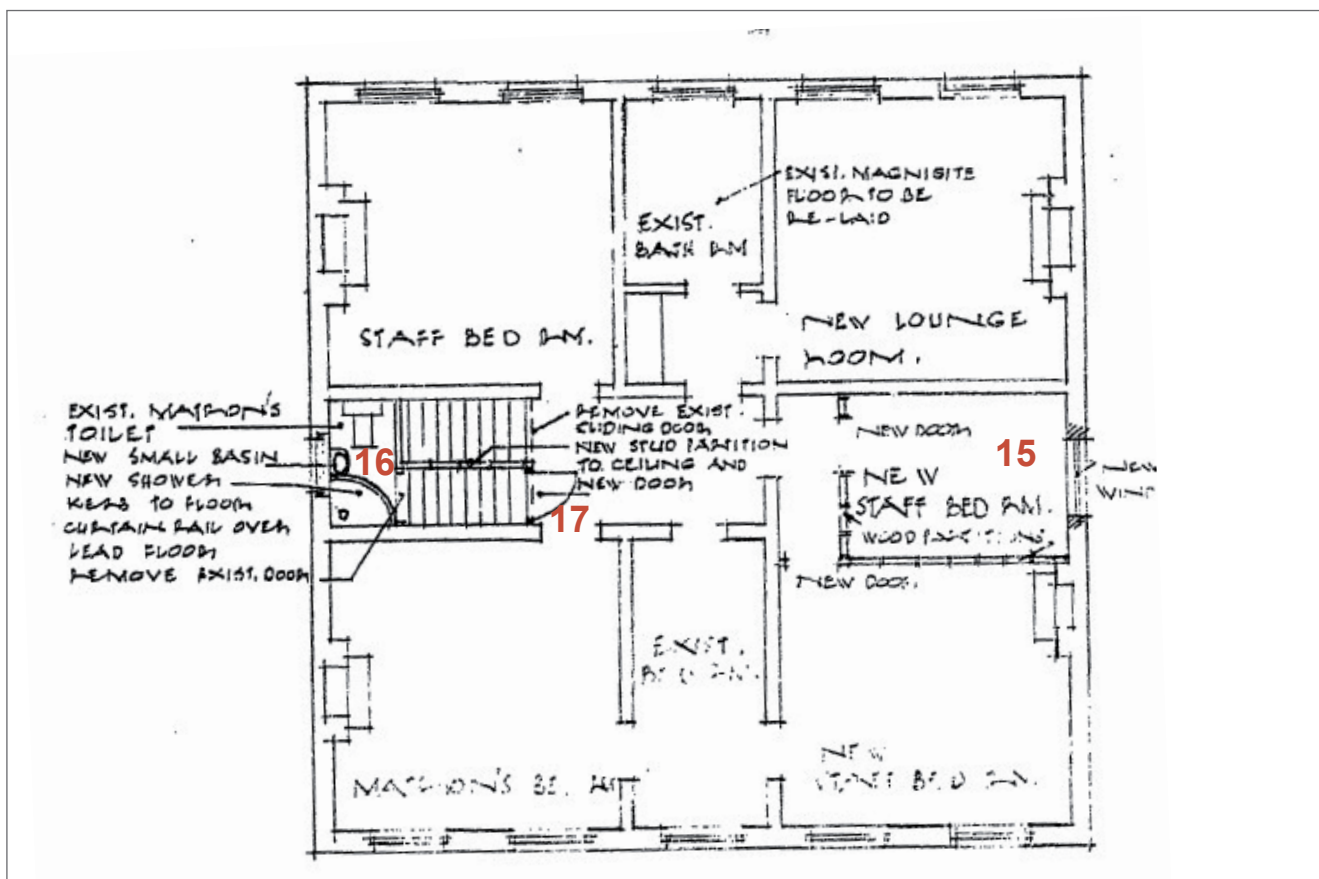
Figure A3.8

TABLE A3.3 : ALTERATIONS SHOWN ON DRAWING CW20-6, FIRST FLOOR LEVEL

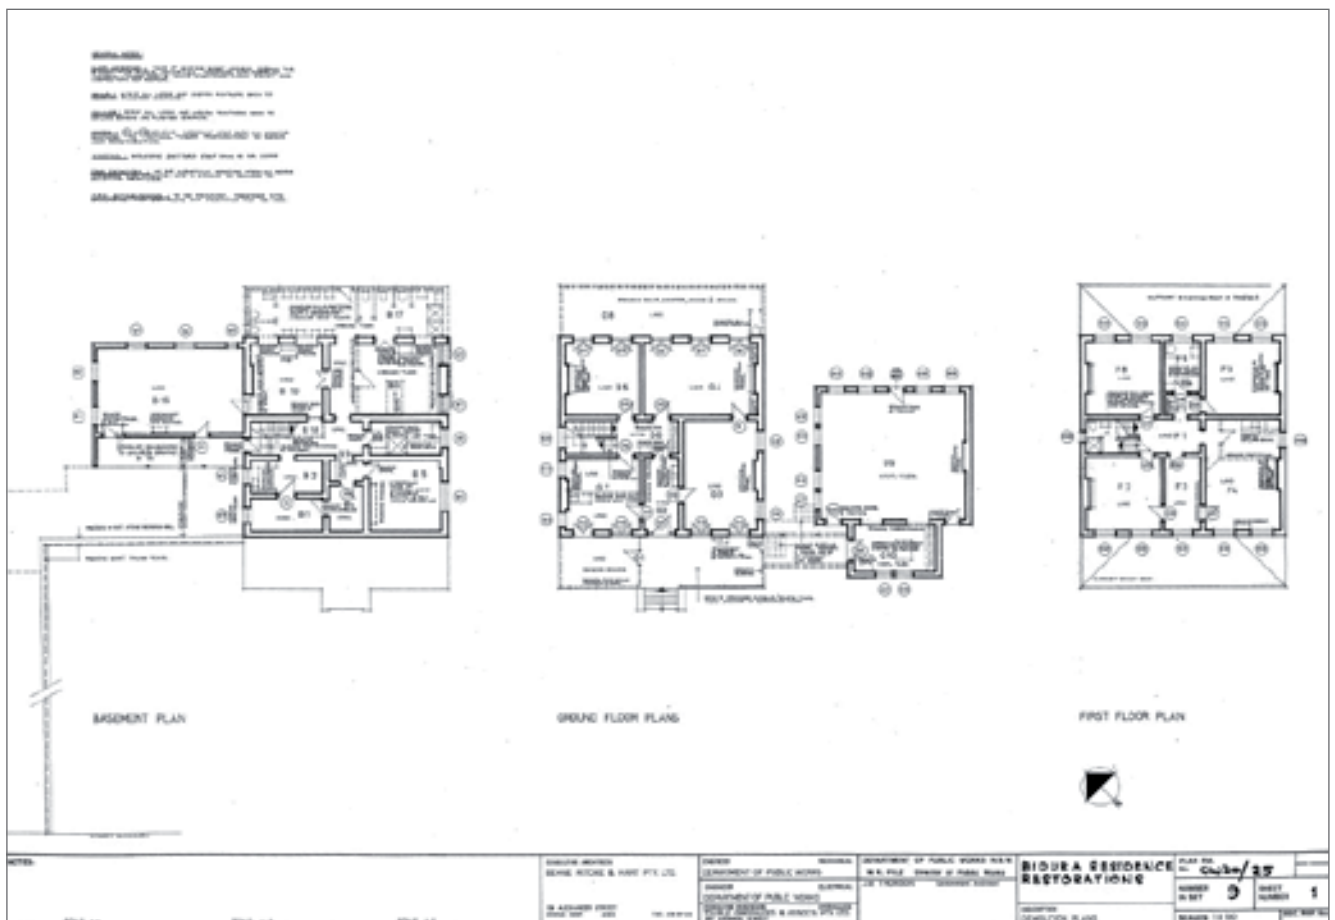
Figure A4.1
Demolition plan for restoration of the Bidura House group, by Behne Ritchie and Hart Pty Ltd, consulting architects, for Public Works Department, undated. Details of this drawing follow below, with main alterations identified.

The drawings below, by consulting architects Behne Ritchie and Hart Pty Ltd for the Public Works Department, show restorations to the Bidura House group. They are undated but presumed to date from 1979-1980 when the Public Works Department is known to have been planning restorations to Bidura. (Not shown are similar drawings detailing electrical, lighting and ventilation plans.¹)

8	Remove sink etc. Construct laundry with shower, tubs, etc, and tile floors.
9	Widen north-westernmost doorway. Construct new bathroom, kitchen, cupboard, install new double doors.
10	Demolish concrete pavement in yard. Install new stone flagging to veranda and yard. Replace doorway from house to veranda with window.
Ground floor	
11	Remove veranda walls, windows, floor, ceiling, retaining roof. Remove WC. Install new timber balustrade, posts, floor and boarded wall at south-eastern end.
12	Dismantle marble fireplace mantel and retain, install new kitchen.
13	Remove fireplace enclosure, retain cupboards.
14	Remove dividing wall, fireplace enclosure, sink, wall tiles. Install marble mantel from back room.
15	Remove fireplace enclosure, install marble mantel from first floor.
16	Remove telephones, railings, lino. Install carpet.
17	Remove front veranda office walls, windows, ceiling, lino. Remove electrical/security panels and door and screen to south-eastern end. Install new columns and balustrade to north-western end, remove steps at north-eastern end, install new slate and marble floors, new boarded walls to both ends.

18	In ballroom, remove doorframes to three external doorways, fireplace enclosure, and steps, screens and posts from covered way while retaining roof. Brick up three external doorways, install marble fireplace mantel from first floor.
19	Remove sink, cupboard, etc from vestibule, and timber panels from arches between ballroom and vestibule.
First floor	
20	Retain existing roof structure, install new cladding.
21	Remove bathroom fixtures and vinyl tiles, install new fixtures and ceramic tiles.
22	Dismantle and retain marble fireplace mantel, replace lino with carpet.
23	Remove partitions, sink, cupboard, dismantle and retain marble fireplace mantel.
24	Remove Matron's WC, fixtures, floor, walls and steps. Install new balustrade to stairs.

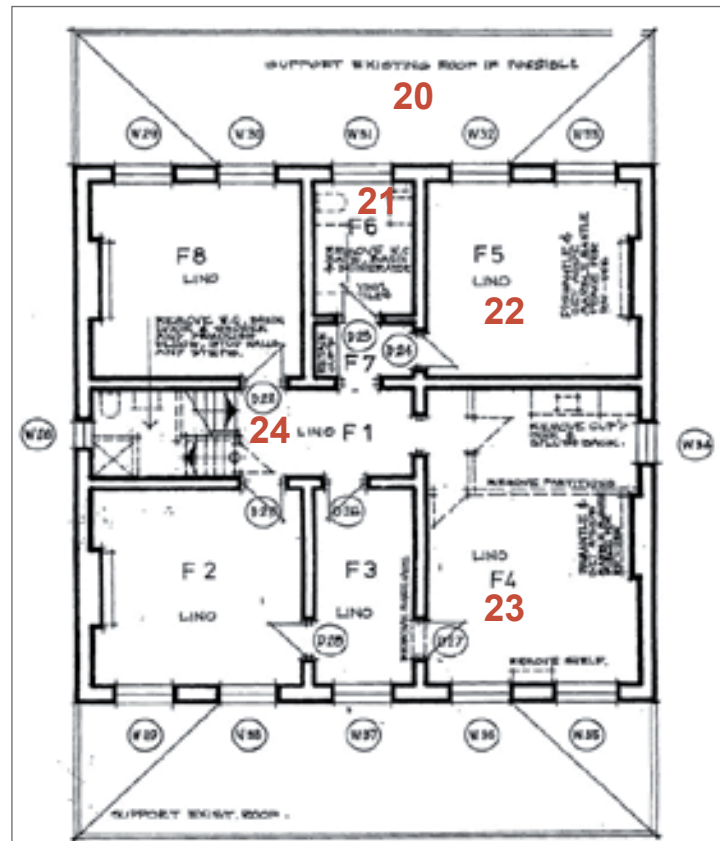
Figure A4.7
Detail of Figure A4.1
showing first floor level
demolition.

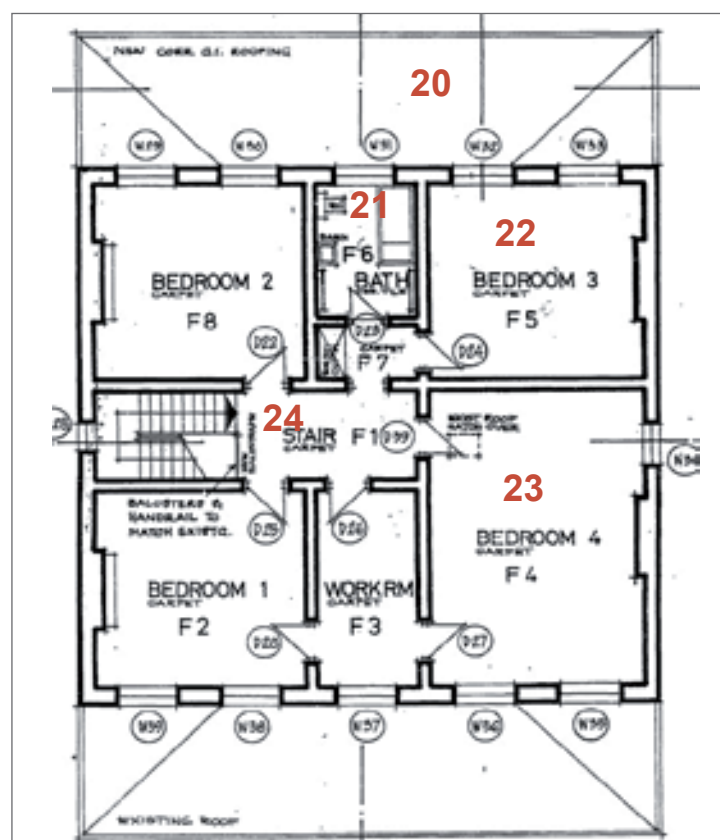
Figure A4.8
Detail of Figure A4.2
showing first floor level
construction.

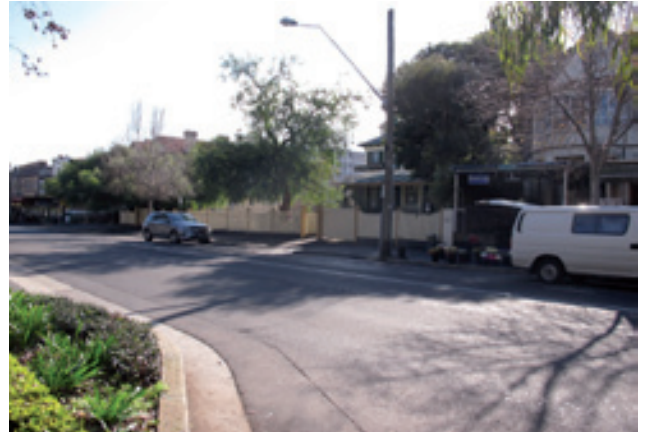
Figure A5.2
View to Bidura House from the opposite side of Glebe Point Road showing that the adjoining development to the south-east, built in close proximity to the street alignment, obscures views to the former Ballroom

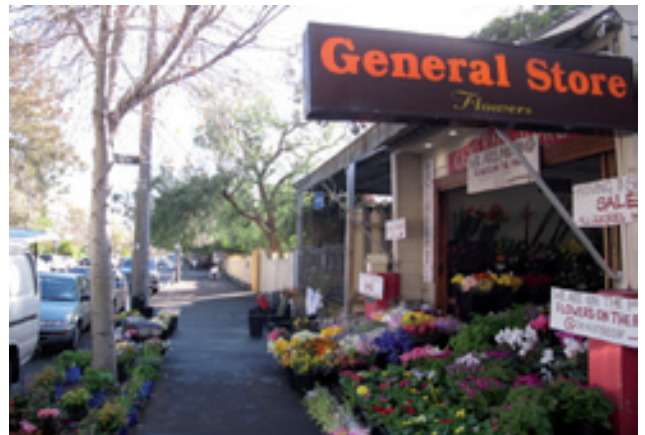
Figure A5.4
View looking north-west along Glebe Point Road, showing that views to Bidura House are obscured by buildings at 355 and 353 Glebe Point Rd when approaching from the south-east. The fence at the front boundary of Bidura can be seen in the background

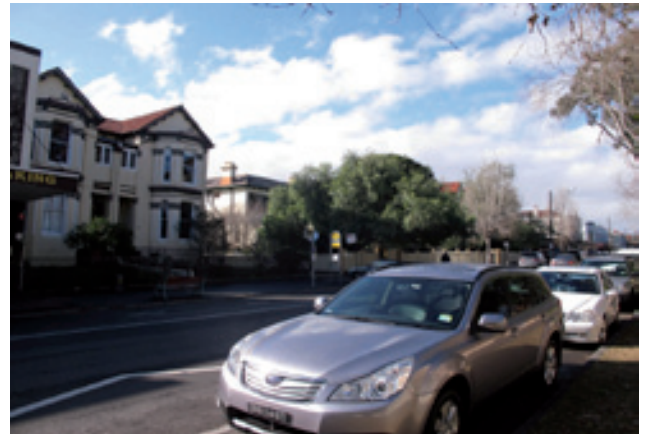
Figure A5.8
View to Bidura from Glebe Point Road, north-west of the site, showing there are limited views to the north-west and south-west elevations of the house from some locations

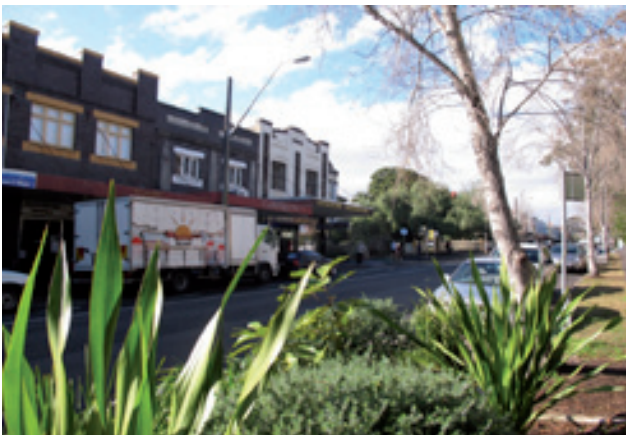
Figure A5.9
View to Bidura (behind trees) from Glebe Point Road, north-west of the site, showing that views to the house from the opposite side of the street when approaching from the north-west are largely screened by the established planting in the front garden and the adjacent buildings, which have a zero setback
