**STAGE 1 DESKTOP ENVIRONMENTAL SITE  
ASSESSMENT**

**PROPOSED MIXED-USE DEVELOPMENT**

**171-189 PARRAMATTA ROAD, GRANVILLE,  
NSW 2142**

Ref: E27710KGrpt-R

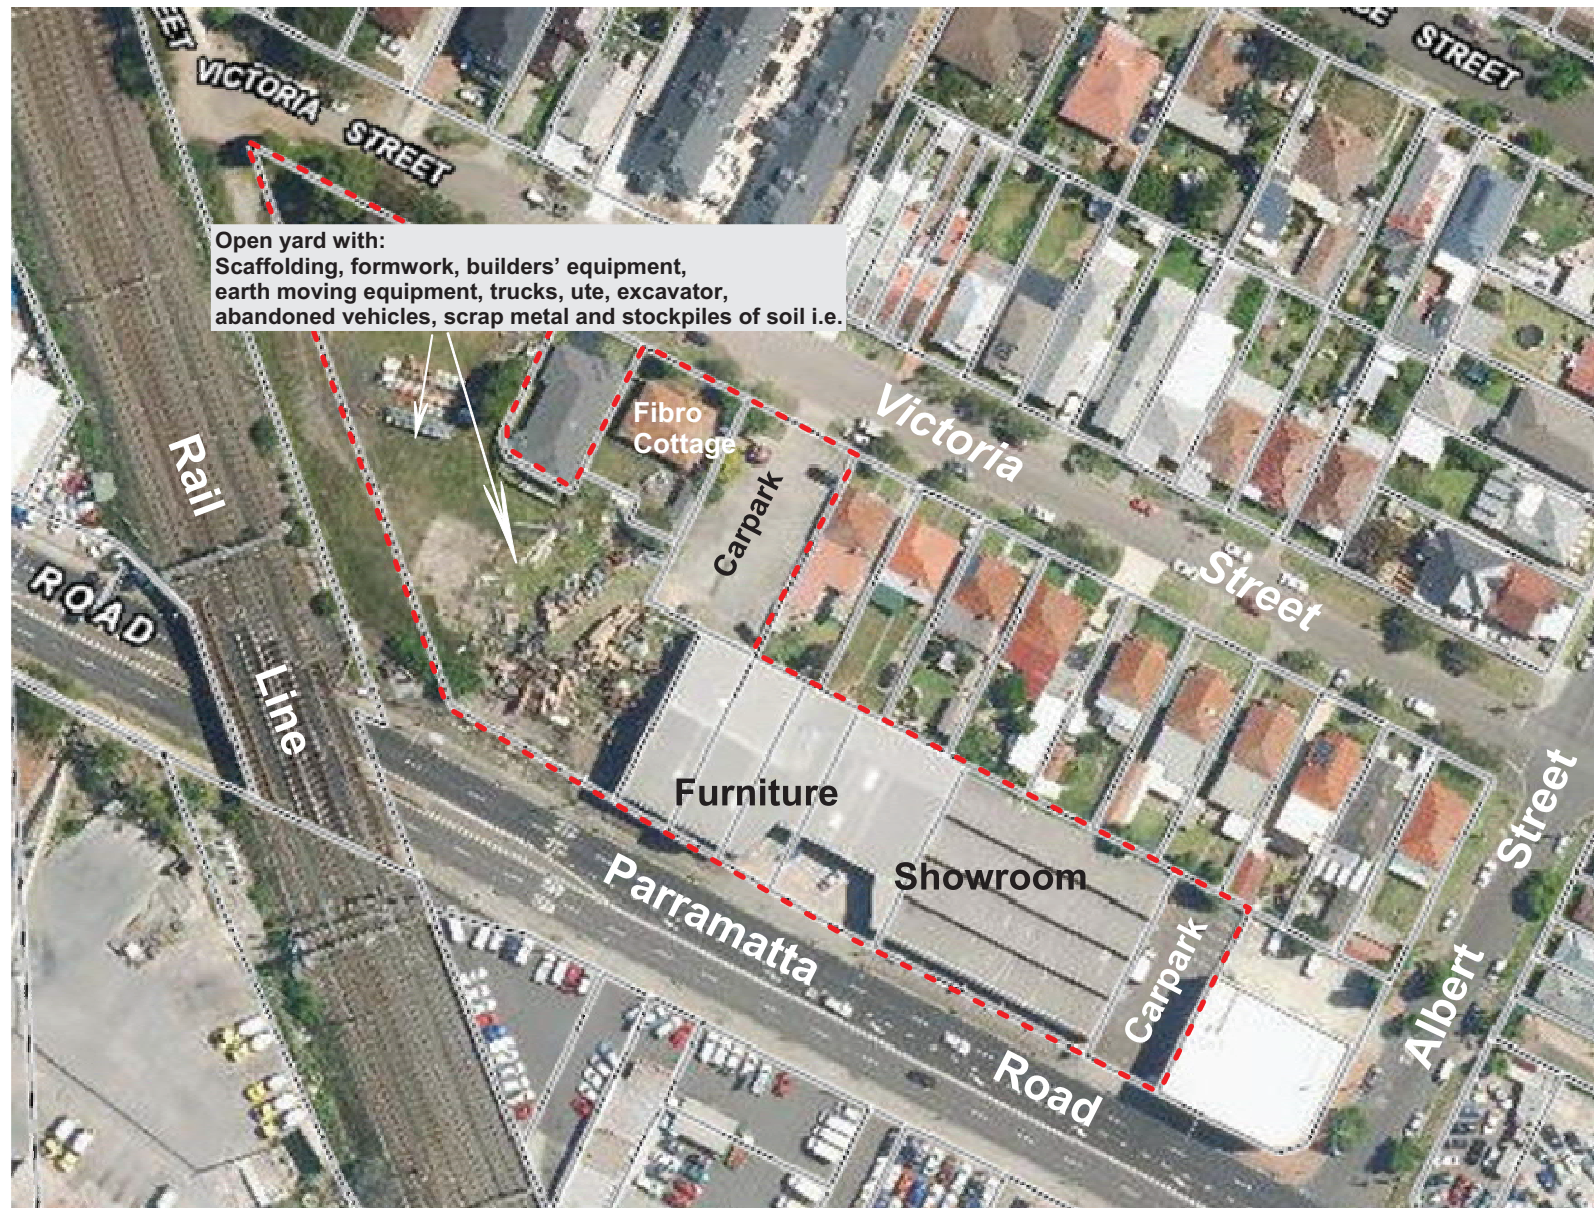
Figure 1: Site Features Plan

**LEGEND:**

- - - Approximate site boundary

The site location is shown on Figure 1 and the Stage 1 ESA was confined to the site boundaries as shown on Figure 2. The proposed development area is referred to as 'the site' in this report. The site is identified as:
