## HERITAGE ASSESSMENT

**Nos. 62-64 Mona Vale Road,  
Pymble**

Final report – 5 May 2014

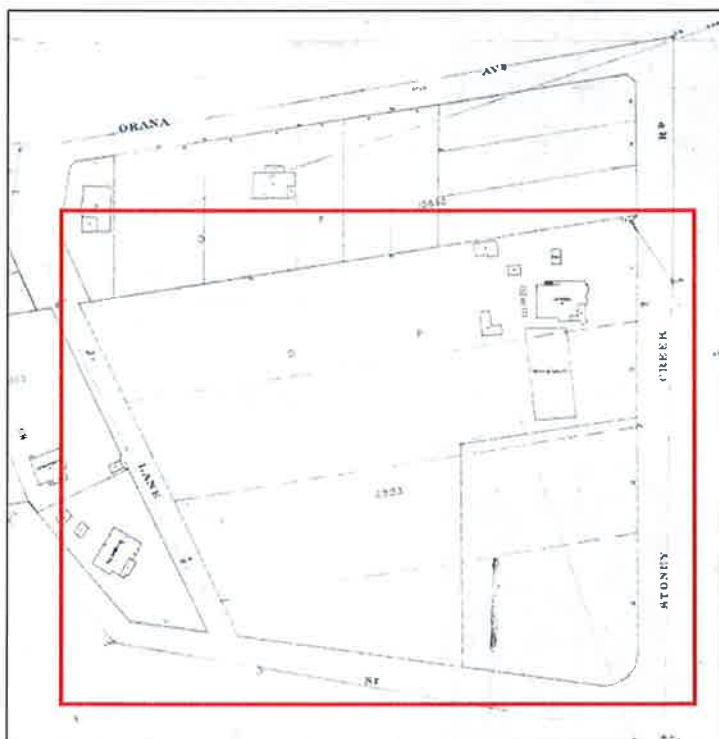
**Figure 2.2** The 1929 plan showing the house Lanosa, surrounding outbuildings and tennis courts. The four allotments of the early subdivision making up the Lanosa estate are also indicated on the plan.

A Sydney Water plan, dated May 1929, shows the house, constructed relatively close to the street frontage with projecting front wing and verandah extending around the south eastern corner of the building. A small verandah and stair is also shown on the northern façade of the rear wing of the building. A number of outbuildings are also shown, including a stable constructed close to the northern site boundary to the north west of the house. The plan (**Figure 2.2**) also indicates the four allotments purchased. The buildings all occupy what was Lot 21. A tennis court is also shown to the south of the house and extends across what was Lot 20. A fence line is also indicated, separating part of Lots 18 and 19, possibly a paddock, at the corner of Church Street and Stoney Creek Road. The plan also shows that a number of substantial houses had also been constructed by this time to the west of the site.<sup>8</sup>

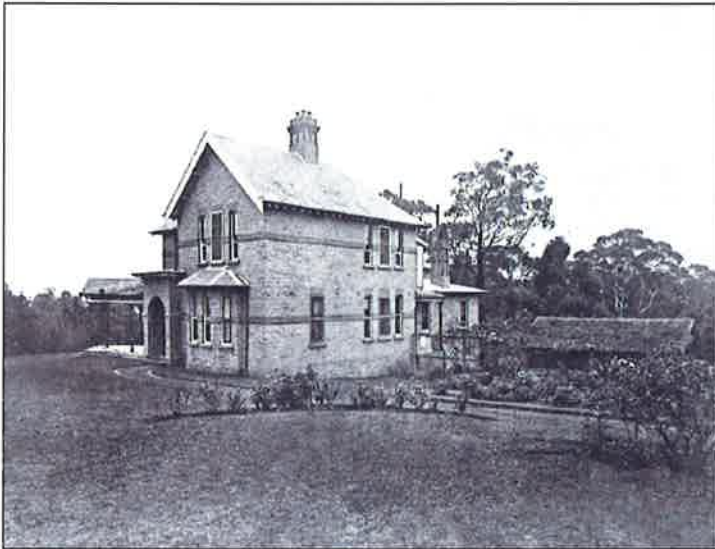
**Figure 2.4** *Lanosa*, 1920. The original face brick facades with contrasting brick details are evident. A small porch/ verandah is visible at the junction of the two wings of the building. A chimney is also visible extending above the northern side of the rear wing.

Photographs of the house and its immediate surrounds, dated 1920 (**Figures 2.3-2.5**), shows the one and two storey face brick building with gabled and hipped roof clad in slates and decorative brick chimneys. The building facades have contrasting brick bands and details. The front projecting bay has a single storey splayed bay with separate hipped roof over. A brick arch and enclosure extending from the front open verandah indicates the building entry. A gabled bay also extends from the south eastern corner of the front verandah. The photographs also show the rear wing and a raised roof section and clerestory window. A tall chimney is also visible extending above the north western section of the building. The building is surrounded by open lawn and garden beds with some ornamental trees plantings.

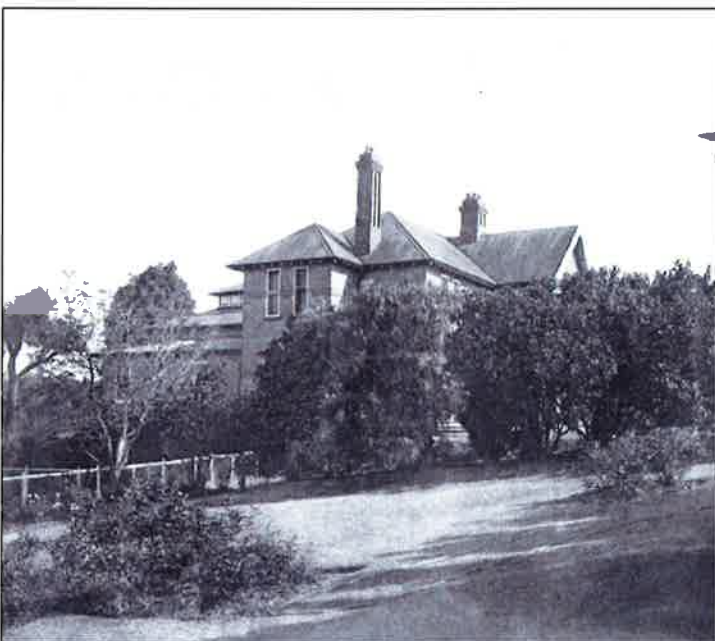
**Figure 2.5** *Lanosa*, 1920. The raised roof and clerestory window over the rear wing are visible.

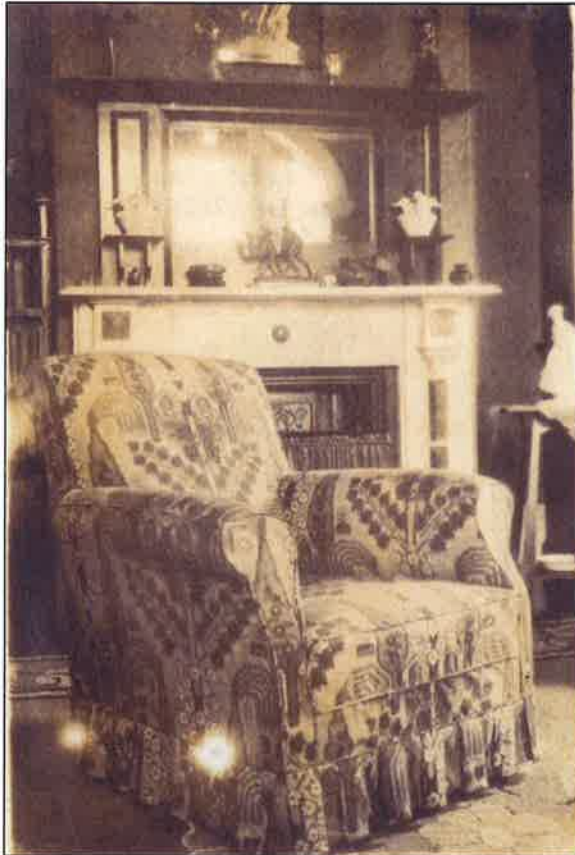
**Figure 2.6** 1930 photograph of the “front room” showing the original fireplace and surround.

Interior images of the "front room" dated 1930 (**Figures 2.6-2.7**) also provide a glimpse of the early character and features of the room. In particular the original fireplace, front bay arch and windows.

**Figure 3.28** The front, north eastern room retains original high pressed metal ceiling and decorative coving and timber joinery and floor. A painted brick fireplace with simple timber mantle located on the western wall appears to have been modified. A photograph dated 1930 (**Figure 2.6**) shows the original fireplace, marble and timber surround. It would appear that the fireplace was modified as part of the early 1940s works to the building.

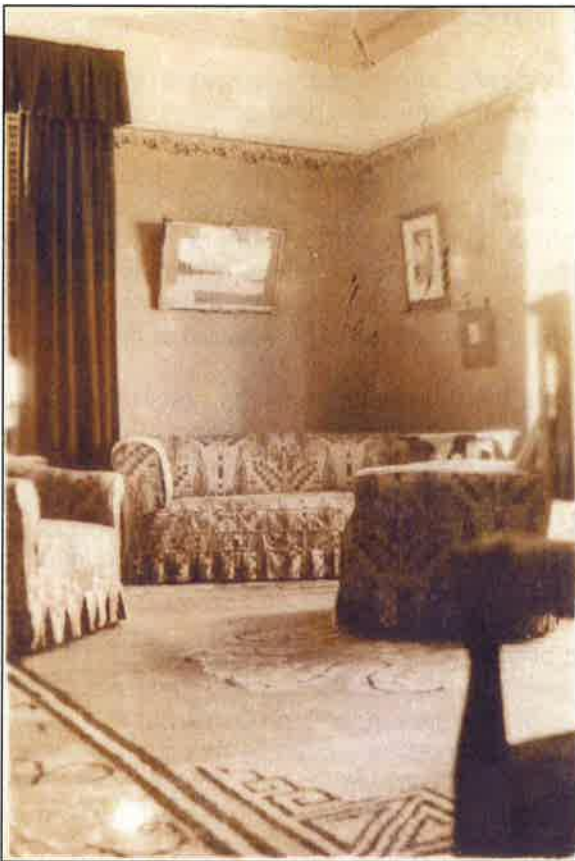
**Figure 2.7** 1930 photograph of the “front room” showing part of the front bay window arch (just visible at right) and window openings.

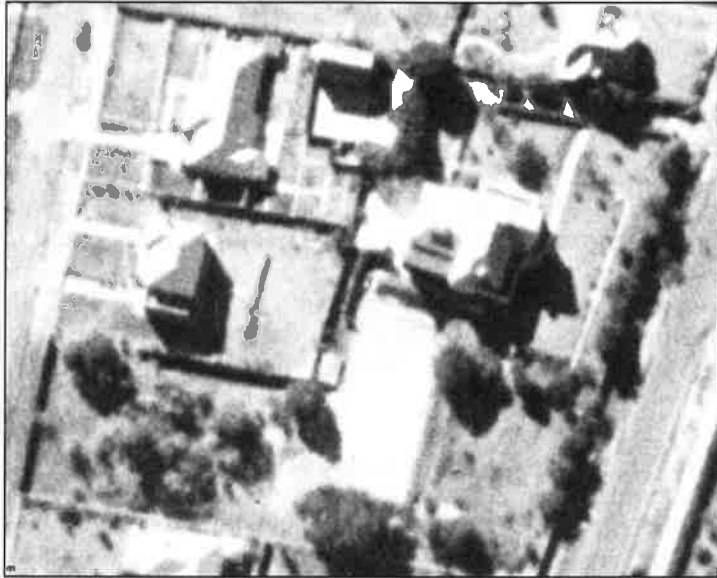
**Figure 2.9** 1943 aerial showing the subdivision of Lot 18. The house *Lanosa*, stables and tennis court are also clear.

The verandah alterations and additions to the front and northern sides of the house are also evident.

An aerial photograph dated 1943 (**Figure 2.9**) clearly shows the subdivided allotment with kinked central boundary line between the larger, house site and three portions along Kywong Avenue. Two of the three sites had been developed by this time. The subject house is clear with stable structure, tennis court and garden with a number of mature trees also evident. A tree and hedge lined driveway is clear extending from the street frontage along the northern site boundary to the stable/ garage structure. A narrow path extends from the drive to the front of the house. In addition to the plantings around the front site boundaries, a central feature tree is visible to the north of the house with a dense stand also clear, extending from near the north western corner of the building to the stable located in the north western section of the site.

The 1943 aerial shows some planting along the street frontage and site perimeters and also one tree to the north of the house and stand extending from the near the north western corner of the house. It would appear that a number of trees have been replaced, added and matured since that time. Some landscaping has been added, however, the alignment of the original access and northern driveway remains (resurfaced c. 1996).

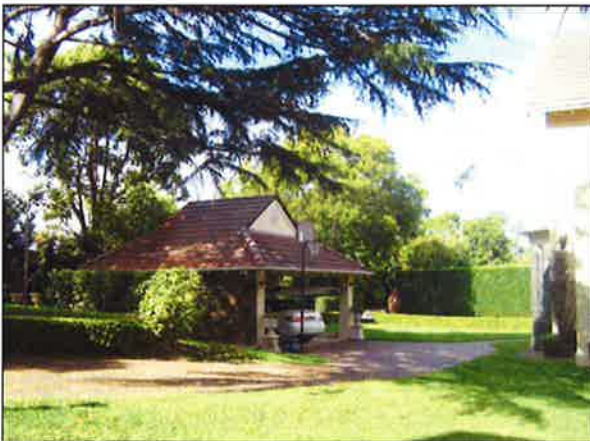
**Figure 3.14** The eastern driveway and carport are later additions to the site (c. 1996). The carport has concrete slab floor and gabled hipped roof supported on solid rendered brick columns

The carport has concrete slab on ground with gabled hipped roof clad in terracotta tiles supported on rendered brick posts. The garden surrounding the house also has a modern in-ground pool located at the south eastern corner of the house and a number of mature trees including feature palm and large pines trees to the north and stand of trees (Camphor Laurels) to the north west. A paved patio is located at the rear (west) of the house with garden steps and planting also extending along the southern side.

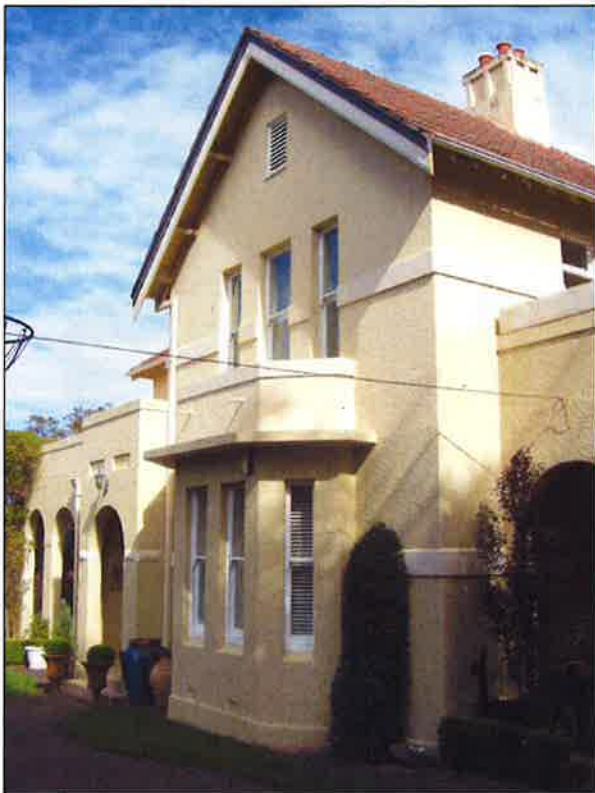
**Figure 3.16** The front, eastern façade of the building has a gabled projection with single storey faceted bay, central entry and verandah which wraps around the south eastern corner of the building.

The main wing has gabled and hipped roof with exposed rafter ends and rendered chimneys.

The building has been rendered with rendered bands added reflecting the former brick details. The faceted bay has also been altered with projecting hood and solid parapet added replacing the original hipped roof.

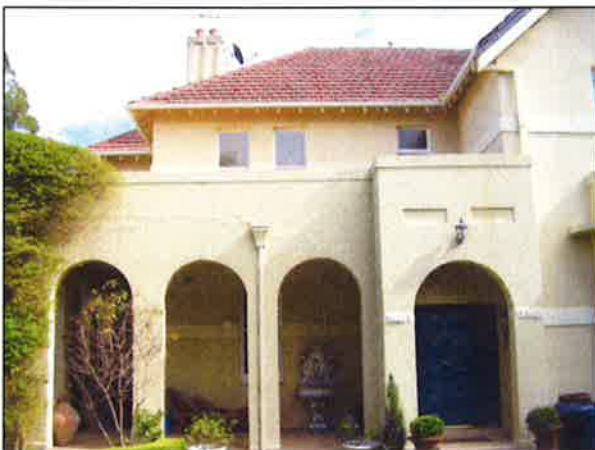
**Figure 3.17** The verandah and entry have a solid parapet/ balustrade and open balcony over. The verandah arches are a later addition and reflect the original arched entry (at right). A deeper window opening on the first floor level appears to have been converted into a doorway to access the balcony. The two chimneys also appear to have been altered and height reduced at some stage.

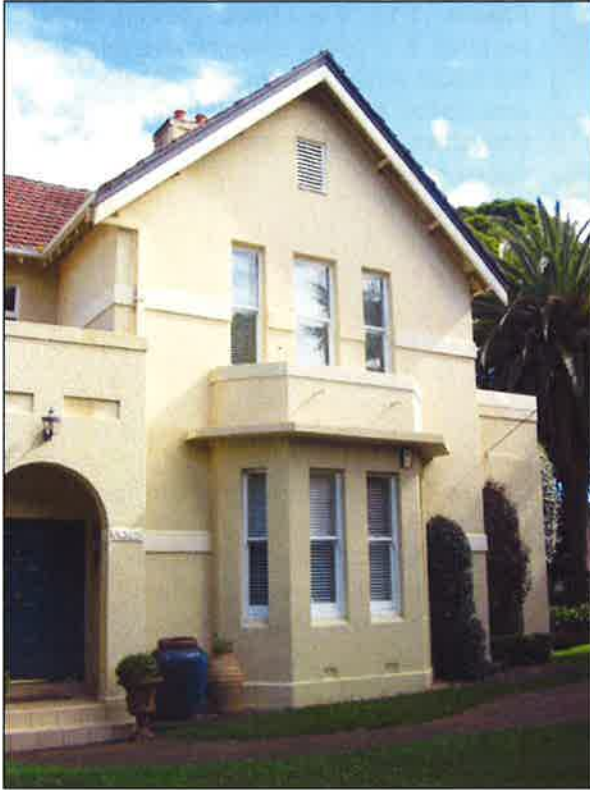
**Figure 3.18** The building entry retains the original door opening and sidelights, however the door appears to have been replaced and porch area modified with opening to the verandah infilled and modern tiles added to the floor and steps.

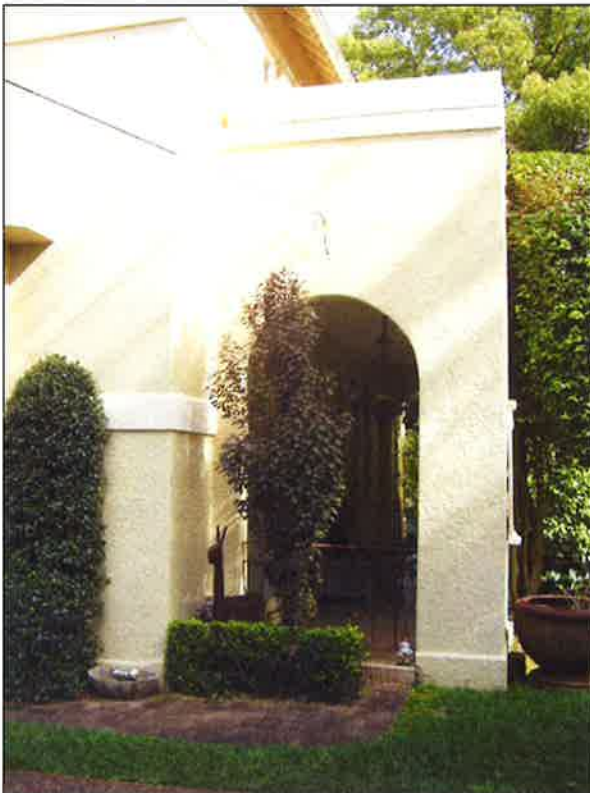
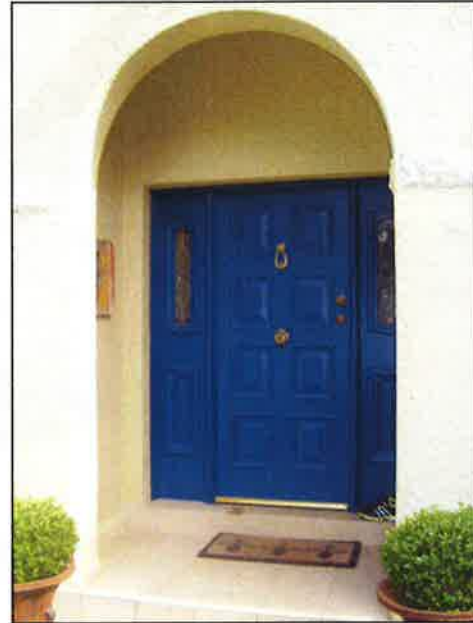
**Figure 3.19** A verandah with arched colonnade has also been added to the north eastern façade. Window openings on the ground and first floor appear to have been altered and replaced with doors to access the verandah and open balcony over.

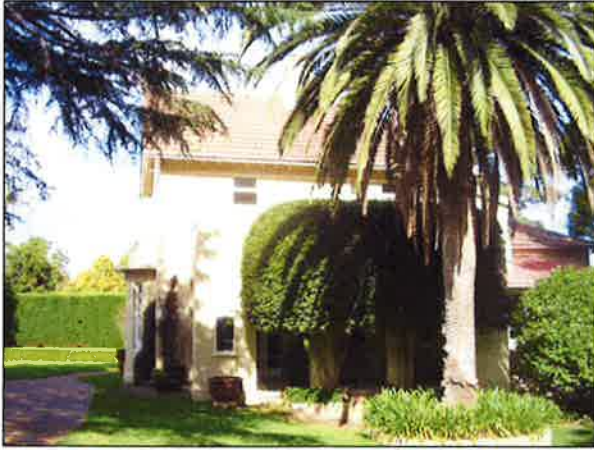
**Figure 3.20** The north eastern façade. The verandah has modern ceramic tiled floor and steps down to the northern garden area.

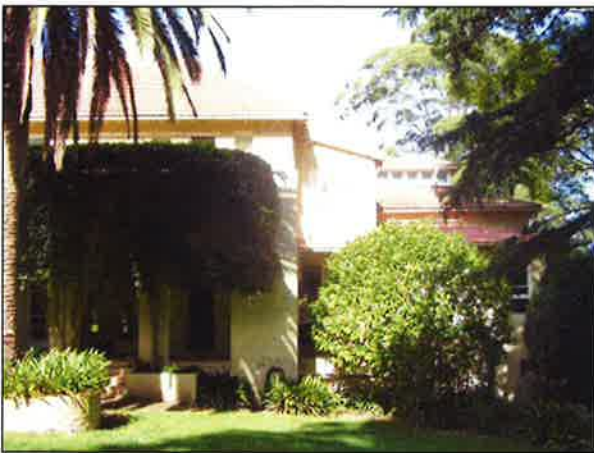
**Figure 3.21** The rear wing is stepped back from the main section of the building and has hipped and skillion roof forms clad in ceramic tiles and corrugated steel. The central section of the roof is raised with clerestory windows and hipped roof over.

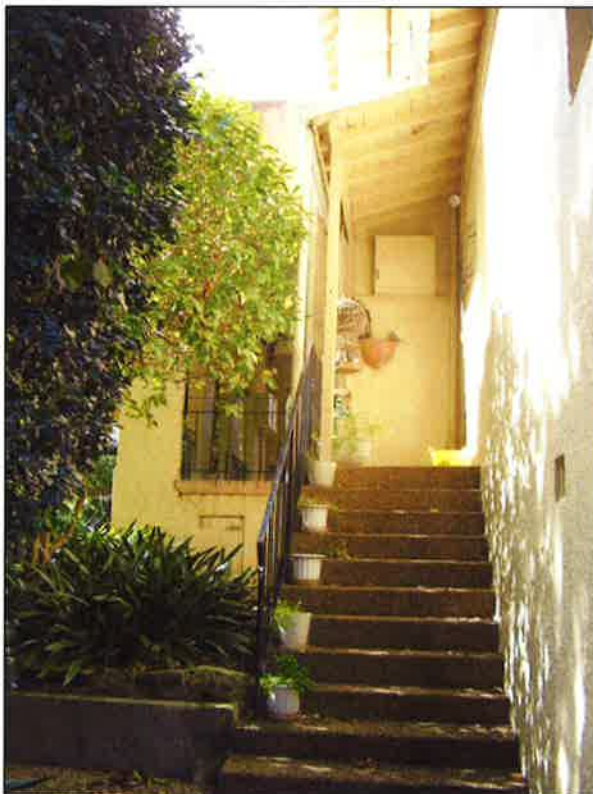
**Figure 3.22** A small porch with skillion roof supported on timber posts is located at the northern junction of the main and rear wings. Steps extend down the north western to the garden area.

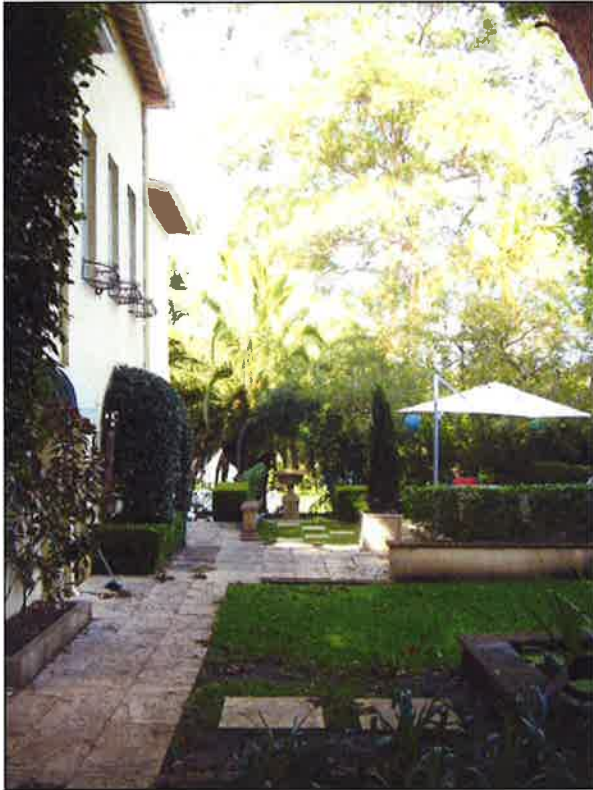
**Figure 3.23** A paved patio is located at the rear (western) side of the building.

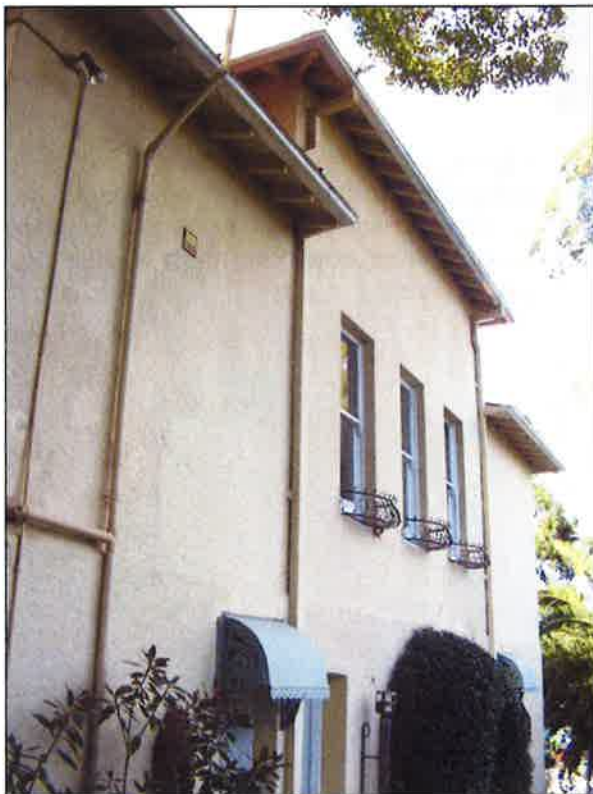
**Figure 3.24** The western façade which also has openings to a lower ground area.

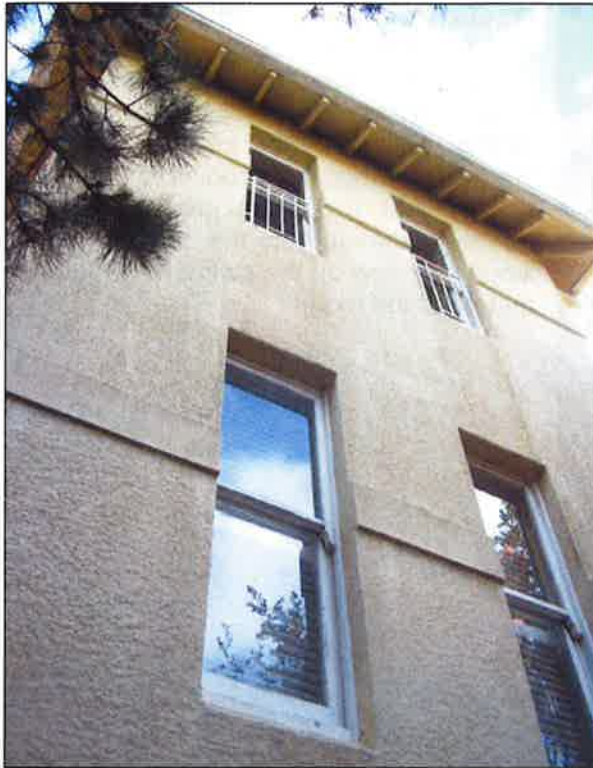
**Figure 3.25** Part of the southern façade. The front verandah returns around the south eastern corner of the building.

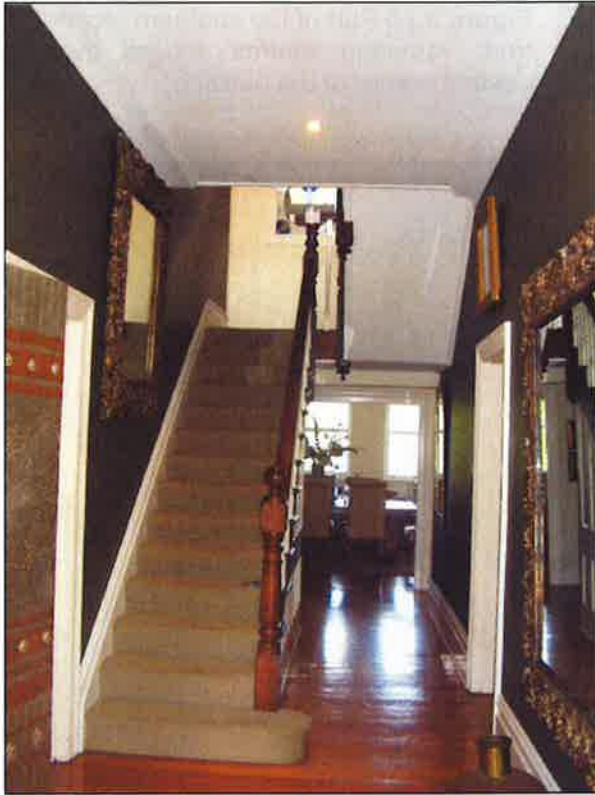
**Figure 3.26** The ground floor central entry hall and stair. The interior generally retains timber floor, rendered and set walls and timber joinery. The hall has simple plaster ceiling with deep, flat coving. The hall is bounded by four main rooms and also leads directly into the large ground floor room (former ballroom) on the ground floor. A leaded window on the stair landing remains a feature of the room.

The two levels are connected by a carpeted timber stair with turned timber newel posts and balustrade and profiled handrail and timber panelled base. The stair is located in the central hall and extends up to a central landing accessing the bathroom and store room on the first floor of the rear wing. The stair returns and continues up to the first floor landing and main rooms (bedrooms) on the first floor.

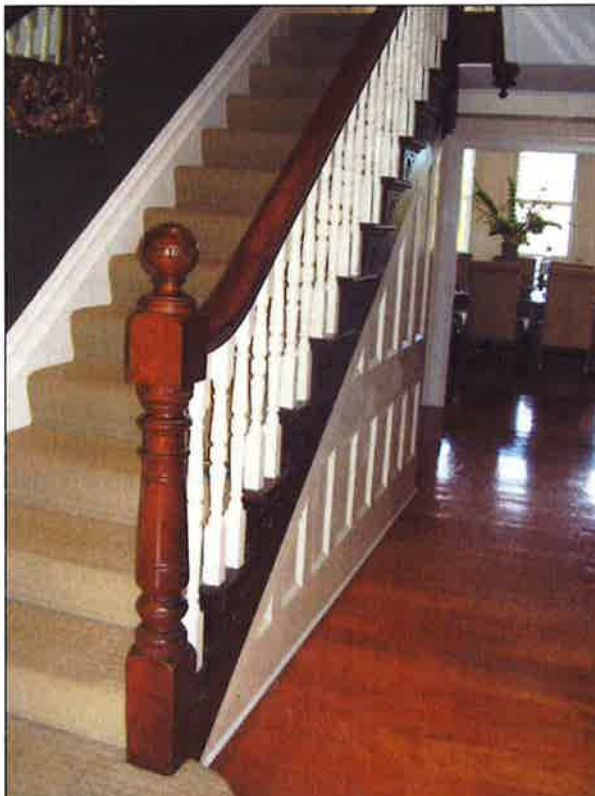
**Figure 3.27** The hall retains the original timber stair and details.

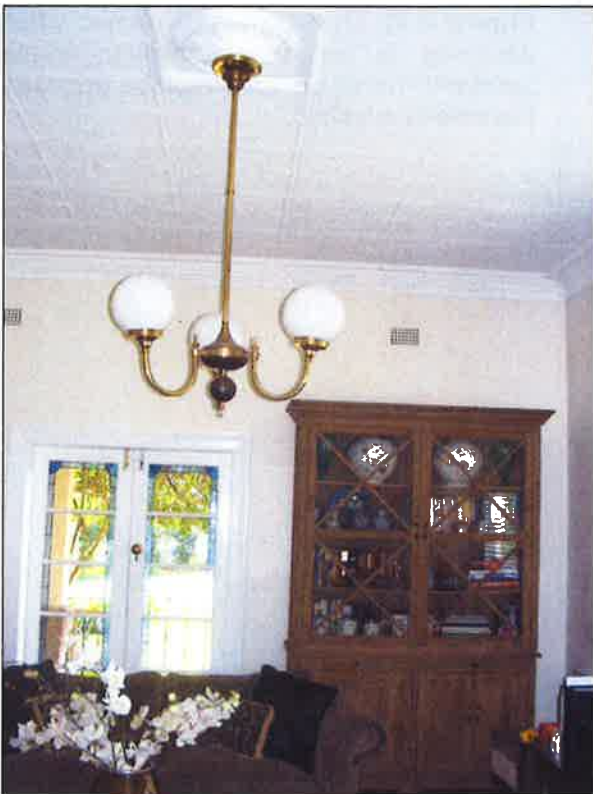
**Figure 3.29** The front, north eastern room also retains the front bay window with moulded details to the arch. French doors, however, appear to have been added to access the northern verandah (c. 1941-1943)

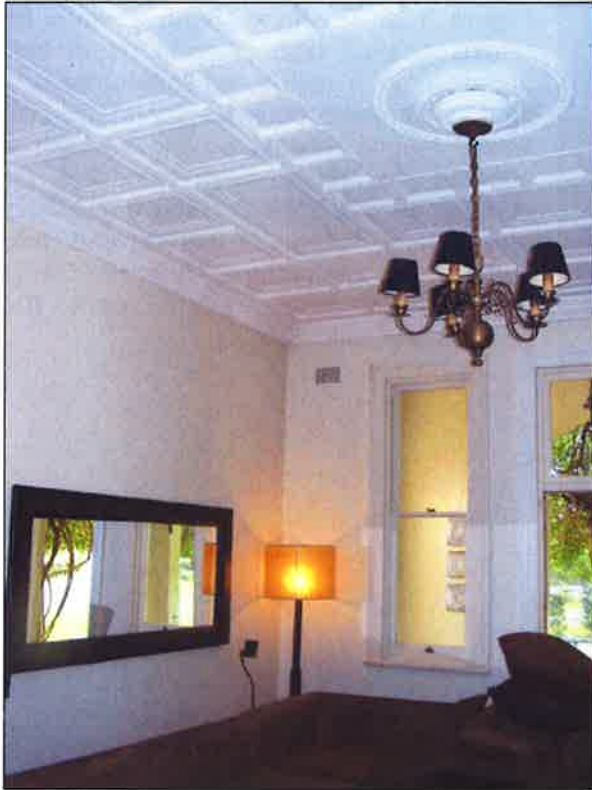
**Figure 3.30** The north western room on the ground floor of the main wing retains a high decorative plaster ceiling and original timber joinery. A window has, however, been modified with door added to access the northern verandah.

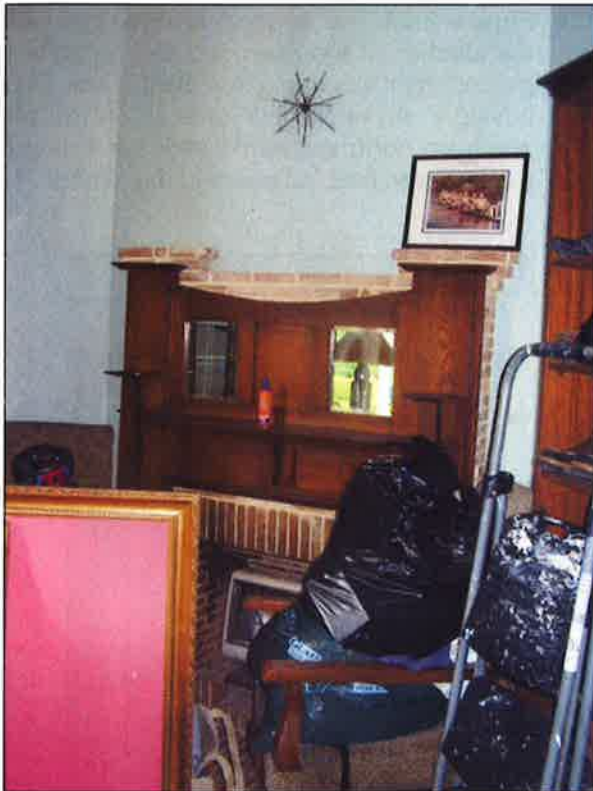
**Figure 3.32** The front, south eastern room features a splayed fireplace with timber surround and pressed metal ceiling and timber joinery including timber panelled doors.

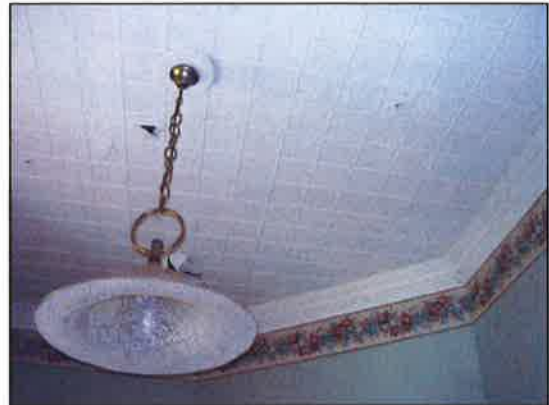
**Figure 3.33** The south western room on the ground floor of the main wing has high pressed metal ceilings and original doorway to the front verandah return. The room also has a painted brick fireplace and breast and original timber joinery and windows.

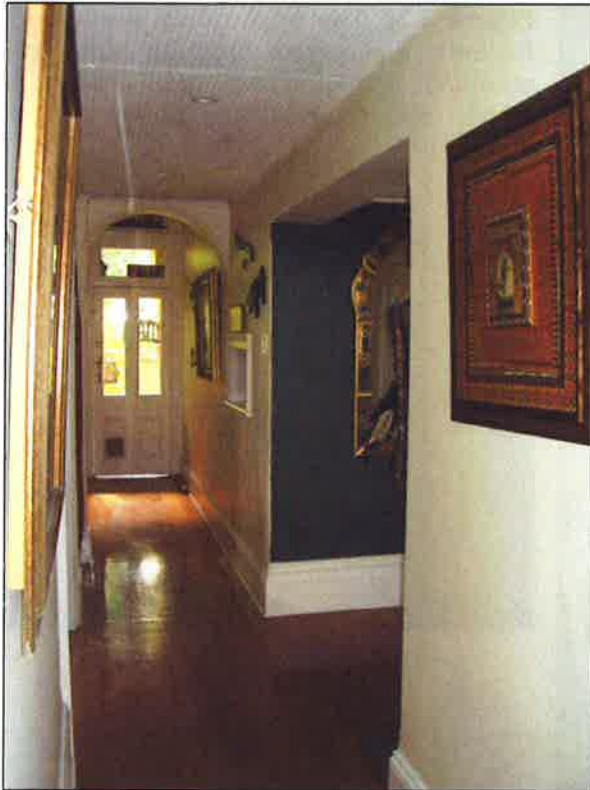
**Figure 3.34** The secondary, traverse hall at the junction of the main and rear wing on the ground floor has ripple iron ceiling with simple coving. An arch and side door (to small porch on north western façade) is located at the northern end, adjacent to the kitchen.

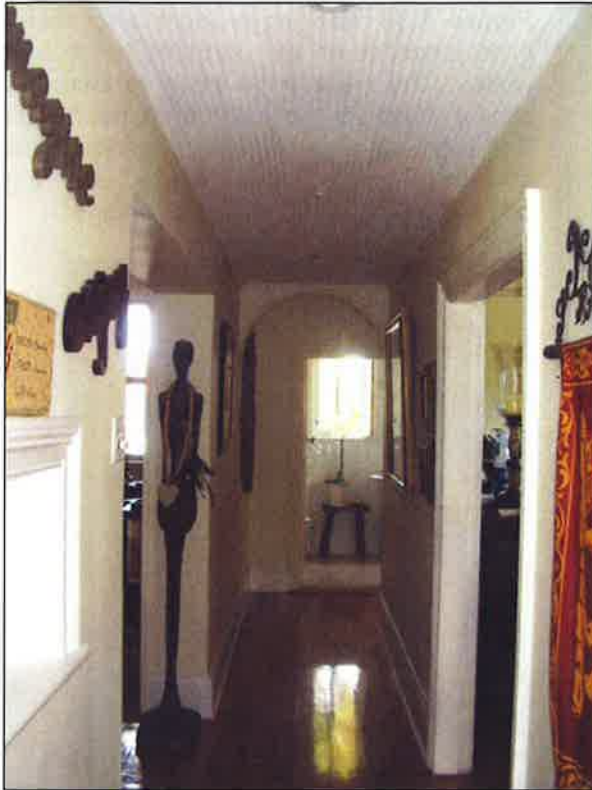
**Figure 3.36** A modern bathroom is located at the southern end of the traverse hall of the ground floor of the rear wing.

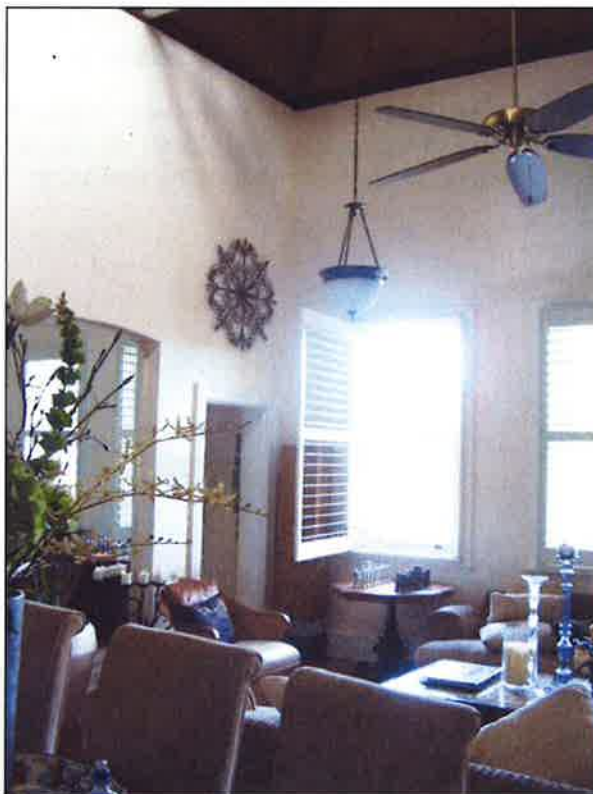
**Figure 3.37** The most notable feature of the rear wing is the central, double height space which has timber panelled ceiling, exposed timber trusses and high clerestory windows.

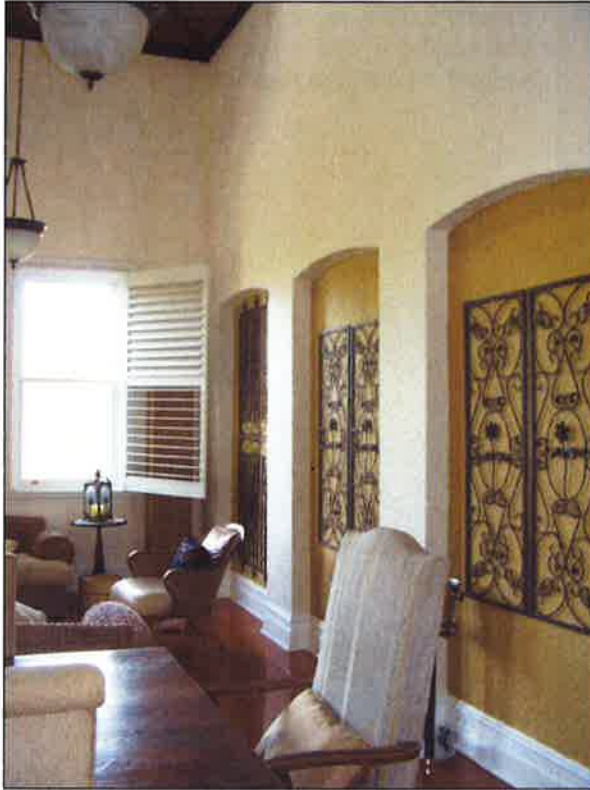
**Figure 3.38** The large room also features blind recesses on the northern and southern walls. The walls have been rendered with similar finish to the exterior of the building. The room also retains a high leaded window on the eastern wall (below, top right, corresponding to the stair mid landing).

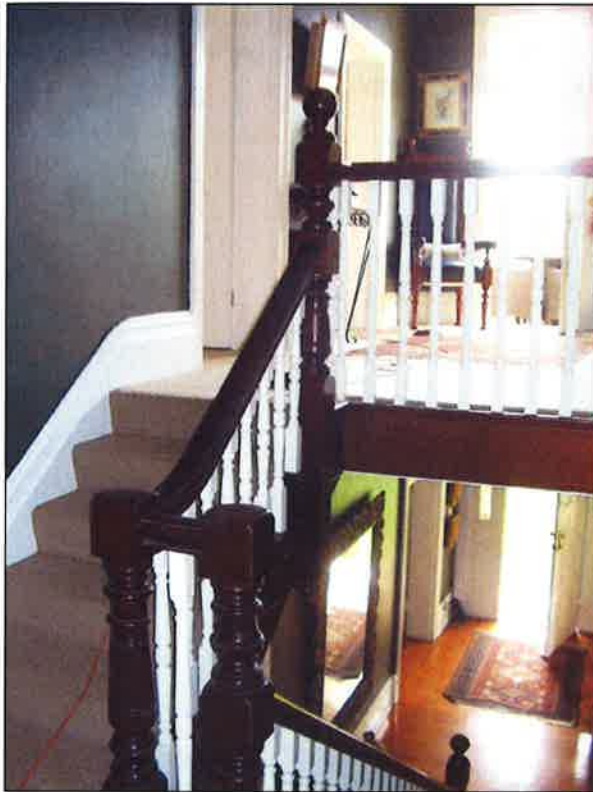
**Figure 3.40** The stair and first floor landing/hallway which retains original pressed metal ceiling and timber joinery.

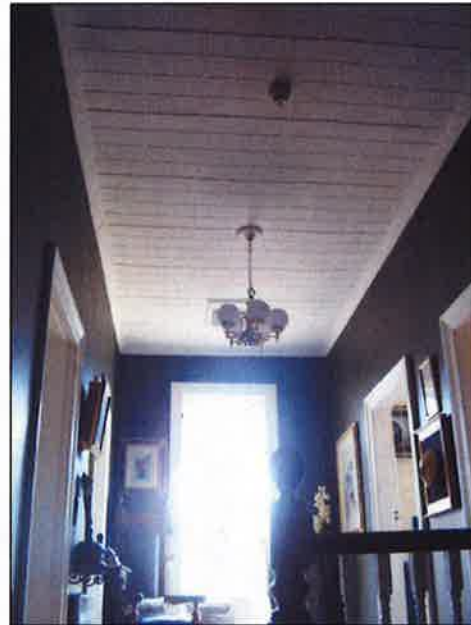
**Figure 3.41** A deep window opening on the eastern wall of first floor hallway has been converted into a doorway and accesses the balcony over the front verandah.

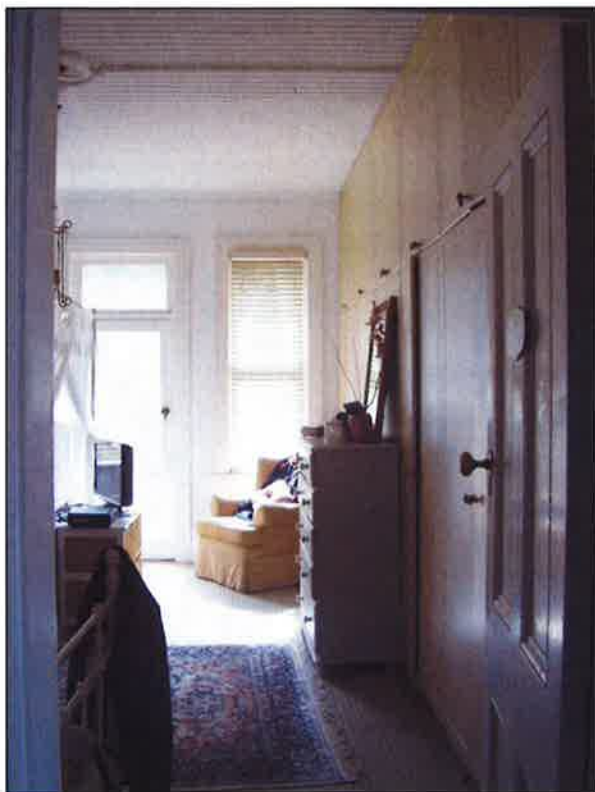
**Figure 3.42** The bedrooms on the first floor have pressed metal ceiling and also retain original joinery.

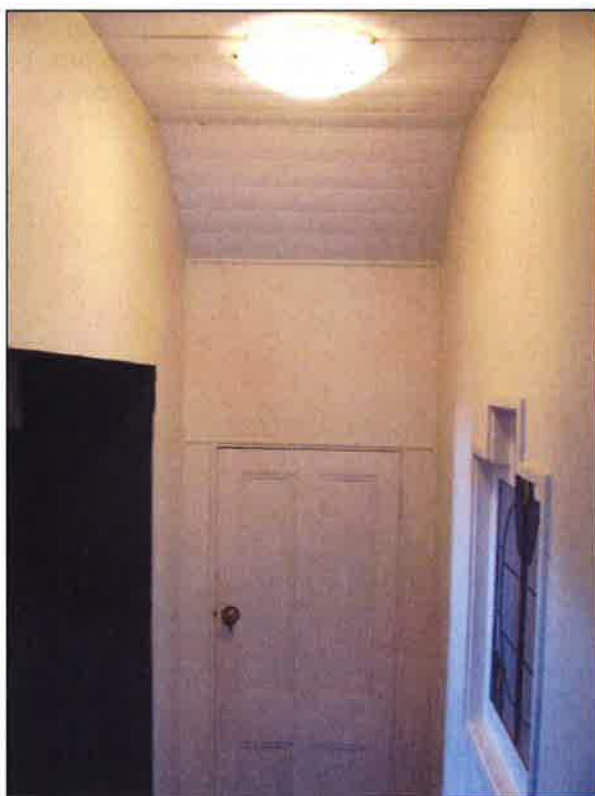
**Figure 3.43** The rear landing (first floor of the rear wing) has a timber boarded raked ceiling with small store and modern bathroom at each end. Note the leaded window. The bathroom retains an early timber battened ceiling.
