# Proposed cemetery site, Old Cooma Road, Googong: Hydrogeological Assessment

**Queanbeyan-Palerang Regional Council**

| <b>Project Name</b> | Old Cooma Road, Googong Groundwater Studies – Cemetery and Crematorium |

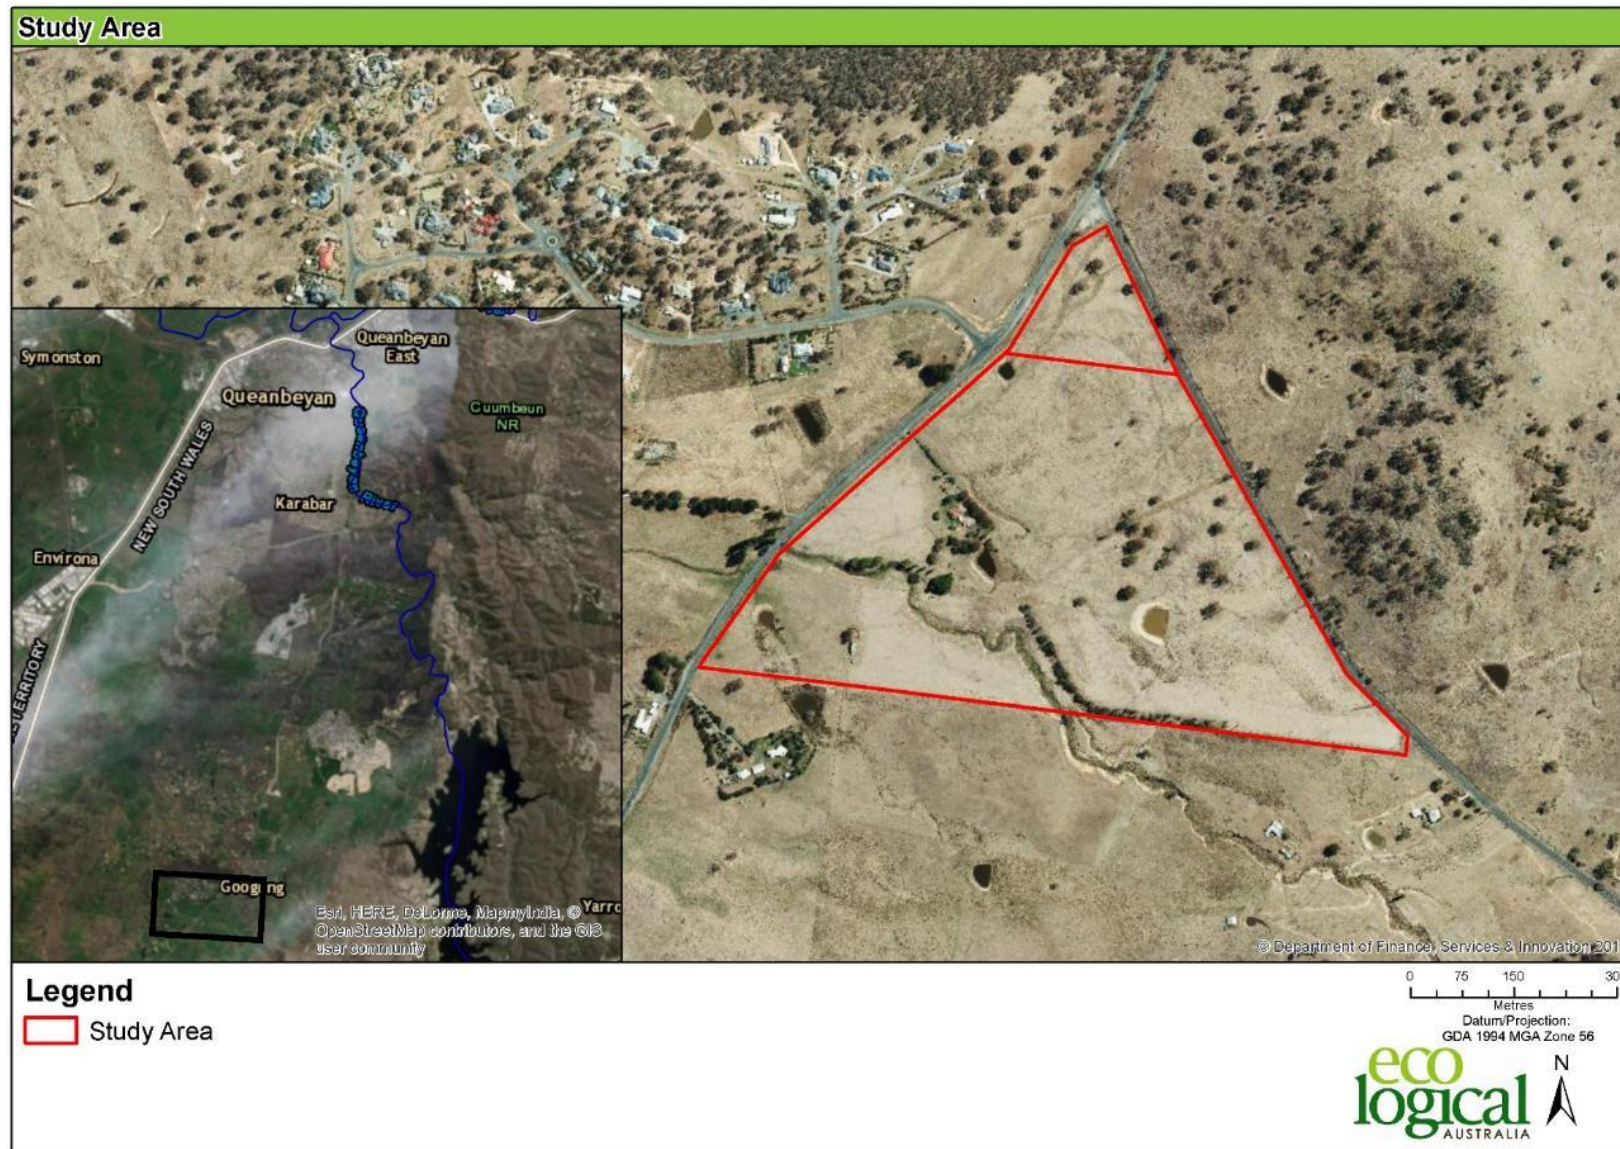
Figure 1-1: Study Area (the line across the top shows two lots associated with this site)

Eco Logical Australia (ELA) has been engaged by the Queanbeyan-Palerang Regional Council (QPRC) to undertake a hydrogeological and hydrological review and constraints assessment for the proposed development and use of a cemetery site located within Lot 2 (DP112382) and Lot 126 (DP754881) situated at 1241 Old Cooma Road, Googong (the Site – Figure 1-1).

The study area is approximately 36.4 hectares and is located approximately 11 kilometres south-west of Queanbeyan, and approximately 5 km west of the Queanbeyan River (Figure 1-1). The Site is triangular in shape and bounded by Old Cooma Road to the west and Burra Road to the east. The Burra Road – Old Cooma Road intersection is located at the northern point of the site.

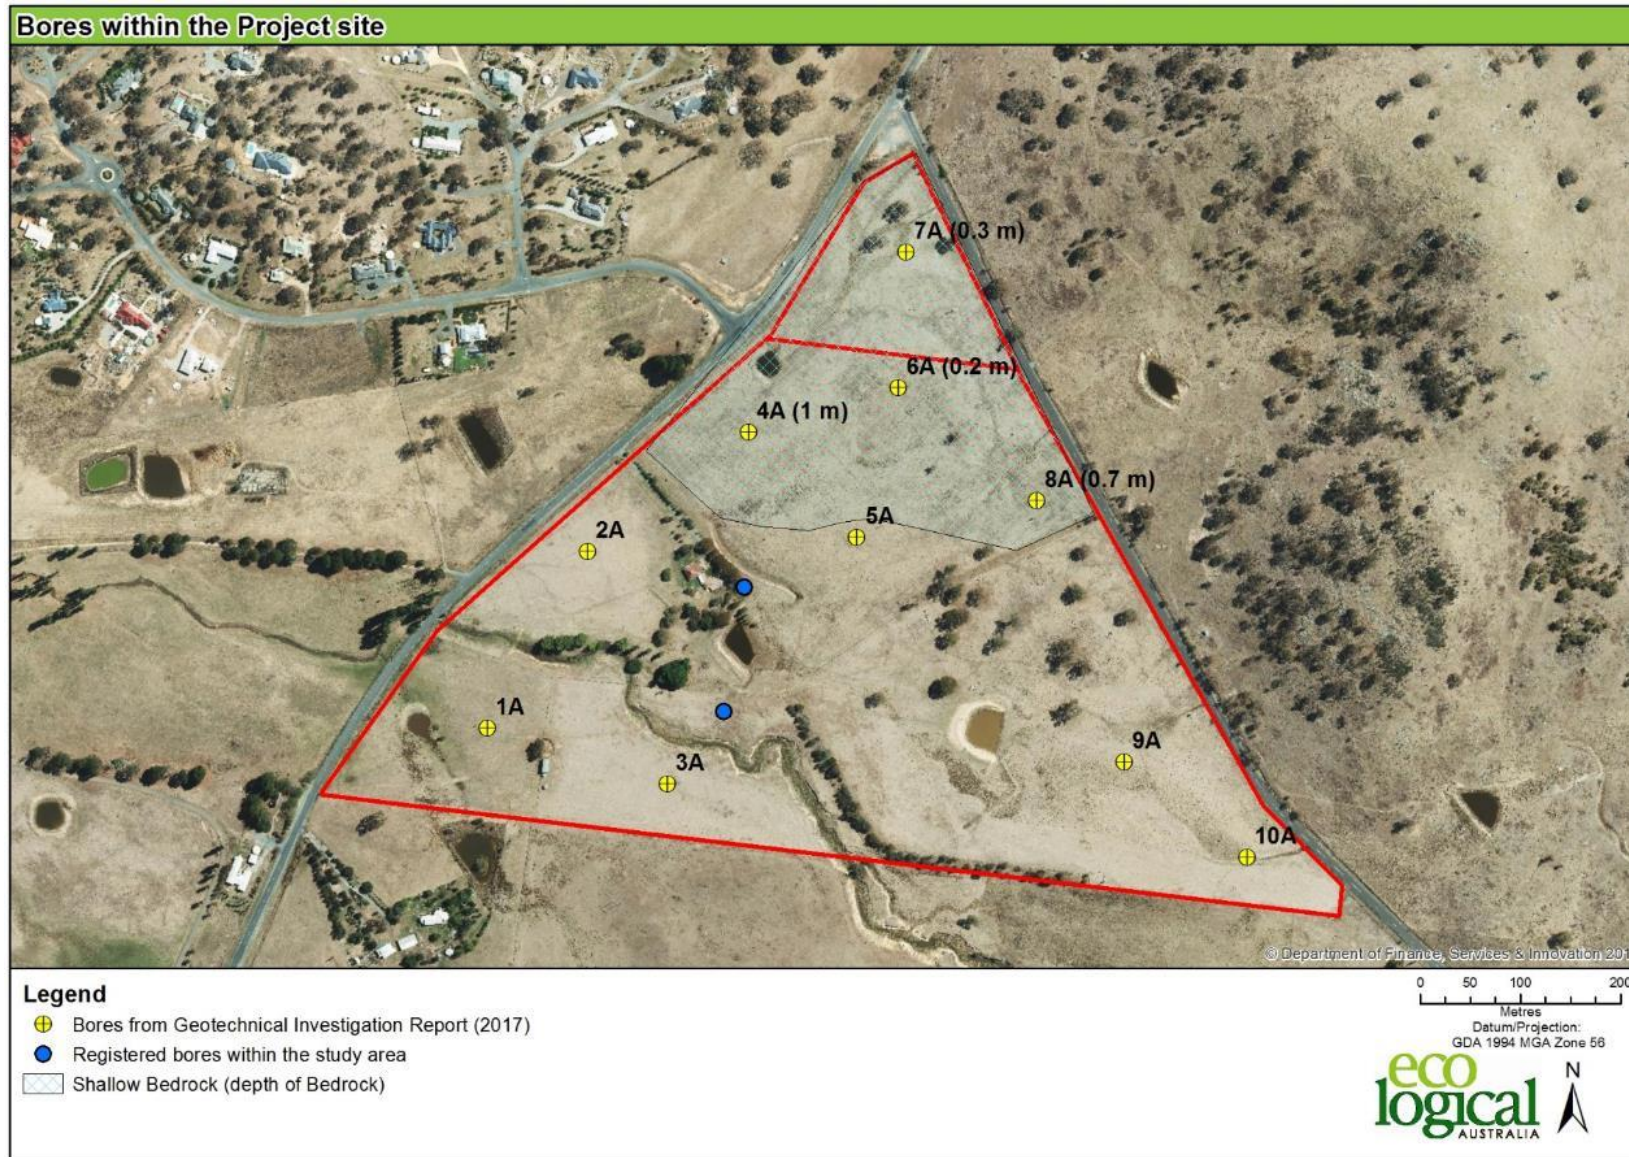
Figure 2-8: Reported bores within the project area prior to this study.

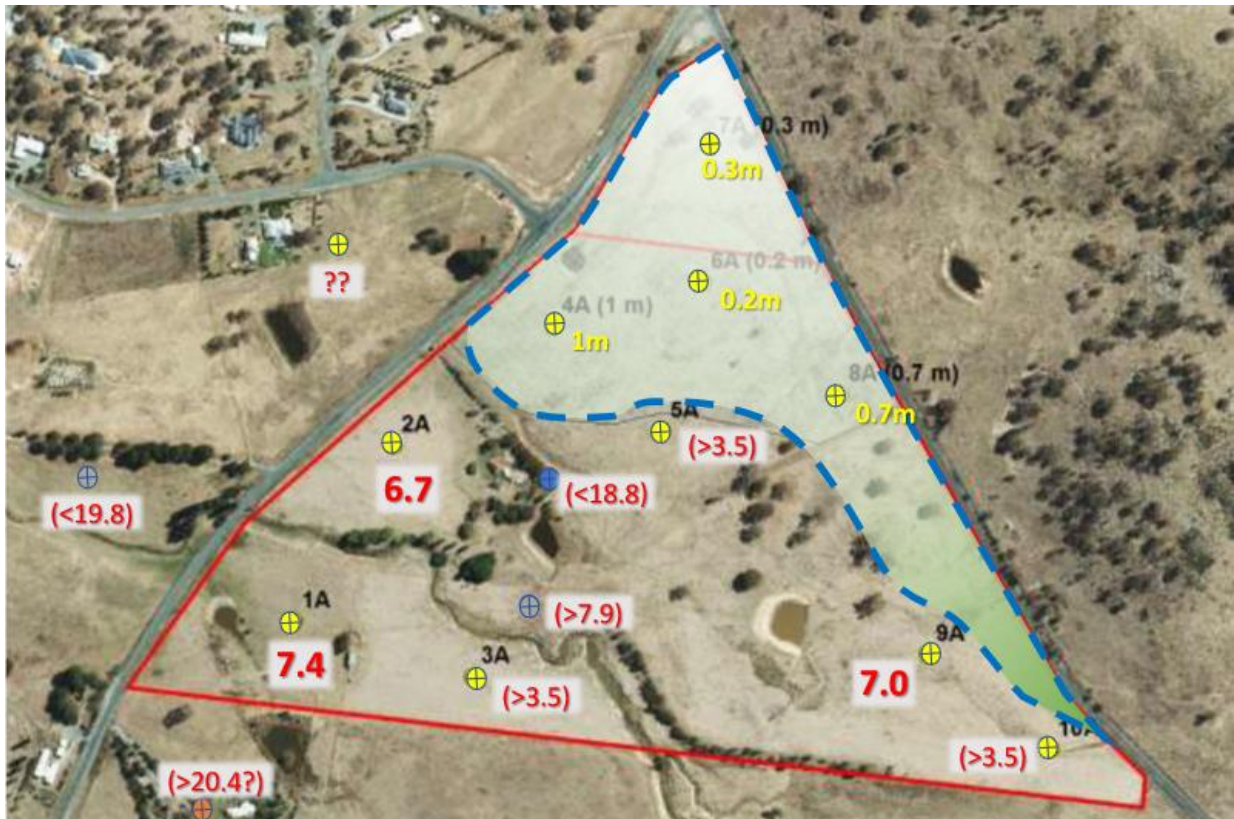
Figure 4-6: Depth to competent bedrock. Shaded area marked where bedrock is less than 3 m below ground. Numbers in brackets inferred from bore construction records.

Depth to unaltered or unweathered bedrock is in excess of 6 m for much of the Site. Areas where bedrock is within 3 m of the land surface have been identified and can be avoided (general recommendation 6).

The additional bore logs generated through installation of the new monitoring bore network provide further ground material information to assess the capability of the Site to host grave sites. Specifically, depth to competent rock can now be estimated for much of the Site and this defines a zone where depth to hard rock is less than 3 m and therefore not suitable for grave sites (Figure 4-6).

All locations investigated to the south of the shallow soil zone had suitable materials for soft excavation. Topsoil and alluvium ranges up to 4 m where logged, increasing to the south and west. Beneath this, incompetent weathered material extends up to 7 m on site and likely deeper to the south and west. Lower horizons tend to be clay-rich and form confining layers above the fractured dacite bedrock.

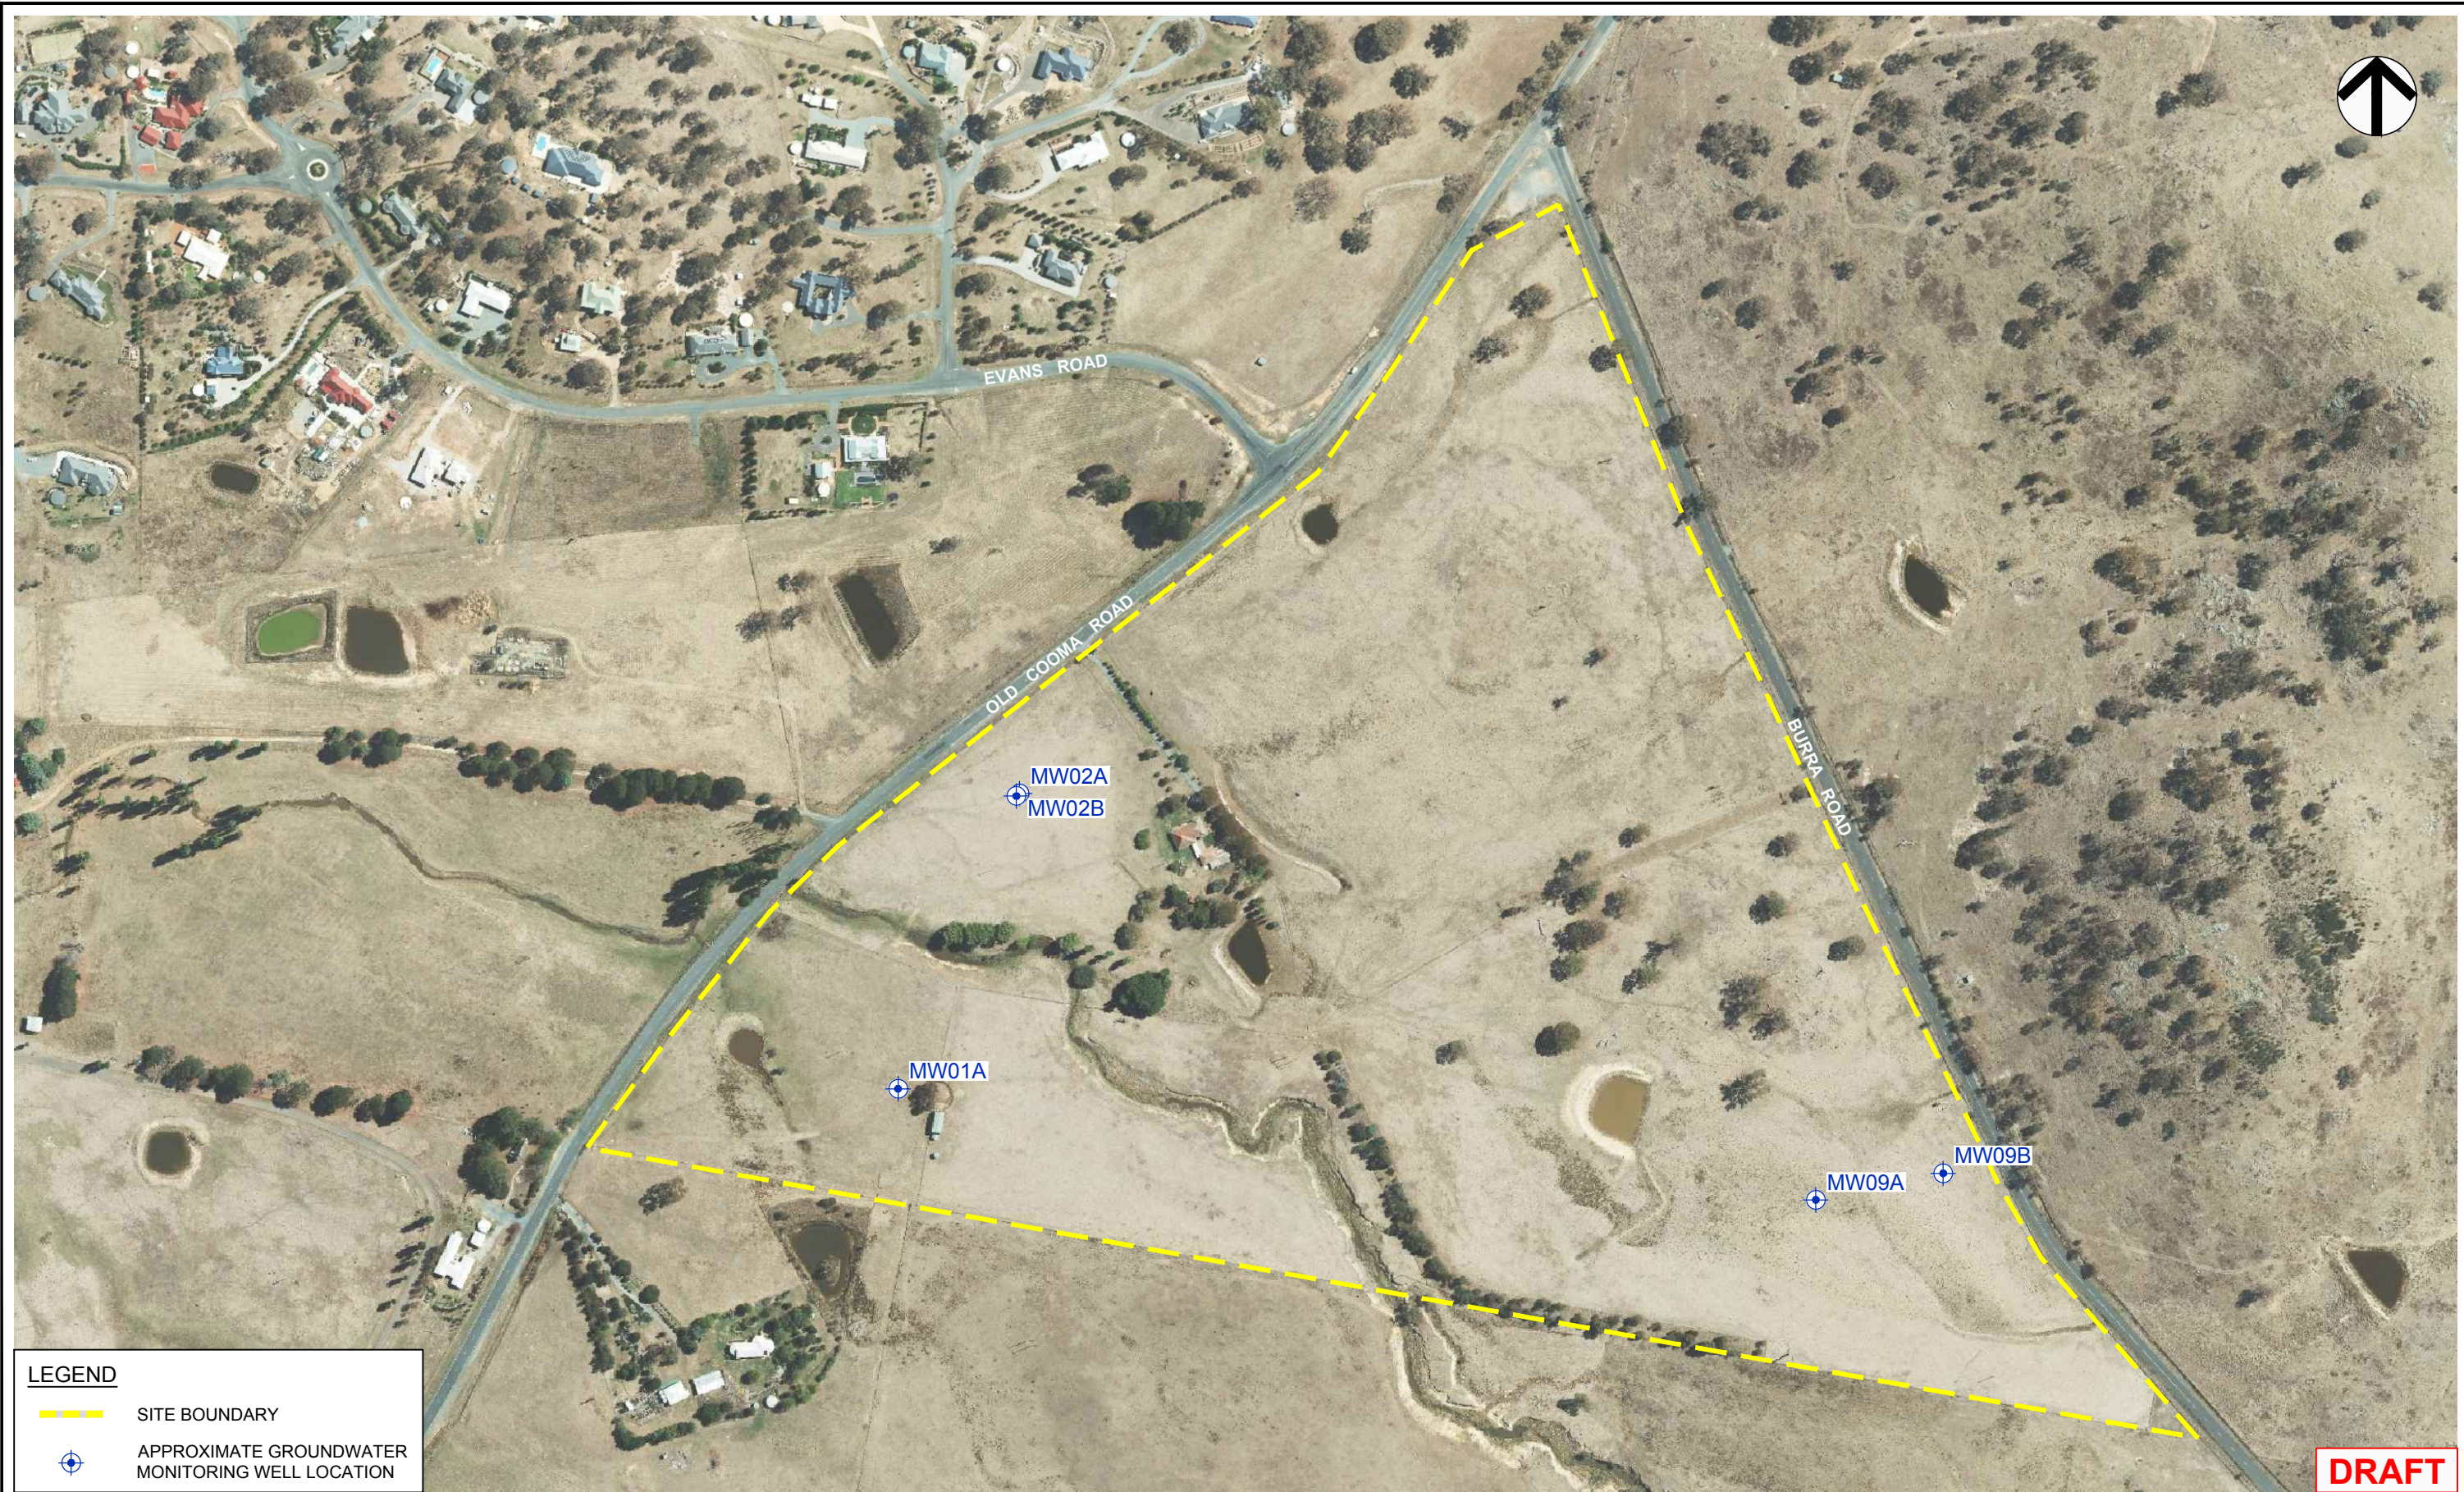
| project no: 754-CBREN225122-R01 | figure no: FIGURE 1 | rev: A |

| title: GROUNDWATER MONITORING SITE LOCATION PLAN | | |

Eco Logical Australia (ELA) on behalf of Queanbeyan Palerang Regional Council (QPRC) engaged Coffey Services Australia Pty Ltd (Coffey) to install groundwater monitoring wells at three locations at a site located within Lot 2 DP112382 and Lot 126 DP754881, situated at 1241 Old Cooma Road, Googong (herein as the 'site'). Based on information provided by ELA, Coffey understands the site is being considered as a proposed development site for future use as a cemetery. The site location is shown in Figure 1, Attachment A, while a site layout plan is presented in Figure 2.
