# Engineering Assessment

## Heartwood Residential Precinct Planning Proposal

### Endeavour Drive Bellingen

November 2020

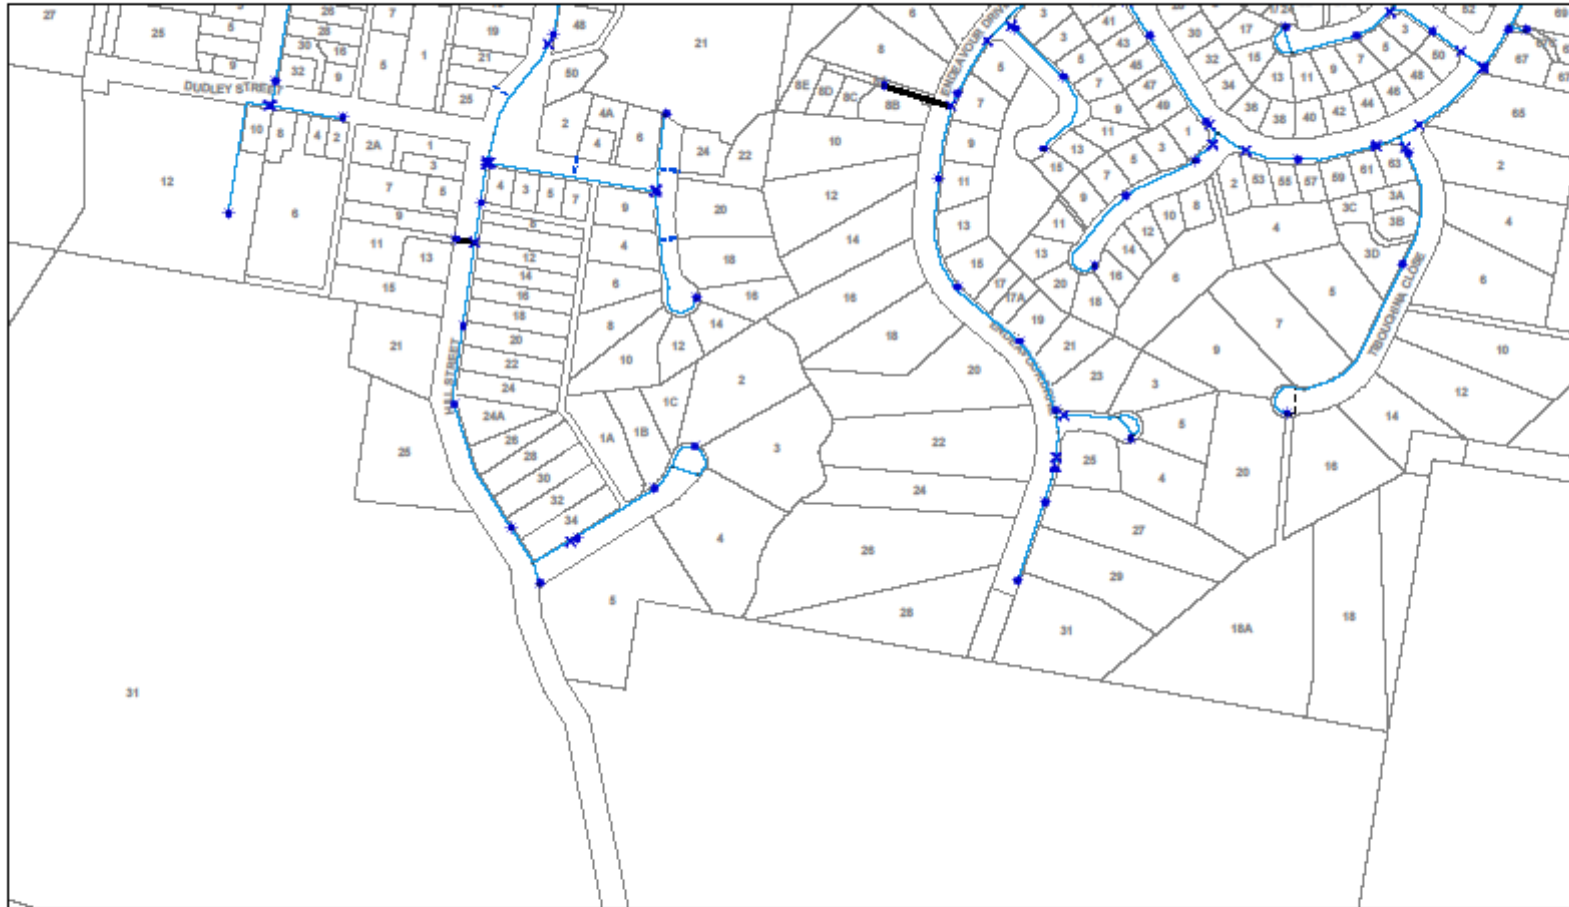
**Appendix D – Heartwood Community water supply network**

**Bellingen Shire Council - Water**

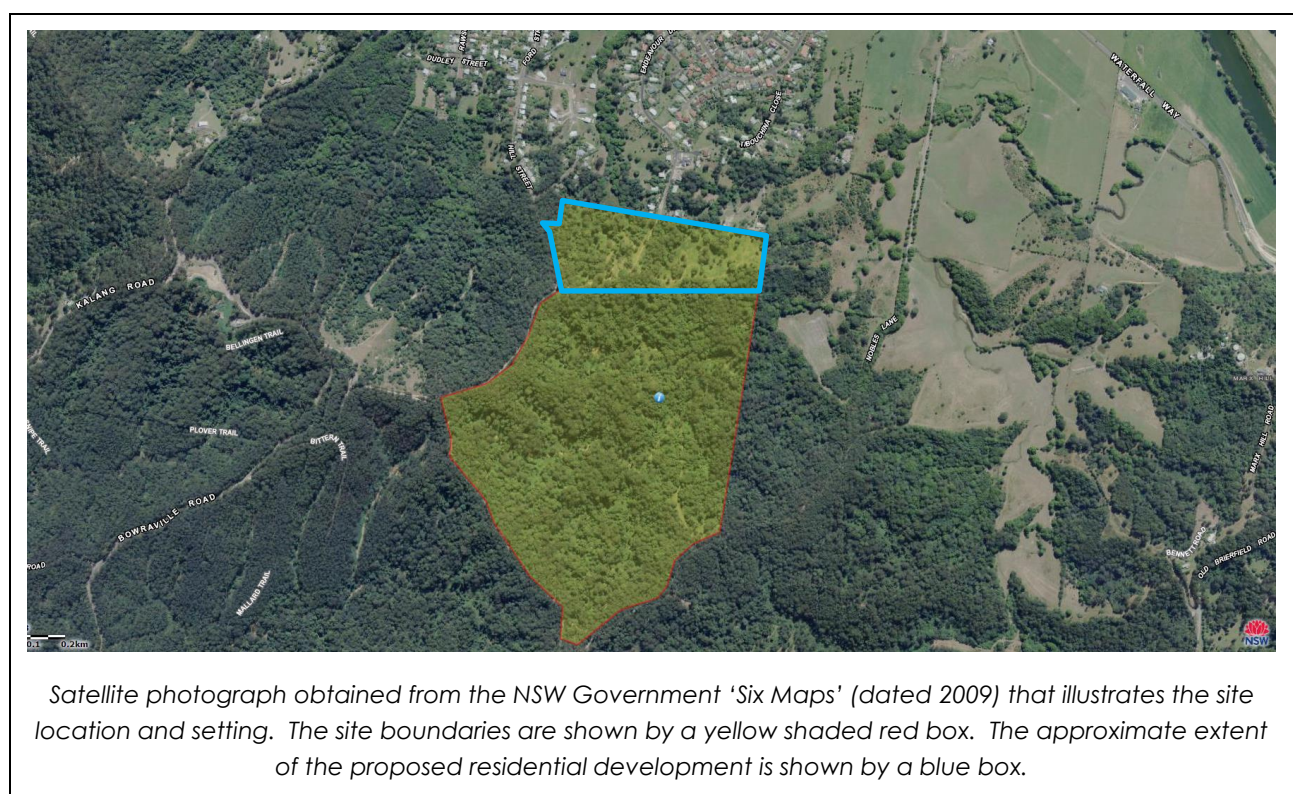
The 75.07ha site is bound by the Hill Street trail to the west, bushland to the south and west, and by large lot residential lots to the north that are accessed by Endeavour Drive. Site access is currently from Endeavour Drive. A satellite photograph that shows the location of the site and the site setting is reproduced below.

The site is situated within a region characterised by moderately to steeply sloping terrain. The northern portion of the site where development is proposed is dominated by an east-west trending ridgeline in the south of the development footprint (i.e. blue box above). A north plunging ridgeline spur bisects the development and grades down towards Endeavour Drive.

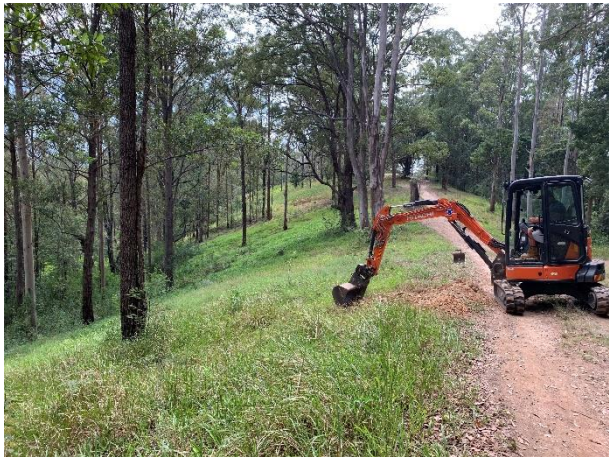
*Looking south along the ridgeline spur from near the existing end of Endeavor Drive at TP4*

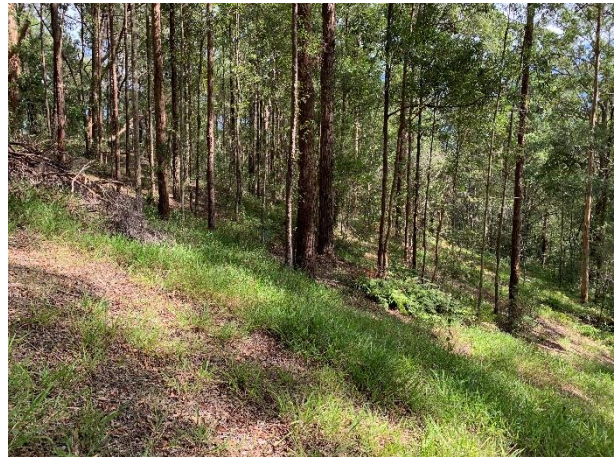
*Looking west across the northern face of the east-west trending ridgeline towards sparse vegetation*

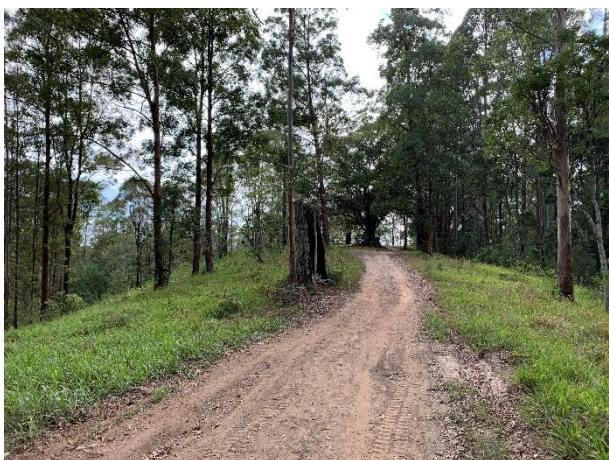
*Looking east along the crest of the ridgeline in the west of the site*

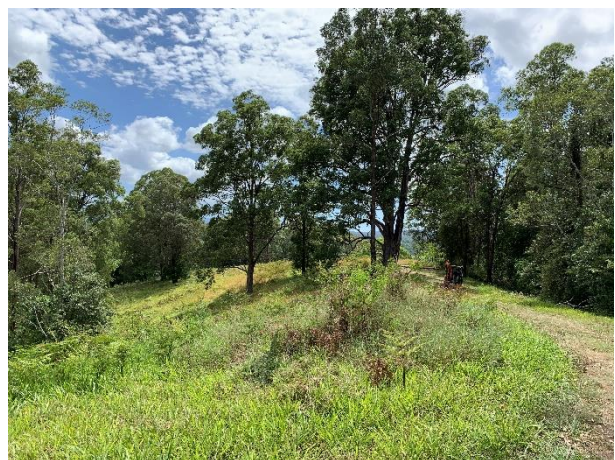
*Looking east from along the crest of the ridgeline in the east of the site*

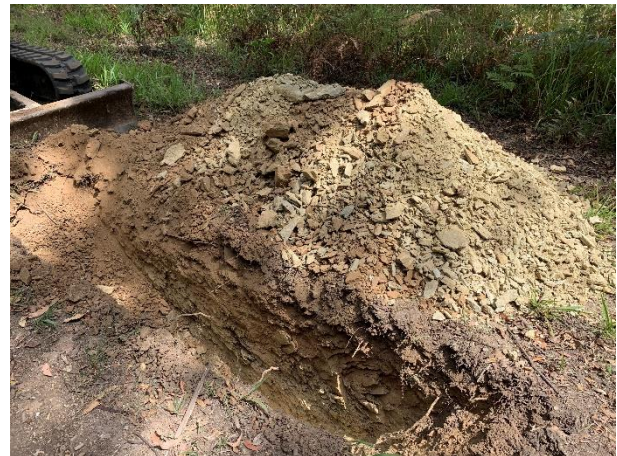
Highly to moderately weathered phyllite was encountered in TP6
