Headfort House

95 Stanhope Road, Killara

Heritage Significance Assessment

Report prepared for Stockland

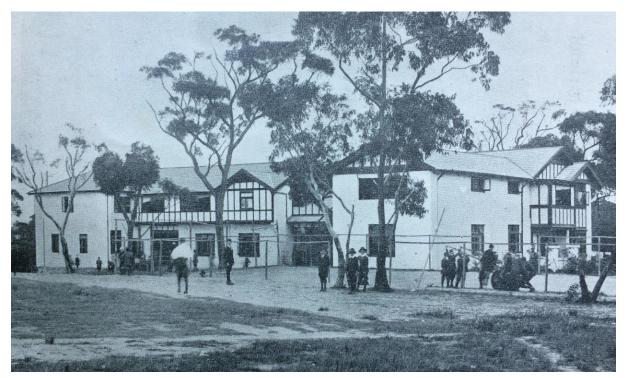
Figure 2.8 Photograph of Headfort School, taken in c1921. Headfort House is on the right. The building on the left has since been demolished. (Source: *The Headfort Chronicle: The Magazine of Headfort School, Killara*, p 3)

The school continued to grow with steadily increasing attendance.²² A photograph of the school taken in 1921 shows two connected two-storey buildings (one of these being Headfort House) with students in the surrounding gardens and a tennis court to the east of the school buildings (Figure 2.8). During the early 1920s, work was undertaken to improve sporting facilities including enlarging the tennis court, installing a cricket pitch and practice area, and construction of swimming pool.²³ In 1922, the students of Headfort School successfully raised funds for the construction of a mini rifle range and they were applauded for their initiative (Figure 2.9).²⁴ A newspaper article in January 1921 described the Headfort School as follows:

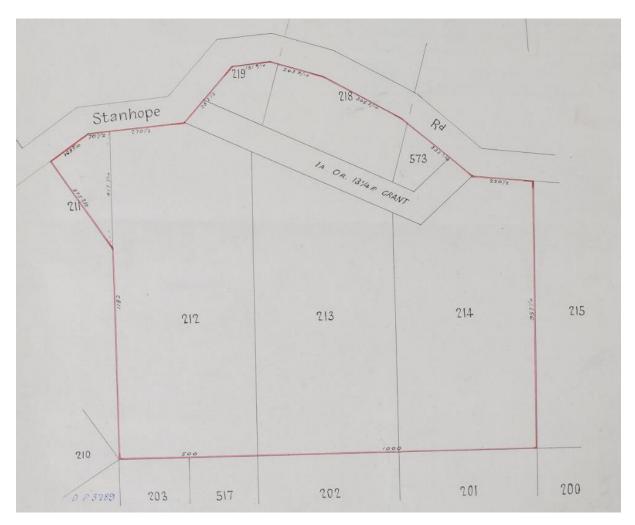
Figure 2.12 1934 plan of Congregational Union of NSW landholdings at Stanhope Road, Killara. (Source: CT 4664–126, LPI NSW)

In 1927, Headfort School was acquired by the Congregational Union of NSW, which had been eager to establish a school of its denomination (Figure 2.11).³⁰ However, it was not until December 1934 that the Congregational Union purchased the land (portions 212, 213 and 214 and part of Portion 211) plus additional adjoining land (Figure 2.12).³¹

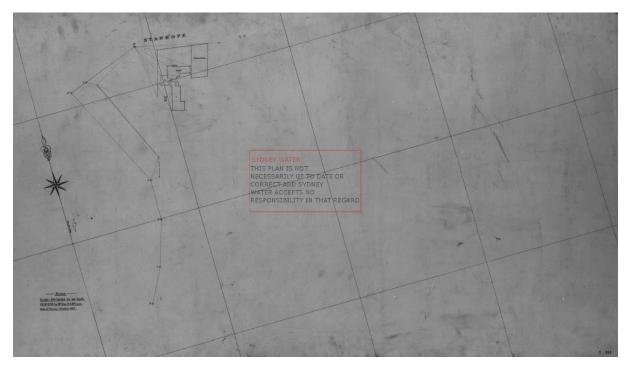
Figure 2.13 1927 Sydney Water survey of the Milton Grammar School. (Source: Sydney Water Archives)

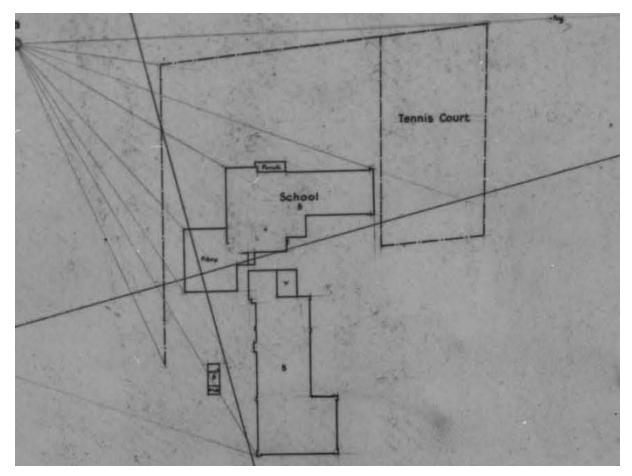
Figure 2.14 Detail of the 1927 Sydney Water survey of the Milton Grammar School. (Source: Sydney Water Archives)

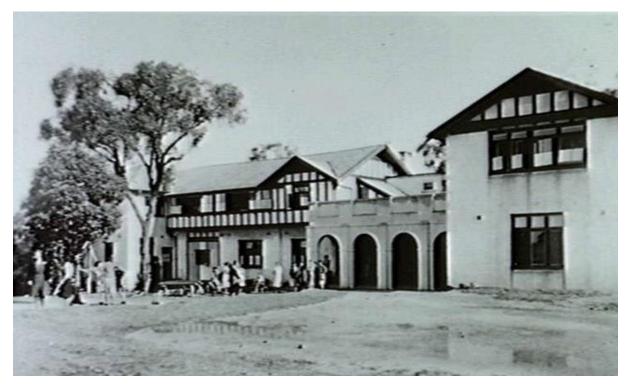
Figure 2.19 1942 view of the former school buildings, here being used by the Australian Women's Army Service. The east elevation of Headfort House is on the left. The arched structure was constructed in 1928. (Source: Australian War Memorial, viewed 22 February 2017 <hr/>

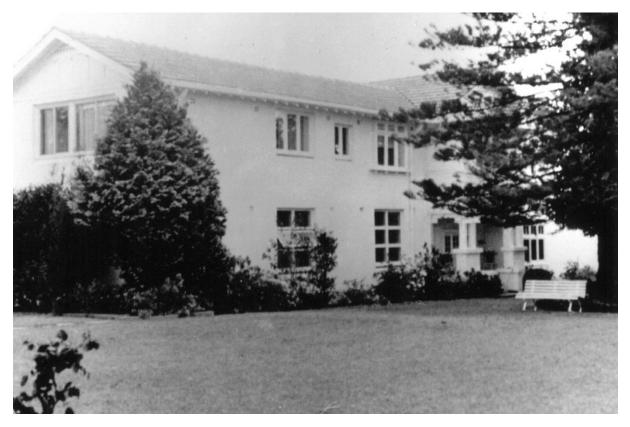
Figure 2.23 Headfort House c1950s, published in Cook, KM 1991, *The Railway Came to Ku-ring-gai*, Genlin Investments, Pymble. Note that the original windows in the chapel wing have been replaced. (Source: Ku-ring-gai Historical Society photographic collection)

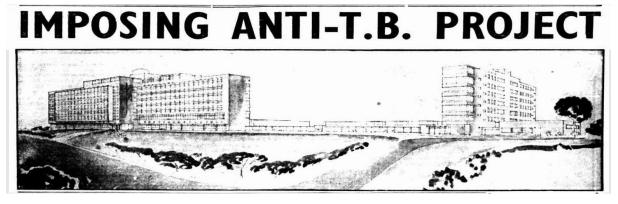
Figure 2.25 Published drawing of the proposed 250-bed hospital (not realised). (Source: Catholic Weekly, 12 October 1950)

During the late 1940s and early 1950s, the SMSM submitted a proposal to construct a new hospital that would accommodate 250 beds on site, although this plan never came to fruition (Figure 2.25).⁴⁴ In 1957, Lourdes was gazetted as public hospital. A 1927–1953 Blackwattle Plan from Sydney Water Archives

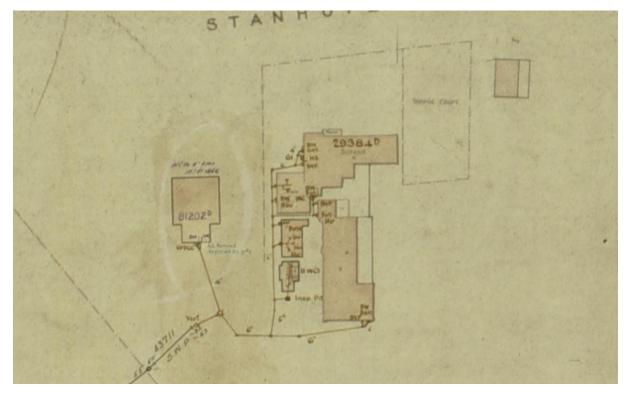
Figure 2.26 The Blackwattle Plan of the subject site, dating between 1927-c1953. (Source: Sydney Water Archives)

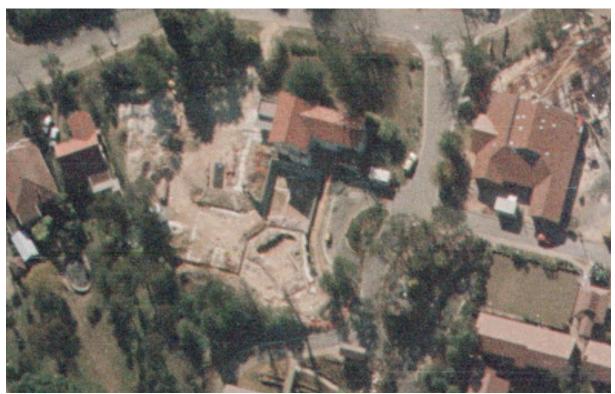
Figure 2.30 Detail of subject site on 1986 aerial showing one of the former school buildings already demolished and the footings of the new administration building. (Source: LPI NSW)

In December 1984, Aevum (then the Hibernian Society) received approval from council to construct a 44-bed nursing home on the subject site, to be called Lourdes Retirement Village (Figures 2.29 and 2.30). As part of the works, apart from the earliest school building (Headfort House), all the other earlier buildings on the site were demolished. It was most likely at this time that the Chapel wing was altered to house the retirement village's chapel, and the rear of the main part of Headfort House was altered and connected to a new building in its southern side. In July 1995, the company received approval to increase the number to 48 beds.⁴⁹ In 2011, Council approved the construction of an additional 18 self-contained units (Figure 2.31).⁵⁰

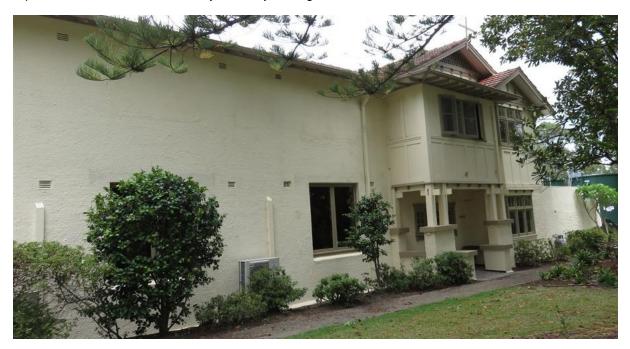
Figure 3.1 The north (front) elevation of Headfort House at 95 Stanhope Road, Killara (facing Stanhope Road), in its garden setting. (Source: GML 2017)

The front of Headfort House addresses Stanhope Road (although the main entrance to the Chapel is on the southern side of the building) (Figure 3.1). The front of the building is parallel to the roadway, and a rectangular front yard—with perimeters defined by garden beds containing hedge plants— separates the building from Stanhope Road (Figure 3.2). The front yard consists primarily of open lawns. Three mature trees are located within the front lawn area—two large Norfolk Island pine trees and a Moreton Bay fig tree, the latter surrounded by a roughly circular garden. Other planting consists of small shrubs and ground covers, generally exotic species. The extent and form of the front garden—areas of flat lawns surrounded by hedges with some planting interspersed—largely matches the 1943 aerial photograph. However, the front garden currently extends further to the east than it did in 1943, when its eastern boundary roughly aligned with the eastern wall of Headfort House. Photographs dating from the late 1920s and 1930s show the front garden's northern and western perimeters further defined by timber post and rail fences with wire mesh infill; these fences no longer exist. On its eastern side was a fenced open area, possibly a tennis court.

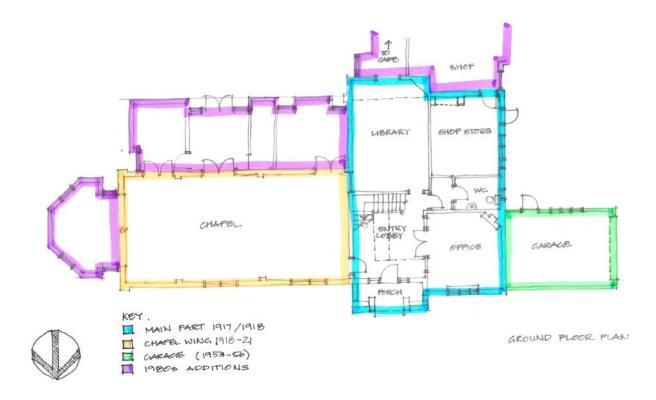
Figure 3.6 Sketch of the existing ground floor plan of Headfort House, coloured to show the construction periods of various components. (Source: GML)

External walls of Headfort House are generally masonry with painted stucco finish. The main roofs are pitched with red glazed terracotta tiles and painted metal eaves gutters. The architecture of the main part of the building is of the Arts and Crafts style, but the chapel wing is more austere externally, with little architectural decoration and a simplicity of form. The single storey portions of the building (garage and ancillary rooms to the chapel on its south and east sides) date from the mid to late twentieth century. Figures 3.6 and 3.7 show the current floor plans of the building, coloured to express the different construction periods of the various parts of the building.

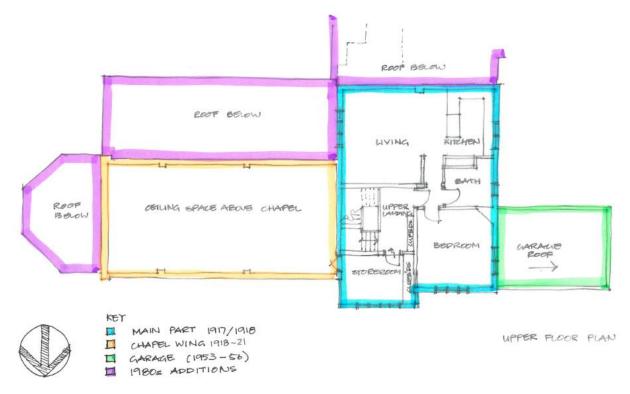
Figure 3.7 Sketch of the existing upper floor plan of Headfort House, coloured to show the construction periods of various components. (Source: GML)

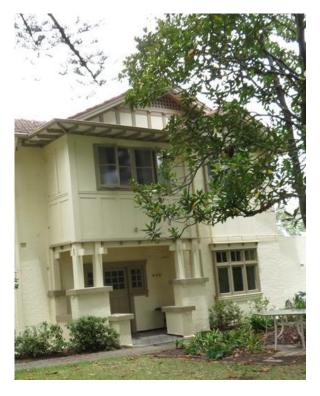
Figure 3.8 The north (front) elevation of the main part of Headfort House at 95 Stanhope Road, Killara (facing Stanhope Road), in its garden setting. (Source: GML 2017)

The north elevation of the main part of the building faces Stanhope Road (Figure 3.8). It has a double roof gable and features an entry porch which provides access to the building's original front door. The external walls are primarily masonry with painted stucco finish, although framed walls panels are a feature of the north elevation. These wall panels—the walls below the windows (ground and first floors)—are framed with fibrous cement sheet cladding, paint finished to match the stuccoed walls (Figure 3.9). The framed walls feature expressed vertical timber battens, which are also used on the building's gables. Although the timber battens are currently painted to match the walls, early photographs show that the expressed timber elements and window frames were originally painted or stained to be dark coloured, to contrast with the light coloured broad walls. Similar detailing is used on the north elevation. The two timber framed windows within the framed wall panel on the north elevation match those in early photographs, and are most likely original.

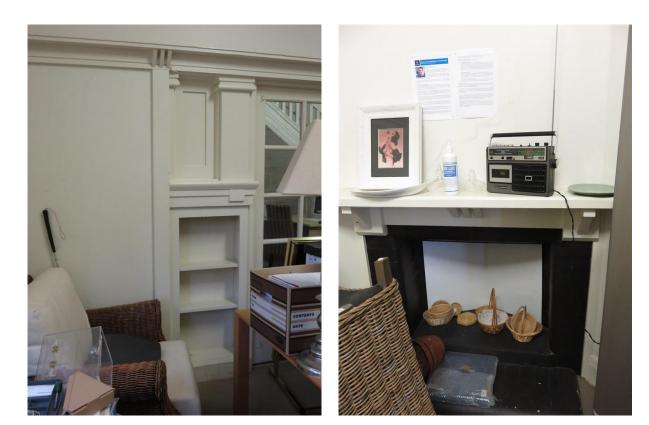
Figure 3.26 The timber joinery adjacent to the door of the office. (Source: GML 2017)

The floor of the office consists of tongue and groove timber boards with carpet finish. The walls and ceiling are smooth set and the room's plaster cornices and timber skirtings match those in the entry hall. A grooved timber rail runs around all walls at door head height. Built-in timber joinery fixtures, consisting of open shelves and other decorative features, frame the door on either side (Figure 3.26). The built-in timber window seat/storage box is a later addition. There is a fireplace in the southwestern corner with painted brick hearth and surrounds, and a timber mantelpiece (Figure 3.27). The style of the timber joinery in the space is consistent with the Arts and Crafts style, although it is unclear if the grooved timber wall rail is original. Two gridded wall grilles are located at high level in the western wall.

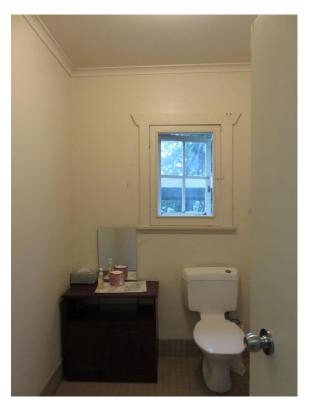
Figure 3.28 The bathroom: the window is original, but fixtures and fittings in the room are contemporary. (Source: GML 2017)

The bathroom is accessed through a small anteroom. The bathroom floor is tiled (contemporary) with matching tiled skirtings, and the walls and ceiling are smooth set (Figure 3.28). The room has a small coved contemporary plaster cornice. Bathroom fixtures are contemporary. The timber casement window with casement flyscreen is most likely original. The anteroom has smooth set walls and ceiling without cornices. It has a timber skirting that matches the profile of the skirting in the entry hall, but is shorter. The doors to both the anteroom and bathroom are contemporary lush doors, but timber frames and architraves are detailed alike, and are most likely original.

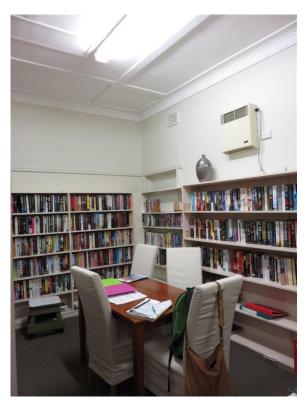
Figure 3.29 The library, looking towards the northeastern corner. The former doorway to the chapel can be seen behind the bookshelves. (Source: GML 2017)

The library is legible as a single large room, even though it is partly subdivided by a glazed screen wall which is a contemporary addition (Figures 3.29–3.31). It has a framed floor with carpet finish, smooth set walls and a smooth set ceiling with battened detail. The room's plaster cornices and ceilings match those in the entry hall and are most likely original. There is a lower section of ceiling adjacent which is not original (with small coved cornices), and its form and finishes are likely to relate to the 1980s building connection. Parts of the room have a timber skirting which matches that in the entry lobby. At the southern end of the room there is a wide opening which allows access into the 1980s building adjacent (Figure 3.31). This has a timber door frame and highlights with obscure glazing, but no doors. On the northern wall is an opening with timber frame leading to the entry lobby, but again there is no door leaf. Both of these doorways are likely to be original. On the eastern wall there is a blocked-in doorway that previously led to the chapel, and it is unclear if this opening is original (Figure 3.29). On the eastern wall at high level are two air grilles that match those in the office, and are original. In the southwestern corner the splayed wall is suggestive of a chimney breast. Bookshelves placed hard against this wall indicate that even if a fireplace remains behind the shelves, no protruding mantelpiece or hearth remains.

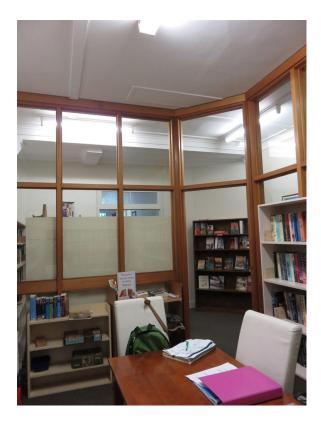
Figure 3.30 The contemporary glazed screen wall that divides the room. (Source: GML 2017)

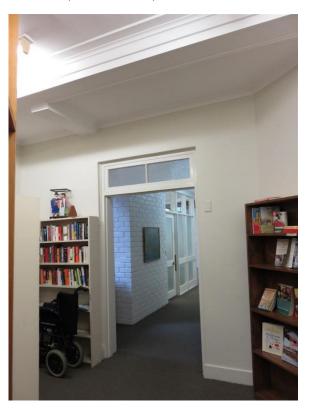
Figure 3.31 The doorway in the southern wall that leads to the 1980s building. (Source: GML 2017)

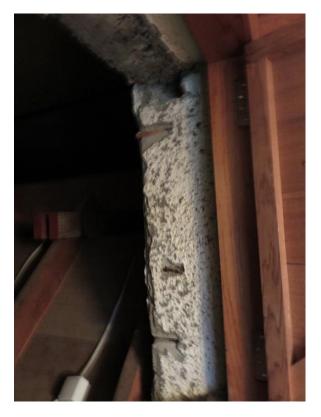
Figure 3.42 When opened the access door allows for views of the building's original external stucco finish and the space above the ceiling of the chapel. (Source: GML 2017)

There is a small door on the eastern wall that provides access to the ceiling space above the chapel. Within this opening the original white painted stucco finish of the external walls of the main part of the building is visible. The stucco continues around the eastern wall (the chapel's west wall), which again supports the idea that the chapel wing was built as a later addition to the main part of the building (Figure 3.42).

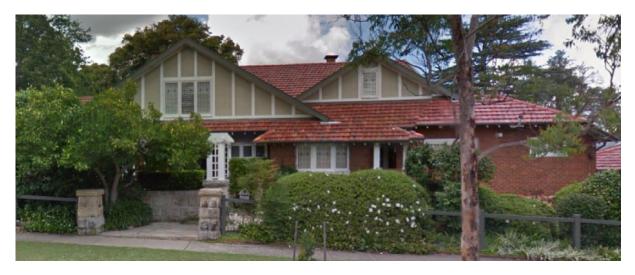
The house at 77 Arnold Street, Killara (not listed as a heritage item) has pitched tiled roofs with boarded gables, and expressed timber rafters on its eaves. Large and small roof gables have been used to affect the composition of the street elevation of the house.

Figure 4.3 77 Arnold Street, Killara. (Source: Google Maps)
