No. 131 St Vincent Street, Ulladulla
Preliminary Desktop Geotechnical Assessment

Our Ref: TERRA23-288.Rep2.Rev0

13 October 2023

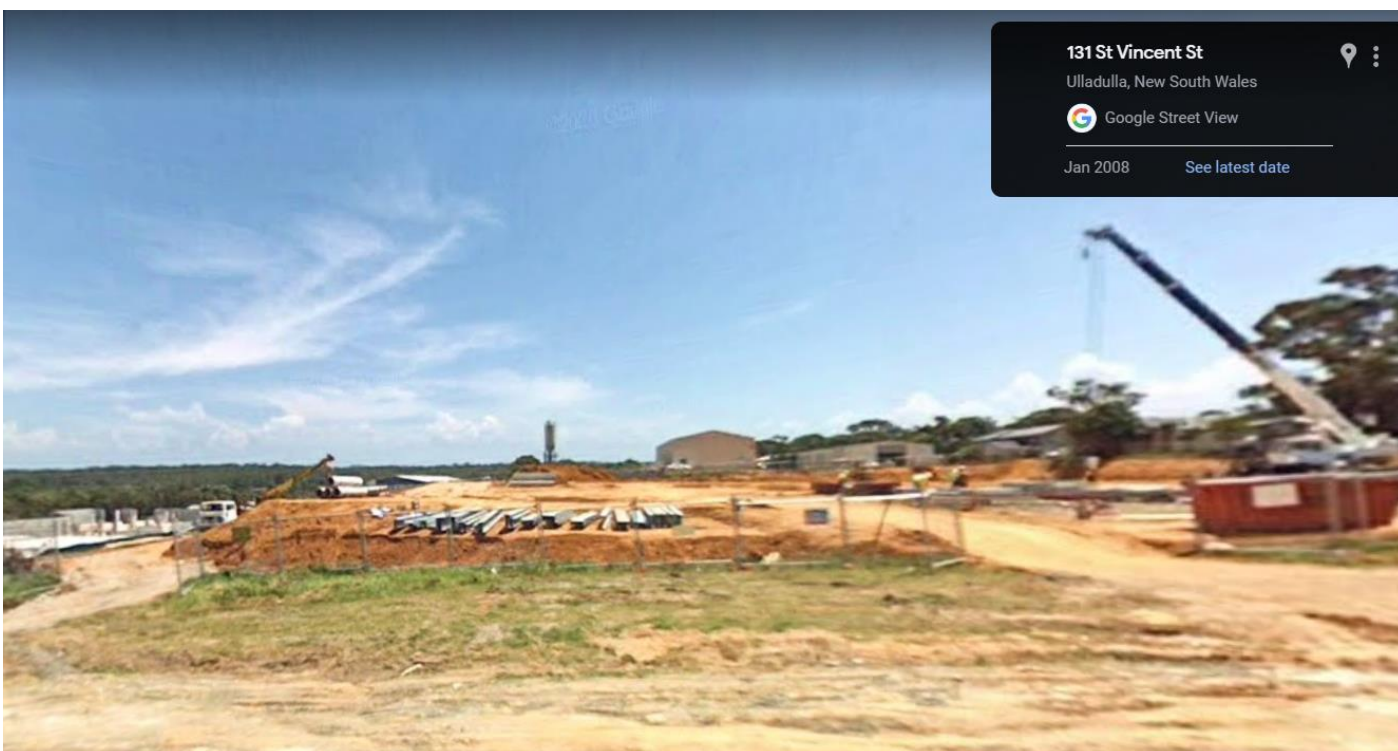
Image 1: Google StreetView Imagery dated January 2008, view looking west from St Vincent Street

Aerial imagery from 1959 to 2022 was sourced and has been summarised in Figure 2. In addition to aerial imagery, Google StreetView imagery was used to cover gaps in the timeline of the aerial imagery. Image 1 is from 2008 and shows the Site during the construction of the Bunnings Warehouse. Filling of the Site is clearly visible.

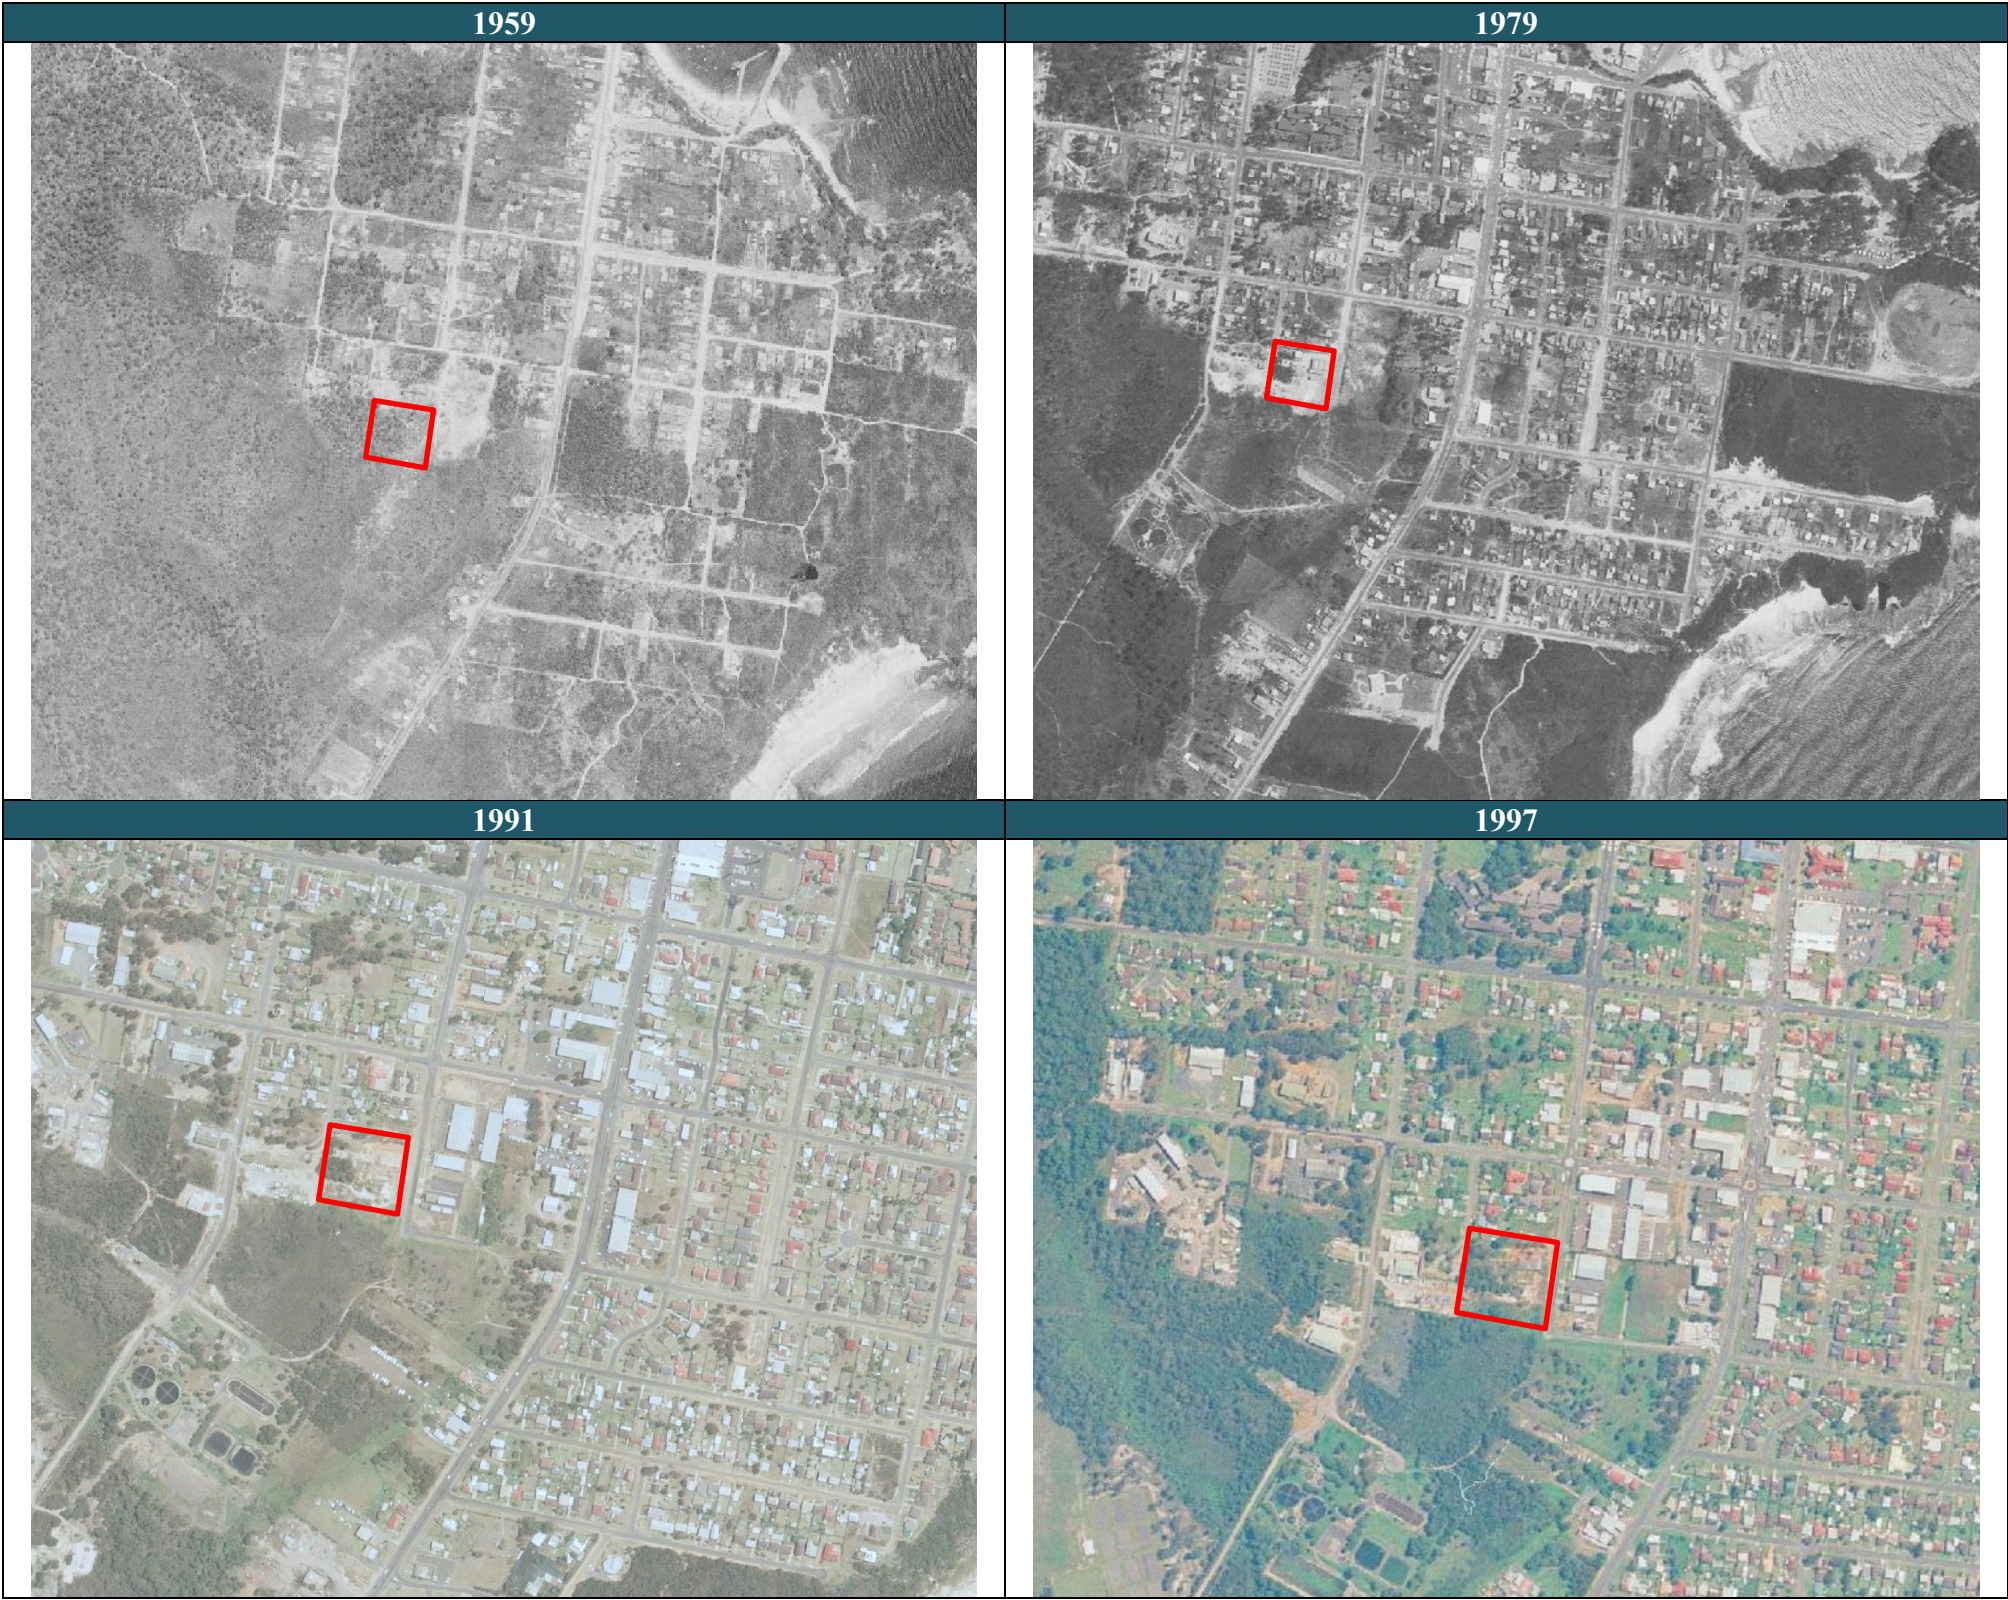
Historical Imagery

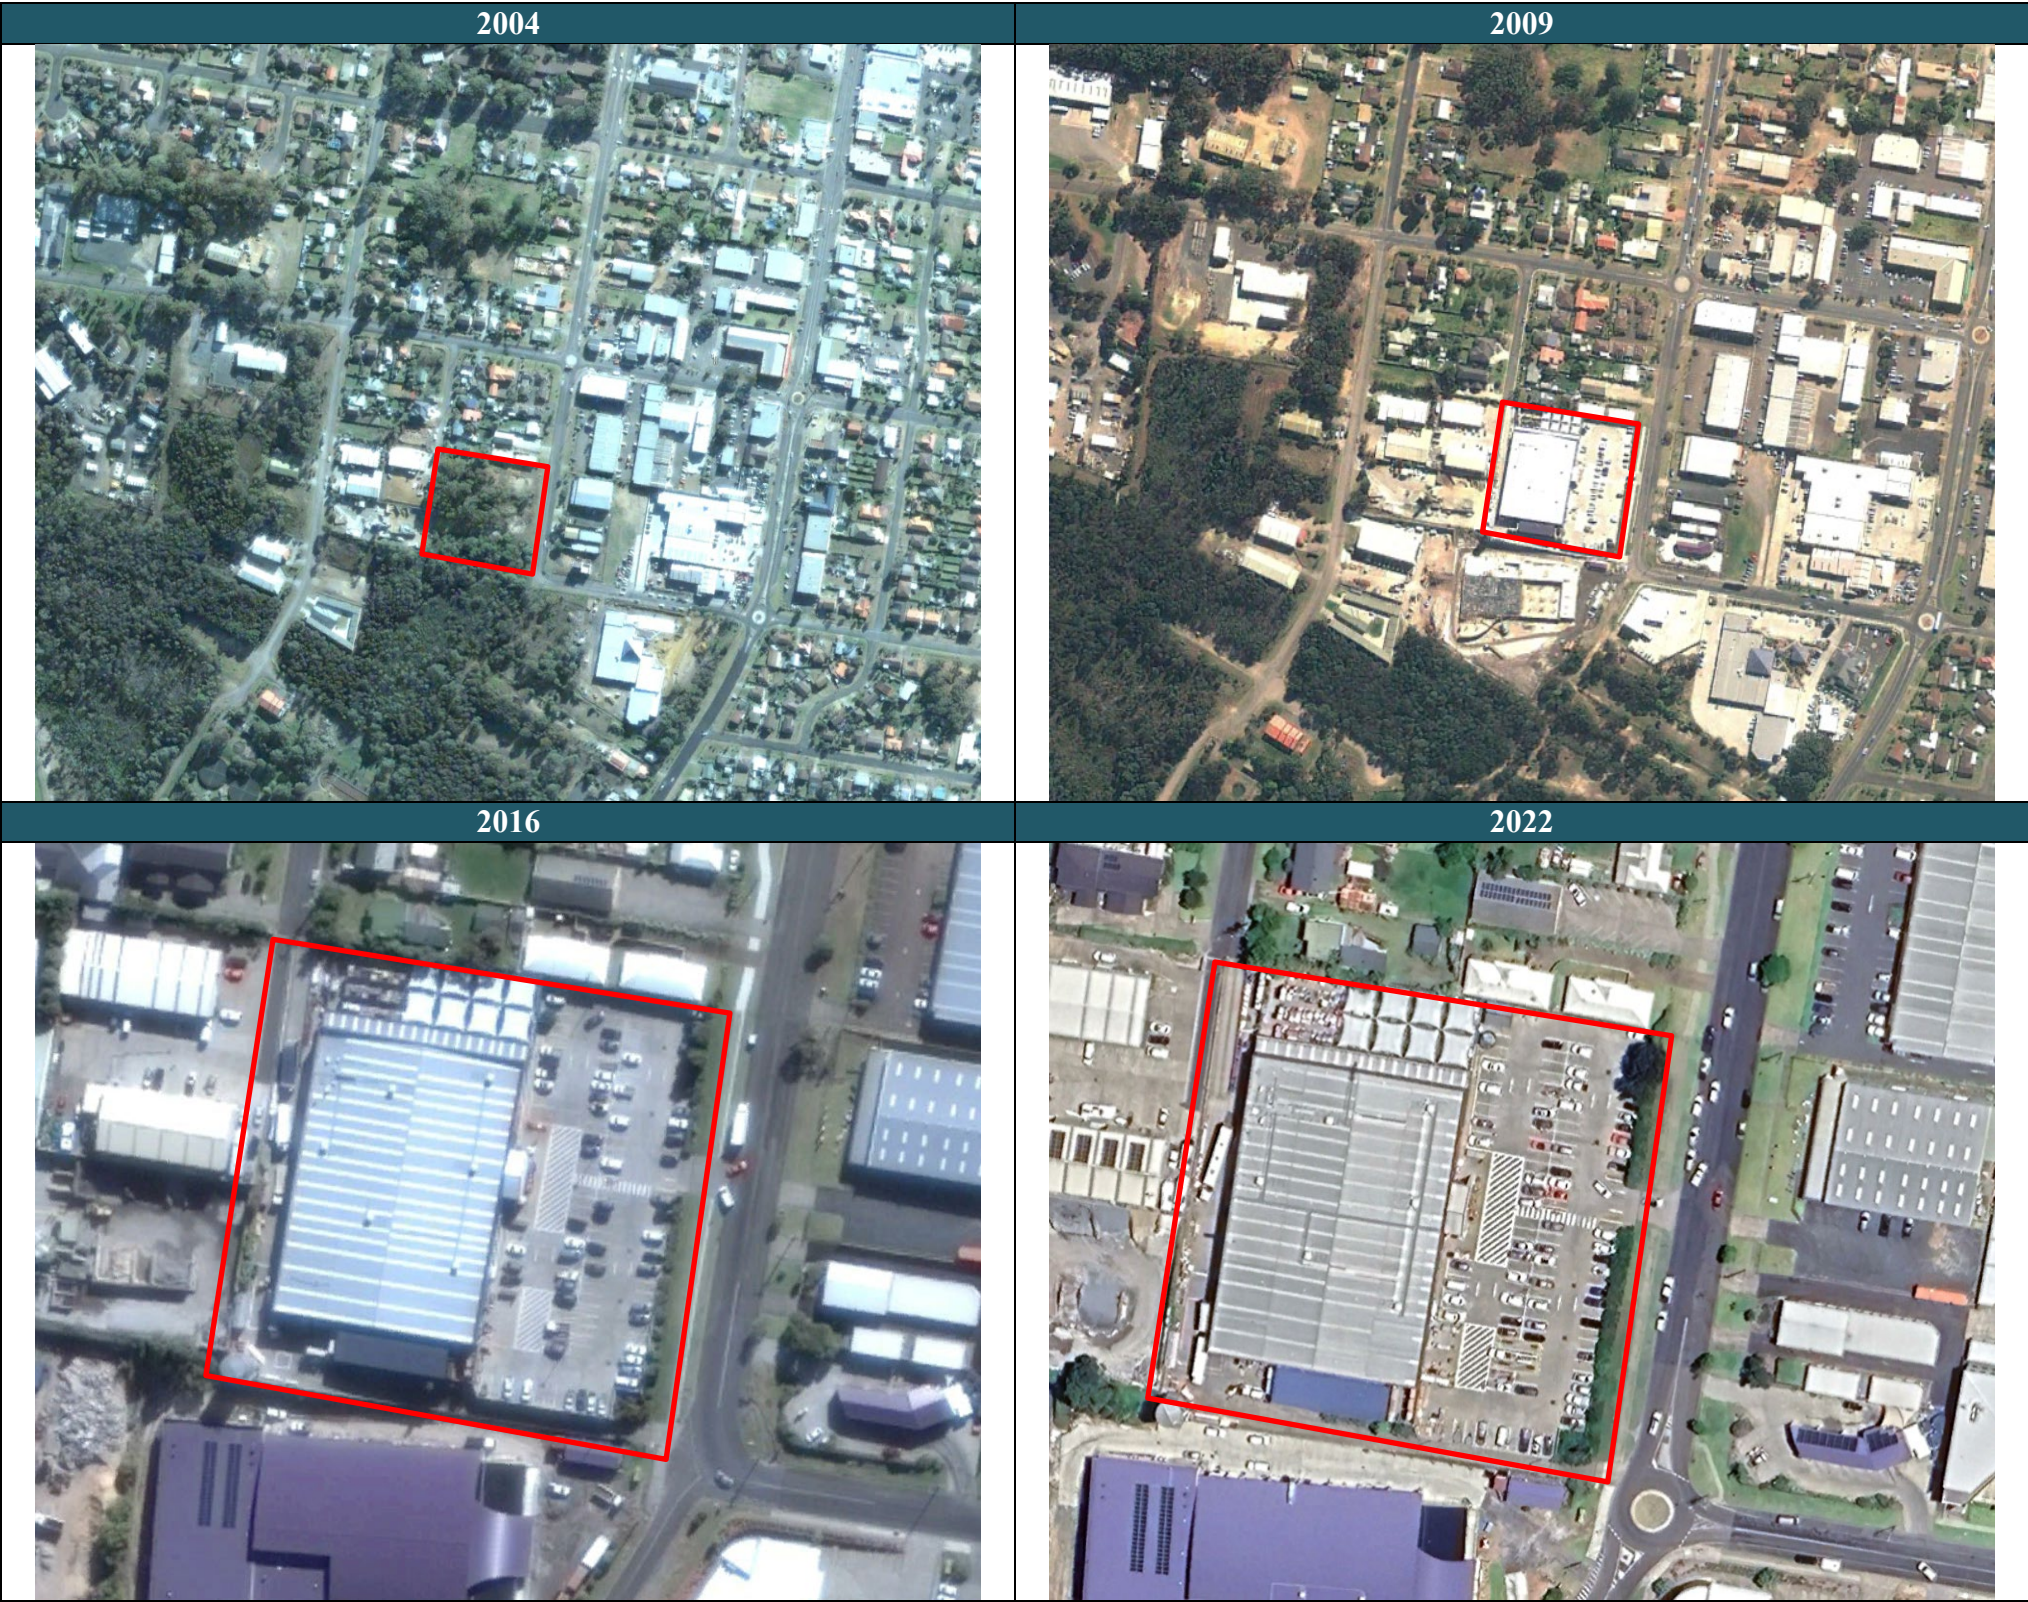
Historical Imagery
