Our Ref: TERRA23-288.Rep2.Rev1

RE: No. 131 St Vincent Street, Ulladulla Preliminary Desktop Geotechnical Assessment

Preliminary Desktop Geotechnical Assessment

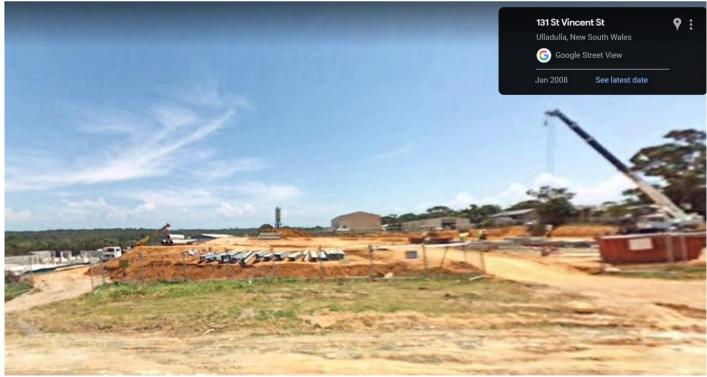
Image 1: Google StreetView Imagery dated January 2008, view looking west from St Vincent Street

Aerial imagery from 1959 to 2022 was sourced and has been summarised in Figure 2. In addition to aerial imagery, Google StreetView imagery was used to cover gaps in the timeline of the aerial imagery. Image 1 is from 2008 and shows the Site during the construction of the Bunnings Warehouse. Filling of the Site is clearly visible.

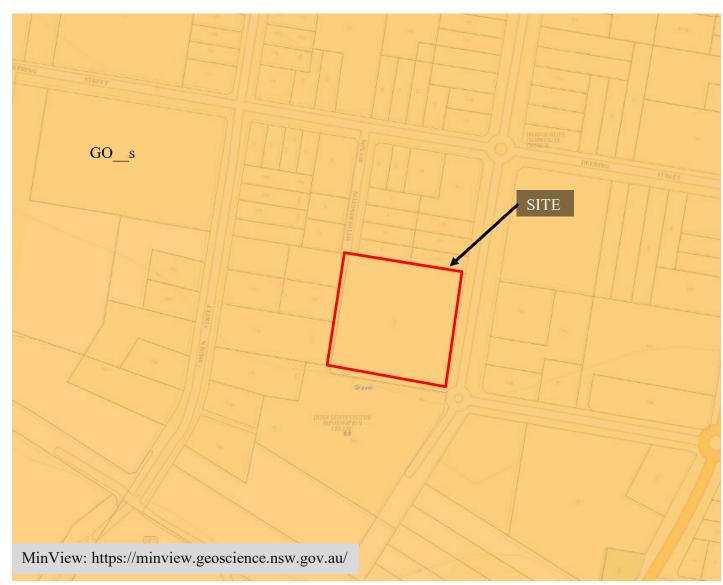
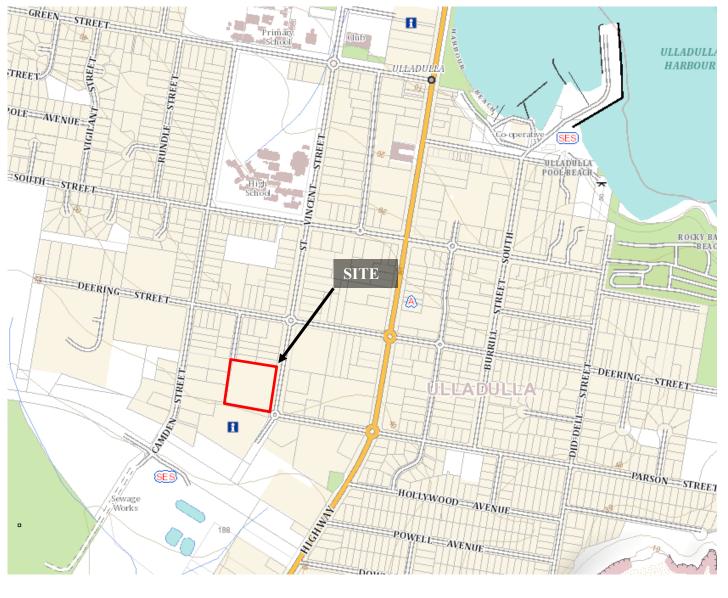
Symbol	Group	Subgroup	Unit	Lithology
GOs	-	-	Alluvial gravel, sand and clay deposits	Unconsolidated to poorly consolidated alluvial gravel, sand and clay deposits which are closely associated with basalts of similar age near Ulladulla.

description	drawn	approved	date	Ν		•	client: Ulladulla	Precinct
svision	Site location and geology	JH	KEG	8/09/2023		CONTERNA INSIGHT		project: 131 Saint Vincent Street, Ulladulla Preliminary Site Investigation Lot 1 Section 26 DP 759018	
-						scale	NTS	title: Site Location	and Geology
						original size	A3	project no: TERRA23-288	figure no: FIGURE 1

At the request of Ulladulla Precinct (the client), Terra Insight Pty Ltd (Terra) has carried out a Preliminary Desktop Geotechnical assessment No. 131 St Vincent Street, Ulladulla, (hereafter referred to as the Site, shown on Figure 1). The assessment involved a desk top study of existing information available for the site and nearby sites.

Online Geological Mapping accessed using Minview (refer Figure 1) indicates the Site is underlain by an alluvial gravel, sand and clay deposits unit, which is comprised of unconsolidated to poorly consolidated alluvial gravel, sand and clay deposits which are closely associated with basalts of similar age near Ulladulla.

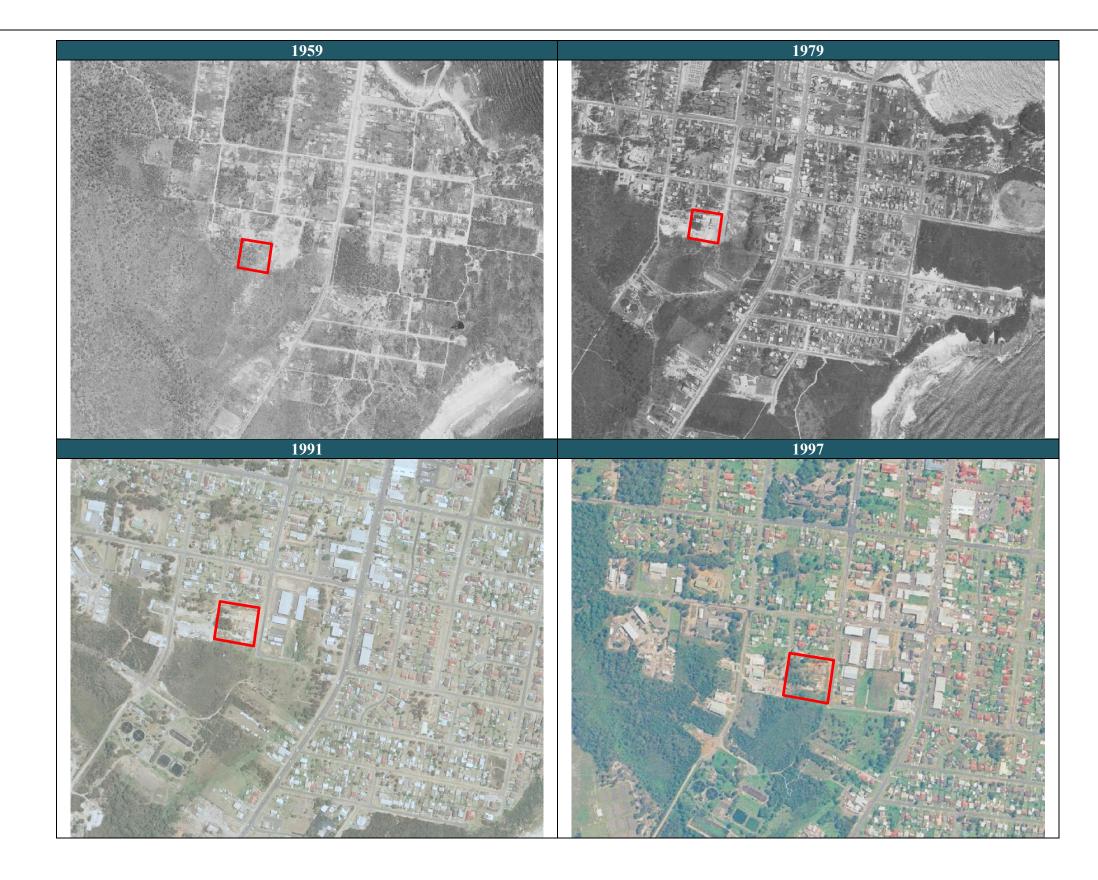
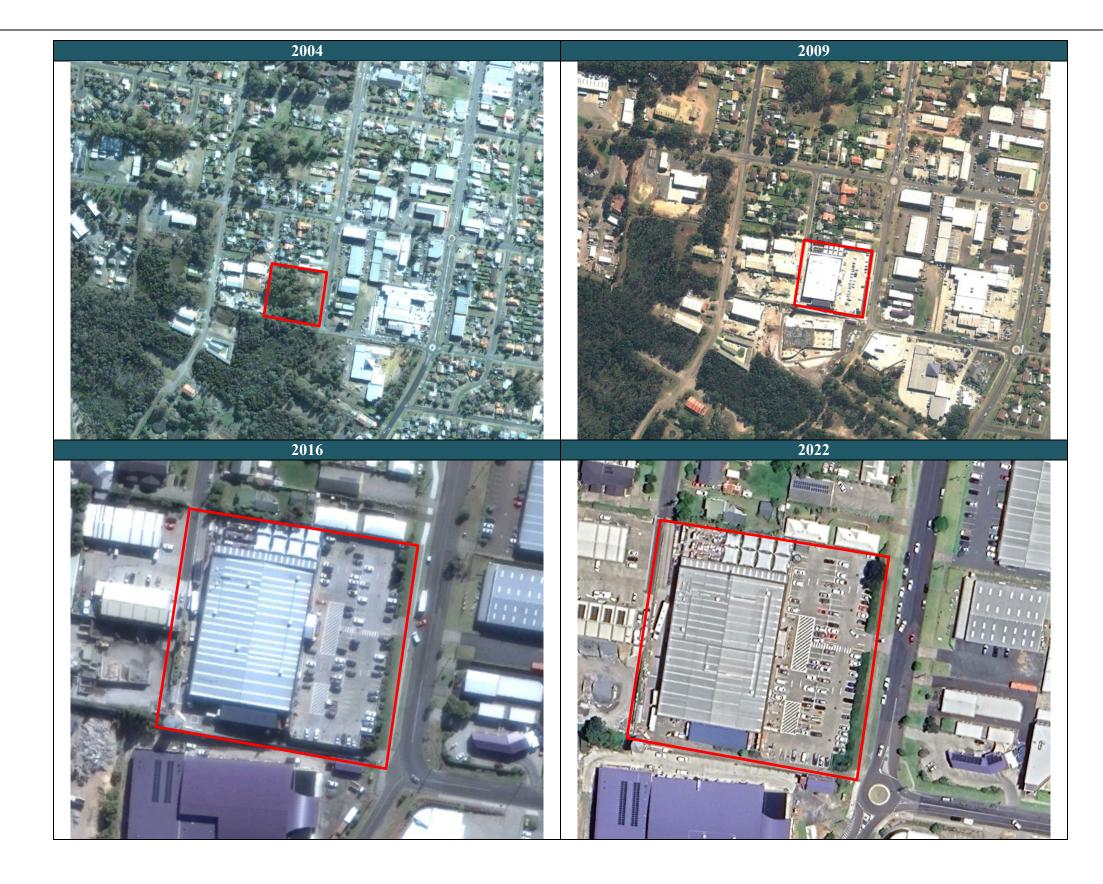
Historical Imagery

description	drawn	approved	date	Ν		
uc	Historical Aerial Imagery	JH	KEG	8/09/2023			TERRA INSIGHT
evisior					$\mathbf{\Lambda}$		
L						scale	NTS
						original size	A3

client: Ullad	ulla Precinct				
Preliminary	t: 131 Saint Vincent Street, Ulladulla Preliminary Site Investigation Lot 1 Section 26 DP 759018				
title: Historica	Historical Aerial Imagery				
project no: TERRA23-288	figure no: FIGURE 2
