Proposed Replacement Commercial Building 179 Russell Avenue, Dolls Point NSW

Geotechnical Investigation

Our ref: 5763-1-G1
25 November 2019

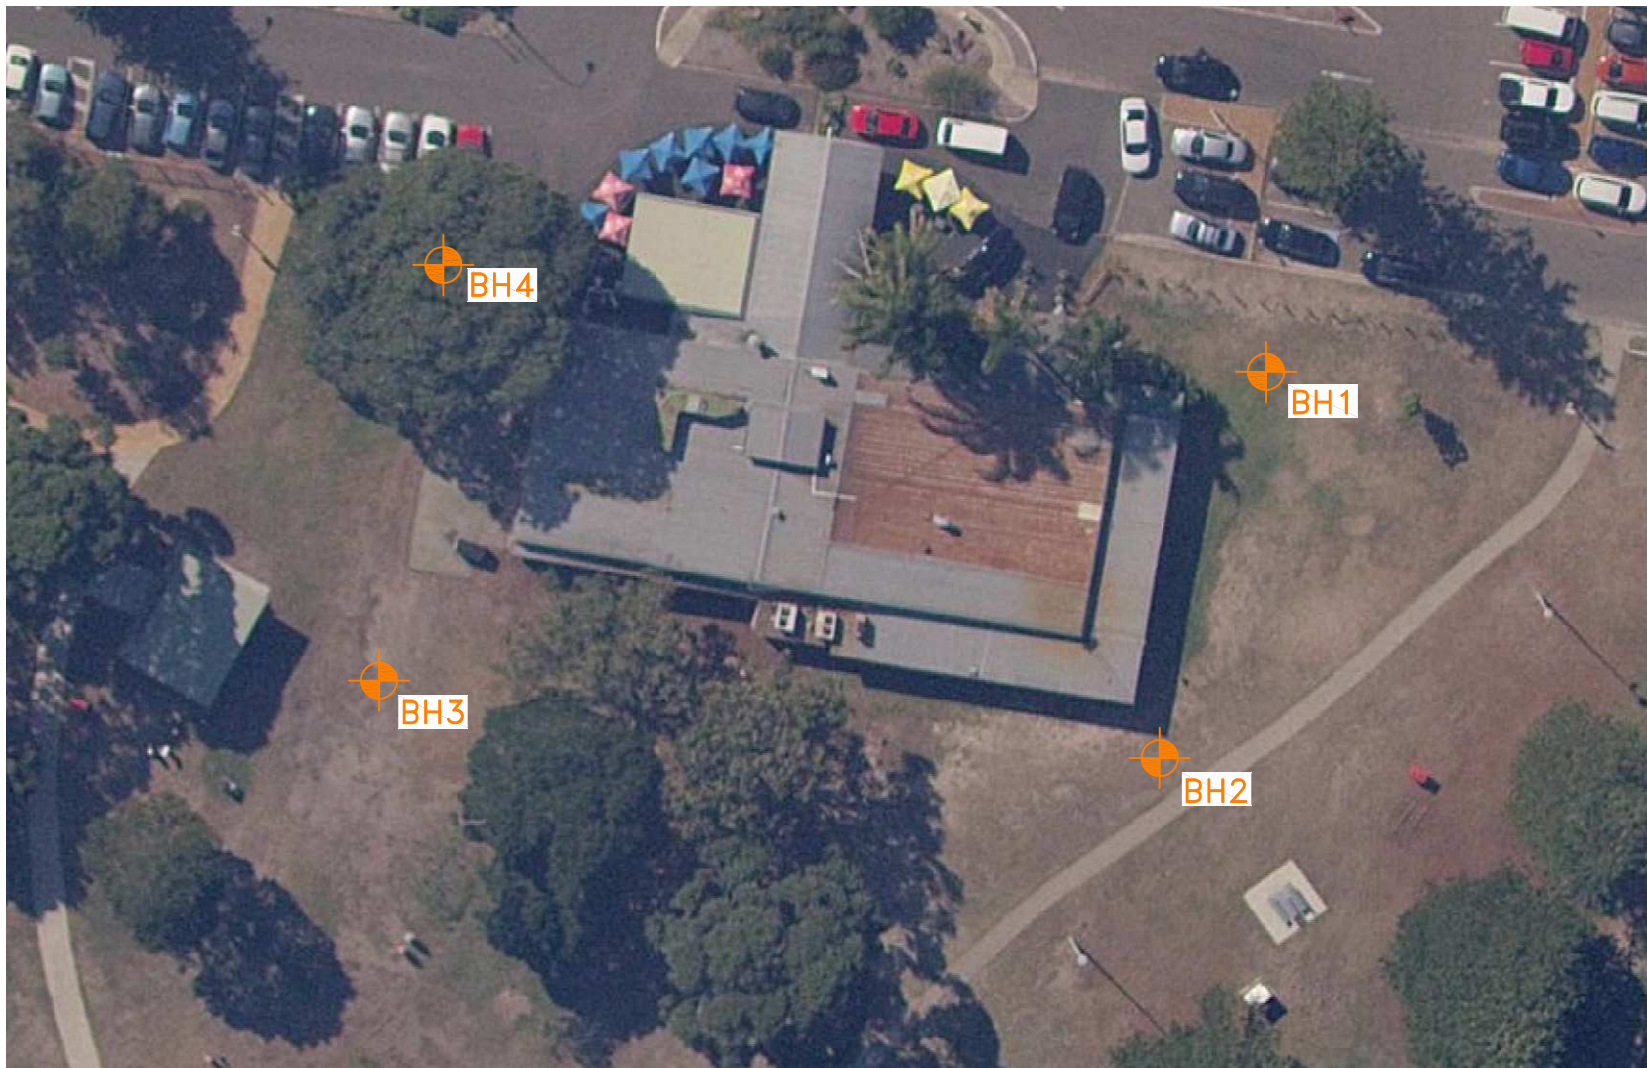
Figure 1 – Site Locality
Figure 2 – Test Locations

The test locations are shown in the attached Figure 2 and were set out by our Geotechnical Engineer by measurements relative to existing site features. Surface levels at the test locations were estimated by interpolation from Google Earth.

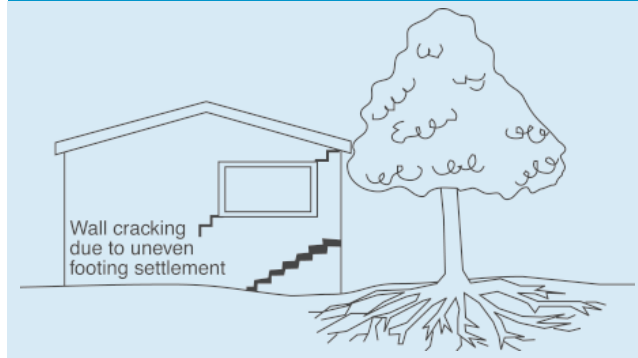
Trees can cause shrinkage and damage

As the weather pattern changes and the soil begins to dry out, the external footings will be first affected, beginning with the locations where the sun's effect is strongest. This has the effect of lowering the external footings. The doming is accentuated and cracking reduces or disappears where it occurred because of dishing, but other cracks open up. The roof lines may become convex.
