Report on  
Geotechnical Investigation

Proposed Redevelopment of Singleton Gym and Swim Facility  
Civic Avenue, Singleton

Prepared for  
Facility Design Group

Project 81592.00  
October 2014

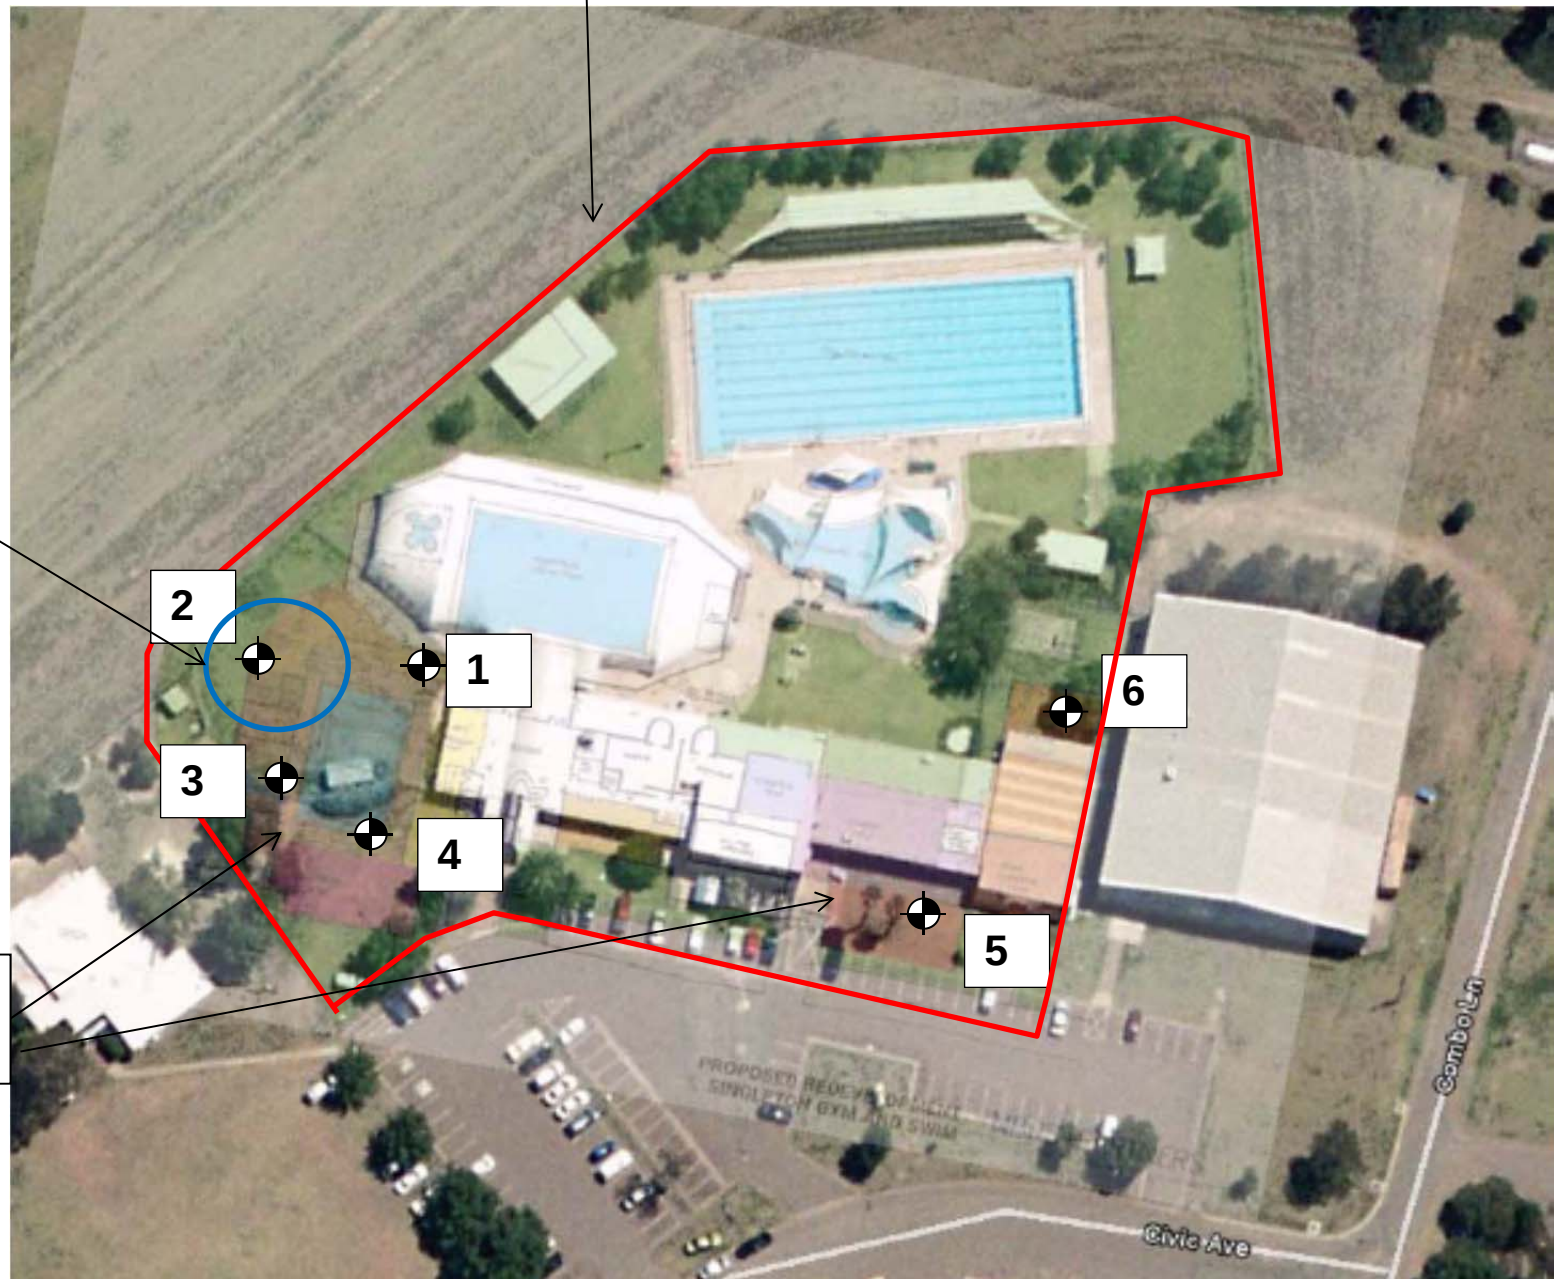
Approximate extent of filling mound

Outline of proposed extensions (shaded area)

Approximate Test Bore Location
