JC03029A-L1

**Re Preliminary Comments and Assessment on Contamination and Geotechnical Issues**  
Lots 1110, 1336, 1108, 1113, 80, 1111 and 20, Oxford Fall Road, Oxford Falls

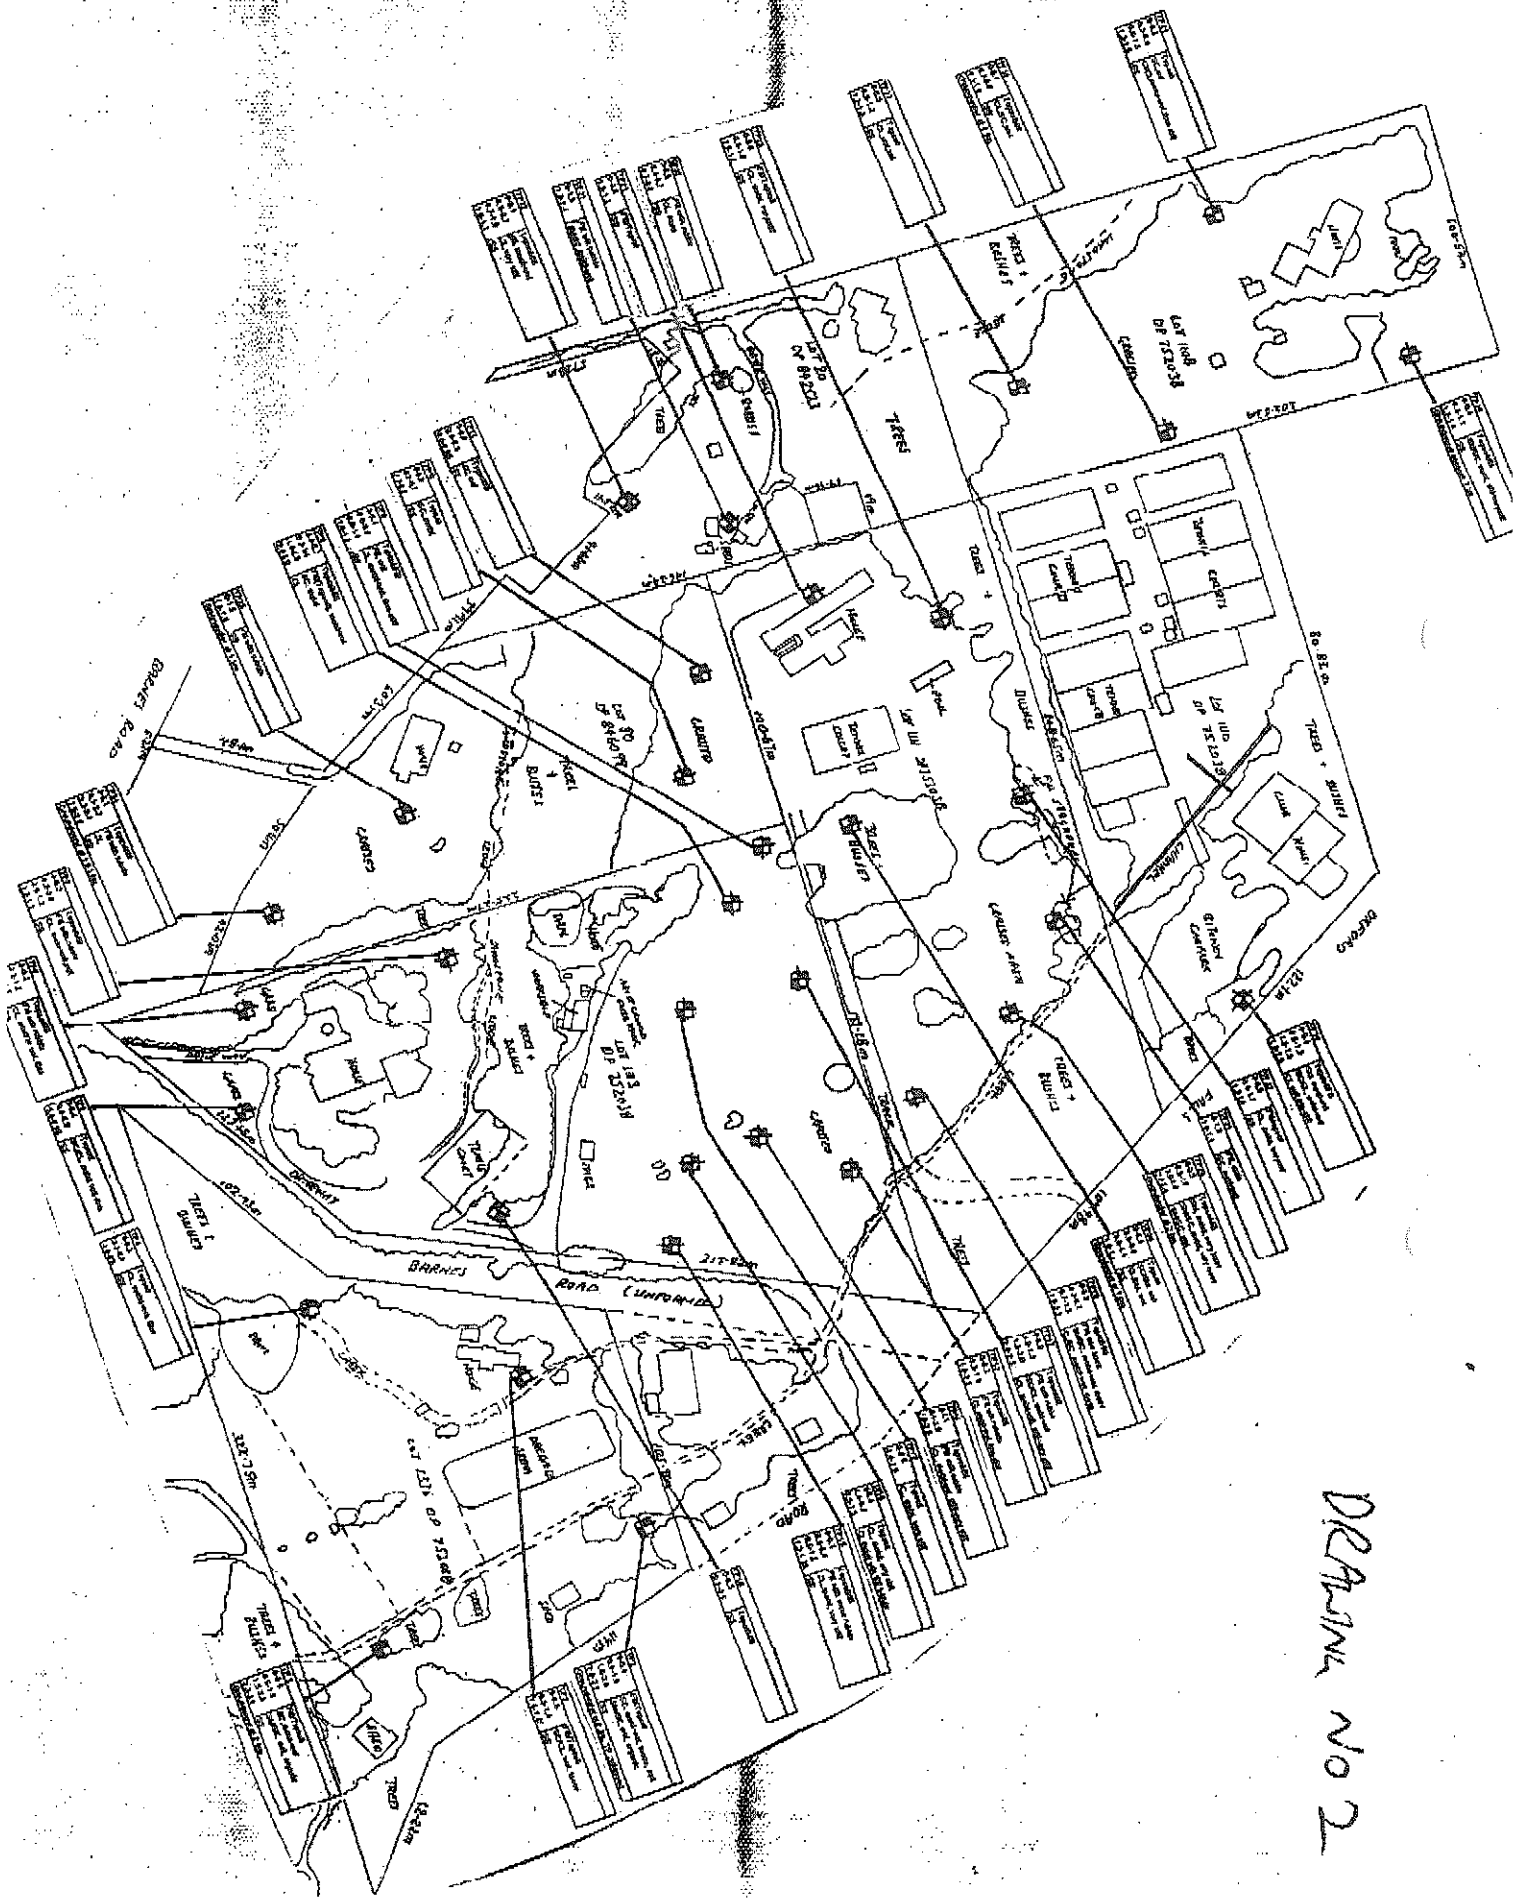
PLANK No 2

The site plan illustrates a complex of buildings and land parcels. Key features include:

Attachement: Drawing No 1: Site Location and Features Plan  
Drawing No 2: Test Pit Location Plan  
Table A: Summary of Test Pit Profile
