## **ASBESTOS MANAGEMENT PLAN**

## **PROPOSED RESIDENTIAL DEVELOPMENT**

# 74-80 RESTWELL & 1-9 LEONARDS STREETS, BANKSTOWN, NSW

Project Id: E29298KBrpt4AMP

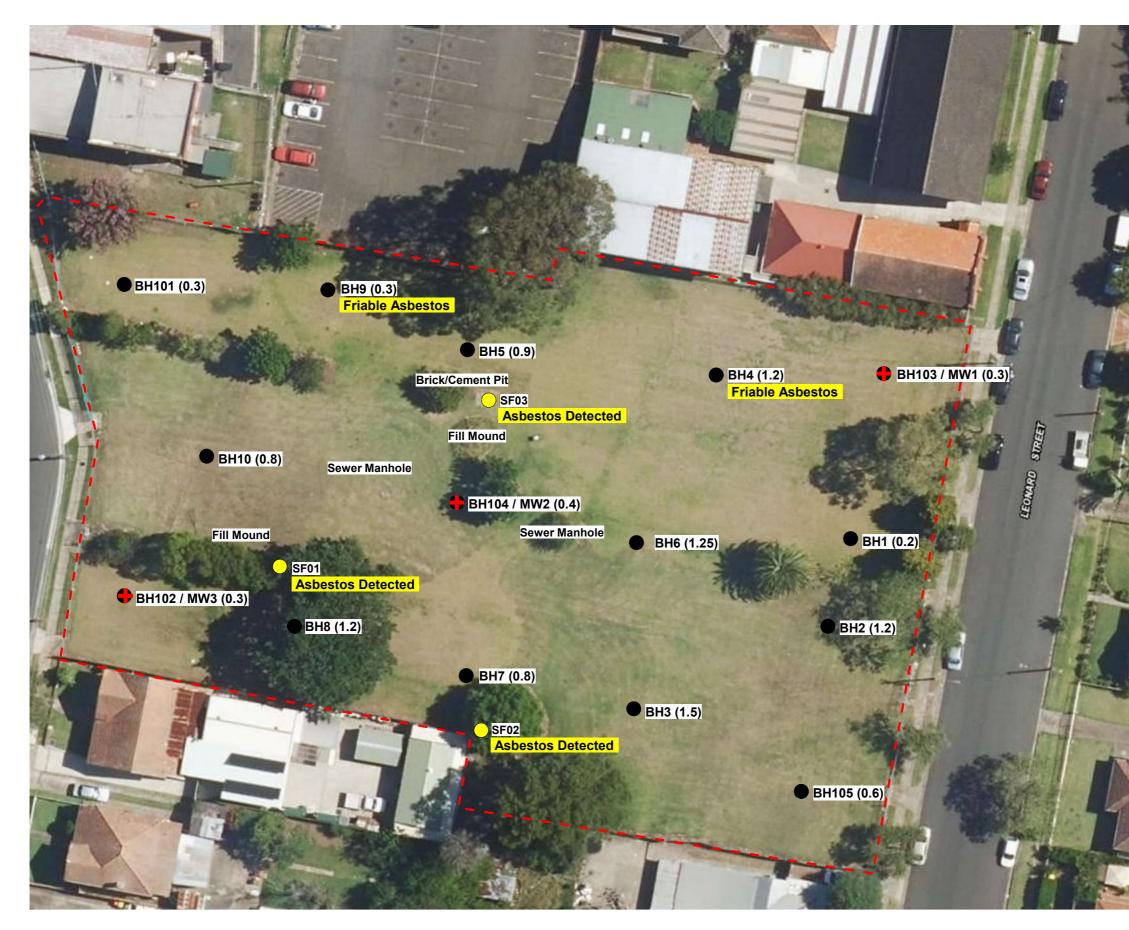
NOTES: Figure has been recreated from http://maps.six.nsw.gov.au

The borehole locations presented on this plan have been established from site measurements only and should not be construed as survey points. The fill depths include the pavement thickness where pavement was encountered.

The Site Location Plan is shown on Figure 1 and the Site Layout and Sampling Plan is shown on Figure 2. The proposed work area is referred to as 'the site' in this report.
