**HERITAGE IMPACT STATEMENT
REVISED**

Heathcote Hall

1-21 Dilwynnia Grove, Heathcote, NSW

Revised Heritage Impact Statement

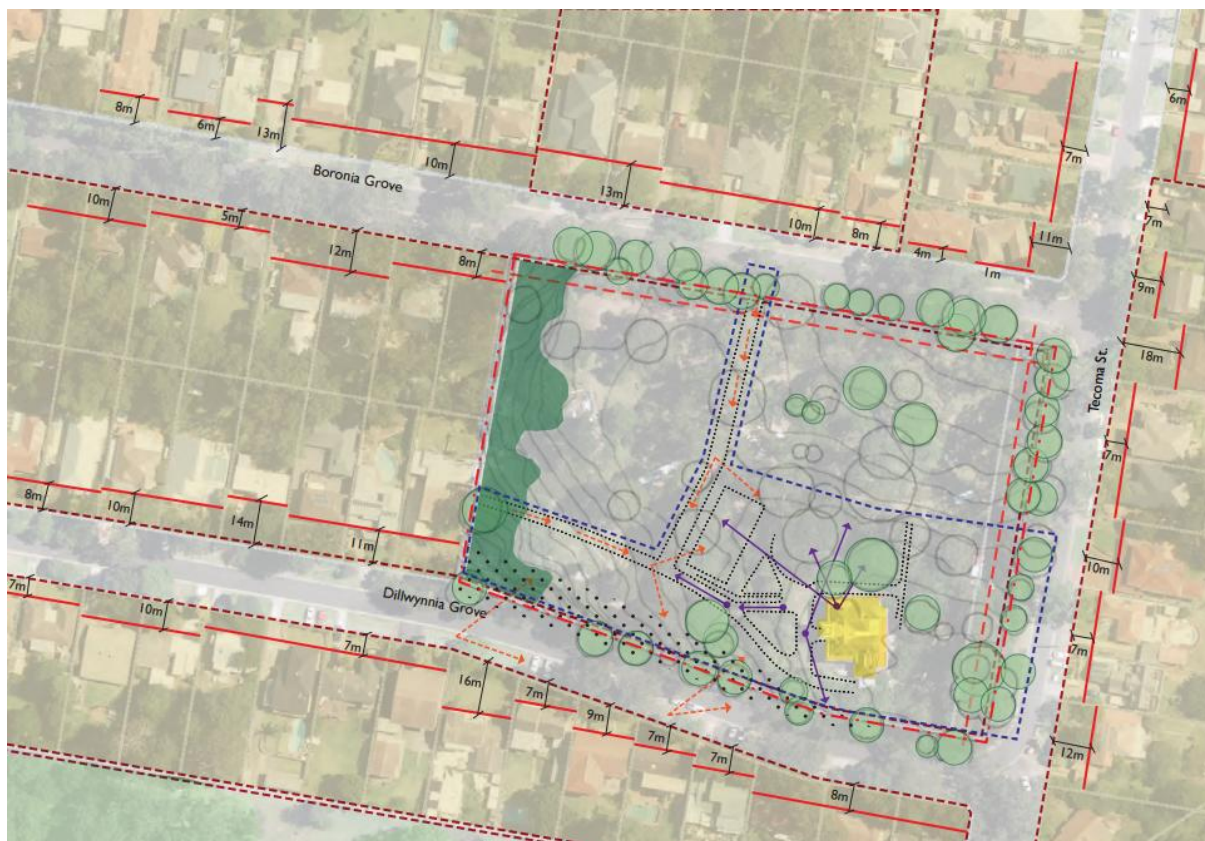
Figure 5: Site Analysis. Drawing by GMU.

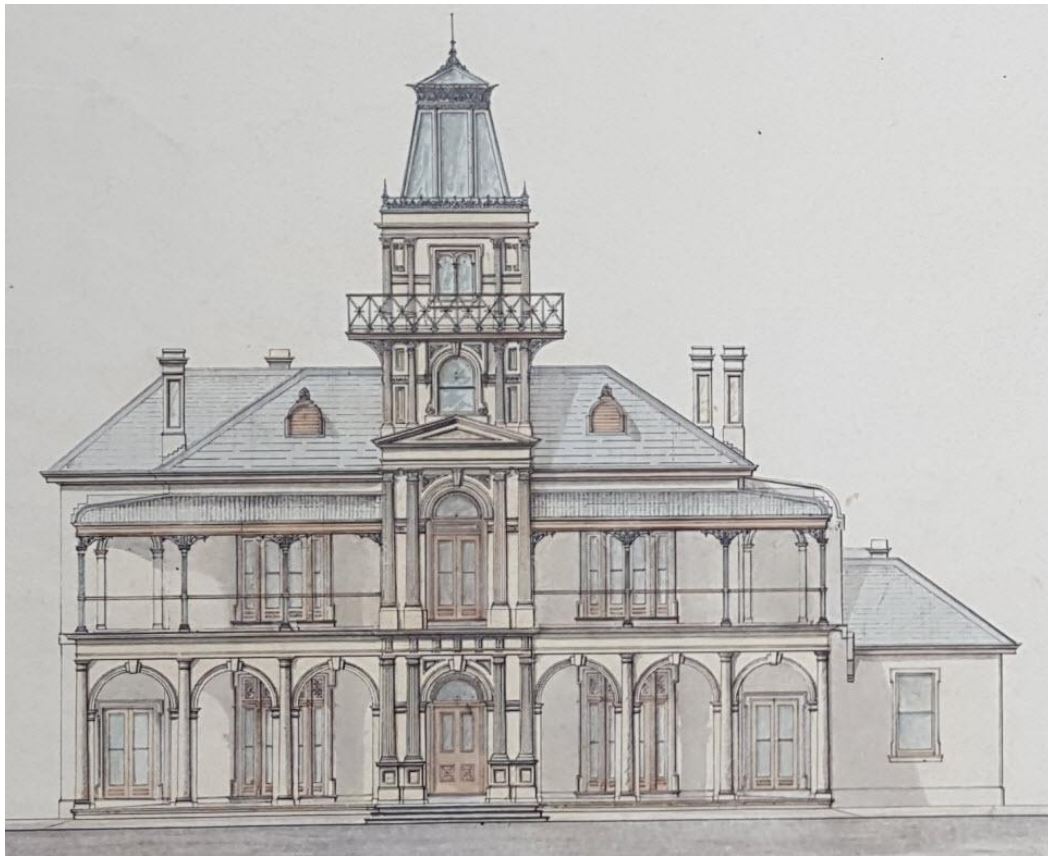
Figure 9: Rowe and Green, 'Plans of Villa for A. Harber Esq.
Note the glass cupola was in the original design.

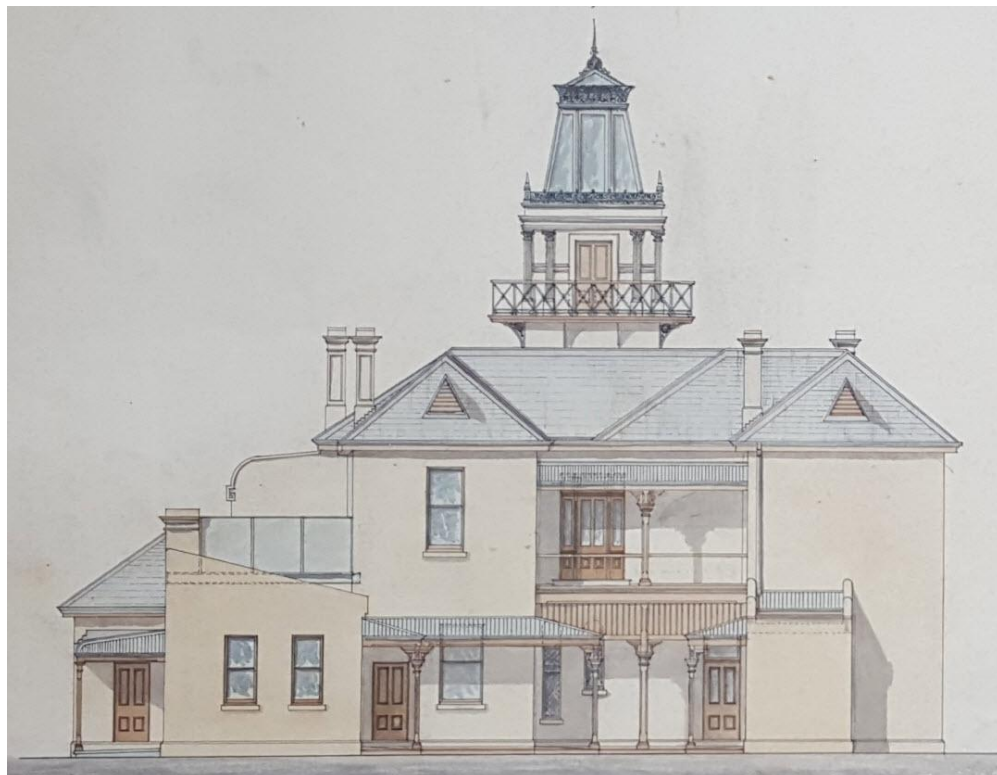
Figure 10: Rowe and Green, 'Plans of Villa for A. Harber Esq.
Note the water tanks on the roof to the left hand side.

- Water tanks removed from roof at rear
- Cast iron balustrade removed from east facing balcony, with panels used to repair balustrade on front verandah.
- New ceramic tiles installed on floor of east facing balcony
- Ceiling to balcony removed.
- New plaster board ceilings installed below water-damaged lath and plaster ceilings to north-east spare room and servant's room.

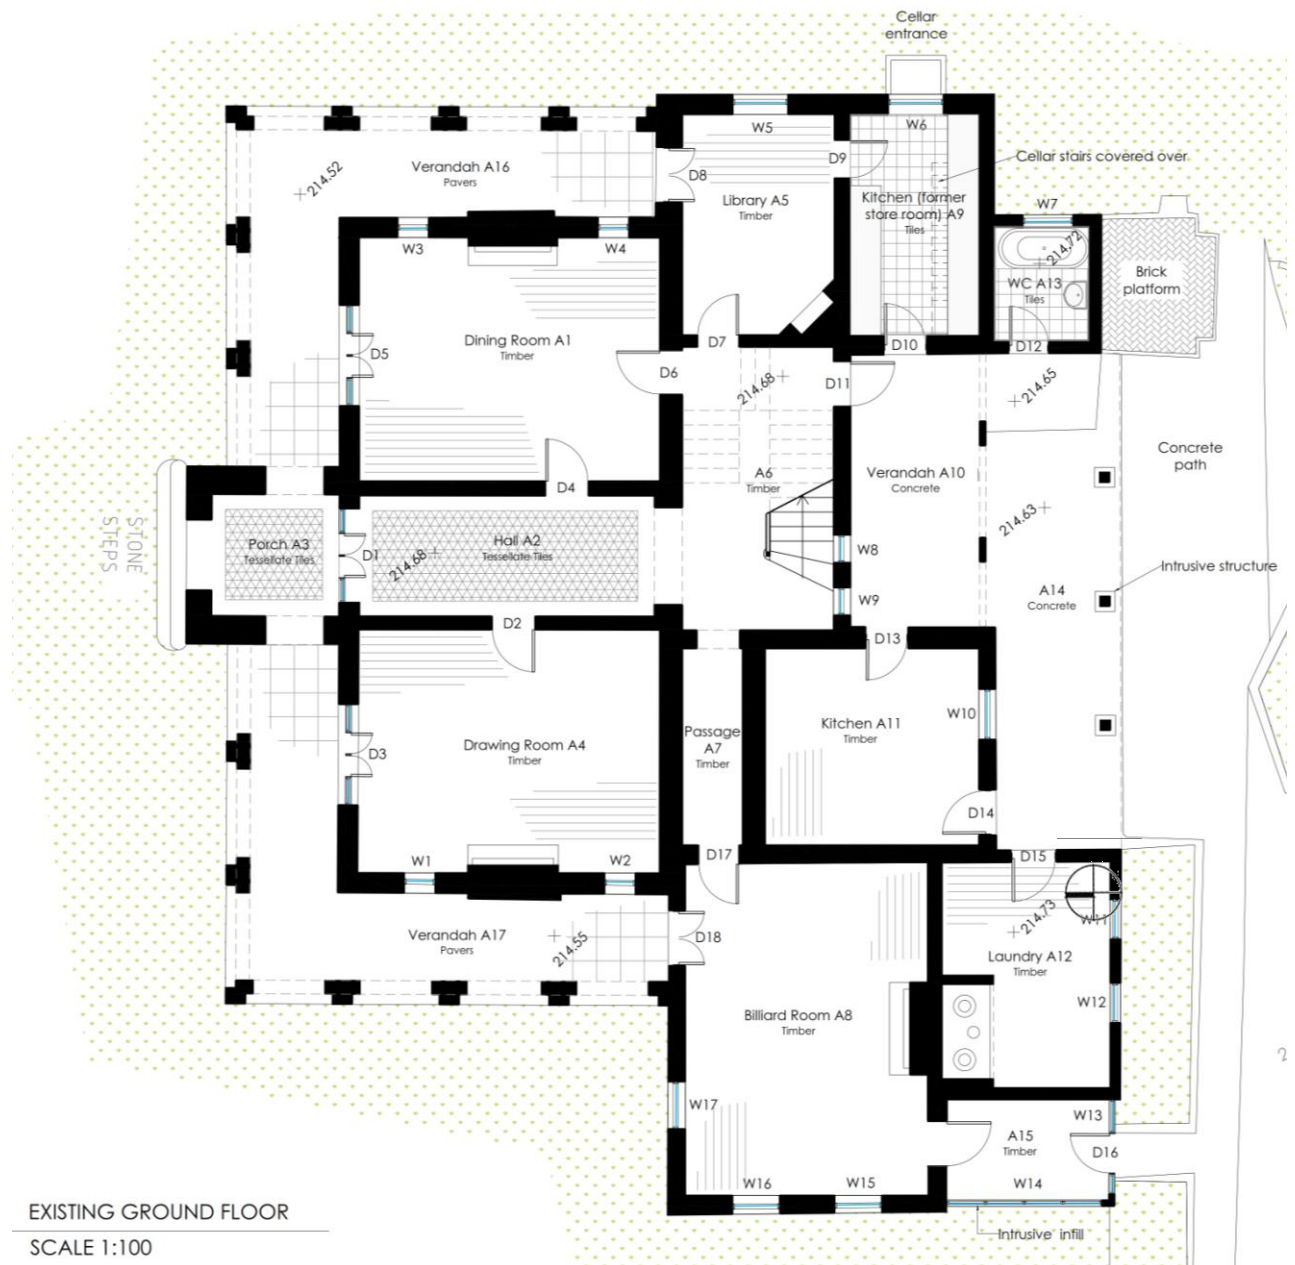
Figure 16: Existing ground floor plan. Not to scale. Site measured and draw by TTA.

From the impressive front entrance flanked by arched colonnaded verandahs, family and guests would have proceeded through the tessellated tiled porch to the front hall, also laid with tessellated tiles, from which opened the dining room to the north and the drawing room to the south. The two formal reception rooms were identically shaped with central fireplaces and French doors opening on to the western verandah, with the dining room having an additional door for easy access to and from the kitchen. At the end of the entrance hall, a large stair hall

with 2 imposing stained glass windows on the east face followed the two-quarter-landing staircase to the first floor. Leading off the stair hall at ground floor were the library to the north, a passage leading to the billiard room to the south, and a door to the rear verandah which allowed access to the utilitarian back-of-house with kitchen, store room, bathroom and kitchen garden.

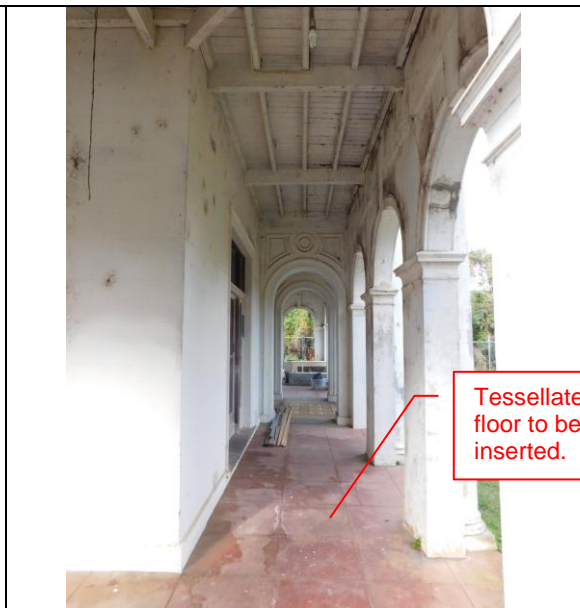
Tessellated
 floor to be
 inserted.

Figure 18: Room A16 - Verandah

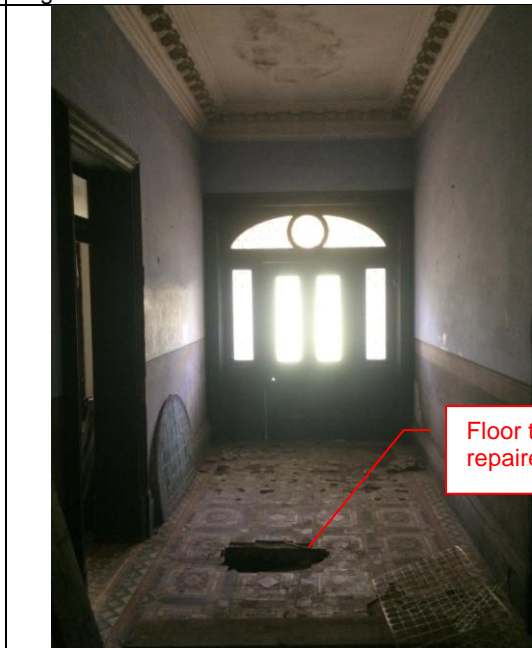
Floor to be
 repaired.

Figure 20: Room A2 - Hall

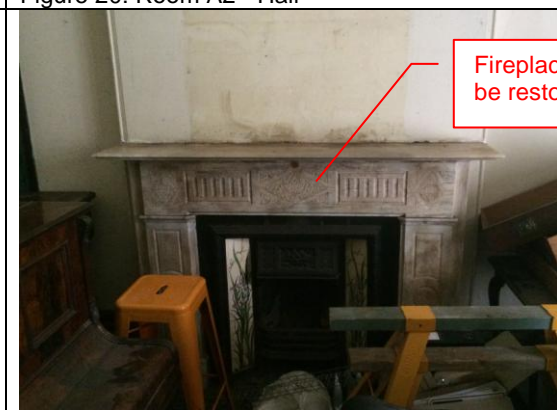
Fireplace to
 be restored

Figure 22: Room A4 - Fireplace

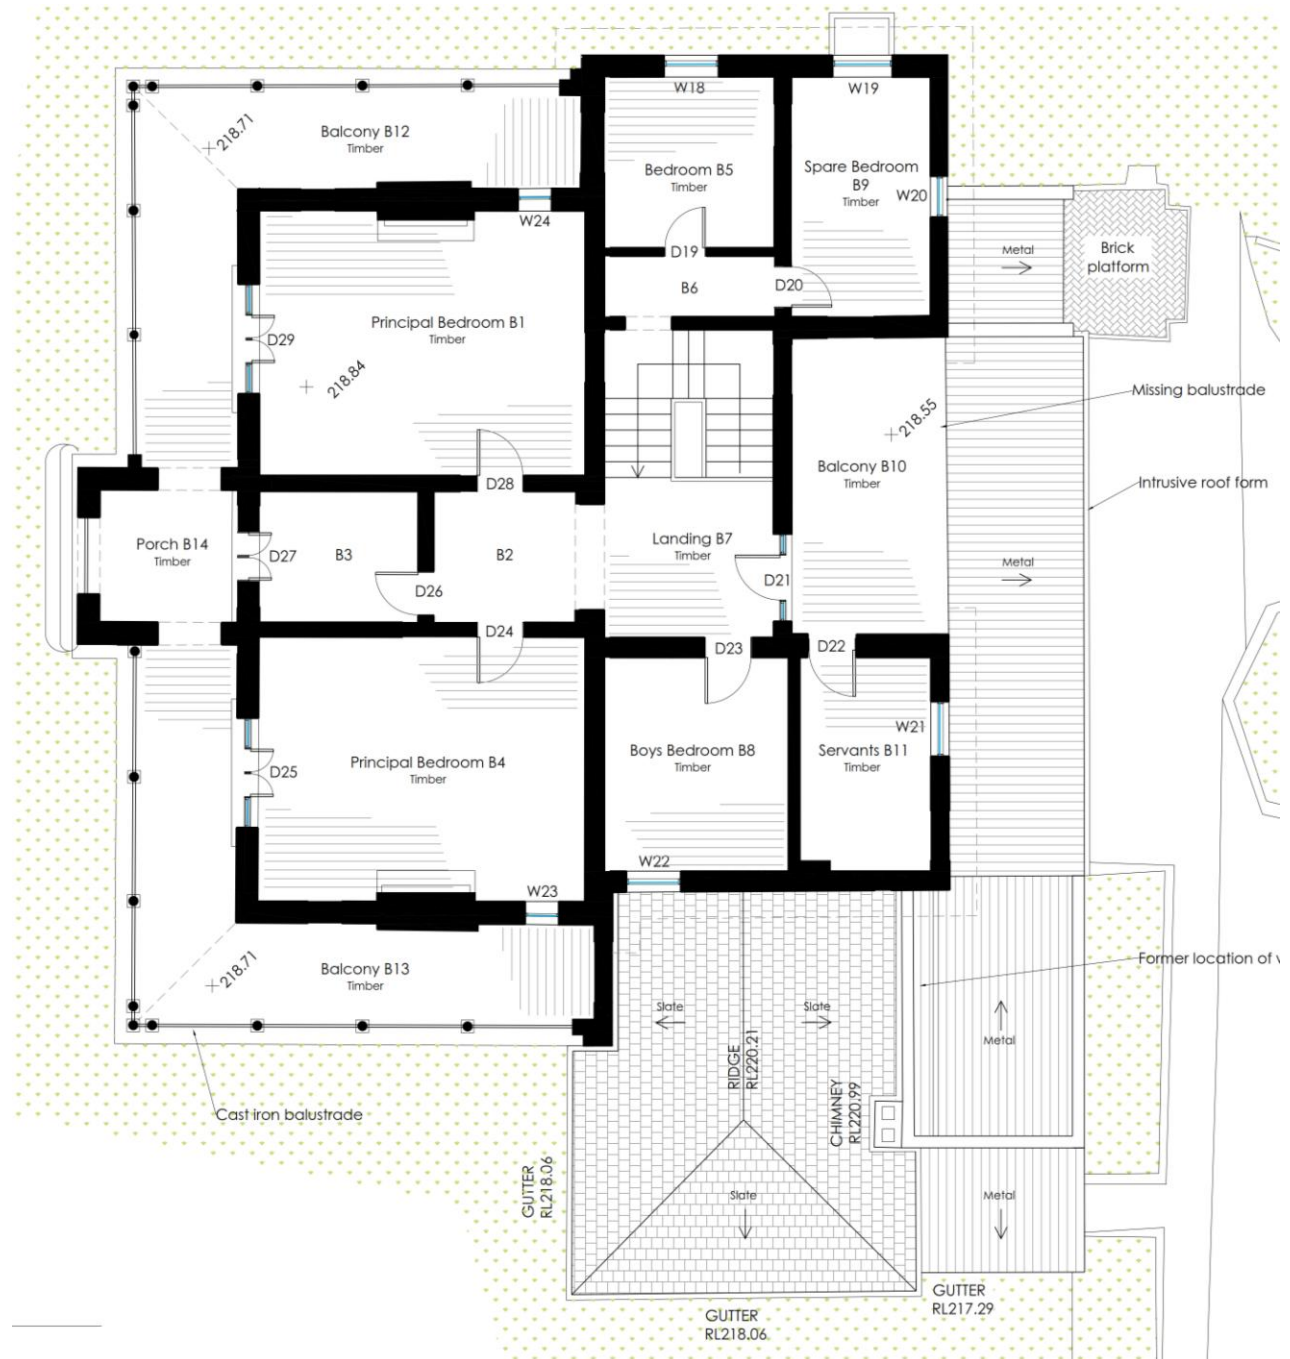
Figure 37: Existing First floor plan. Not to scale. Site measured and draw by TTA.

Upstairs, two large bedrooms mirrored the dining room and drawing rooms below, while two smaller bedrooms were accessed from the stair hall landing, and behind these bedrooms were a spare room and a servants' bedrooms with a central rear balcony between which looked over the back garden.

A stairway leading to the tower was accessed from the passageway at the front of the house between the two principal bedrooms. The room at the top of the tower had sloping glazing on all facades and a galvanized steel pyramid roof. The original drawings show a small balcony with cast iron balustrade surrounding the tower, which was removed during emergency repair works in the early 2000s.

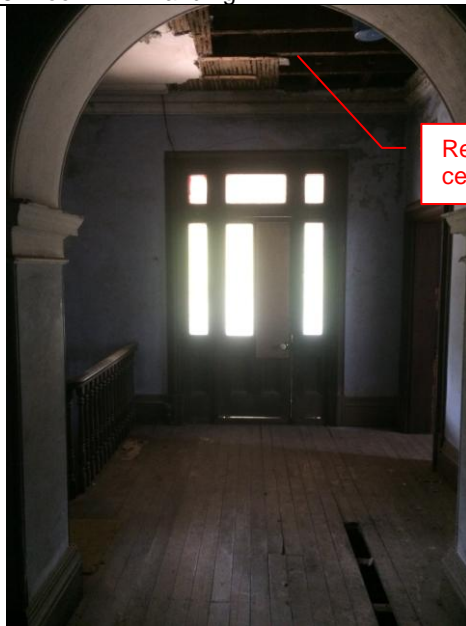
Figure 40: Room B7 - Landing

Repair
ceiling

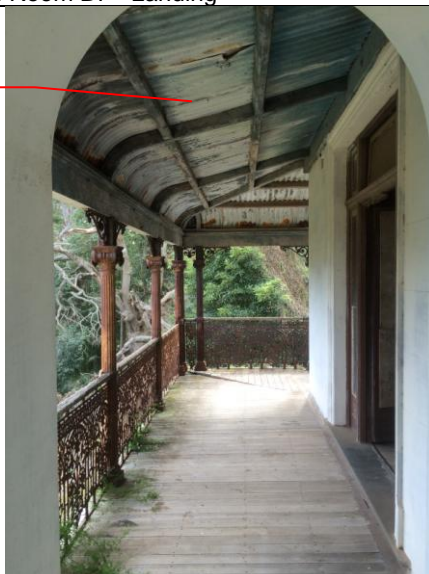
Figure 42: Room B10 - Balcony

Repair roof
or replace

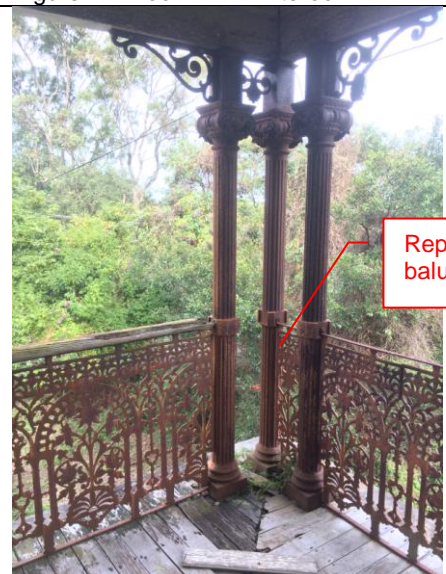
Figure 43: Room B10 - Corner columns

Repair
balustrade

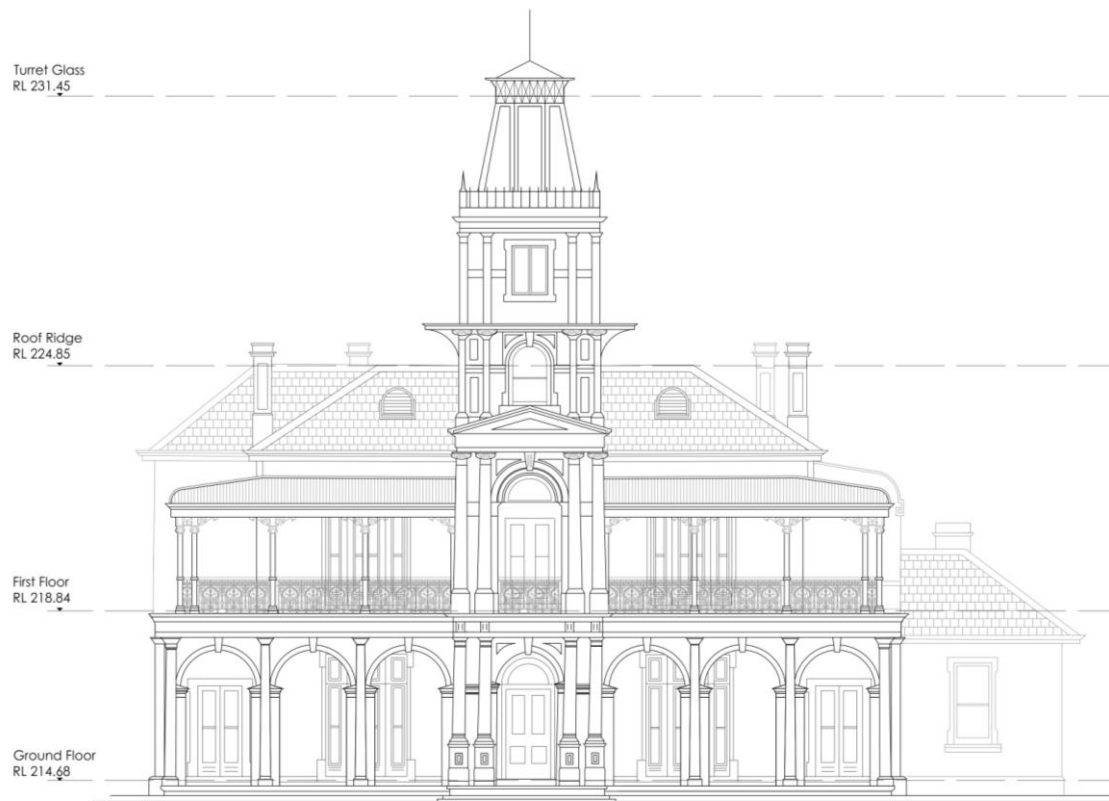
Figure 56: Existing West Elevation. Not to scale. Drawing by TTA.

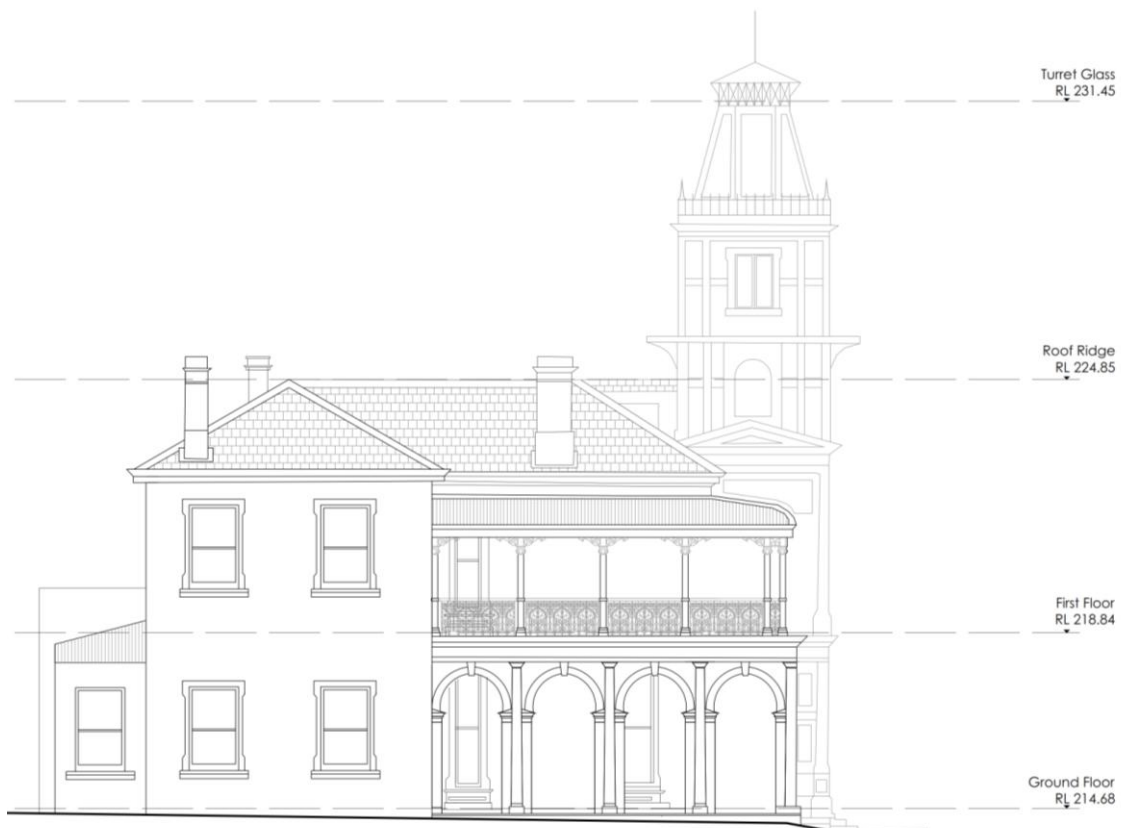
Figure 57: Existing North Elevation. Not to scale. Drawing by TTA.

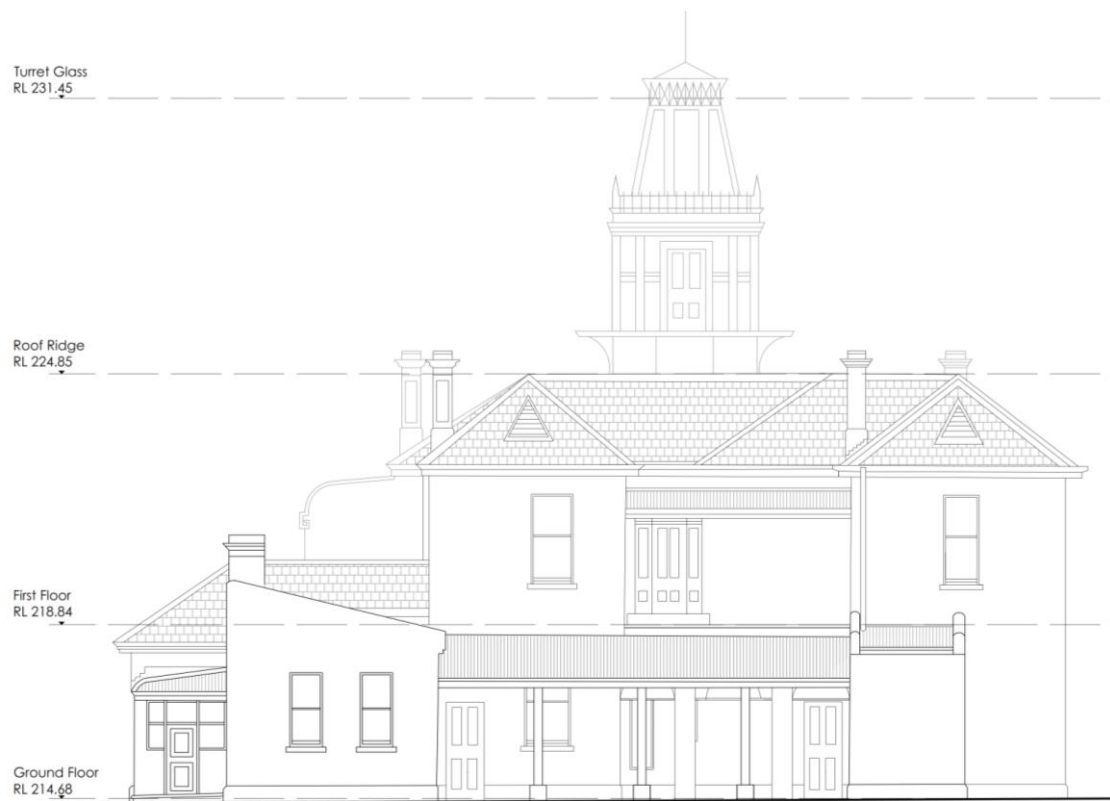
Figure 58: Existing East Elevation. Not to scale. Drawing by TTA.

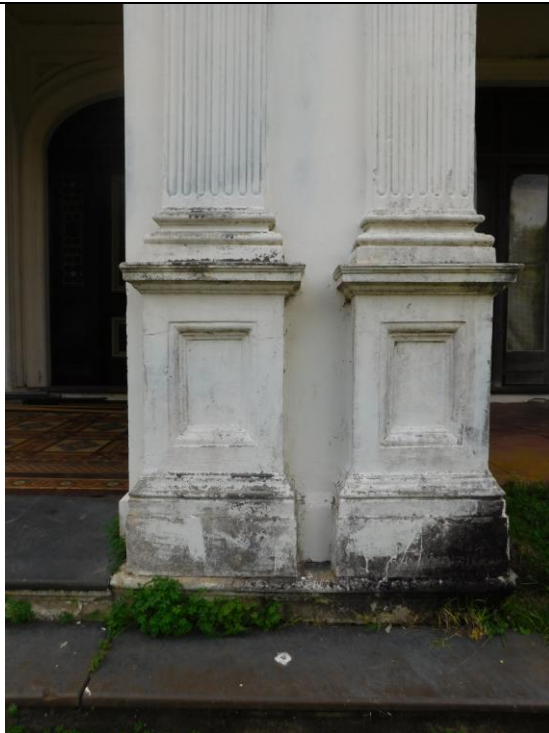
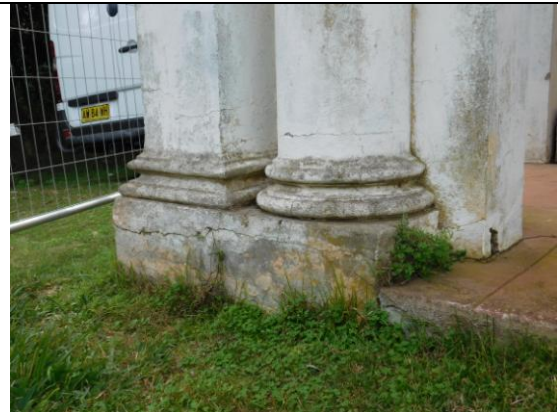
Figure 60: Ground floor verandah colonnade

Figure 61: Ground floor verandah colonnade

The two-storey house is constructed of load bearing solid brickwork, timber framed floors and the main roof which is clad in slate tiles. Rear roofs over bathroom and laundry had parapets and corrugated iron roofs, with structures to support water tanks. The ground floor verandah is colonnaded in rendered brickwork, while the first floor verandah has cast-iron balustrade and ionic-order cast-iron columns, covered with a bull-nosed verandah which appears painted in alternating stripes in early photographs.

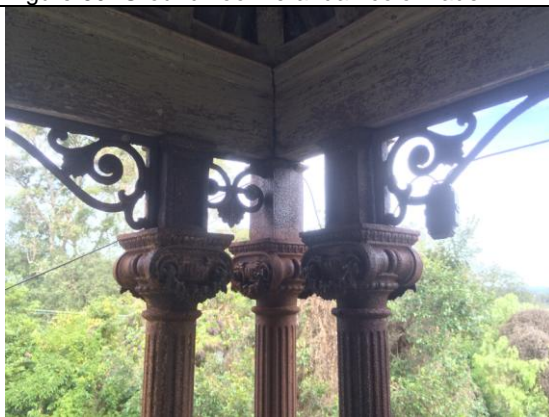
Figure 62: First Floor balcony's corner columns

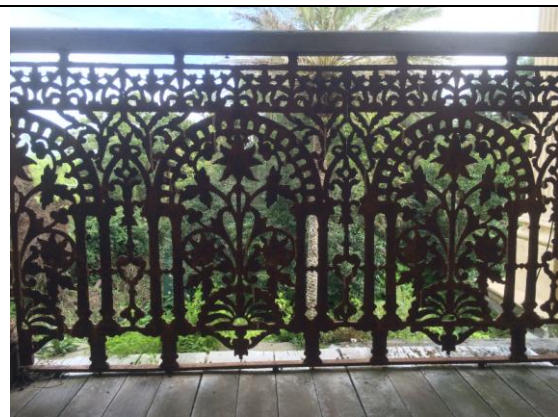
Figure 63: First Floor balustrade

The cast-iron balustrade to the rear balcony has been removed and replaced with a temporary timber structure. The narrow cast-iron balcony to the tower has also been removed. Internally the floors are hardwood except for the entrance hall which is finished with tessellated tiles. The main doors has 3 different set of decorative glasswork.

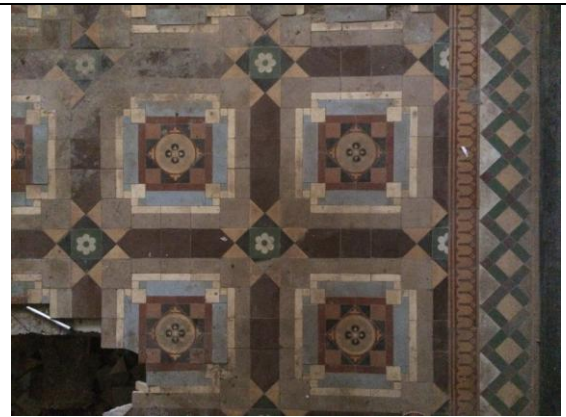
Figure 65: Hall floor room in room A2

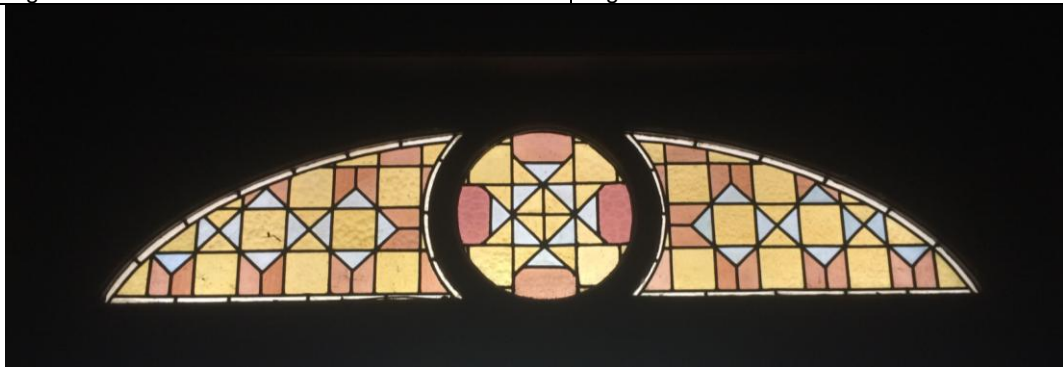
Figure 66: Main door's fanlight

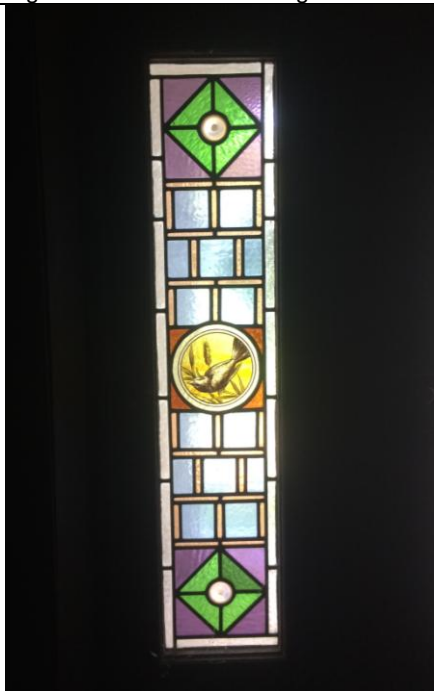
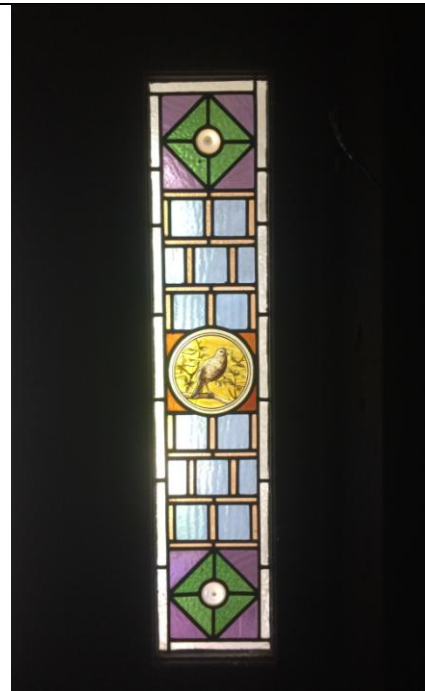
Figure 67: Main door sidelight

Figure 68: Main door sidelight

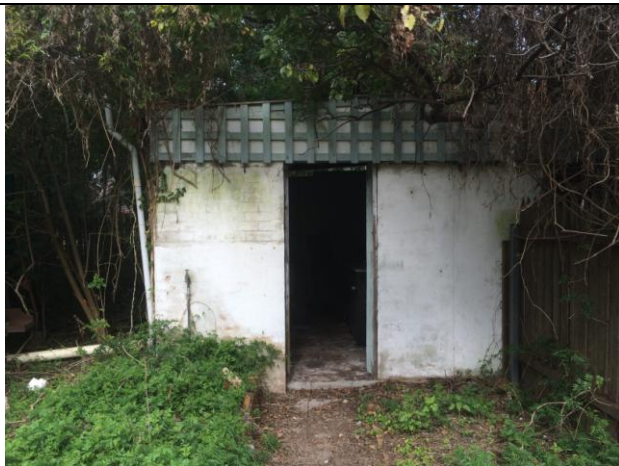
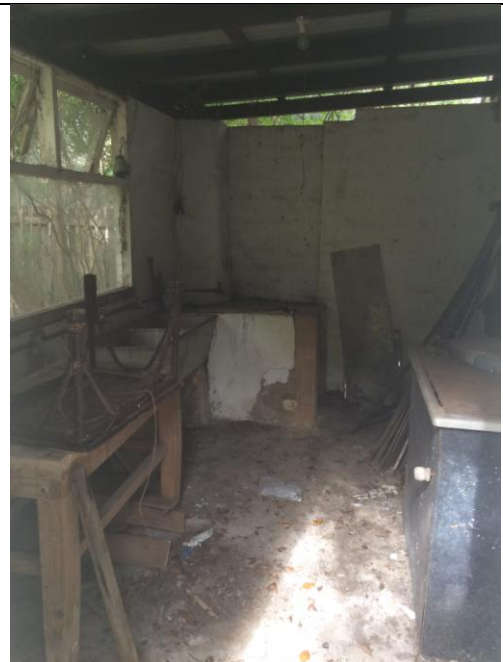
Figure 78: Laundry

Figure 79: Laundry

Immediately south of the main house is a reasonably modern laundry building which houses a laundry and storage shed. It is constructed of timber frame and lined with fibro and lattice.

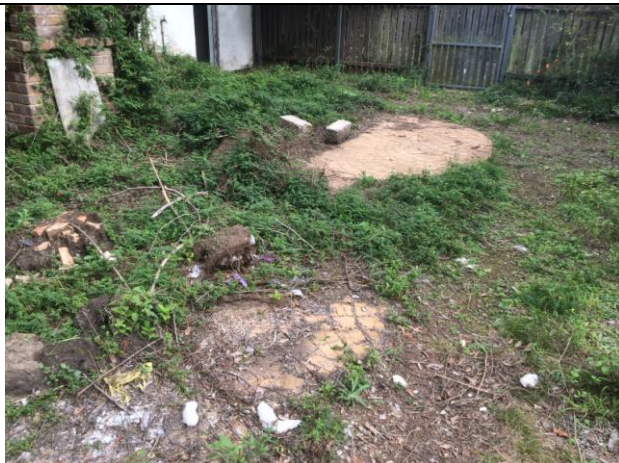
Figure 80: Floor tiled in front of the laundry

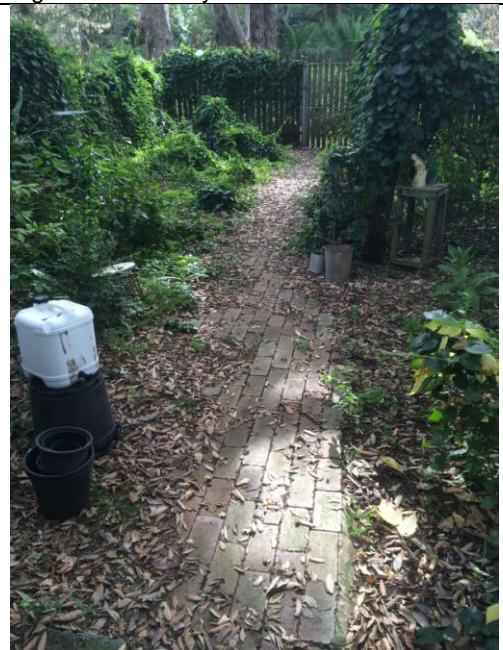
Figure 81: Bricked path-way N-S behind the WC

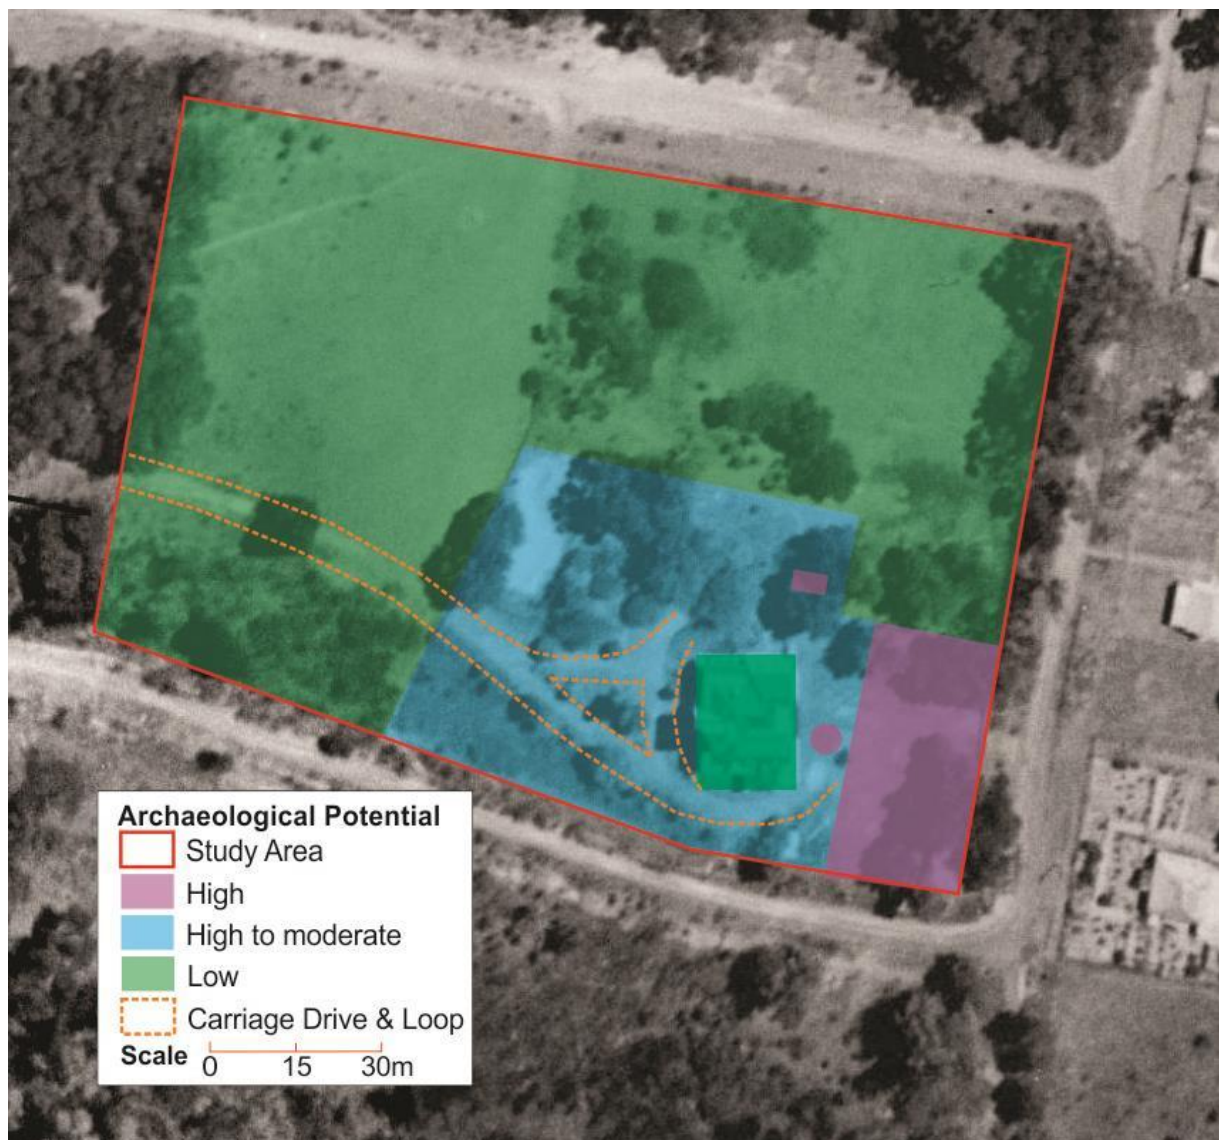
Figure 84: Areas of archaeological potential overlaid onto 1943 aerial photo. From the *Archaeological Assessment - Heathcote Hall 1-21 Dillwynnia Grove, Heathcote*, February 2017, by Casey & Lowe.

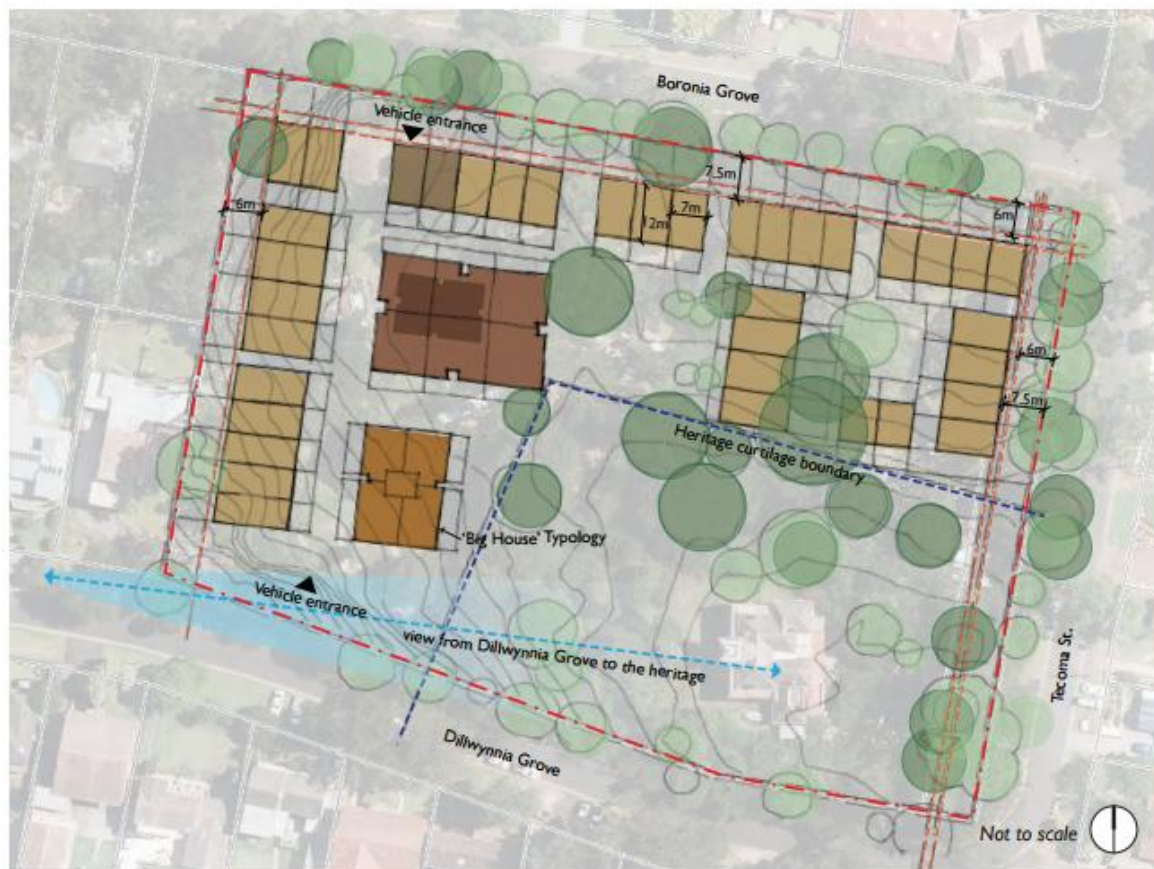
- Three+ storey residential flat building might be considered excessive to achieve a contextual fit.
- Has a strict rectilinear site configuration, which lacks a sensitive response to the site's natural setting.
- Presents three-storey built forms to face single storey dwellings on Dillwynnia Grove.
- Does not provide any direct views to Heathcote Hall from Boronia Grove.

Figure 86: Superseded option 2, by GMU.

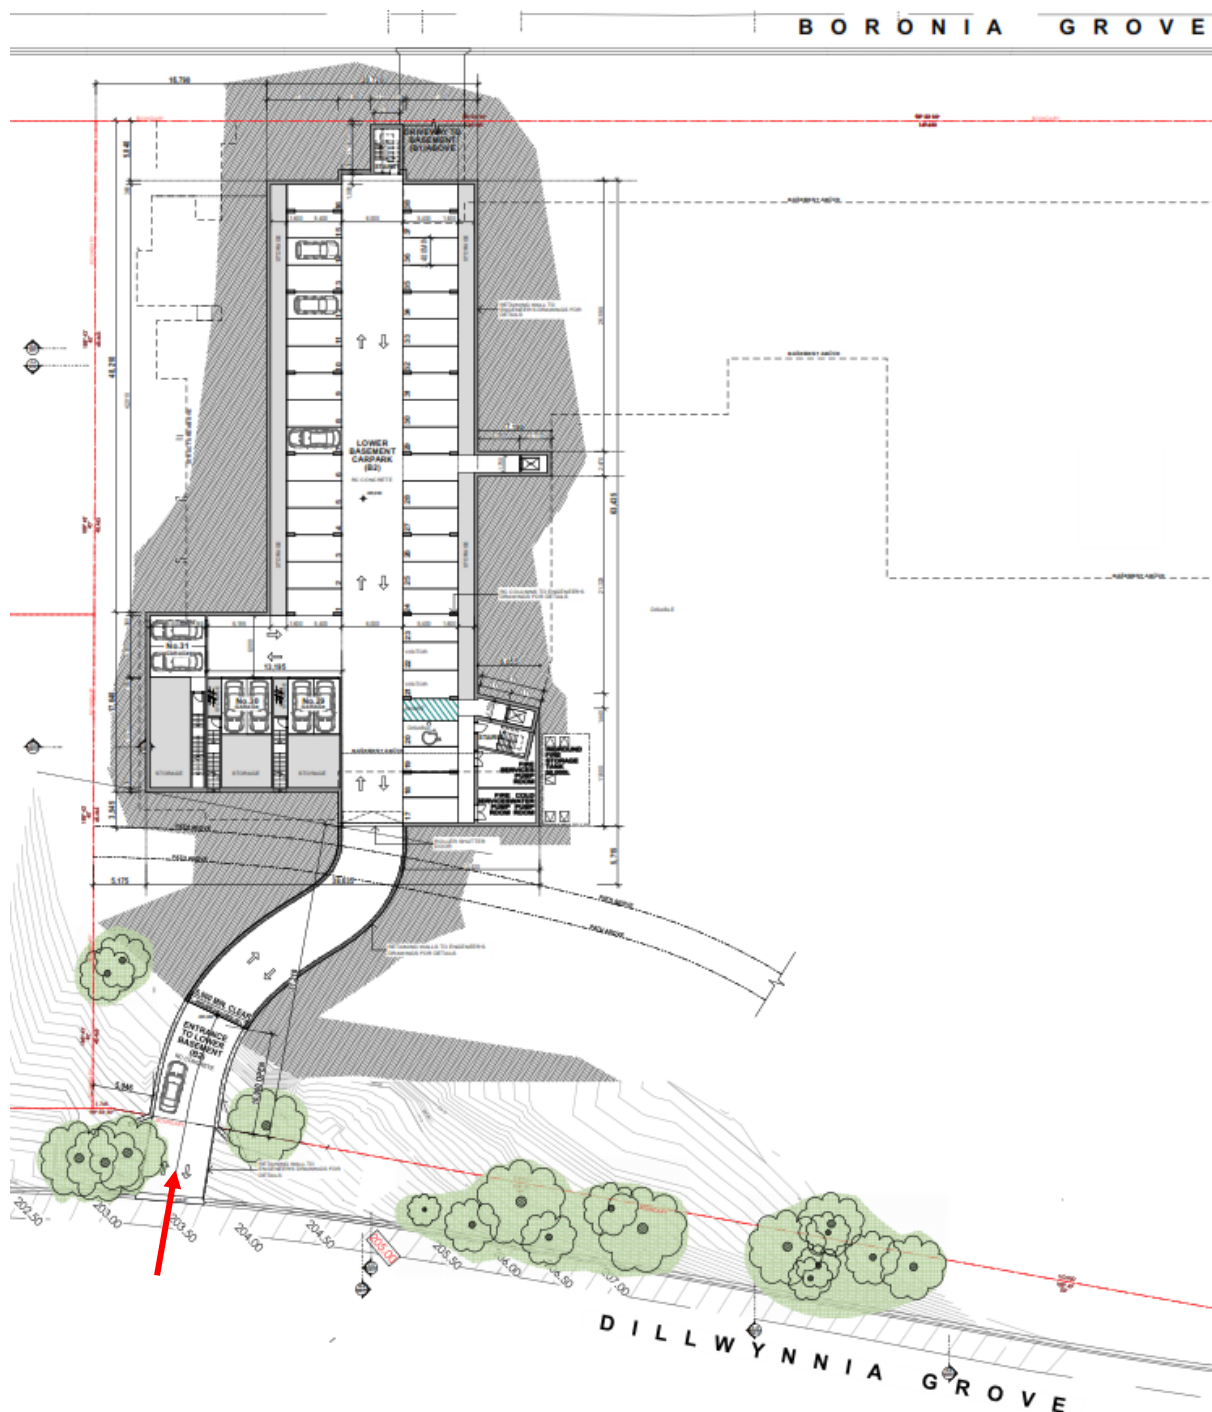
Figure 95: Lower Basement Parking, by Ink Architects.

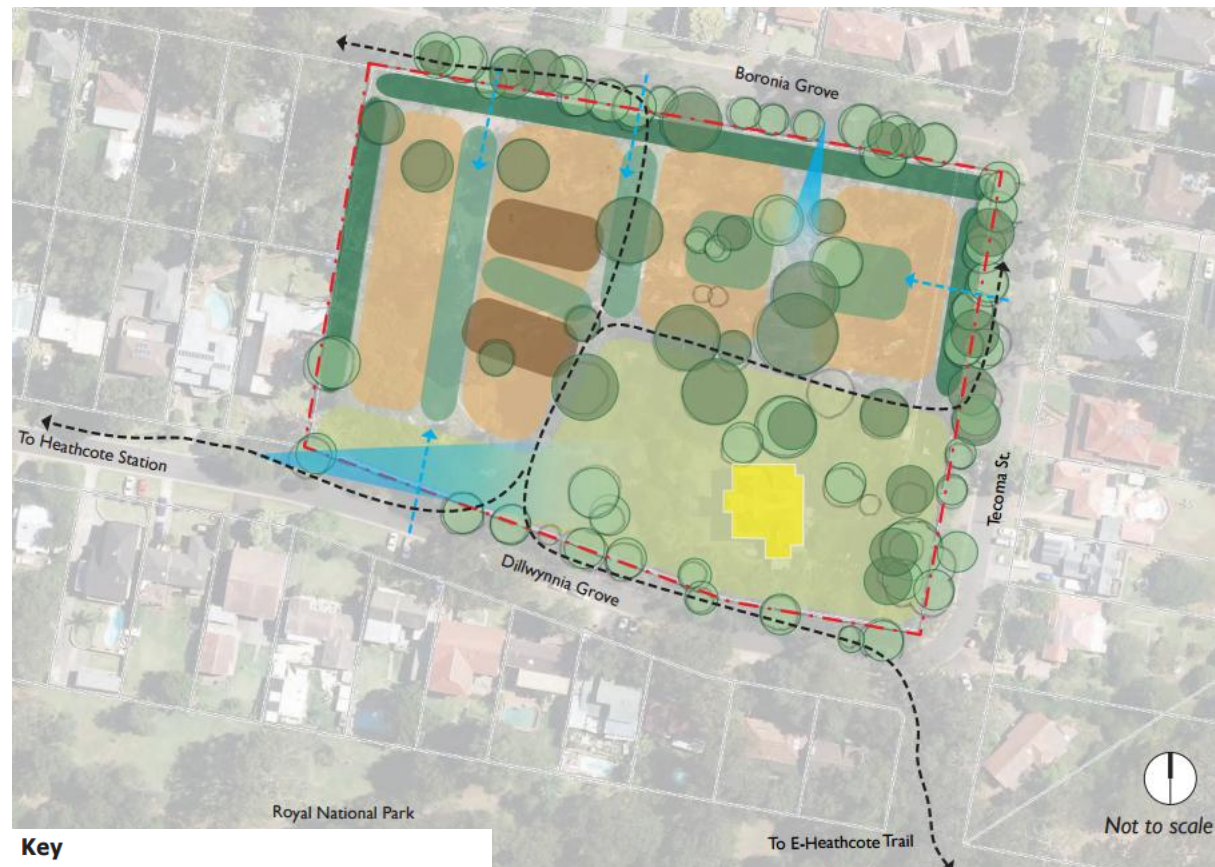
Figure 98: Site and context analysis, by GMU.

- Key**
- The site
 - Heathcote Hall (state-significant heritage)
 - Lower built form interfacing with low-density development
 - Potential location of taller buildings
 - Landscaped setback zone along boundaries
 - Reinterpreted heritage landscaped area
 - Internal landscaped open space
 - Existing trees with large canopies (More than 20m height)
 - Trees to be retained as per arborist report
 - Pedestrian link to the existing trails -shortcut to the station
 - > Visual permeability into the site
 - > Key views to Heathcote Hall and its gardens

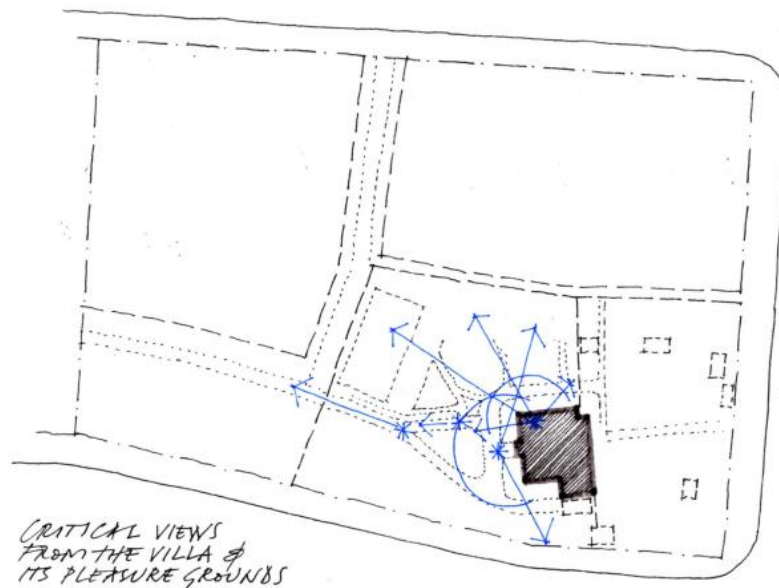
Figure 101: Key views from the villa, from Heathcote Hall CMP.

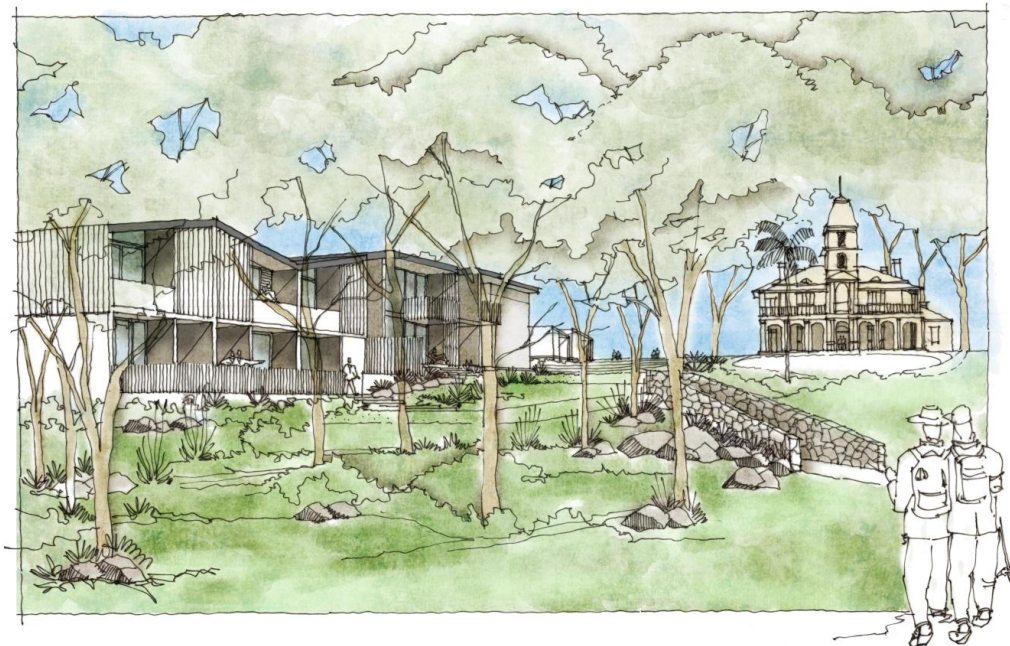
Figure 104: Perspective over Dillwynnia Grove, by the Architects. Un-obtrusive entry using local Sandstone and planting.

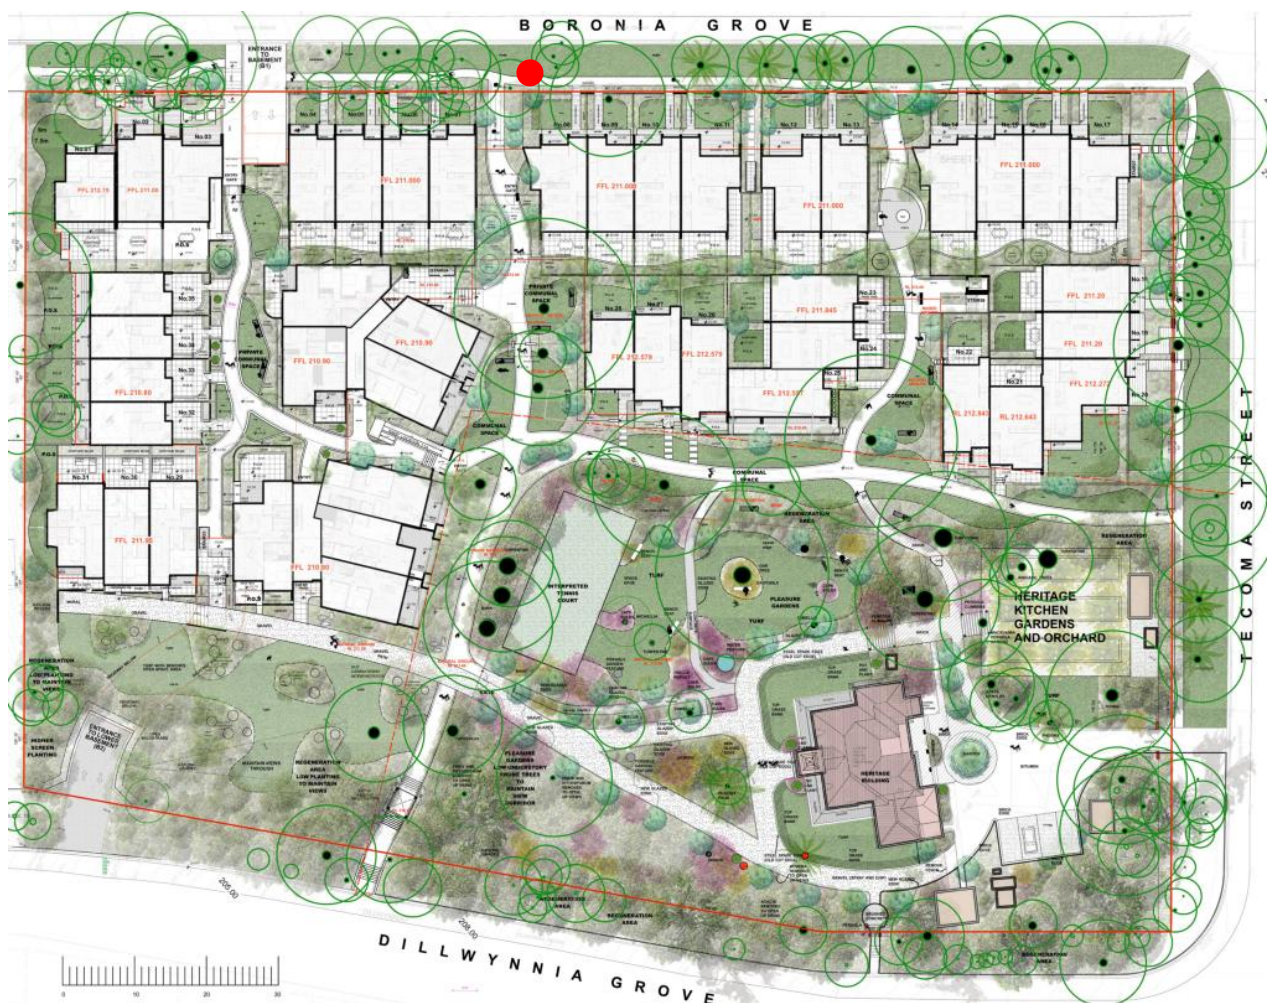
Figure 106: Proposed general landscape of the development, by the landscapers.
