**HERITAGE IMPACT STATEMENT
REVISED**

Heathcote Hall

1-21 Dilwynnia Grove, Heathcote, NSW

Revised Heritage Impact Statement

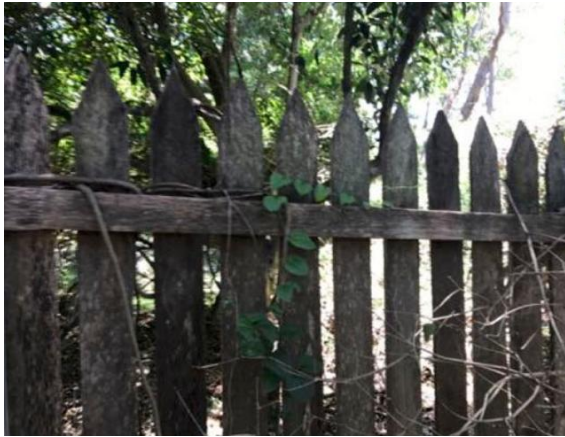
Figure 108: Existing timber fence to be retained and restored. Possible original relic.

Comment on the picket fence and tiled edge: Positive. The restoration of the picket fence will maintain the separation between the inner garden and the out garden. This type of fence allows visual permeability to and from the Hall.

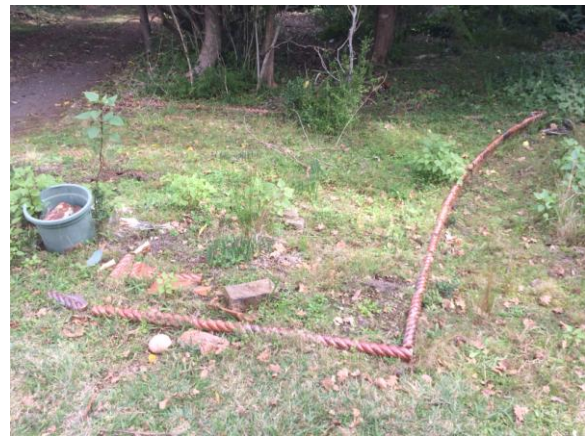
Figure 109: Existing tiled garden edge to be located, marked out and garden beds restored and replanted.

The restoration of the glazed edge, reusing the remaining tiles where possible, is a positive outcome to preserve and re-establish aspect of the inner garden.

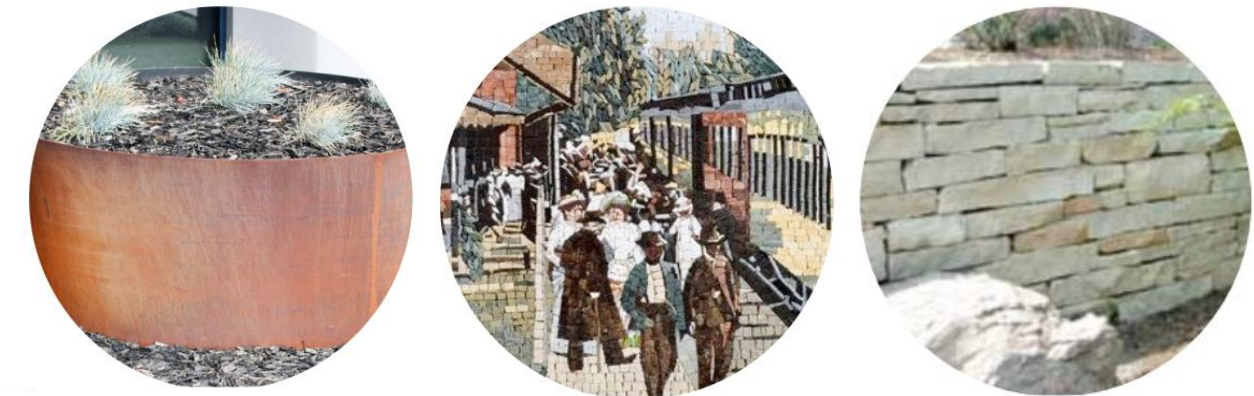
Figure 110: Proposed garden beds in Corten steel, possible mural along the carriageway's wall and sandstone seating proposed as informal seating to soften ground plane.

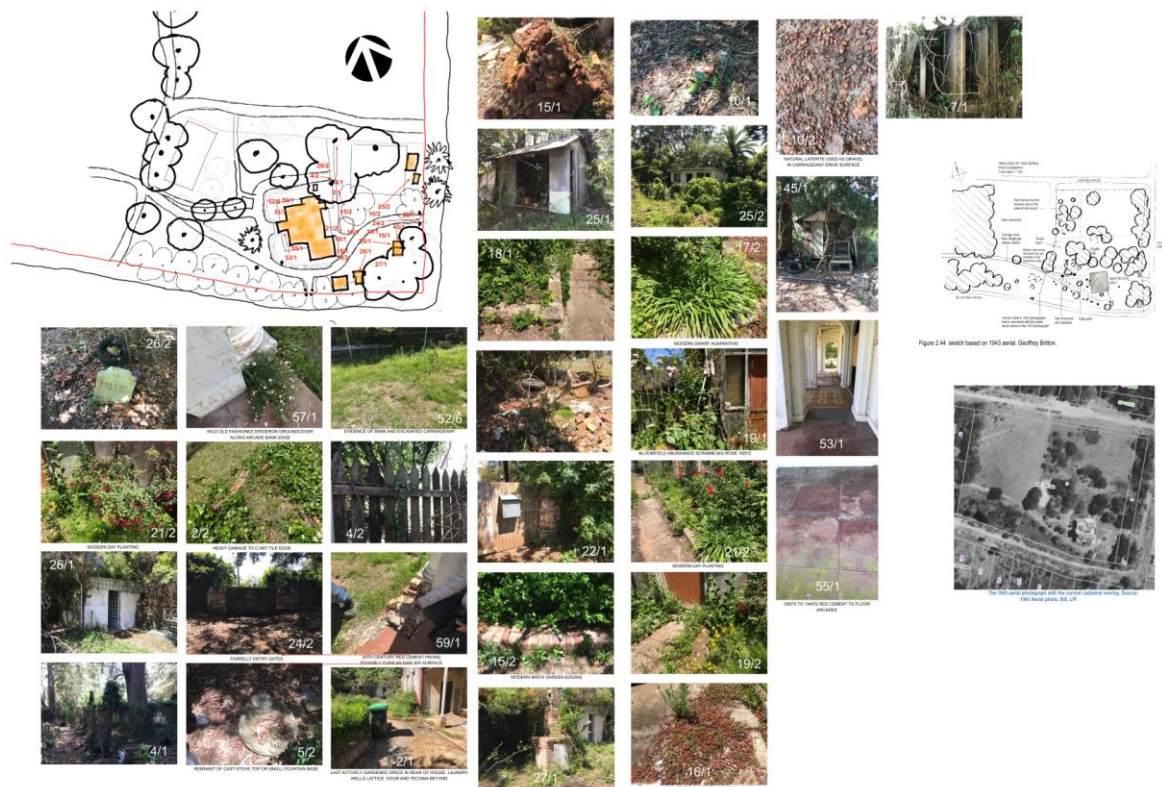
Figure 114: Heritage Site Analysis, by the landscape designers.
