"HEATHCOTE HALL"
TECOMA STREET
HEATHCOTE, NSW

PRELIMINARY ESTIMATE

PREPARED FOR
MAXINE FARRELLY
"HEATHCOTE HALL"
TECOMA STREET
HEATHCOTE

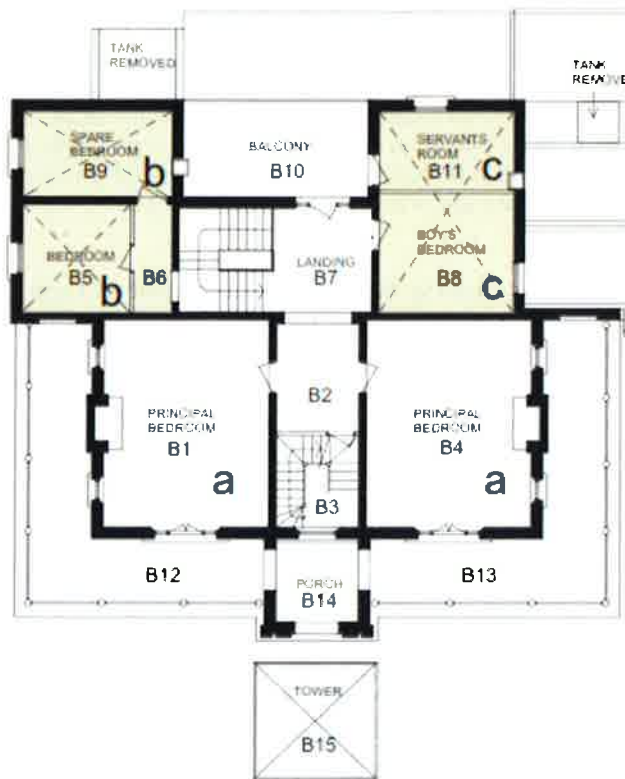
FIRST FLOOR PLAN

Figure 122: Policy recommendations for adaptive re-use, first floor, n.d.
