# CONSERVATION MANAGEMENT PLAN

263 Queen Street Campbelltown NSW 2560

MARCH 2017

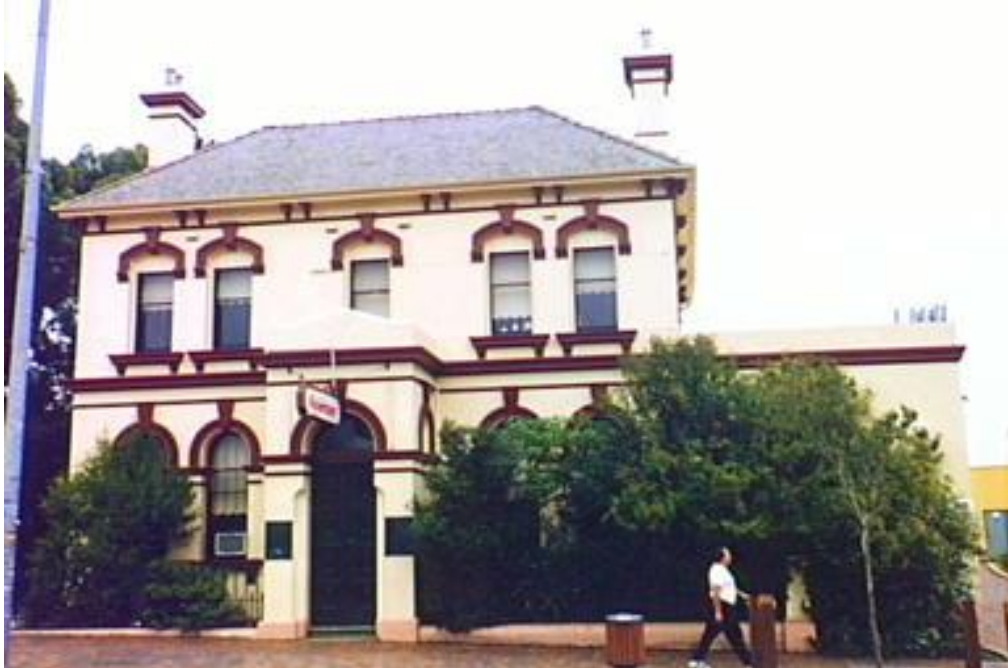
Figure 27 – Macarthur Advertiser, 23 March 2000 / Stan Brabender. Note that the 1958 side extension has been given a parapet. (Source: Stan Brabender Collection -Campbelltown City Library. Local Studies Collection).

263 Queen Street was then converted to offices of Campbelltown-Macarthur Advertiser (Figure 25, Figure 27, Figure 28 and Figure 29) while the rear of the premises was developed with a small number of shops, underground parking. The newspaper occupied the building for some time but by 2011 the building was used as a medical centre.

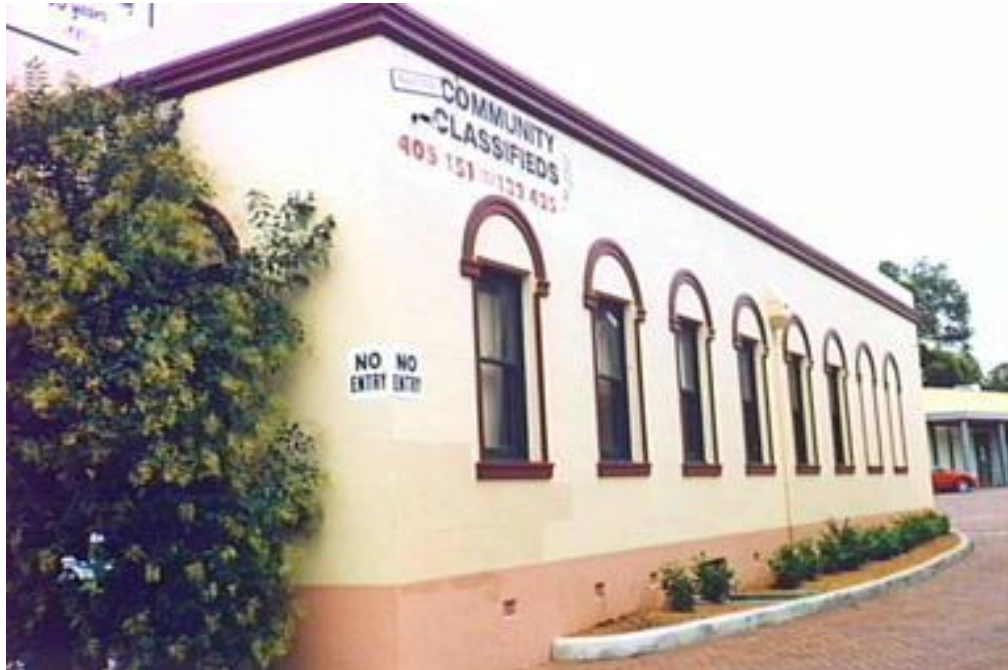
Figure 29 - view of the side extension after the parapet and ornamentation was added. Macarthur Advertiser, 23 March 2000 / Stan Brabender. (Source: Stan Brabender Collection -Campbelltown City Library. Local Studies Collection).

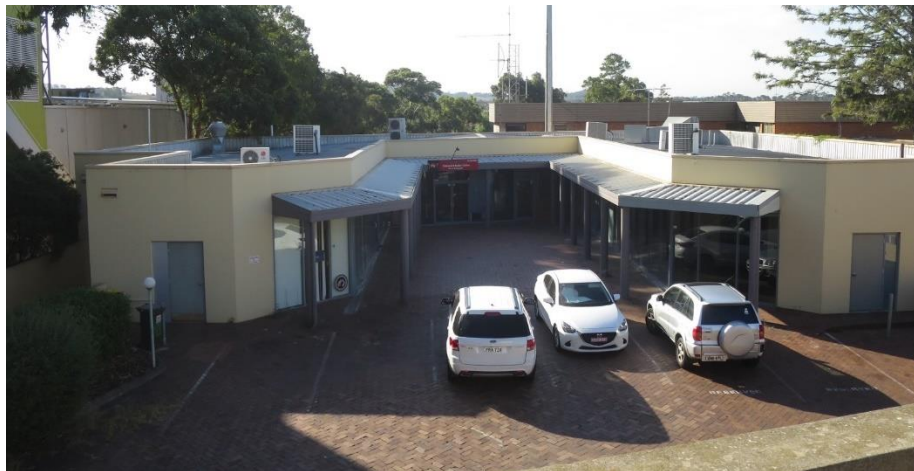
Figure 34 – the commercial building with underground car parking at the rear of the site. NBRSArchitecture February 2017.

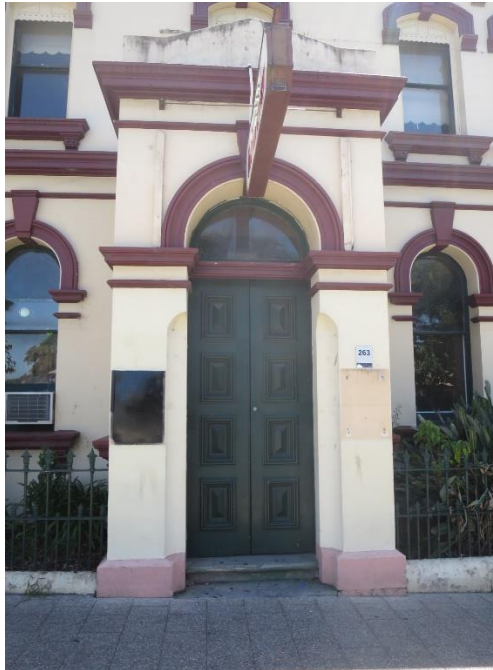
Figure 36 – the bank entry is original, including its doors with bolection mouldings. NBRSArchitecture February 2017.

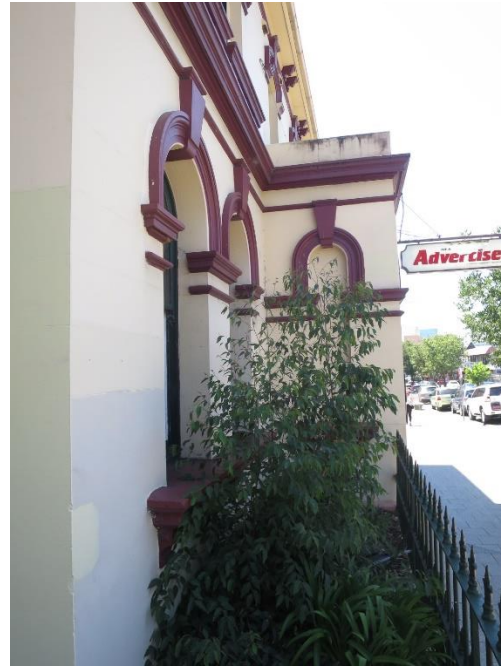
Figure 37 – side view of the enclosed entry porch

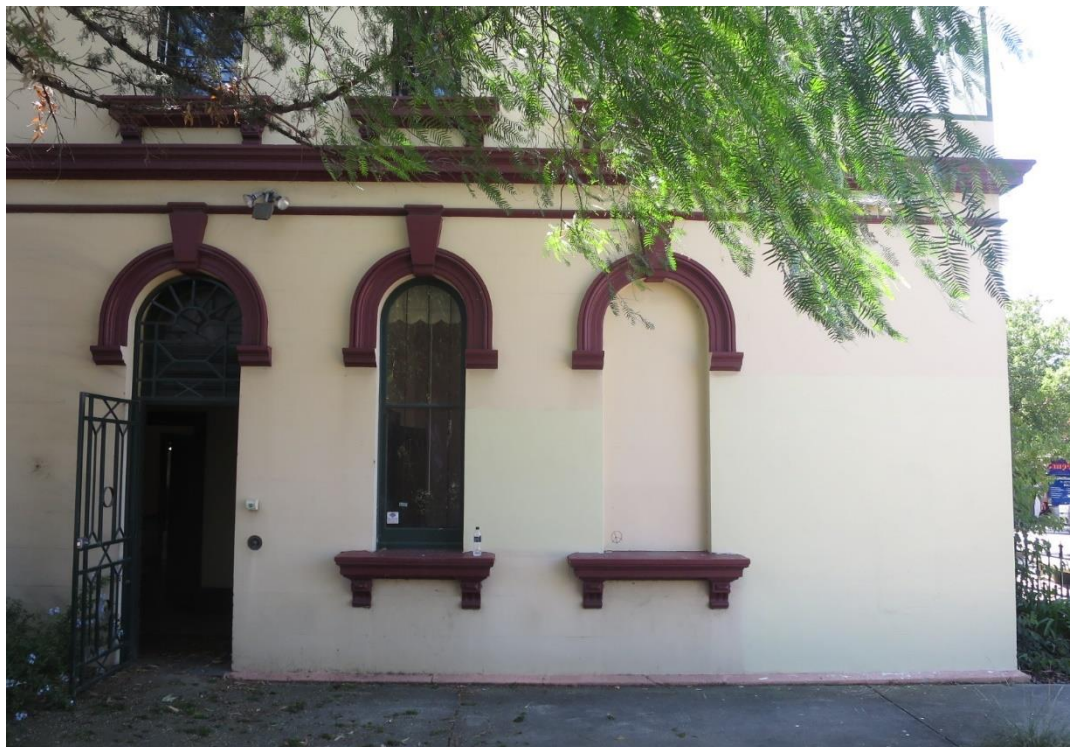
Figure 38 – the entry to the residence and window of the bank manager's study on the south-west elevation. The timber door is original. NBRSArchitecture February 2017.

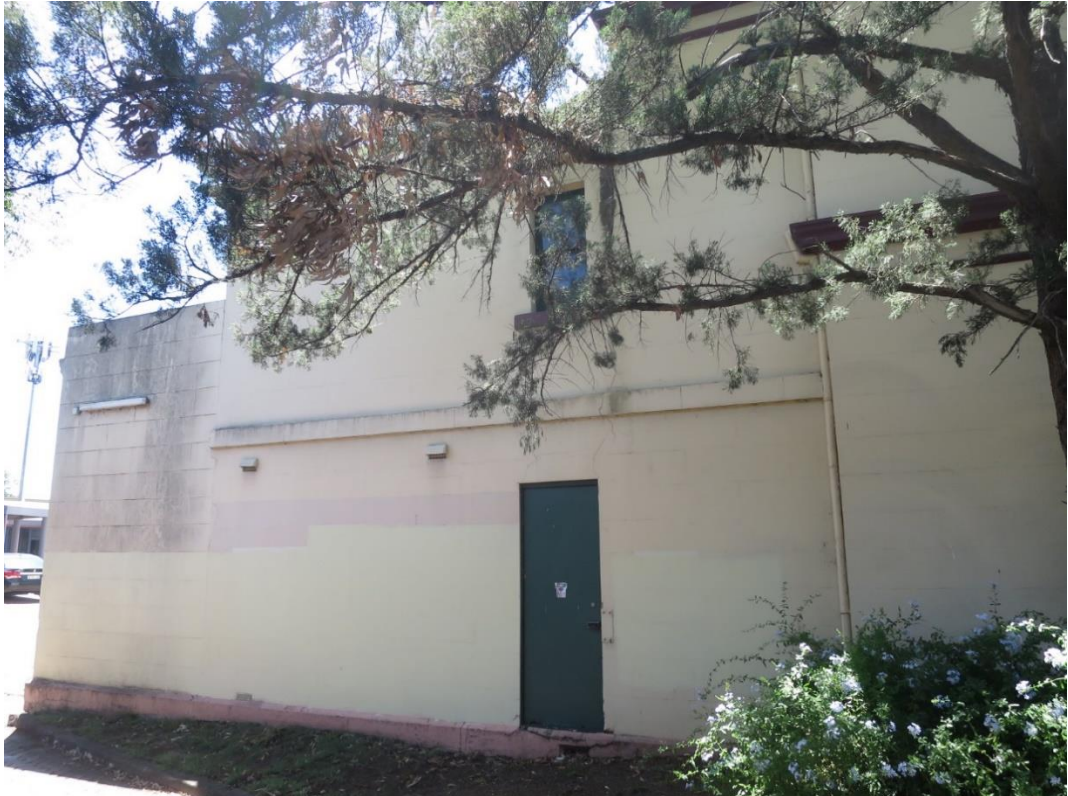
Figure 39 – the south-west elevation of the remains of the service wing. The two-storey section is original, but altered. The single-storey section on the left is 1990s fabric on the site of the much longer single-storey service wing that contained the laundry and coal stores. The tree is a Virginian juniper. NBRSArchitecture February 2017.

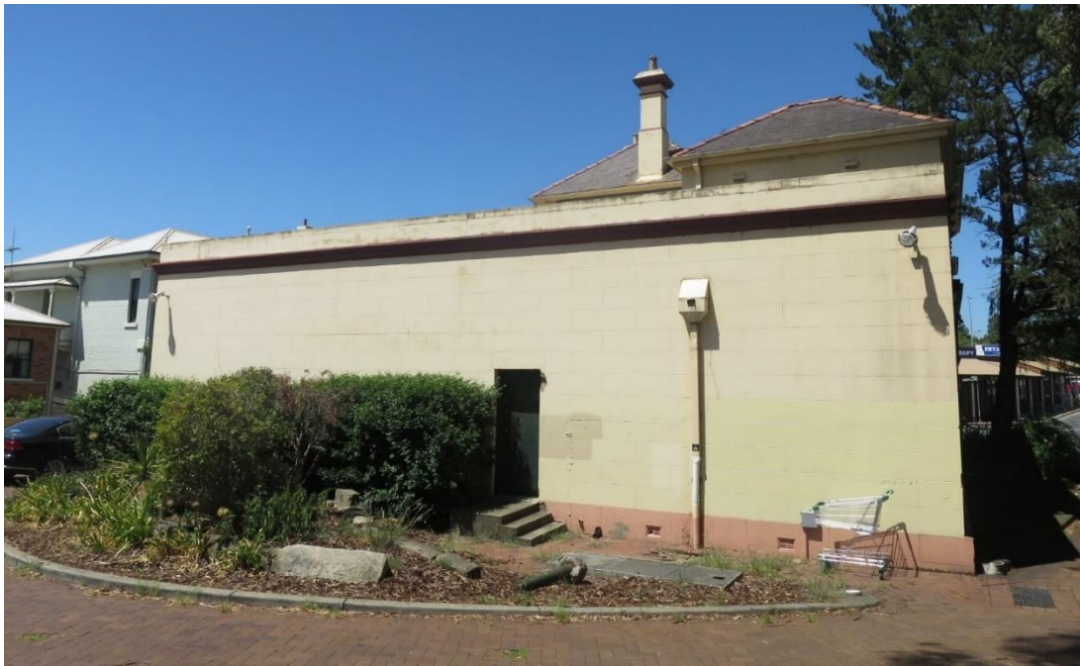
Figure 40 – the rear extension of the former bank was built in the period 1985-95. It is not significant. NBRSArchitecture February 2017.

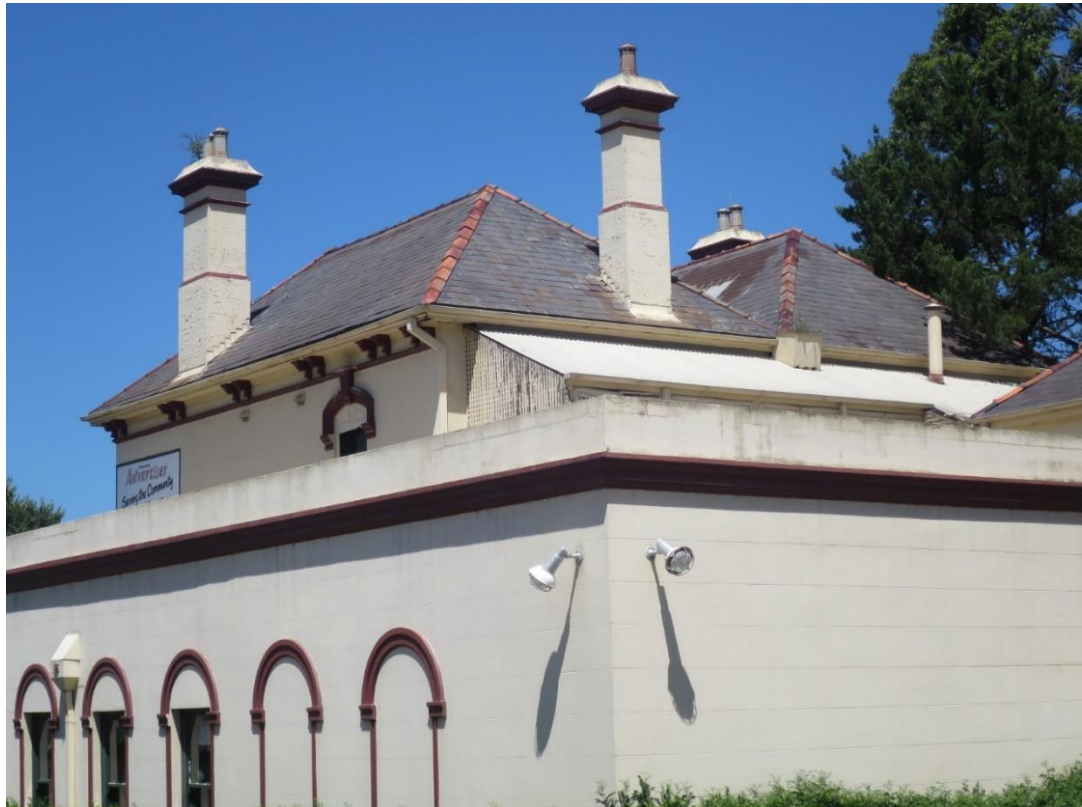
Figure 41 – easterly showing the single-storey rear section, and the two-storey section that is largely original. NBRSArchitecture February 2017.

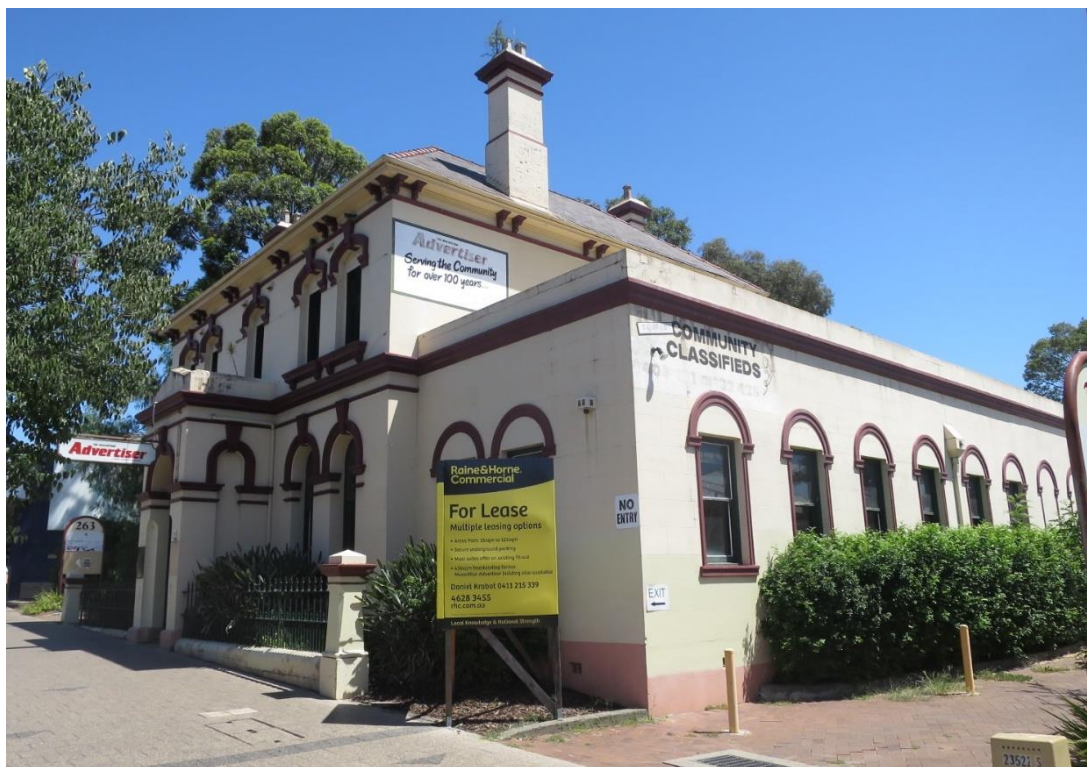
Figure 42 – southerly view showing the single-storey extension in the foreground that should be removed from the original building. NBRSArchitecture February 2017.

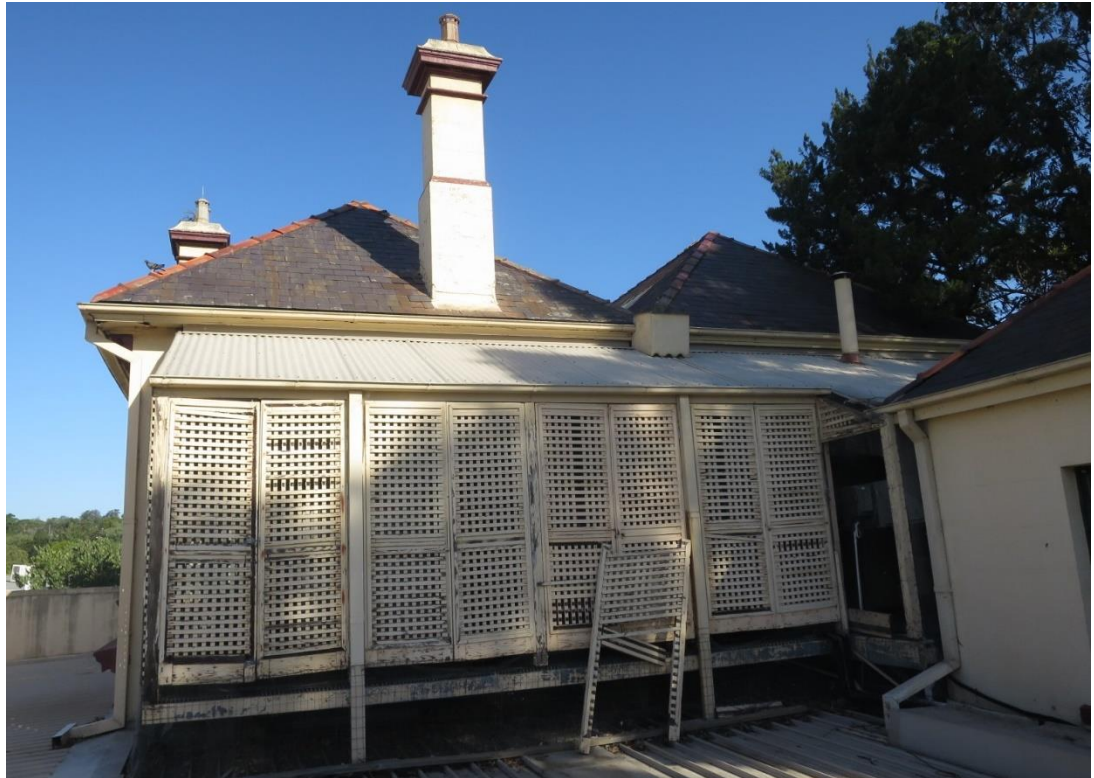
Figure 43 – the rear veranda is from the 1985–95 period. It screens the air-conditioning equipment. NBRSArchitecture February 2017.

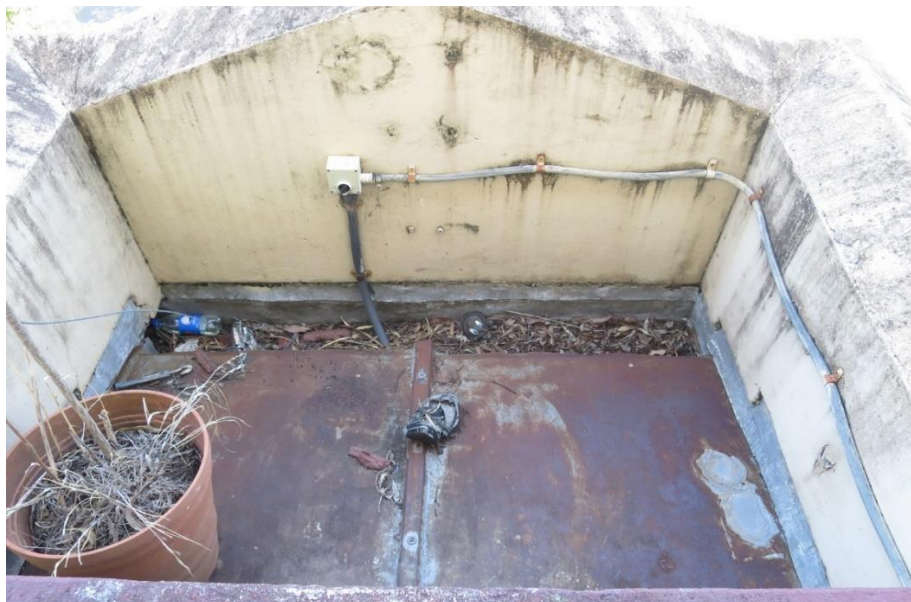
Figure 44 – roof and box gutter over the bank entry porch showing raised galvanised steel roof draining into a sump. NBRSArchitecture February 2017.

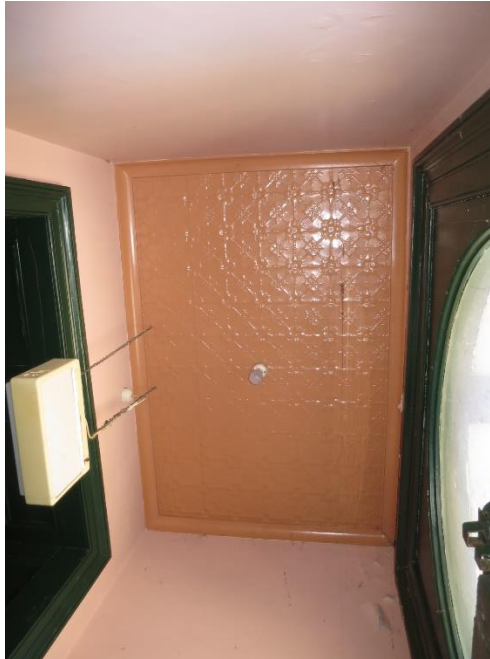
Figure 45 – pressed metal ceiling in G.01, (probably Federation period) and original joinery to the fenestration.

The entry porch (G.01) has a pressed metal ceiling with a small-scale pattern that was popular in the Federation period. It might be original to 1880, or an early change, following a leak in the building's early decades that caused the original lath and plaster ceiling to collapse.

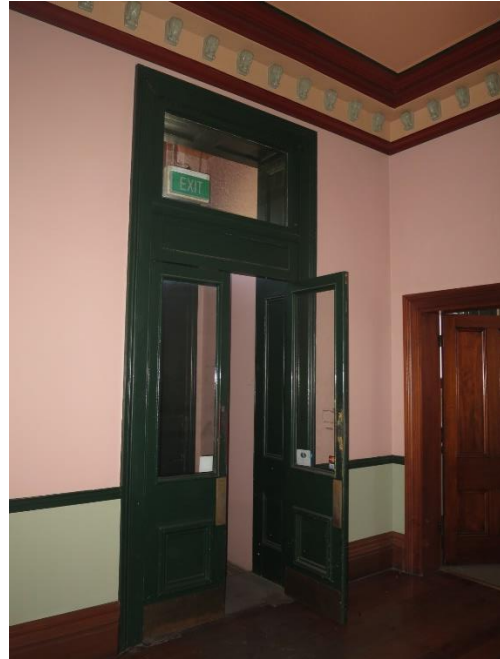
Figure 46 – the original entry doors to the banking chamber G.02. The cornice and chair rail are not original, but the doors and architraves seen here are original.

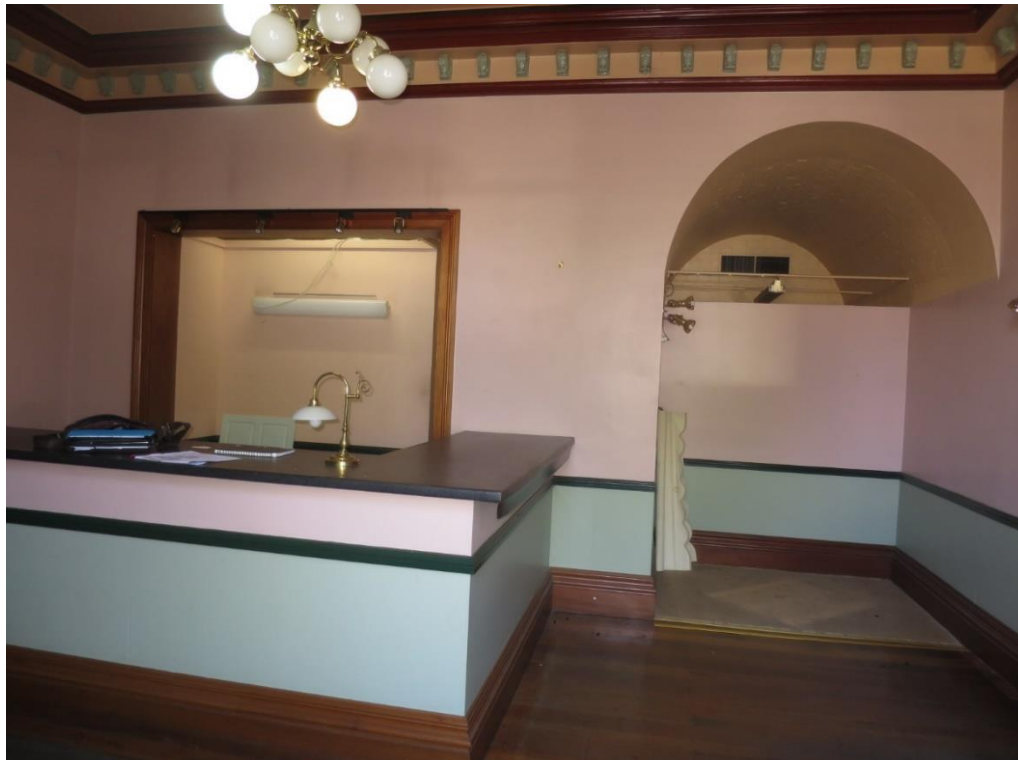
Figure 47 – the banking chamber G.02 showing the recent desk, openings to G.05 and G.06 (former strong room on the right). the skirting is reconstructed, but appropriate. NBRSArchitecture February 2017.

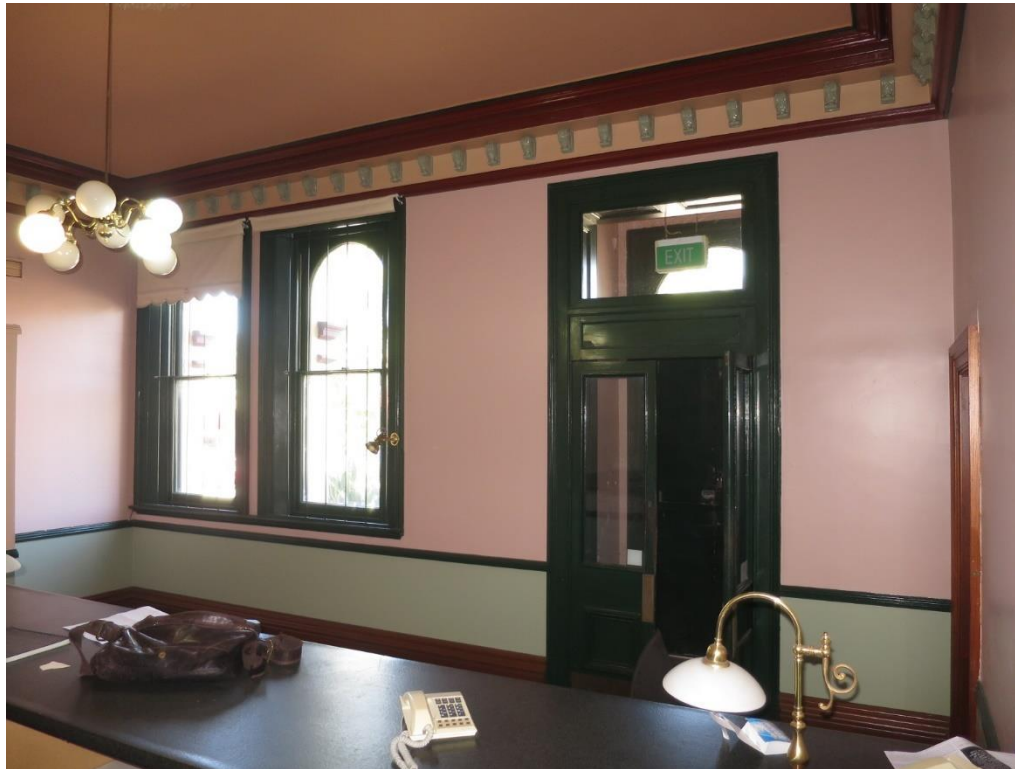
Figure 48 – the banking chamber G.01 showing the original entry doors and windows.

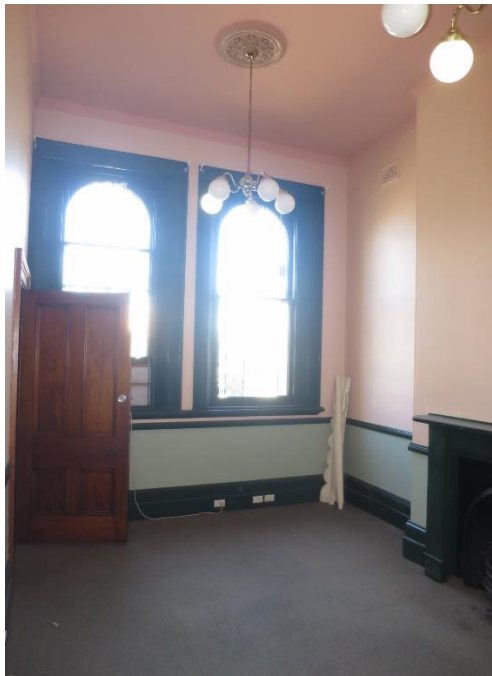
Figure 49 – original windows and skirting in G.03, bank manager's office.

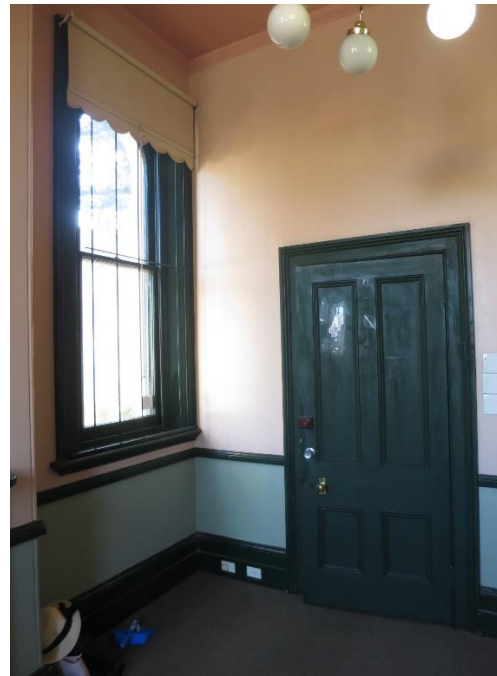
Figure 50 – original door and side elevation window in G.03 to be replicated in the conservation works.

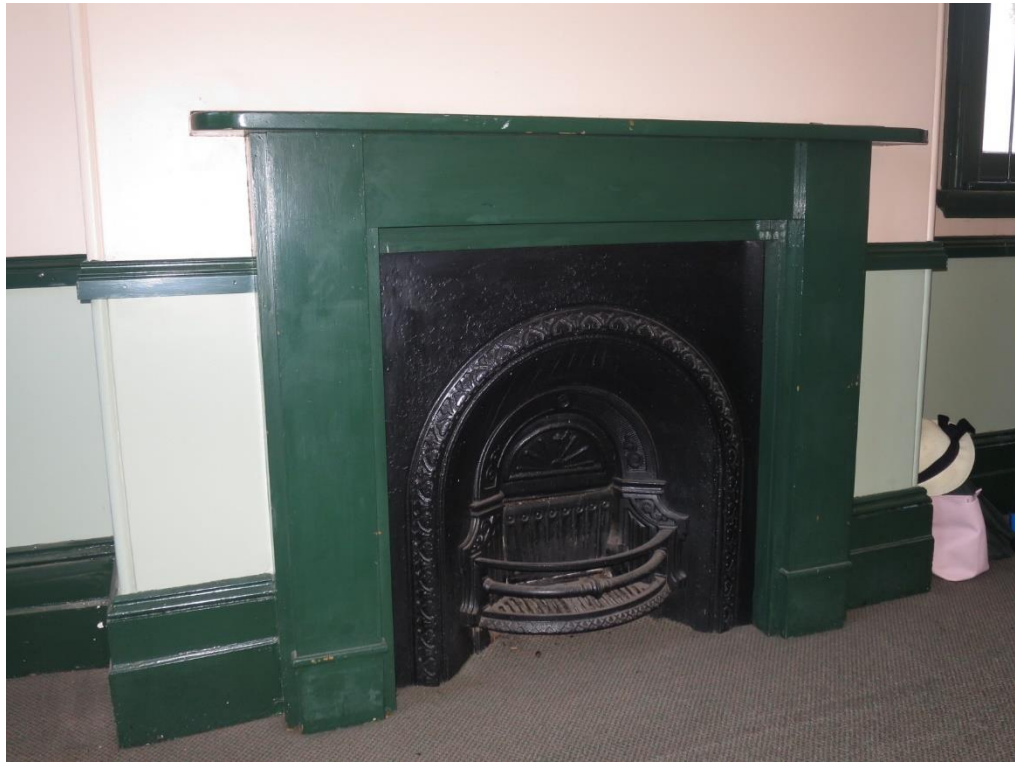
Figure 51 — likely original cast iron coal grate in G.03. the timber mantelpiece is recent and should be replaced with a Victorian design in marble. NBRSArchitecture February 2017.

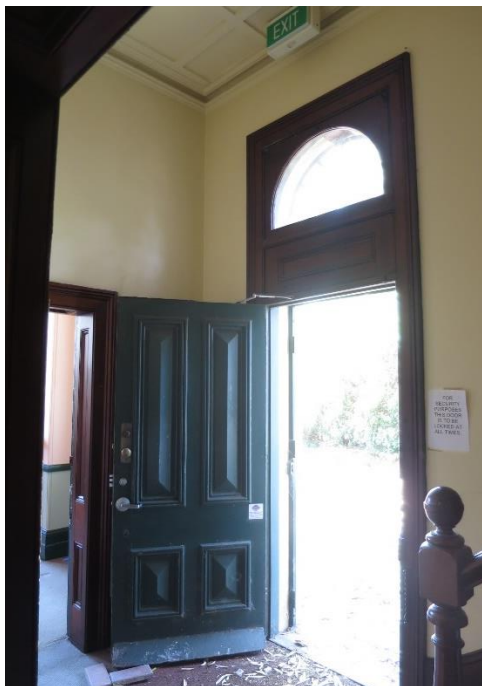
Figure 52 — the original door to the residence on the south-west side, original cornice. NBRSArchitecture February 2017.

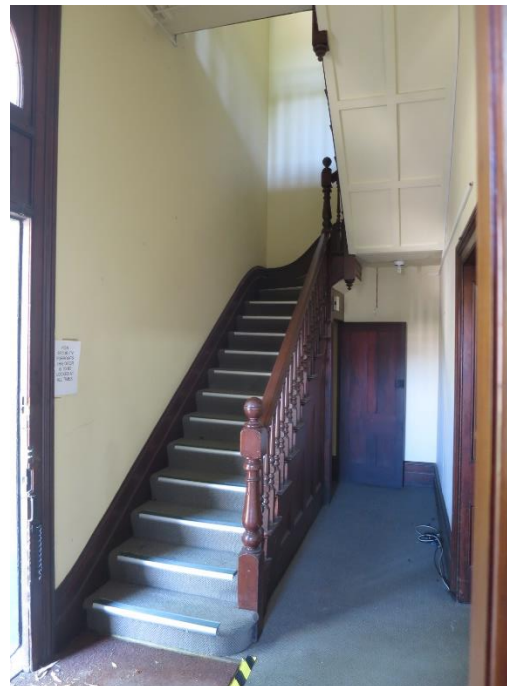
Figure 53 — the original stair, with more recent carpet and stays, in G.04. NBRSArchitecture February 2017.

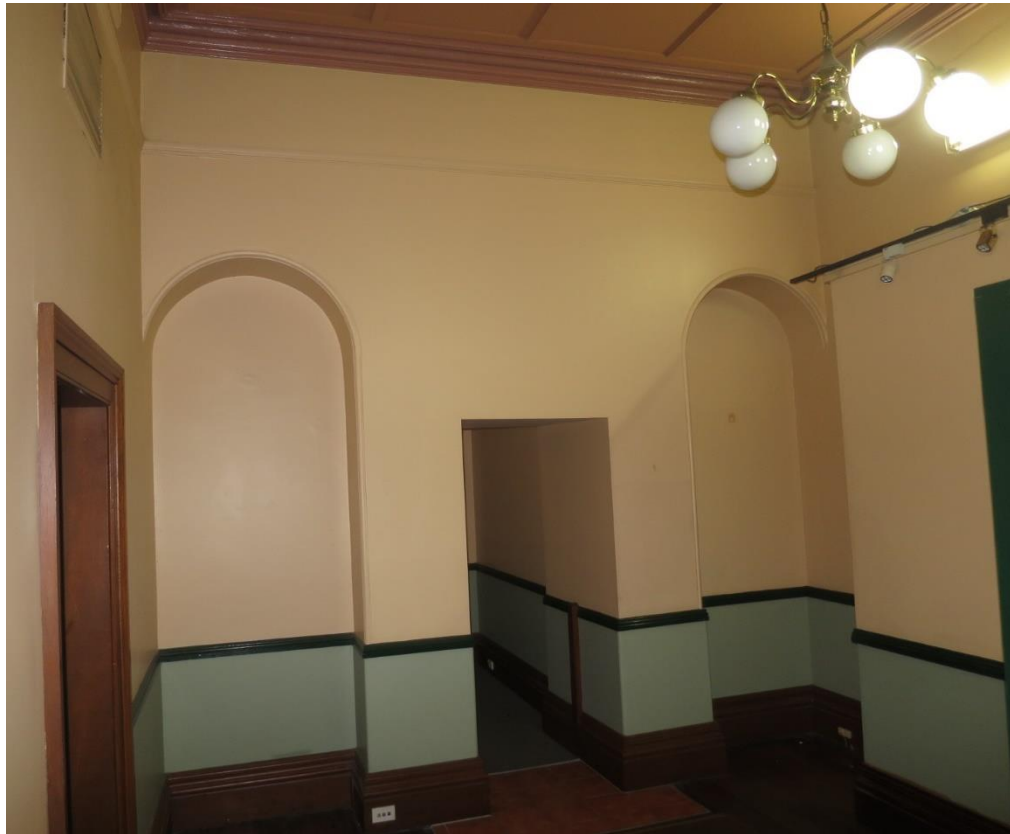
Figure 54 – the original dining room G.05 on the ground floor. The niches, skirting and cornice are original, but the central fireplace has been turned into a doorway to the former strong room. The chimney rises over the left niche.

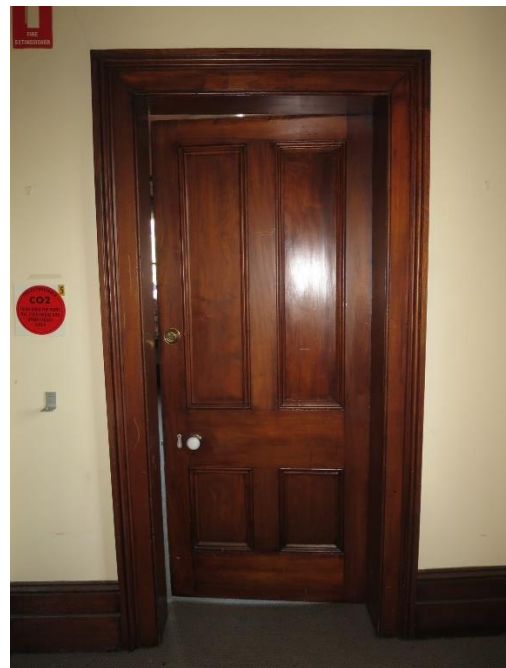
Figure 56 – the intact original door to the former drawing room 1.02. NBRSArchitecture February 2017.

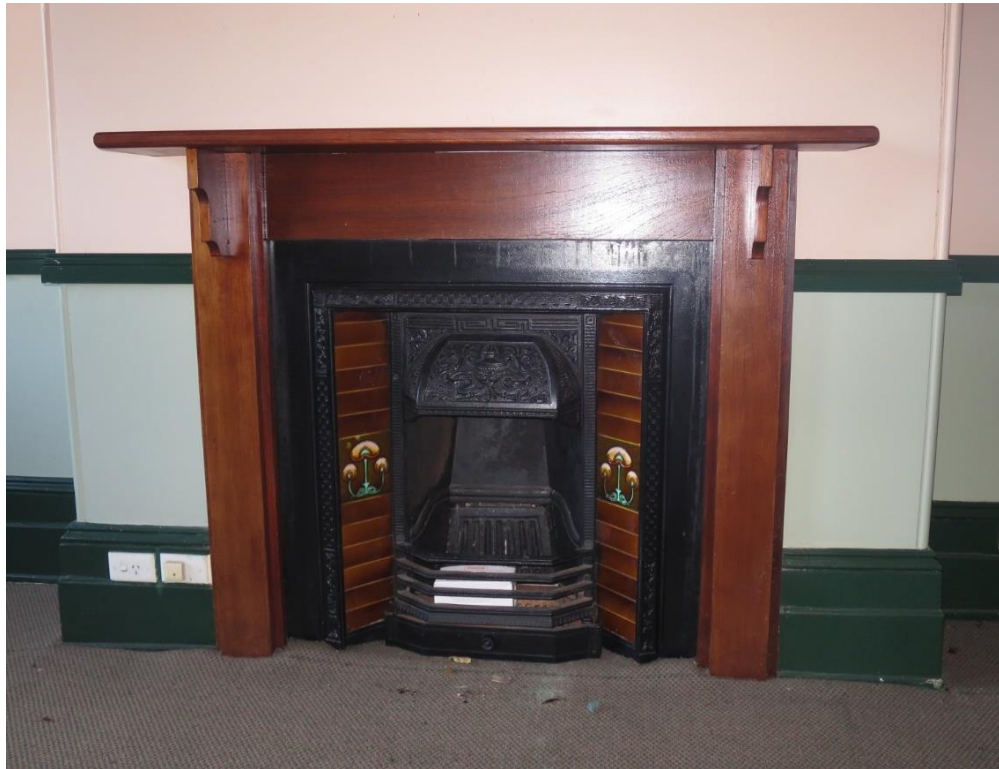
Figure 57 – the cast iron coal grates and their Art Nouveau tiles in rooms F.02 and F.04 are typical of 1910. They may have been installed after a late twentieth-century theft, rather than an early change. The hearth is bare sandstone under the carpet. The timber mantelpieces in these rooms are inappropriate and should be replaced with late Victorian style marble. The chair rails should be removed. NBRSArchitecture February 2017.

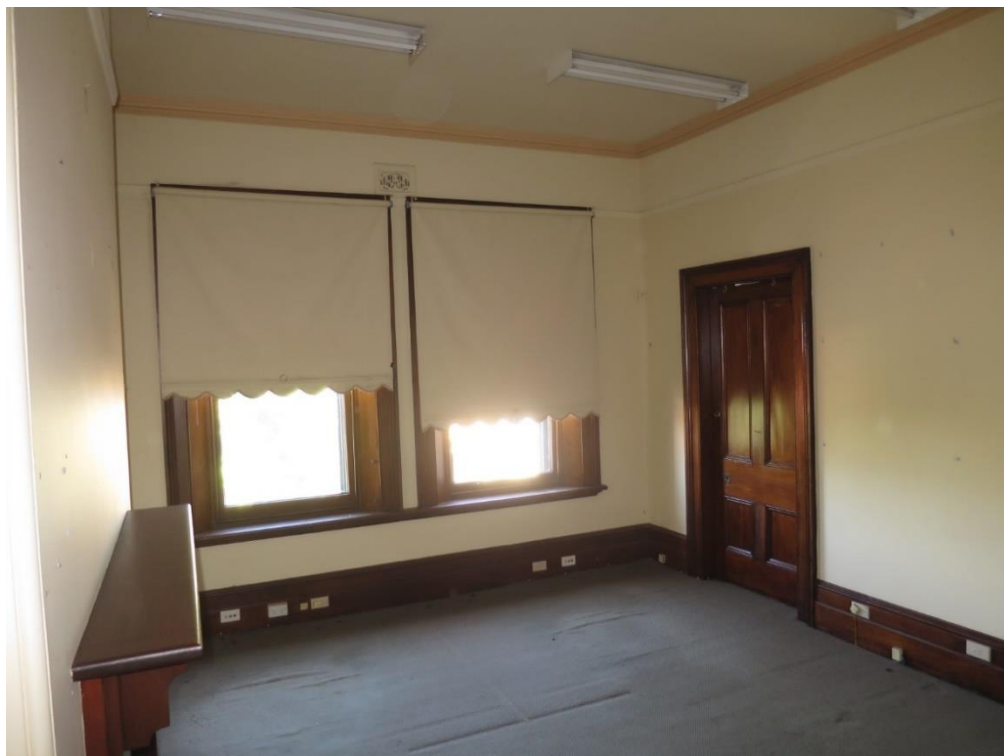
Figure 58 – Rom F.04 has original skirting, window, door and cornice. NBRSArchitecture February 2017.

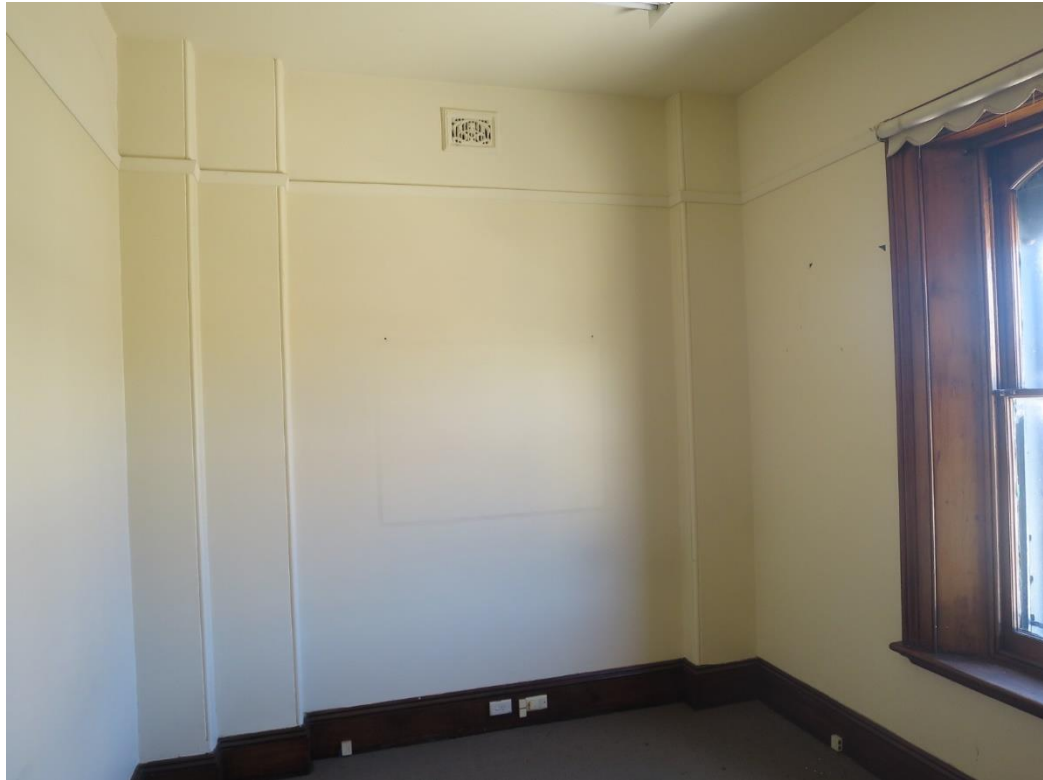
Figure 59 – Room 1.05 is a former bedroom with original door, skirting, window and staff moulds. The former chimney serving room G.05 rises on the left. NBRSArchitecture February 2017.

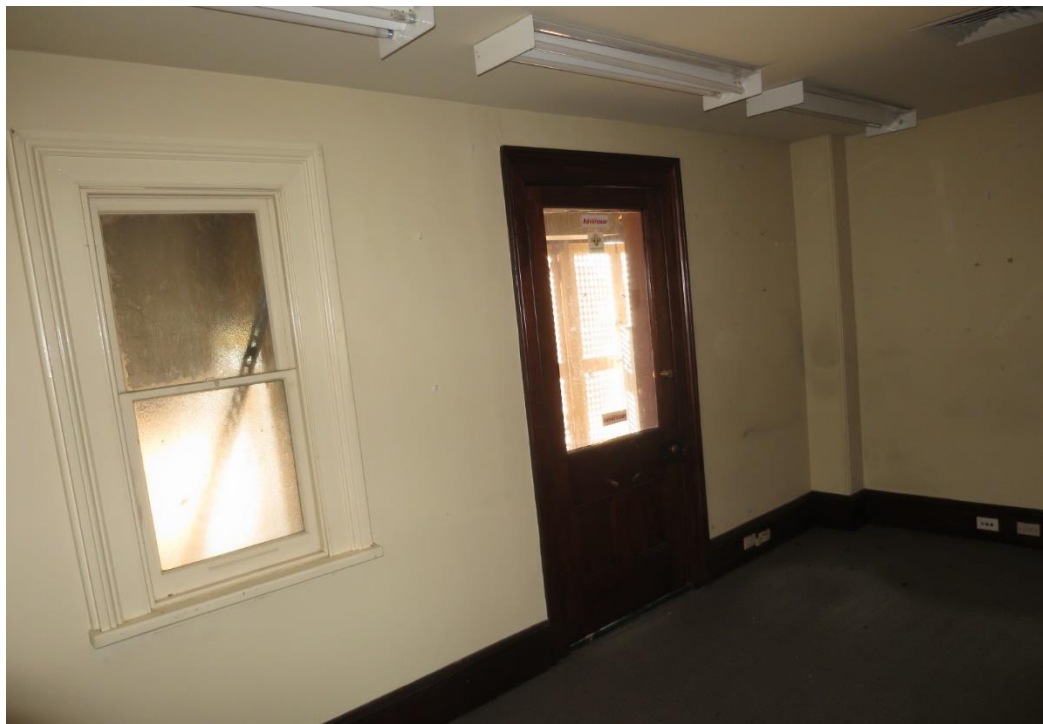
Figure 60 – Room 1.06m showing the original door that leads onto the rear verandah from the former bedroom, and the former bathroom window. There are two doors from the hall leading into this combined space. The low ceiling hides the air-conditioning distribution system. This door seen here has the only original lock and knob, apart from the entry doors. NBRSArchitecture February 2017.

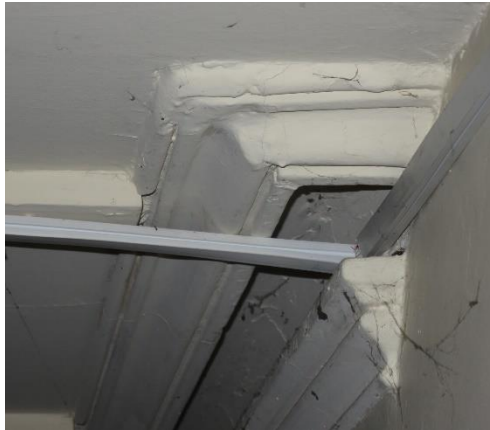
Figure 61 — a section of original whole cornice in the stair hall G.04. This is a good model for cornices in the former residential rooms that need to be reconstructed.

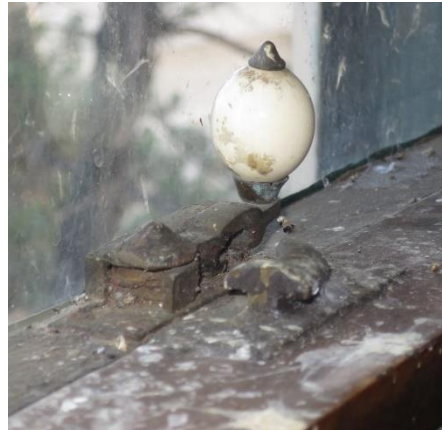
Figure 62 — an original brass and porcelain window catch that is a model for missing window fixtures. NBRSArchitecture February 2017.

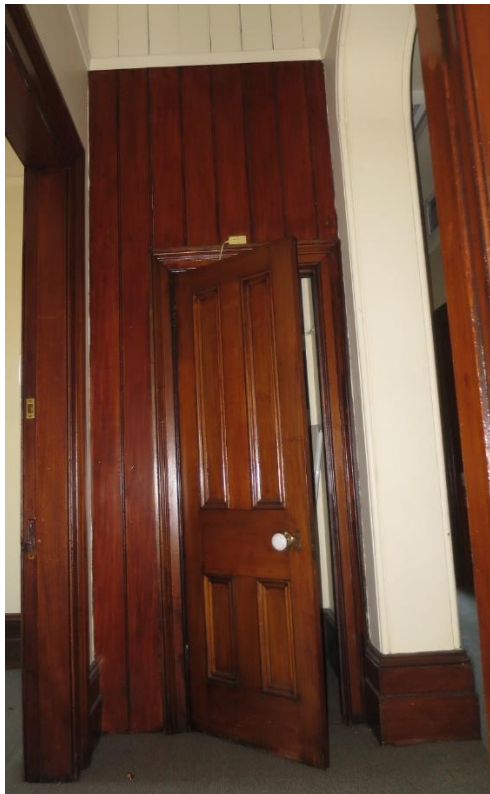
Figure 63 — original door to linen cupboard. NBRSArchitecture February 2017.

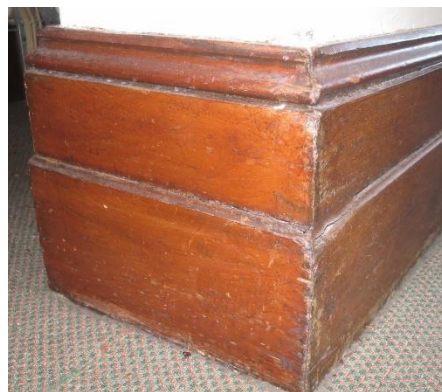
Figure 65 — standard original skirting on Level 1. NBRSArchitecture February 2017.

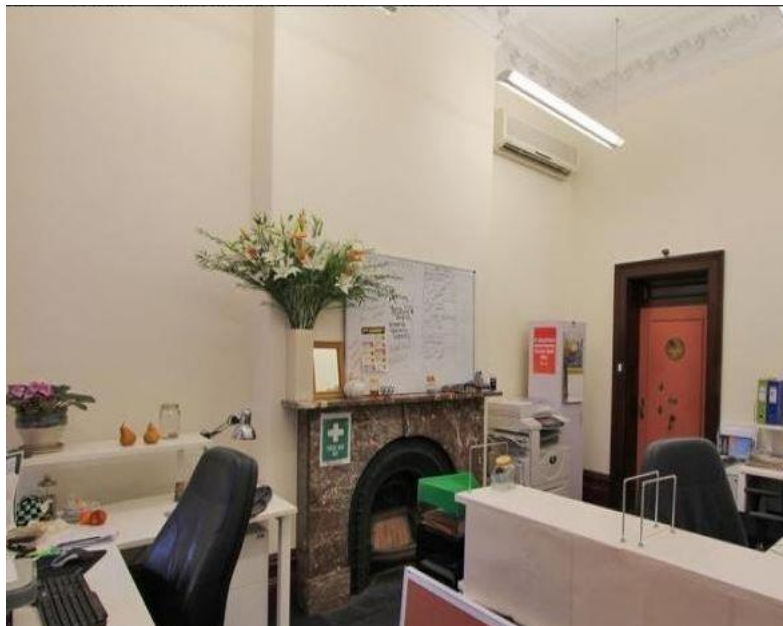
Figure 67 – the banking chamber at Kiama shows an original marble mantelpiece, strongroom door and grand cornice that would be appropriate here at Campbelltown. Source: <http://www.realcommercial.com.au/property-offices-nsw-kiama-5868026>

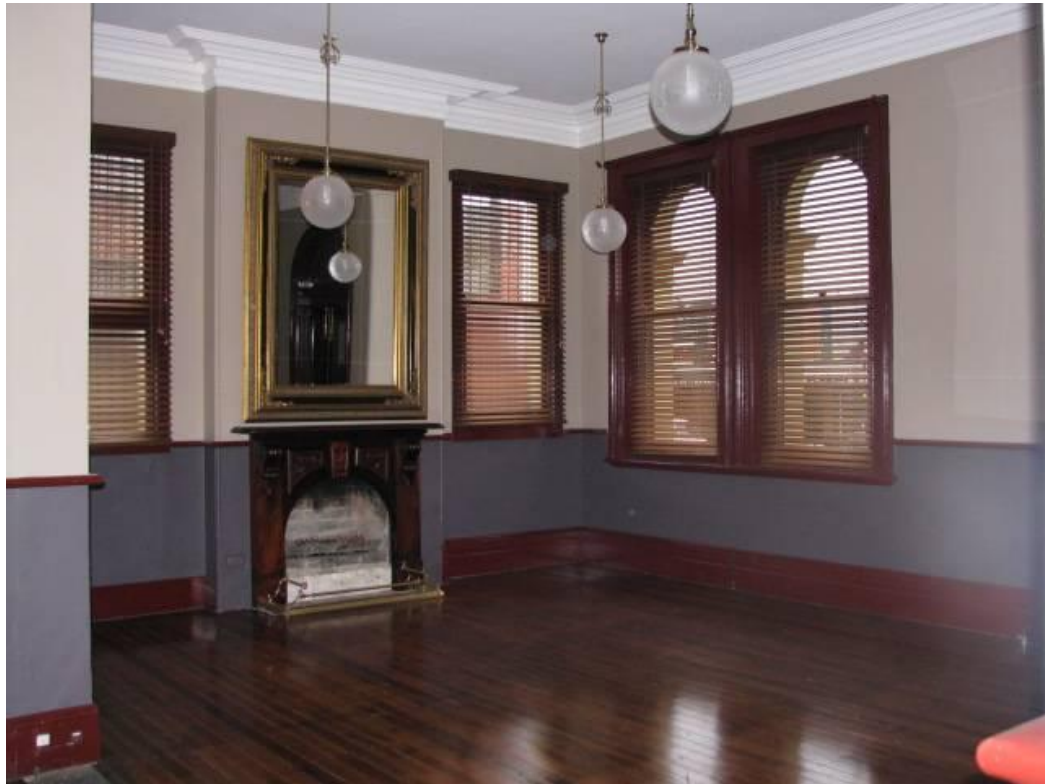
Figure 68 – the branch at Mittagong shows appropriate cornice and mantelpiece fixtures. Source: [http://www.onthehouse.com.au/2058376/83\\_main\\_st\\_mittagong\\_nsw\\_25752](http://www.onthehouse.com.au/2058376/83_main_st_mittagong_nsw_25752)

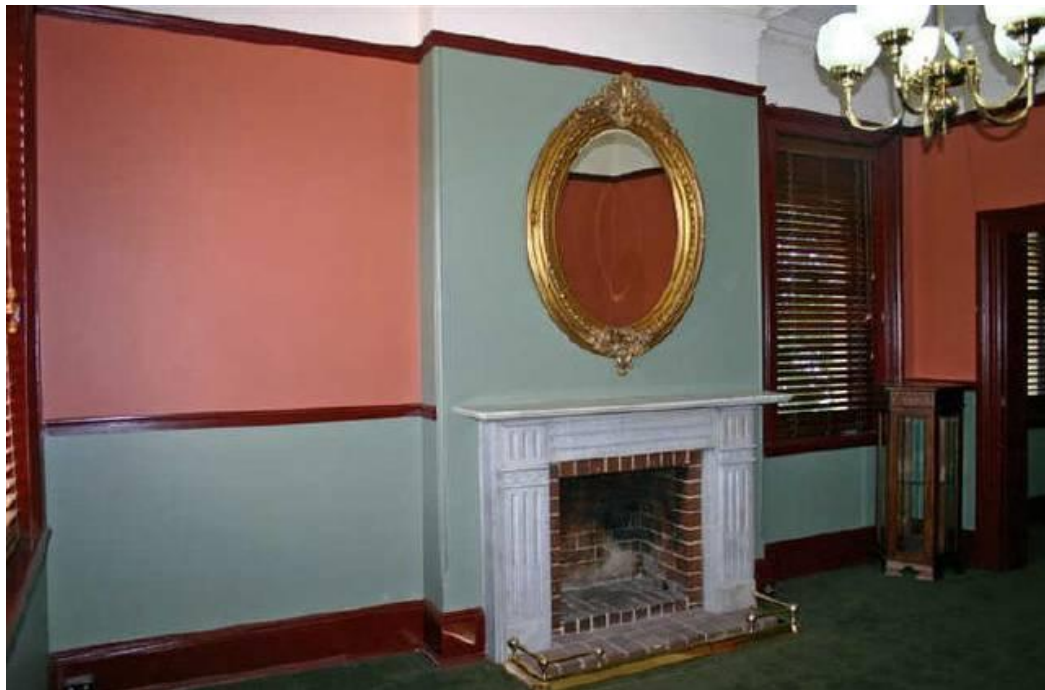
Figure 69 – the branch at Mittagong shows appropriate cornice and mantelpiece fixtures. Source: [http://www.onthehouse.com.au/2058376/83\\_main\\_st\\_mittagong\\_nsw\\_25752](http://www.onthehouse.com.au/2058376/83_main_st_mittagong_nsw_25752)

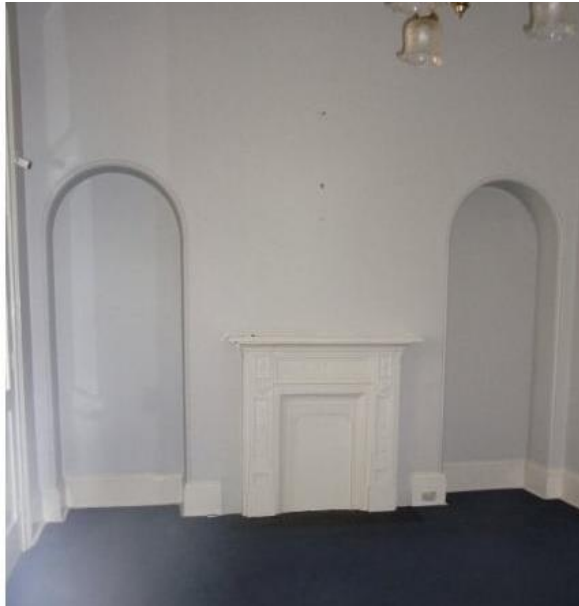
Figure 70 – the former dining room at Moss Vale shows how the fireplace in room G.05 should be conserved at Campbelltown. Source: <https://www.realestate.com.au/sold/property-house-nsw-moss+vale-116539067>

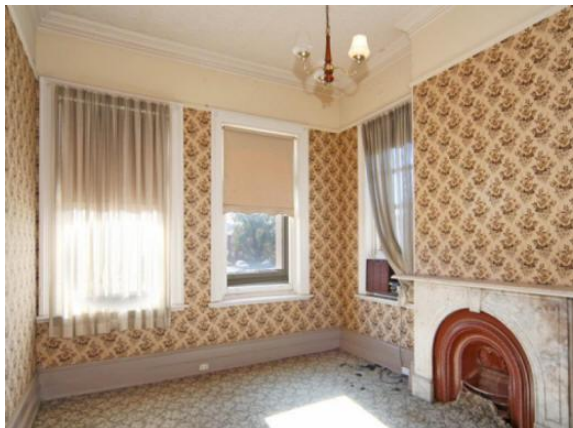
Figure 72 – a typical first floor bedroom at Richmond, showing appropriate mantelpiece and cornice. Source: CBC Officers' Club Inc [www.cbcbank.com.au](http://www.cbcbank.com.au)

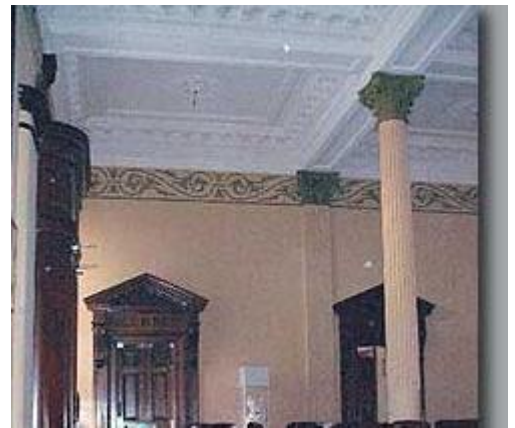
Figure 73 – although grander than Campbelltown, the Maitland branch shows the classical cornice favoured by Mansfield in banks. Source: CBC Officers' Club Inc [www.cbcbank.com.au](http://www.cbcbank.com.au)

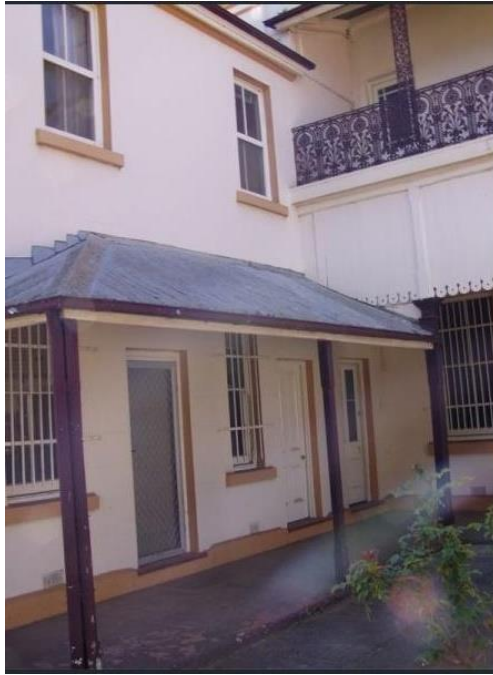
Figure 74 – the Molong branch is a good model for reconstruction of the rear verandah and service wing. Source: <https://www.realestate.com.au/property/46-bank-st-molong-nsw-2866>

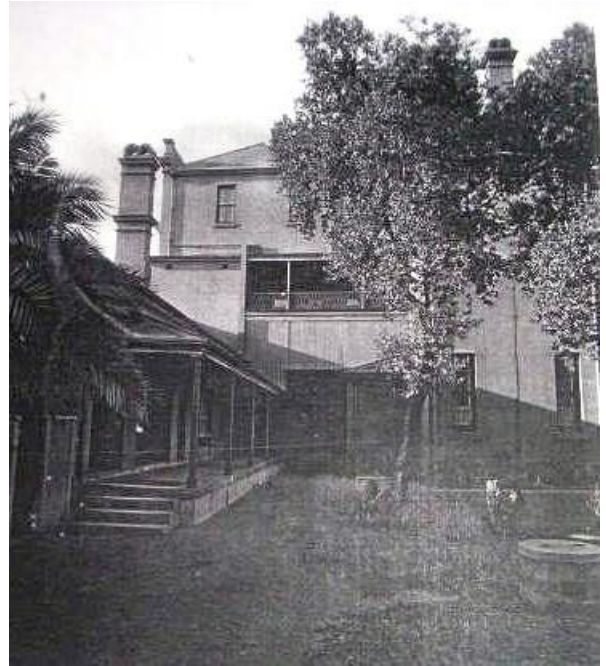
Figure 75 – this early photograph of the rear of the Maitland branch show typical construction for the rear verandah and service wing. Source: CBC Officers' Club Inc [www.cbcbank.com.au](http://www.cbcbank.com.au)
