# CONSERVATION MANAGEMENT PLAN

263 Queen Street Campbelltown NSW 2560

MARCH 2017

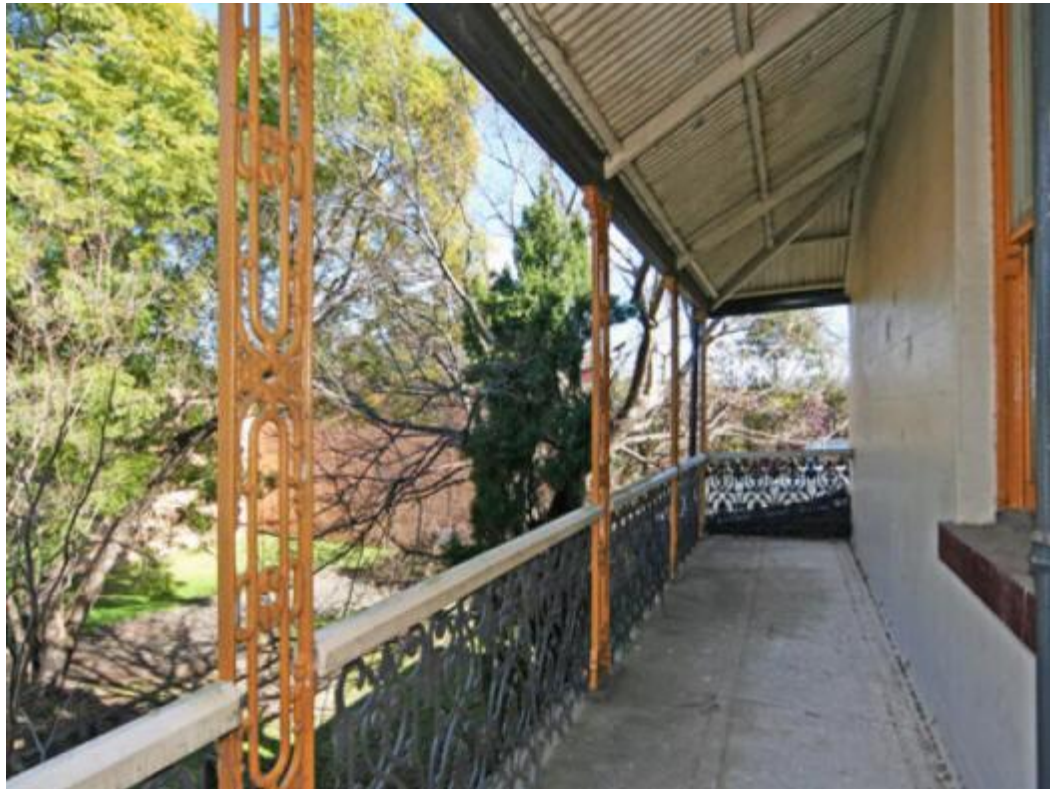
Figure 78 — the rear verandah of the bank at Richmond is a good model for Campbelltown. Source: CBC Officers' Club Inc [www.cbcbank.com.au](http://www.cbcbank.com.au)

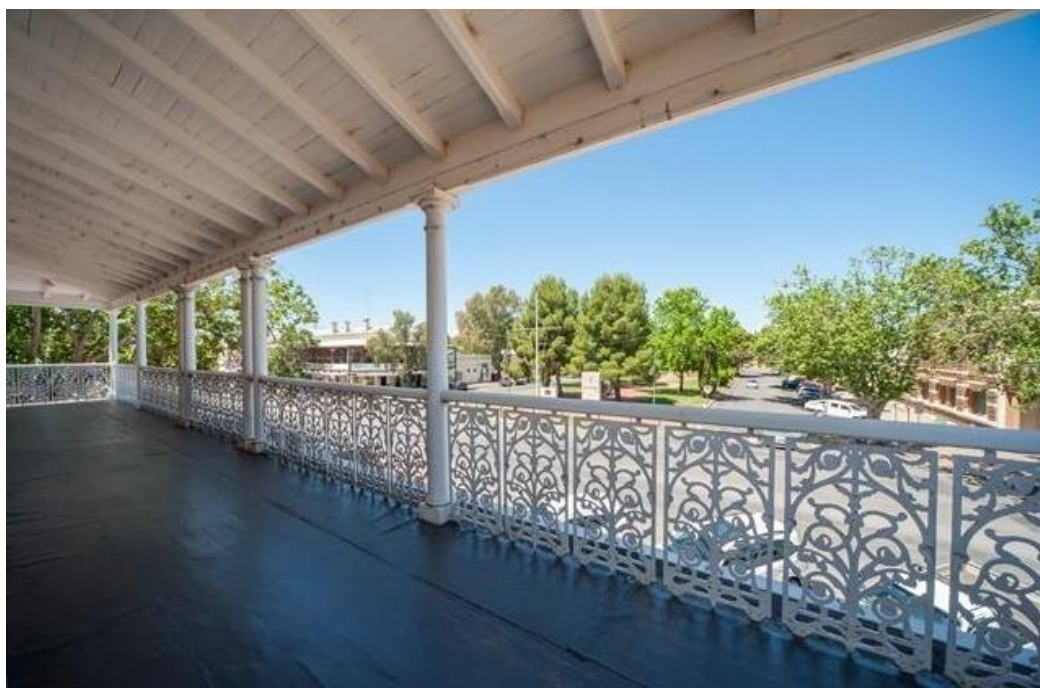
Figure 79 — the rear verandah of the bank at Narrandra is a good model for Campbelltown. Source: CBC Officers' Club Inc [www.cbcbank.com.au](http://www.cbcbank.com.au)

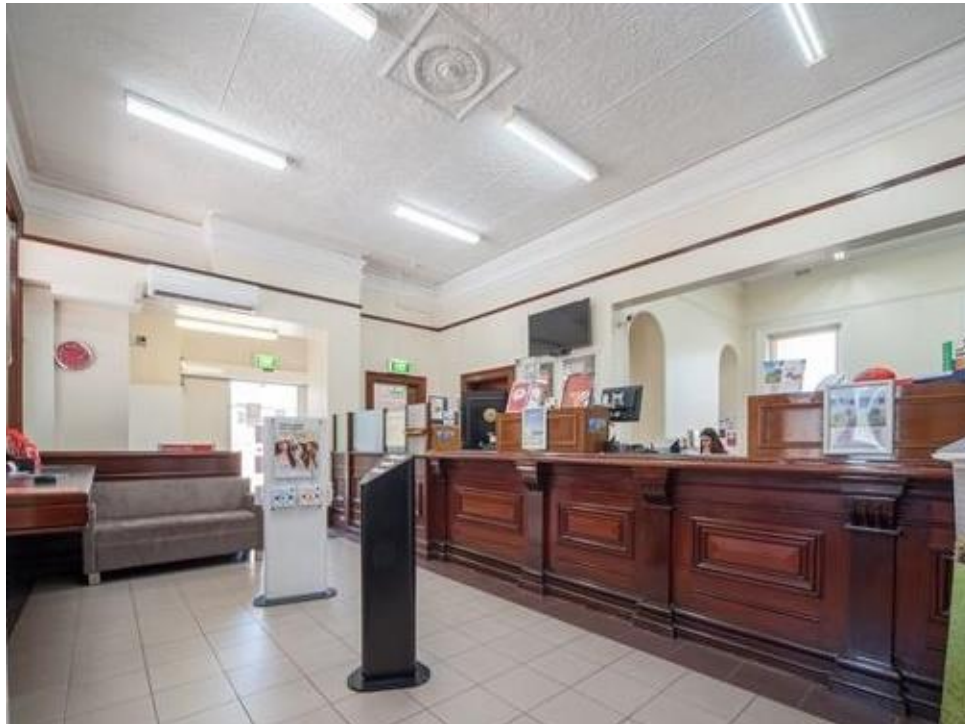
Figure 80 – if an appropriate counter is desired, this one at the Narrandera branch appears to be original to Mansfield's design. This branch shows a pressed metal ceiling, more likely in buildings distant from city trades. Source: CBC Officers' Club Inc [www.cbcbank.com.au](http://www.cbcbank.com.au)

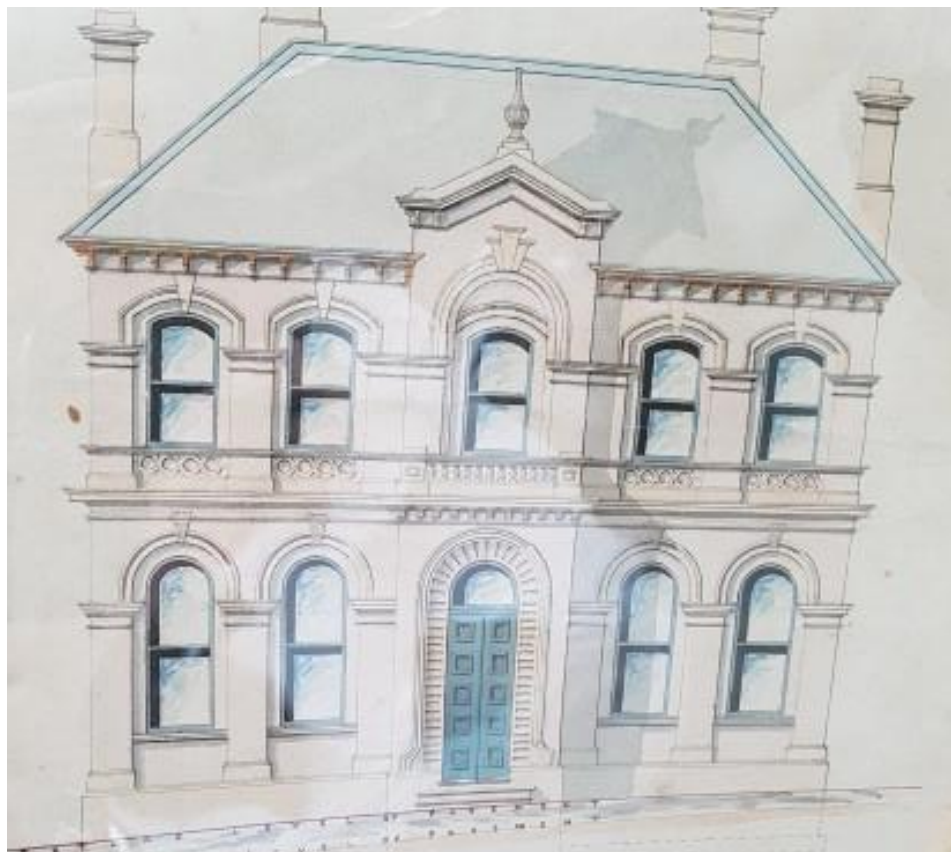
Figure 81 – Mansfield's design drawing for Maitland, similar to Campbelltown. Source: NSWSL PXD 954

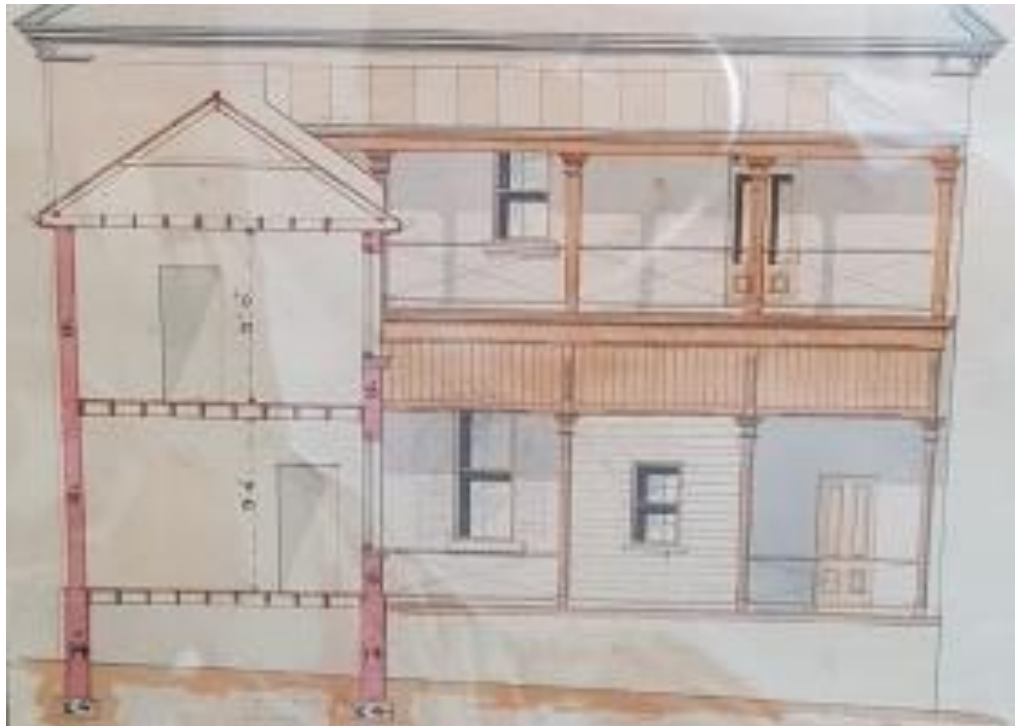
Figure 82 – Mansfield's design drawing for the rear elevation of the Maitland branch. Source: NSWSL PXD 954

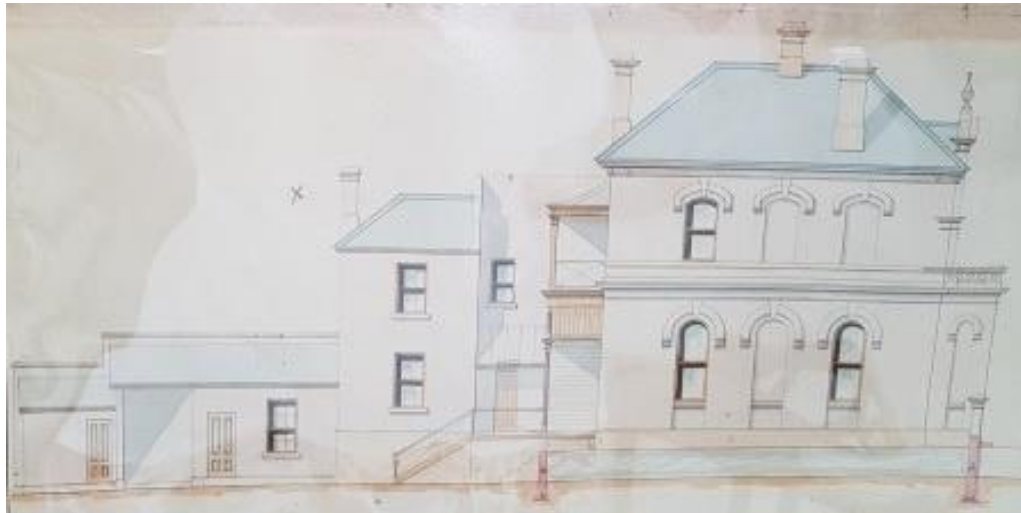
Figure 84 — Mansfield's design drawing for the side elevation of the Maitland branch. Source: NSWSL PXD 954

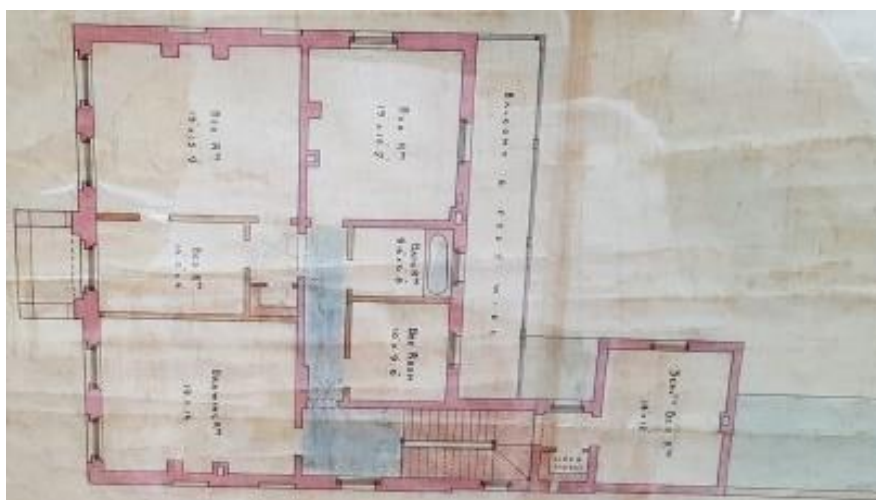
Figure 86 — Mansfield's design drawing for the first floor of the Maitland branch, which is almost the mirror image of Campbelltown. Source: NSWSL PXD 954

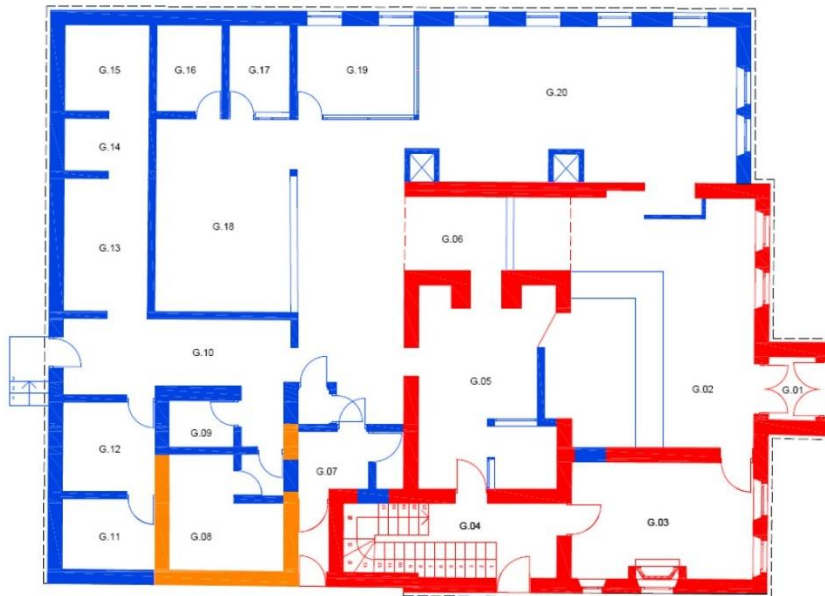
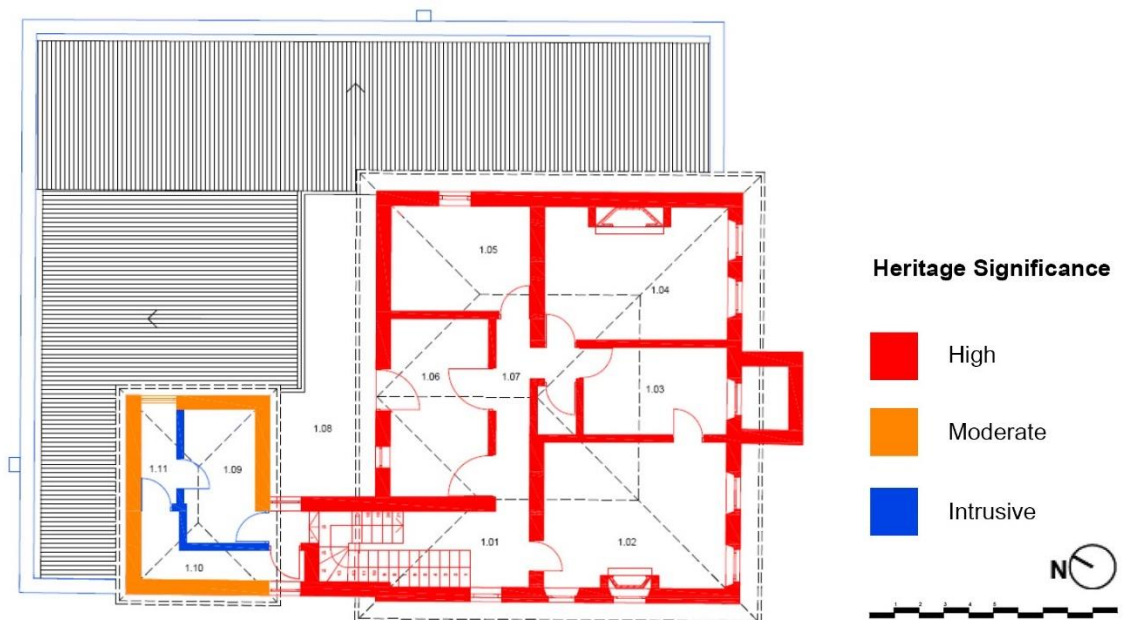
### Floor Plans

Figure 88 — Heritage significance of built fabric focussed on the eras of construction. Scale: 1:200

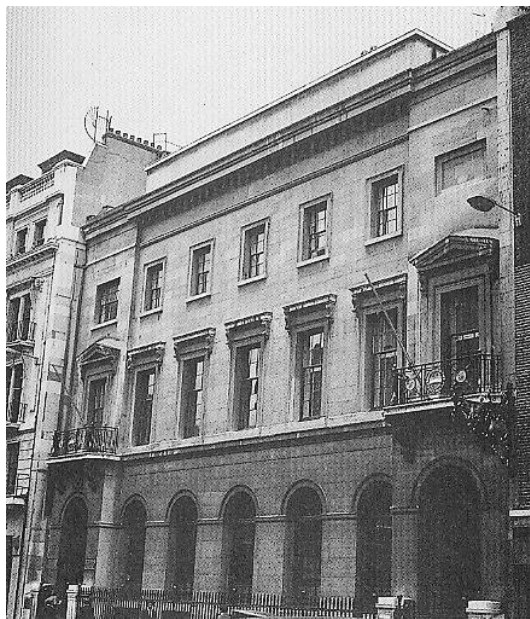
Figure 89 – The first Italianate bank in London, for Hoare & Co at 37 Fleet Street. Built 1829–30 to Charles Parker's design. The architectural language of this bank was often the first choice for bank design in Australia. (source: Booker, *Temples of Mammon*, p 39)

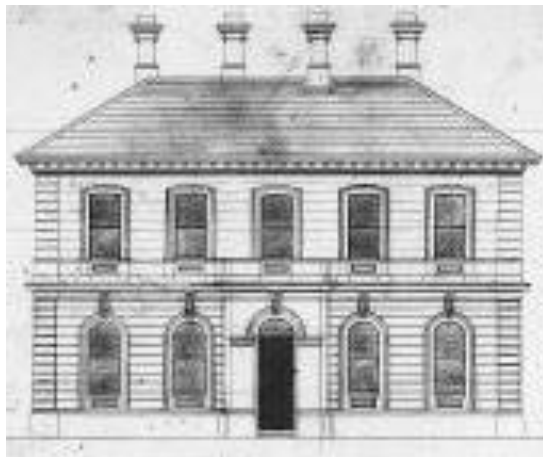
Figure 90 – Street elevation of the former Bank of New South Wales branch, Bathurst, by Edmund Blacket. This was among the first three branches design 1856–59 for the Bank of New South Wales by Blacket. The similarity with the CBC branch at Campbelltown shows how this early model influenced the design of many architects designing for many bank clients in the second half of the Nineteenth Century. (source: Mitchell Library, D215–1; 41)
