STATEMENT OF HERITAGE IMPACT

Dawn Fraser Baths, Balmain

October 2018

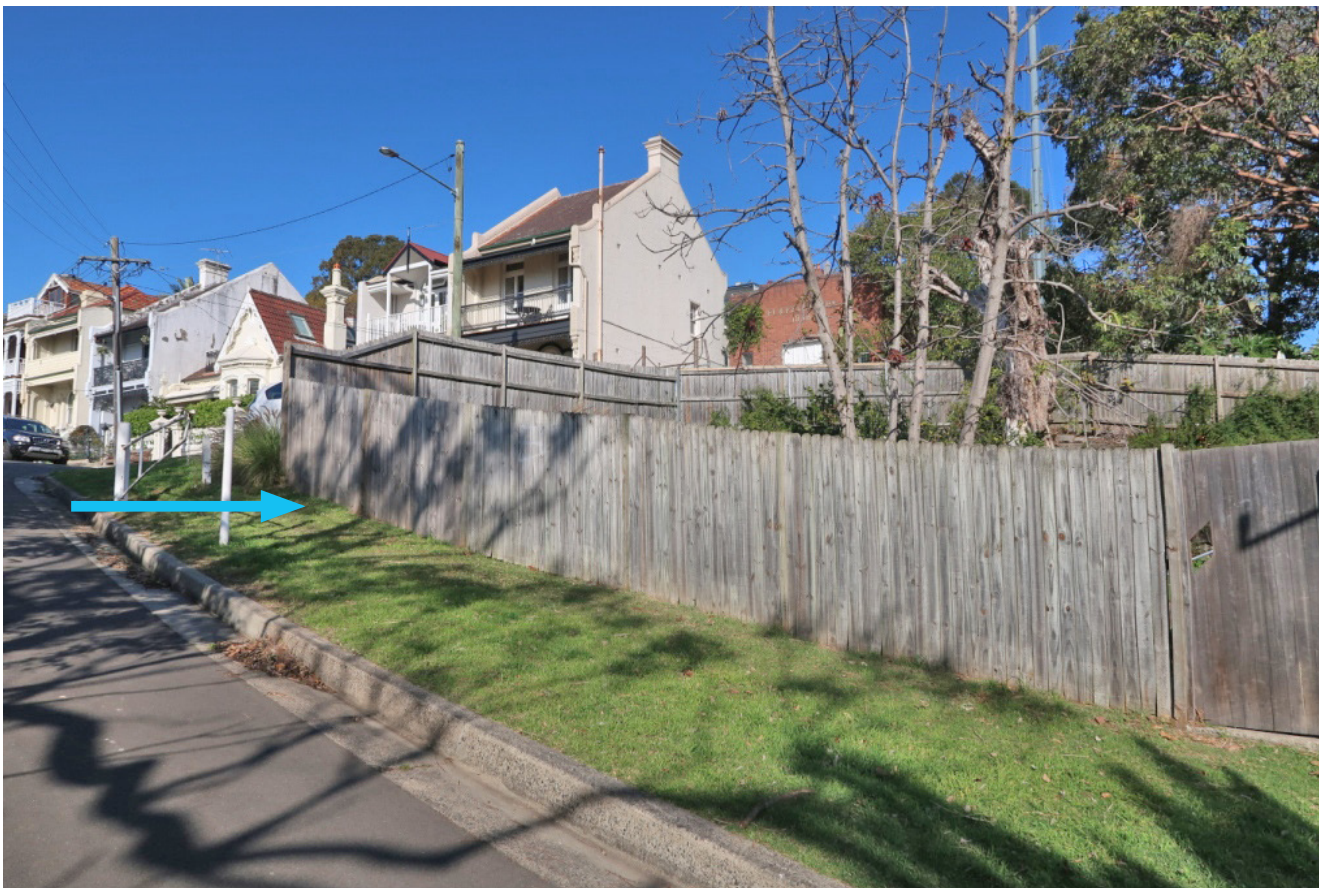
Figure 3.6 (below)
Photograph of Fitzroy Avenue looking south-east. The proposed location of the sprinkler booster and valves is indicated with a blue arrow. Visible is the rear yard to the Elkington Park Caretaker's Cottage. It is understood that the rear pailing fence is higher than the proposed installation

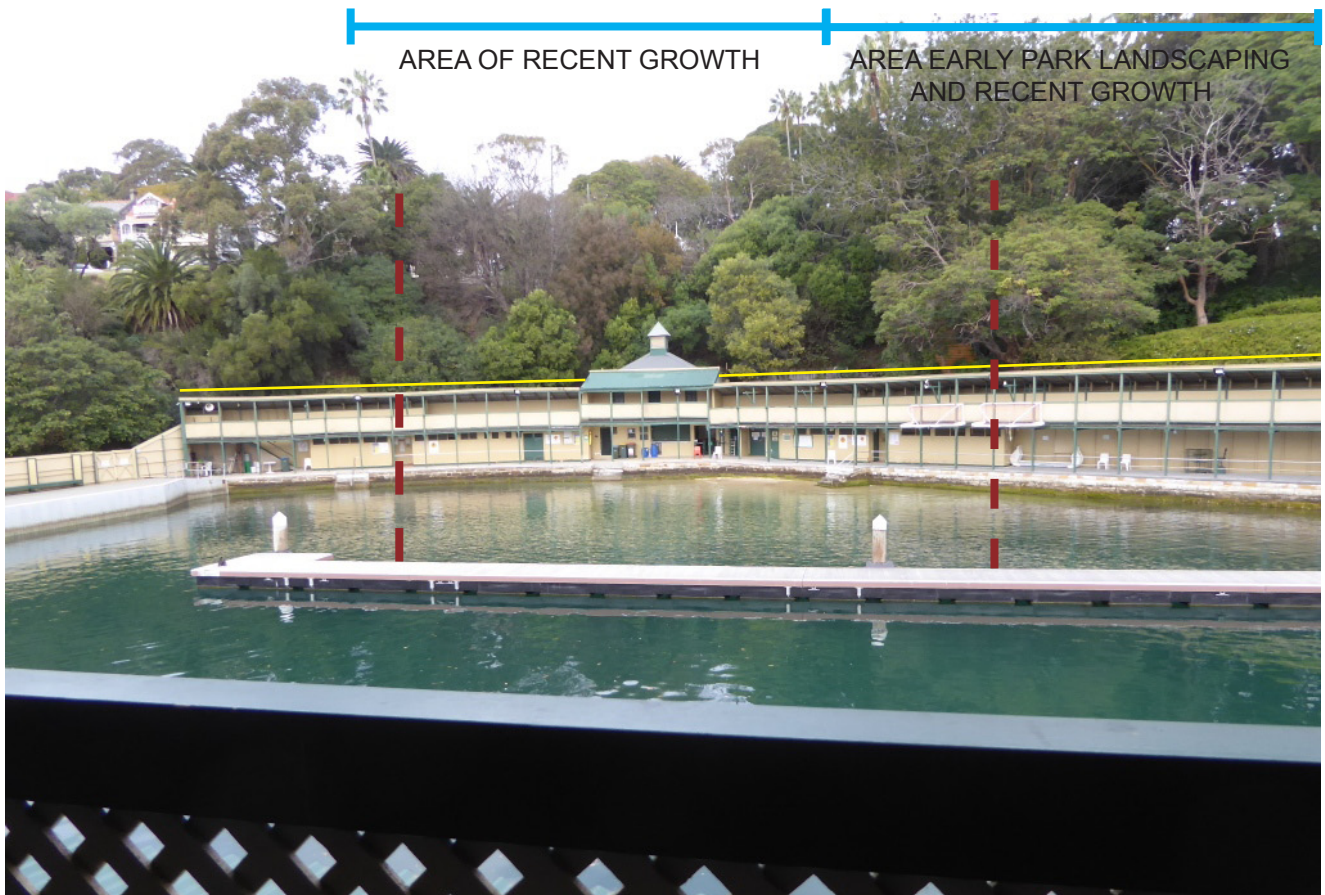
Figure 3.8 (below)

View from the northern pavilion first floor. The approximate location of the proposed water polo lights are shown with red dashed lines and the raised pavilion wings with yellow lines. From this perspective, views towards early Elkington Park plantings on the western side (right) will be partly obscured by one light pole

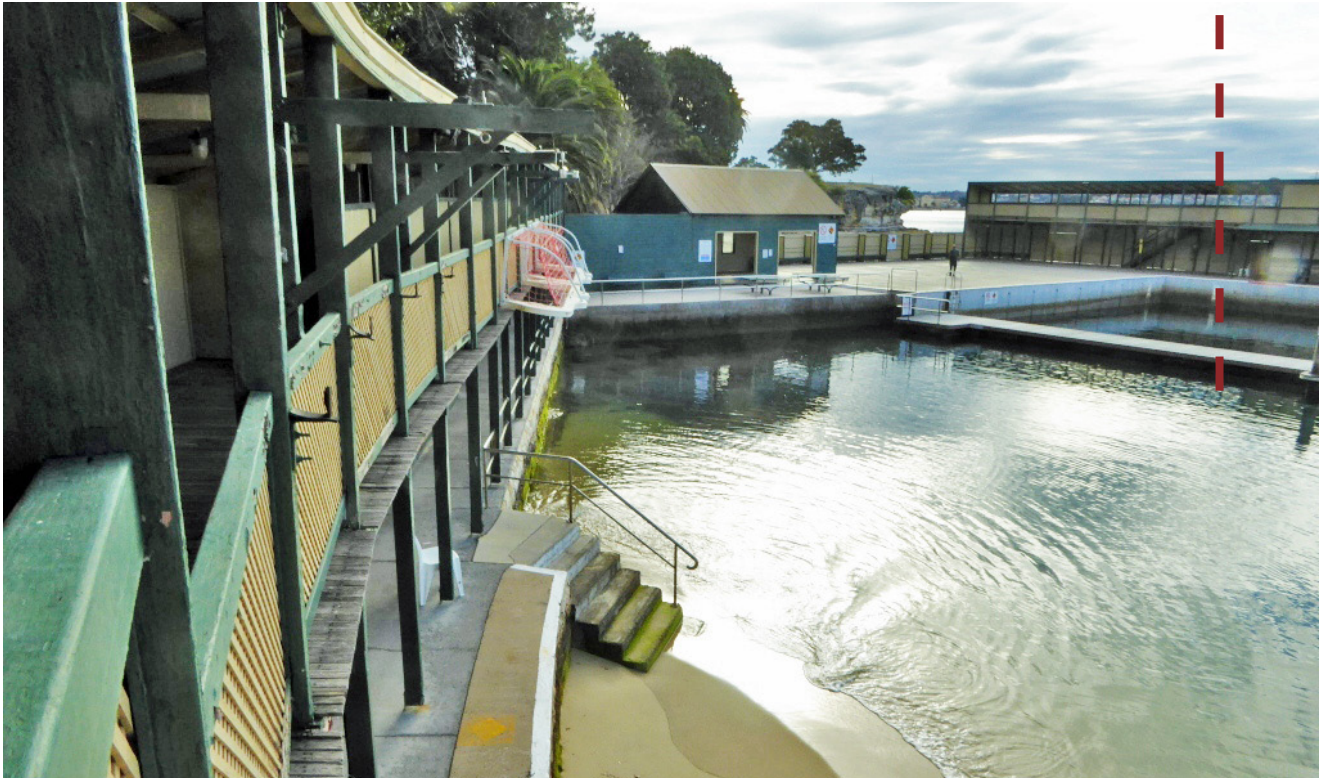
Figure 3.9 (above)

View towards White Horse Point in Elkington Park from the eastern first floor end of the Southern Pavilion. The approximate location of one proposed lighting poles are indicated with a dashed red line. The other proposed poles are further east (right), out of the photograph

The proposed water polo lights and raised Southern Pavilion wings will impact views to and the setting of Elkington Park from limited areas of the baths. As shown in figure 3.9, the proposed water polo poles will not disrupt any views of White Horse Point (in Elkington Park) from the Southern Pavilion. The poles will partly impact views to early plantings within Elkington Park from areas within the Northern Pavilion and the western boardwalk. The heritage impact would, however, be minor. Elkington Park was primarily designed to be viewed from within the park, not from the baths and, as such, this is not a historically significant view for the Park. The existing park setting has also changed considerably in recent decades. As is visible in a 1961 aerial photograph and indicated on a contemporary photograph from the northern pavilion (see figures 3.7 and 3.8), the significant early plantings related with Elkington Park were a backdrop to the western side of the southern pavilion, largely on the upper slopes, while the remaining area was largely devoid of trees. In recent decades, dense vegetation has filled the historically open areas on the slopes with dense new growth, thereby diminishing the historic setting of the park from this perspective. The light poles are also slender and would only obscure a limited part of any views to the park. The proposed lighting poles would not visually dominate Elkington Park. The raised pavilion wings (680 mm higher) would have very little impact on views to early park plantings, which are generally higher up the adjacent slope. The proposed water polo lights and raised pavilion wings would have an acceptable impact on views to and the setting of Elkington Park.

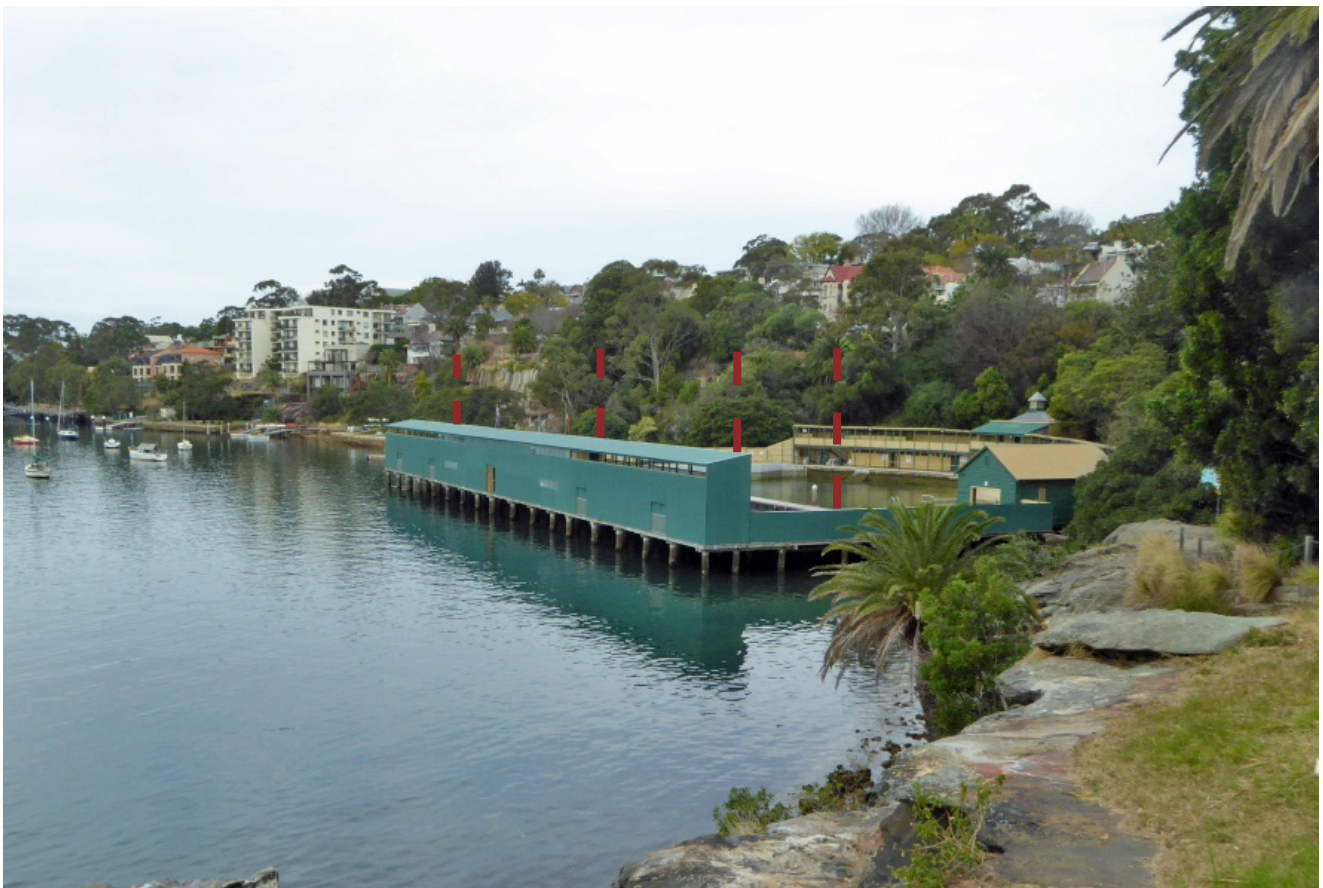
Figure 3.10 (below)

View from White Horse Point towards the Iron Cove Conservation Area (HCA). Fitzroy Avenue Park, beyond the baths, features tree growth that has little heritage significance. The approximate location and height of the proposed poles is shown with dashed lines, and would not obscure views of houses in the HCA

The proposed works are required to retain the existing function and significant aspects of two landmark features in the Iron Cove Heritage Conservation Area (HCA); Elkington Park and the Dawn Fraser Baths. The proposed works will be visible from limited viewpoints within the HCA. The proposed water polo lighting poles will visually confirm the baths as a high quality aquatic sporting venue in views around the facility. The poles will slightly reduce views of the HCA from White Horse Point but this is likely to be restricted to the rock walls of Fitzroy Avenue Park and not to the houses above, as illustrated in Figure 3.10. The proposed works will be required to retain significant aspects of the HCA and, on balance, will have a positive heritage impact.
