PROJECT TITLE  
**Domremy College Solais Project**

DRAWING TITLE  
**PROPOSED SITE PLAN**

## DOMREMY COLLEGE SOLAIS LAB PROJECT

### STORMWATER MANAGMENT CONCEPT PLAN – CIVIL ENGINEERING

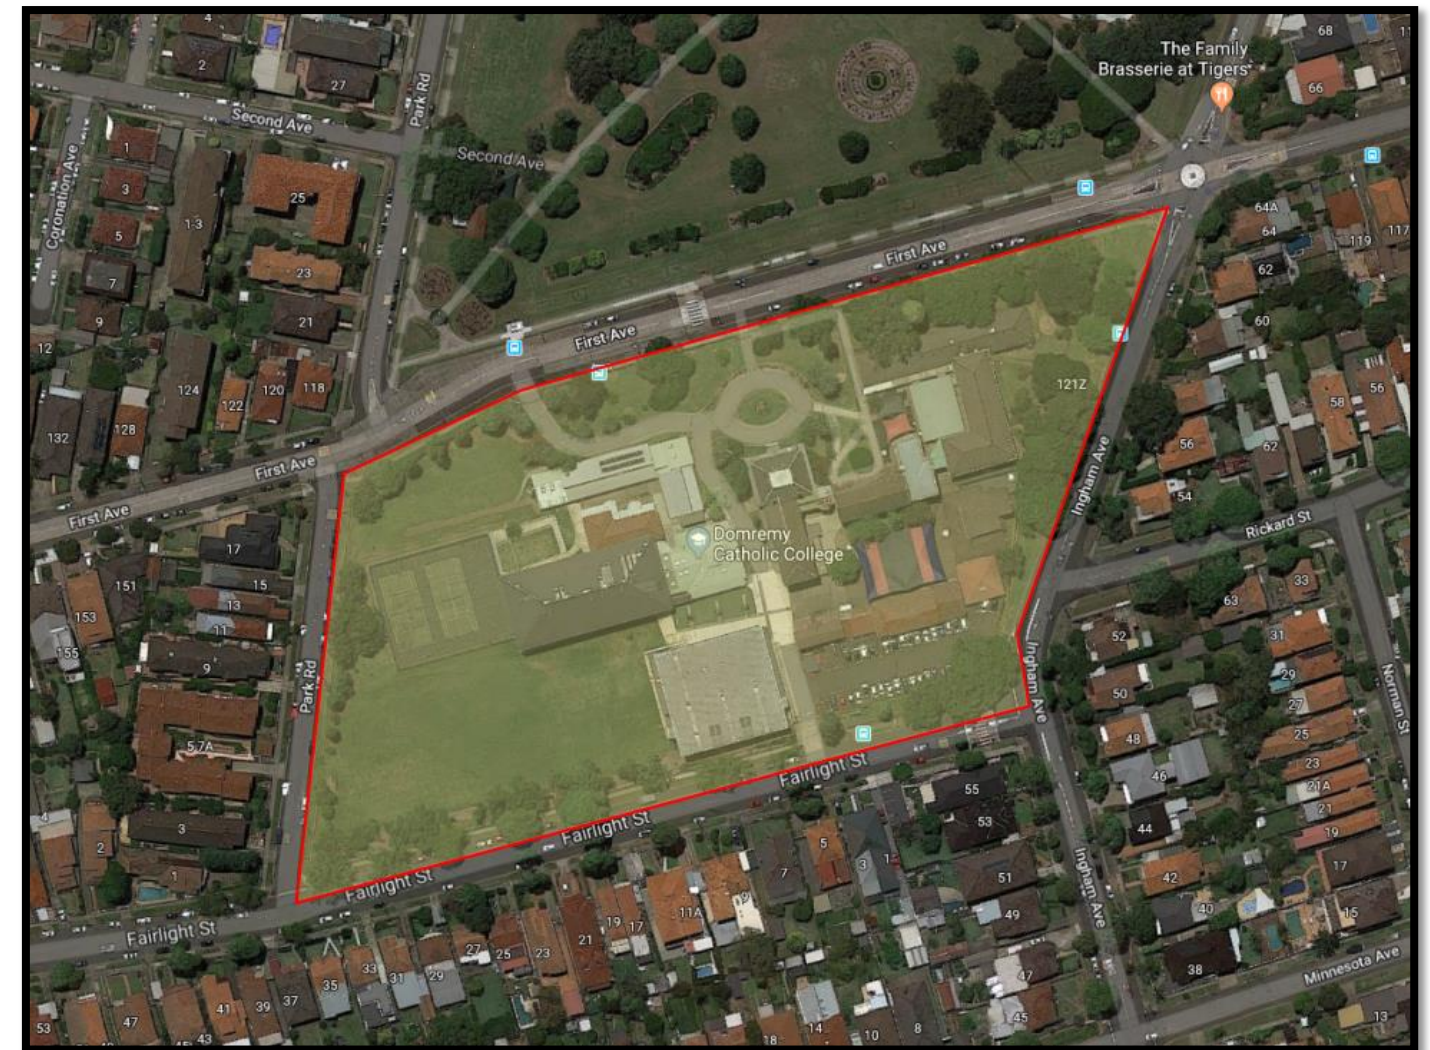
Figure 1: Site Location Plan

The existing site is located in the Domremy College campus at 121 First Avenue in Five Dock, NSW. The site, depicted on Figure 1, is bounded by First Avenue to the north, Ingham Avenue to the east, Fairlight Street to the south and Park Road to the west. Domremy College is situated in a suburban residential area and adjoins Five Dock Park at its northern boundary.

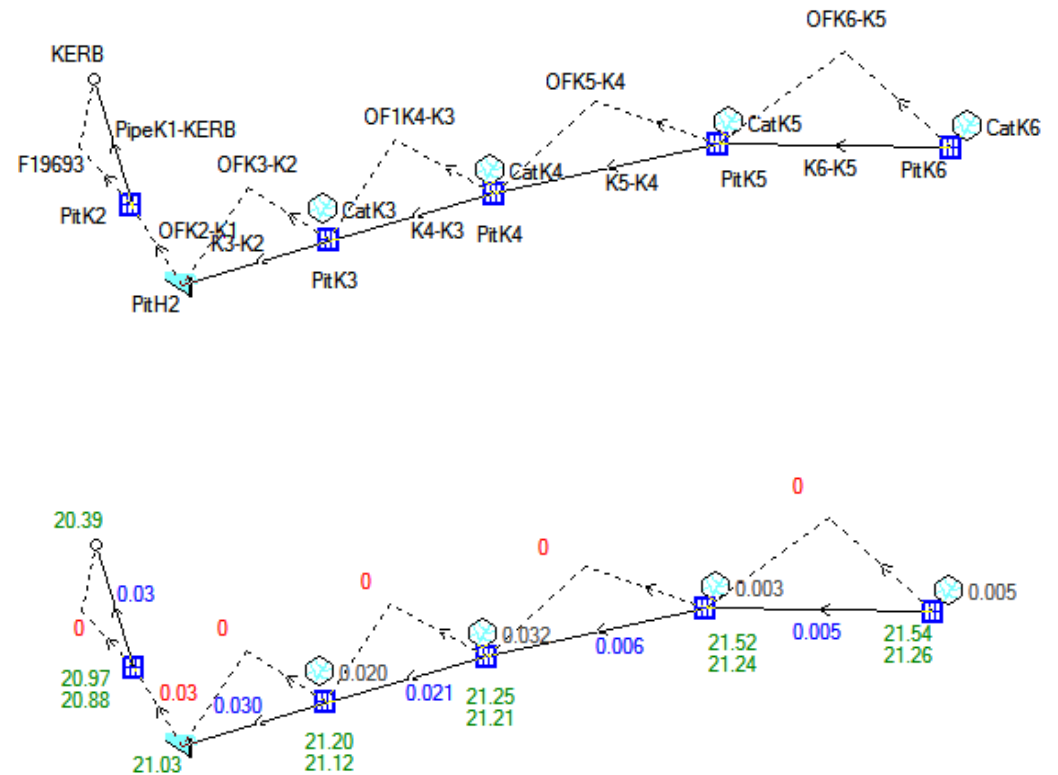
DRAINS File Path:		P:\1-5500\5503\00 - Enstruct Documents\0.3 - Analysis\Civil\OSD\DRAINS\CARPARK																				
DRAINS Version:		DRAINS Version 2017.11 - 26 Oct 2017																				
Modeller's Name:		Miqueas Moreno																				
Description:		CAR PARK Area																				
PIT / NODE DETAILS																						
Version 13																						
Name	Type	Family	Size	Ponding Volume (cu.m)	Pressure Change Coeff. Ku	Surface Elev (m)	Max Pond Depth (m)	Base Inflow (cu.m/s)	Blocking Factor	x	y	Bolt-down lid	id	Part Full Shock Loss	Inflow Hydrograph	Pit is						
PitH6	Sag	NSW RTA SO V-Channel Pit	Single SO1 Pit	1	1.9	21.51	0.15	0	0.5	681.52	-746.32	No	3627822	1 x Ku	No	New						
PitH5	Sag	Hornsby Council Inlets (K14)	Hornsby 0.9 m lin	1.96	1.2	21.5	0.07	0	0.5	500.08	-743.44	No	3627813	1 x Ku	No	New						
PitH4	Sag	NSW RTA SO V-Channel Pit	Single SO1 Pit	24	2.2	21.2	0.15	0	0.5	322.96	-782.32	No	3627815	1 x Ku	No	New

PitH3	Sag	NSW RTA SO V-Channel Pit	Single SO1 Pit	20	1.3	21.15	0.15	0	0.5	193.36	-819.76	No	3627818	1 x Ku	No	New						
PitF2	Sag	GRATE P-50 PITS	450sq GRATE-P3	2	2	20.9	0.2	0	0.5	39.28	-790.96	No	3627910	1 x Ku	No	New						
KERB	Node					20.25			0		9.04	-693.04		3627936		No						
DETENTION BASIN DETAILS																						
Name	Elev	Surf. Area	Not Used	Outlet Type	K	Dia(mm)	Centre RL	Pit Family	Pit Type	x	y	HED	Crest RL	Crest Length	id							
PitH2	19.84	21	1	None						78.16	-854.32	No		3627928								
SUB-CATCHMENT DETAILS																						
Name	Pit or Node	Total Area (ha)	Paved Area %	Grass Area %	Supp Area %	Paved Time (min)	Grass Time (min)	Supp Time (min)	Paved Length (m)	Grass Length (m)	Supp Length (m)	Paved Slope(%)	Grass Slope %	Supp Slope %	Paved Rough	Grass Rough	Supp Rough	Lag Time or Factor	Gutter Length (m)	Gutter Slope %	Gutter FlowFactor	Rainfall Multiplier
CatH6	PitH6	0.011	100	0	0	5		5	5									0			1

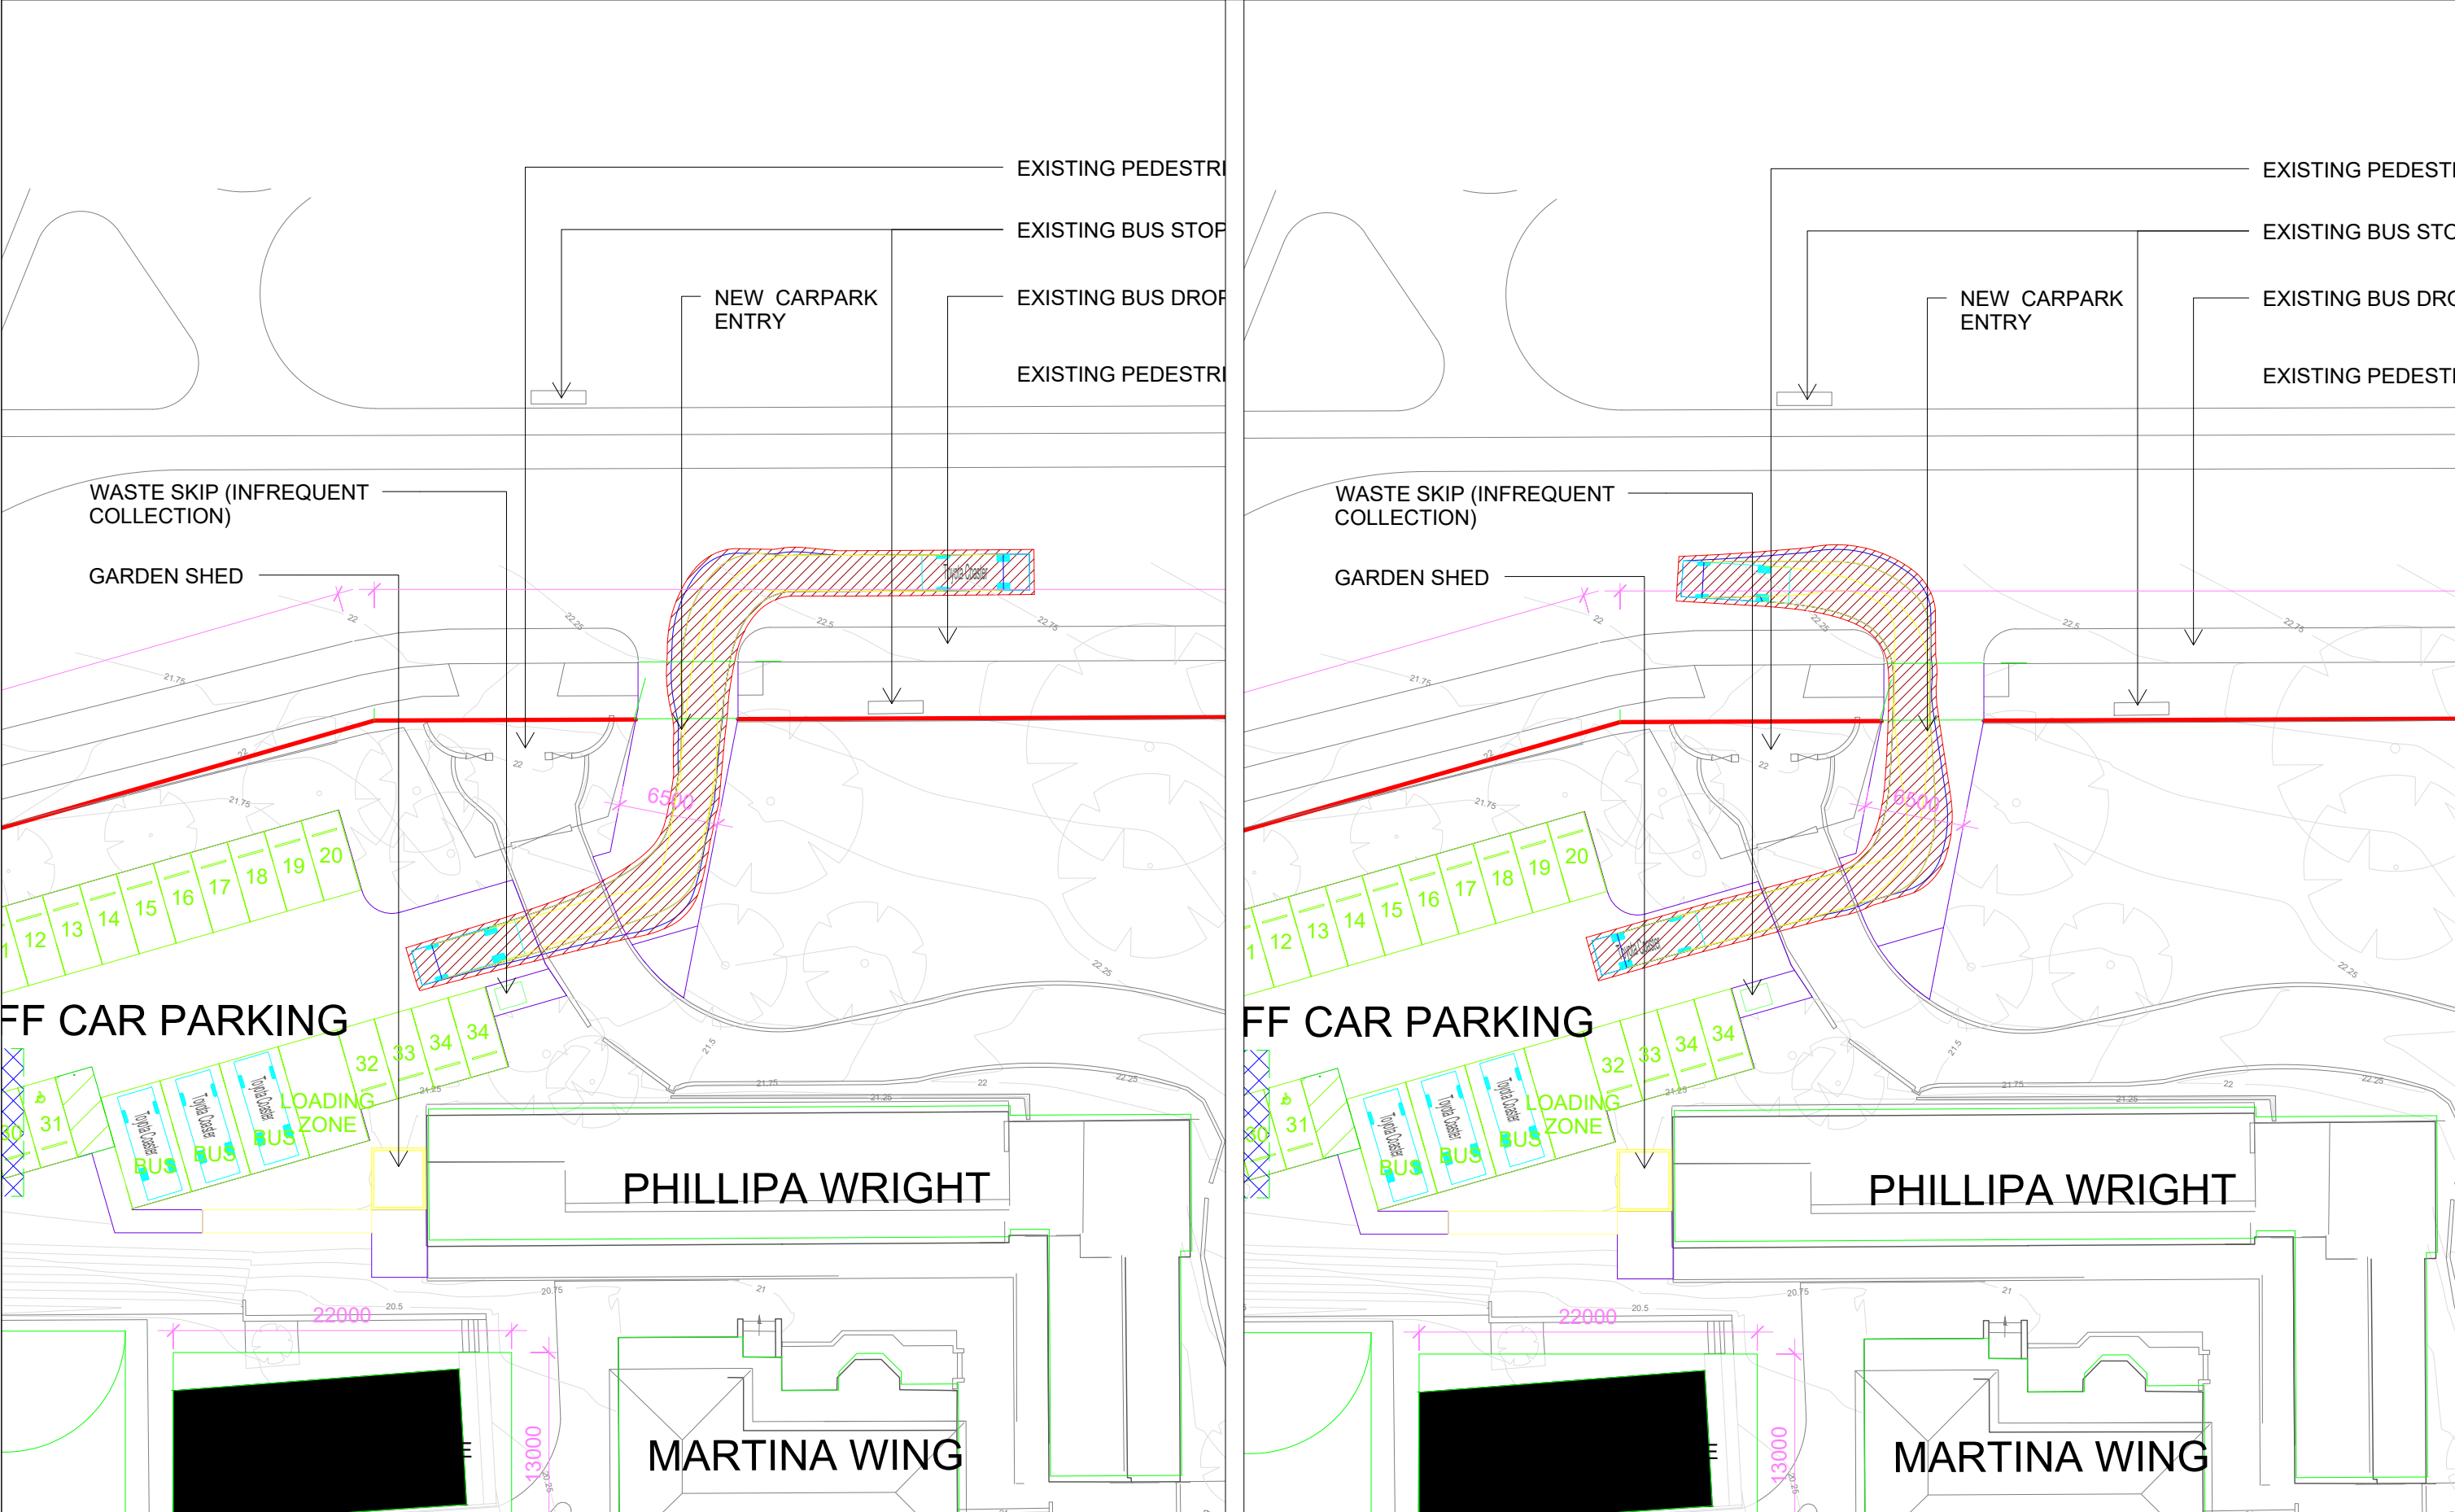
No.	Date	Description	Swept Path Key	North	Drawing Prepared By	Architect	Project	Drawing Title	Drawing No.	Revision No.
			— Wheel Path	N	PDC Consultants	Hayball	Domremy College	Proposed Site Plan	002	E
			— Vehicle Body Envelope		Level 5, 104 Commonwealth Street	11-17 Buckingham Street	Five Dock NSW	7.6m Toyota Coaster Swept Path Analysis	Drawn By	Date
			▨ 300mm Clearance Envelope		t: +61 2 7900 6514	Sydney Catholic Schools	Project No	First Avenue - Site Entry/Exit Movements	PC	3/07/2018
					w: www.pdcconsultants.com.au		17.130	Sheet Status		
					ABN: 70 615 064 670			NOT FOR CONSTRUCTION	Scale	
									1:400 @ A3	
									0m 4 8 12 16

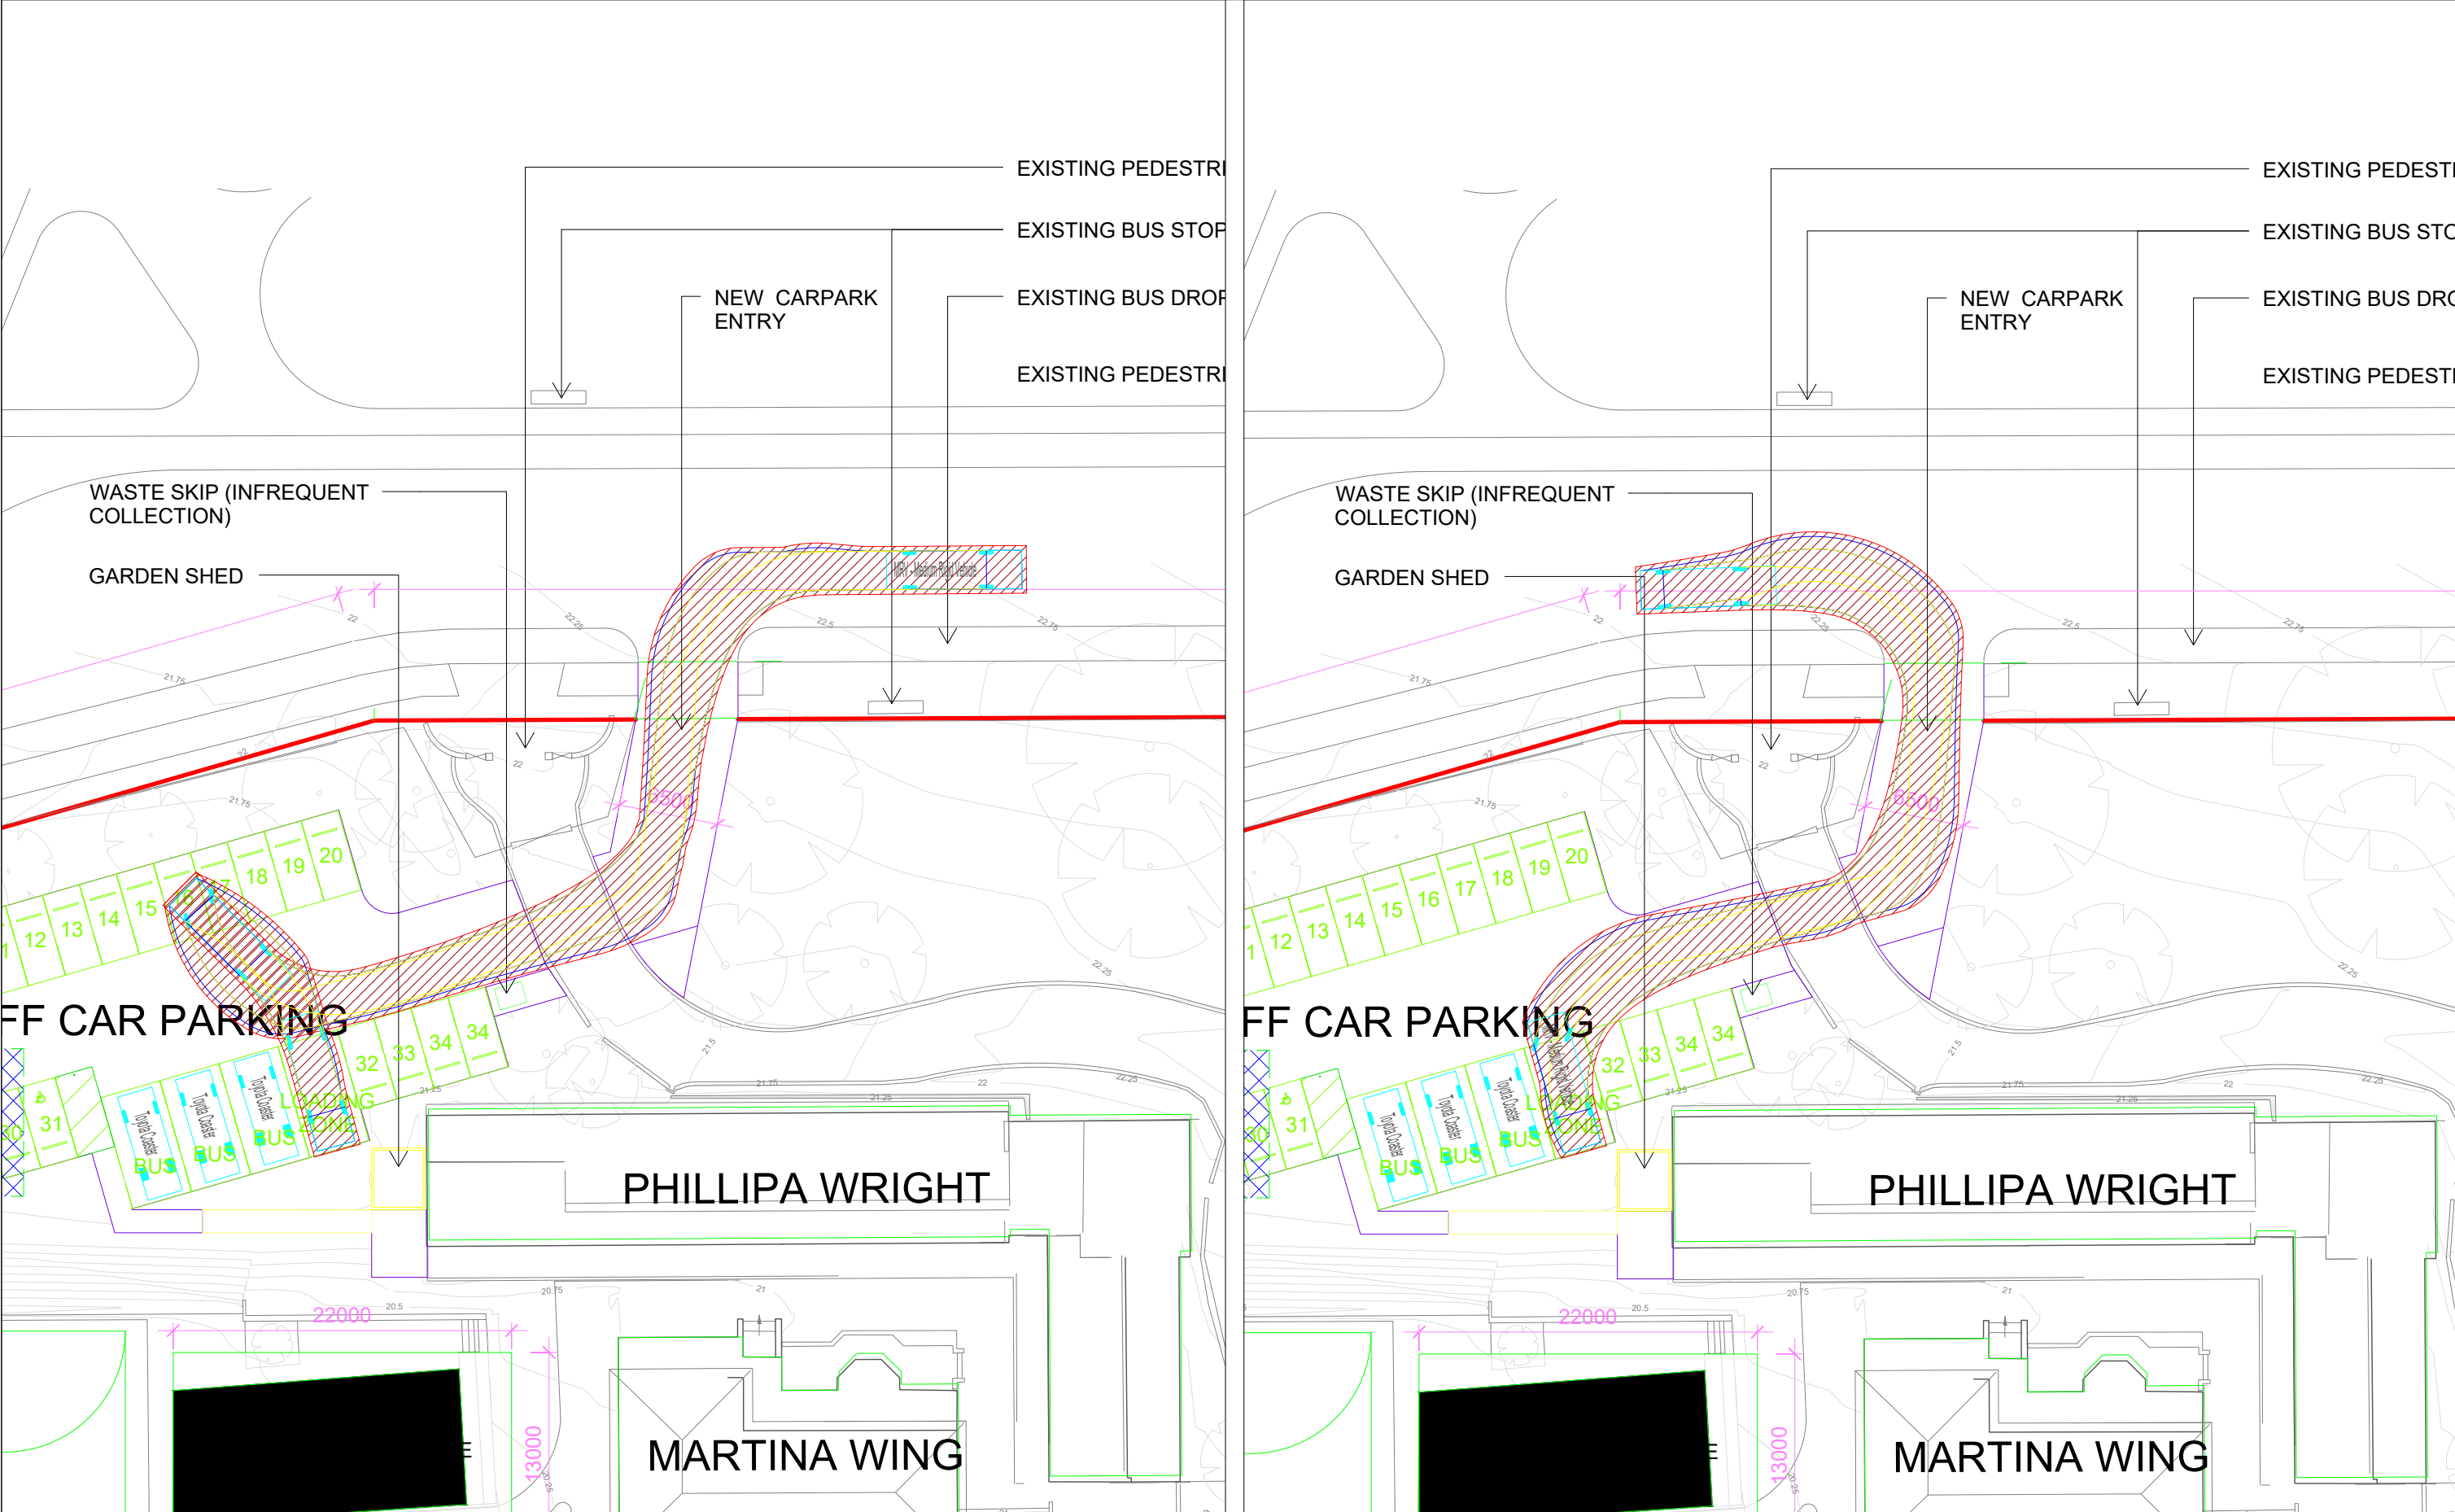
No.	Date	Description	Swept Path Key	North	Drawing Prepared By	Architect	Project	Drawing Title	Drawing No.	Revision No.
			Wheel Path	N	PDC Consultants	Hayball	Domremy College	Proposed Site Plan	007	A
			Vehicle Body Envelope		Level 5, 104 Commonwealth Street	11-17 Buckingham Street	Five Dock NSW	8.8m MRV Swept Path Analysis	Drawn By	Date
			300mm Clearance Envelope		t: +61 2 7900 6514	Sydney Catholic Schools	Project No	Site Entry/Exit Movements	PC	3/07/2018
					w: www.pdcconsultants.com.au		17.130	Sheet Status		
					ABN: 70 615 064 670			NOT FOR CONSTRUCTION
