REMEDIATION ACTION PLAN

**Former Bankstown Golf Course Driving Range
Corner of Bullecourt Avenue & Bullecourt Lane
Milperra NSW 2214**

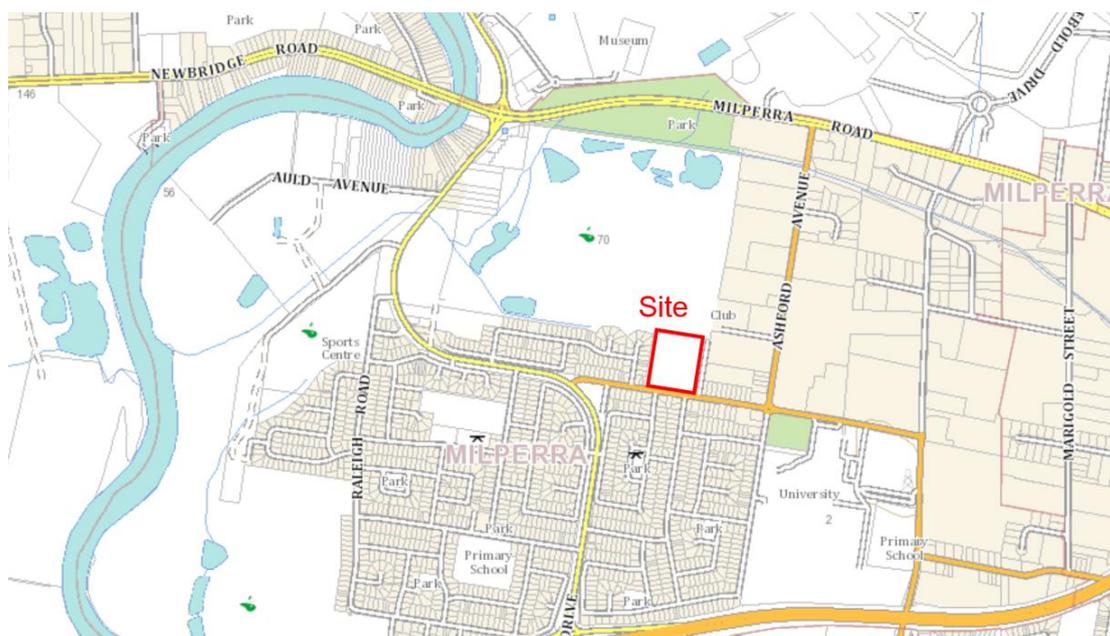
Figure 1 - Site Location Plan

The location of this Site is presented on Figure 1 - Location Plan (Six Maps).

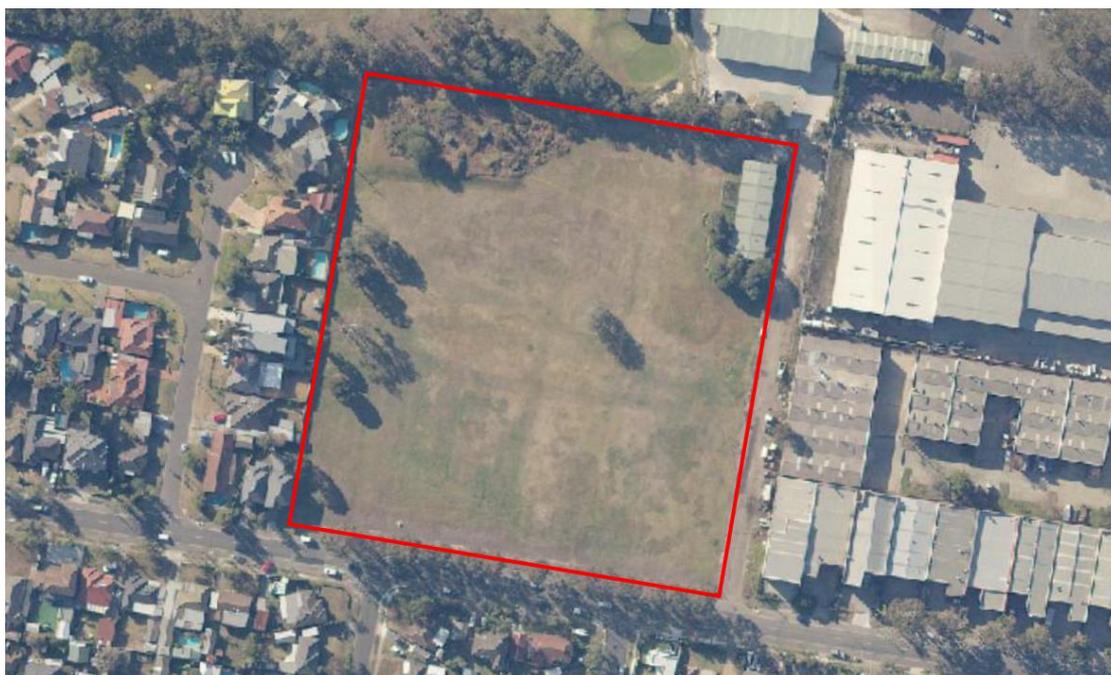
Figure 2 – Aerial Photo

The Site is rectangular in shape and is bounded by Bullecourt Avenue to the south and Bullecourt Lane to the east. The Site has a length north-south of approximately 170m and a width of approximately 160m. The developments that surround the Site include commercial/industrial, residential and open space and are specifically:

The layout of the Site is presented on Figure 2 (Six Maps).

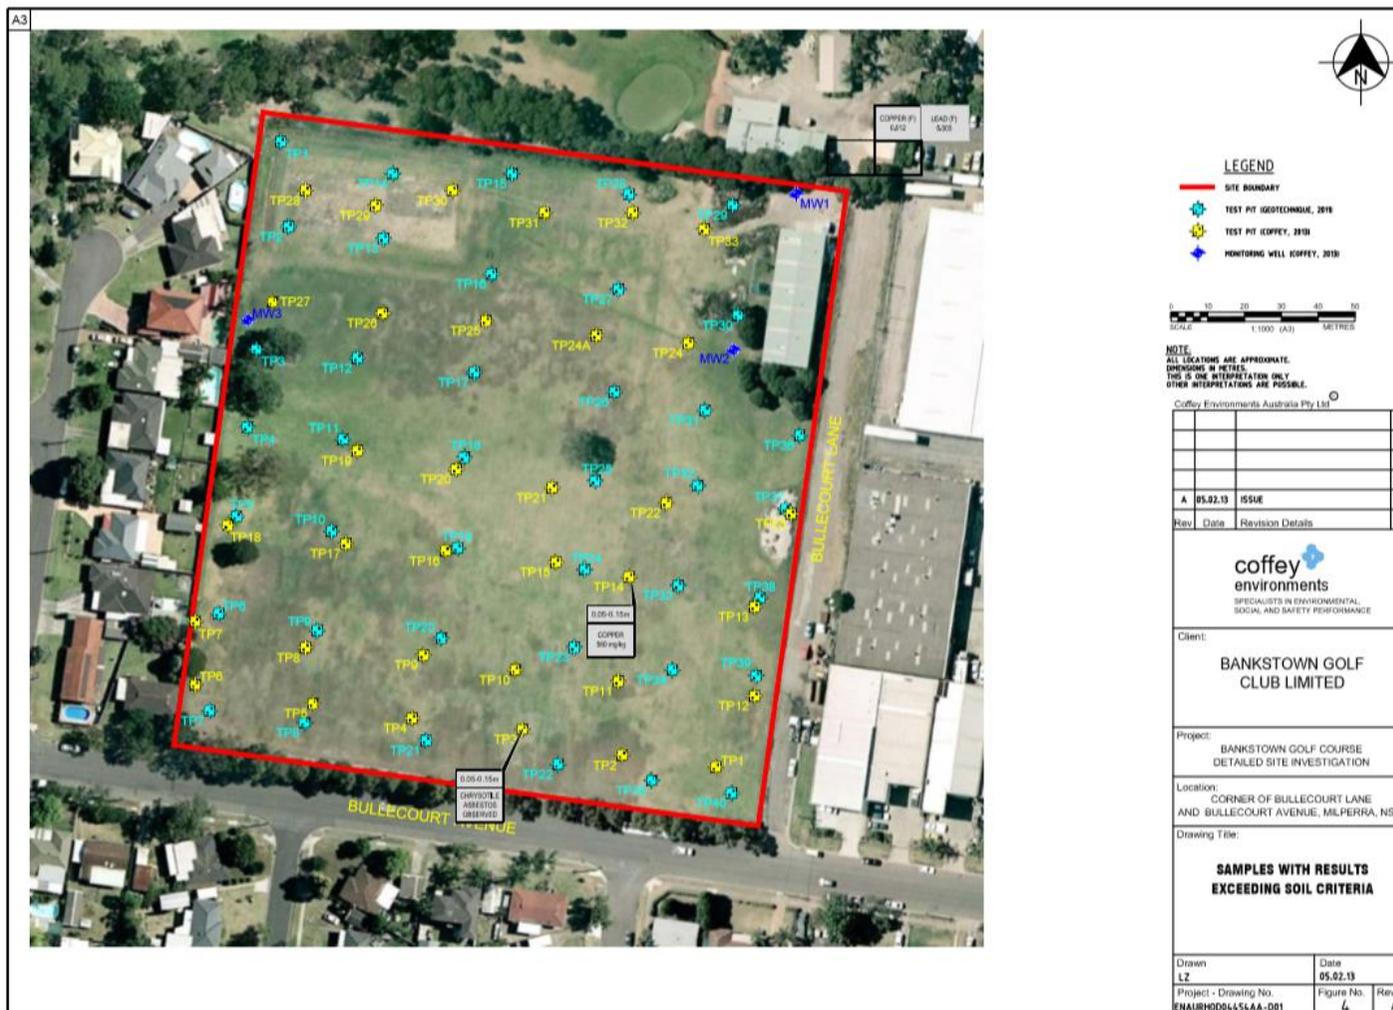
Figure 3 – Test Pit Locations (Coffey 2013)

- Drilling of three boreholes using a Geoprobe to a maximum depth of 12 m bgs;
- Excavating thirty-four (34) test pits across the site using a backhoe to a maximum depth of 2.5m bgs. Test pit locations are shown on Figure 3;

The detailed investigation indicate that the general subsurface profile across the site comprises of:

- Topsoil that consisted of sandy silty and silty sand, with some clay and traces of gravels;
- Fill materials that included gravelly and silty sand or silty clay at depths ranging between 0.2m and 1.5m bgs;
- Silty sand, generally comprising pale grey and white fine grained sand, at depths ranging between 0.4m and 0.8m bgs;
- Clay or sandy clay, generally comprising medium plasticity, grey, orange, brown and red, at depths ranging between 0.2m and 8.4m bgs; and
- Shale, highly to extremely weathered shale, grey, black and brown, at depths ranging downwards from 2.0m bgs.

- The observed conditions following the excavation of fill material around test pit TP3; and
- The results of validation sample analysis.

- Fill material is identified within 5m of test pit TP3 following excavation;
- ACM is observed in fill on surrounding land (within 5m of the perimeter of the excavation; or
- Validation samples indicate the presence of asbestos
