TOGA WICKS PARK DEVELOPMENTS PTY LTD

Geotechnical Investigation Report

182-198 Victoria Road and 28-30 Faversham
Street, Marrickville, NSW

Report No: E24098.G03

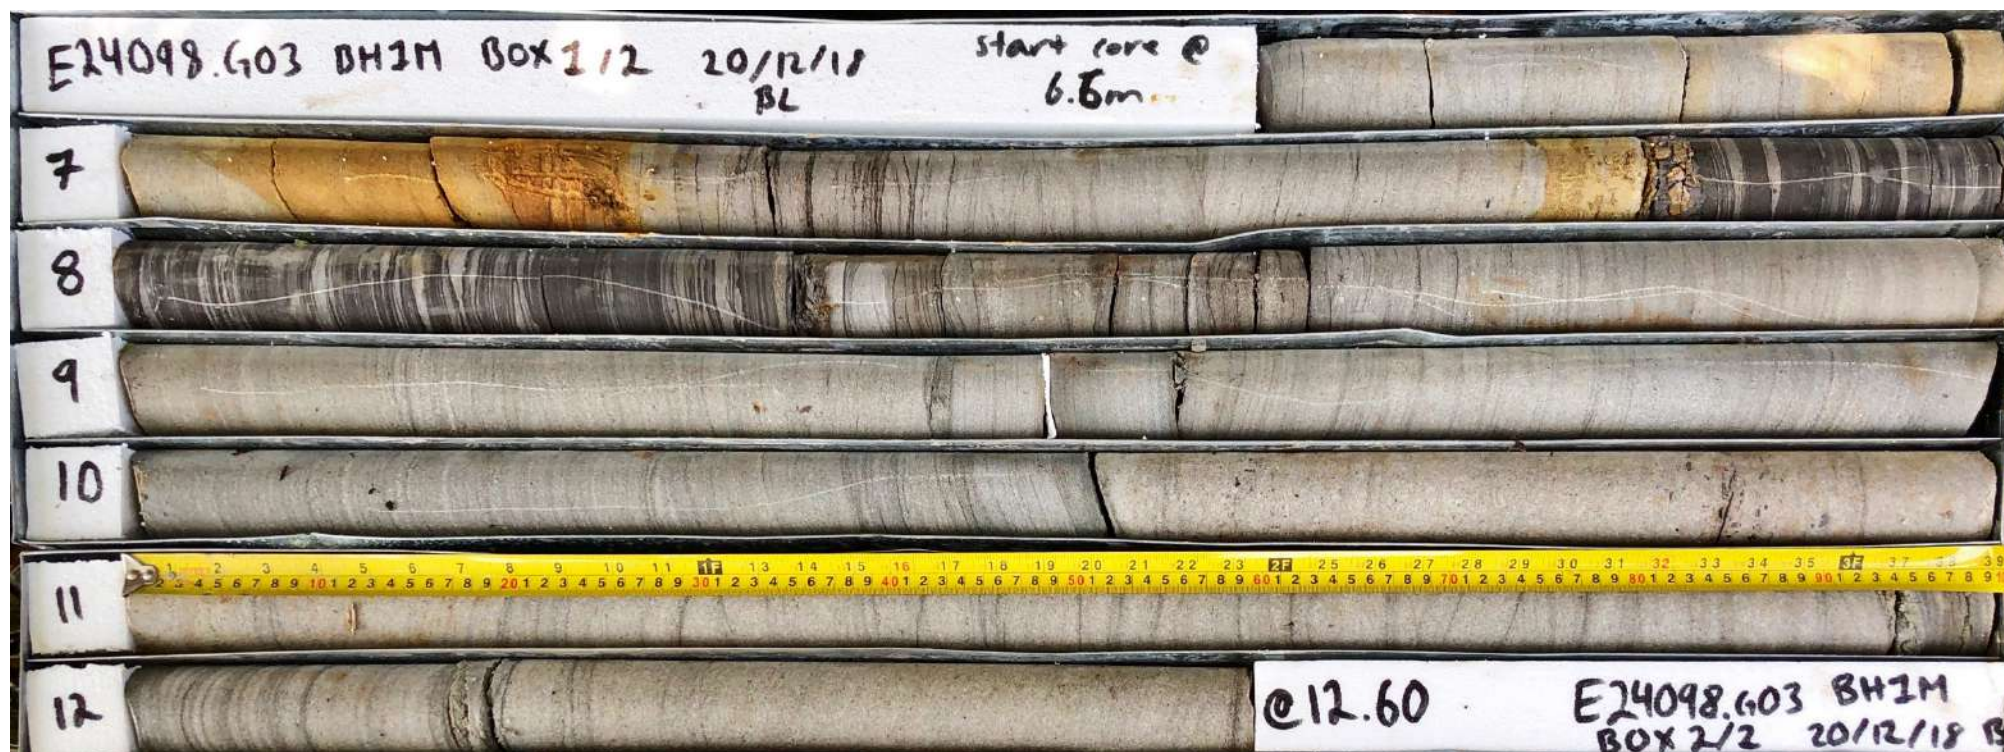
CORE PHOTOGRAPH OF BOREHOLE: BH1M

Project	Proposed Development	East	330163.8	Depth Range	6.6m to 12.6m BEGL		
Location	182-198 Victoria Road & 28-30 Faversham Street, Marrickville, NSW	North	6246419.5	Contractor	Geosense Drilling Engineers Pty Ltd		
Position	See Figure 2	Surface RL	≈ 3.1m	Drill Rig	Hanjin D&B 8D		
Job No.	E24098.G03	Inclination	-90°	Logged	BL	Date	20 / 12 / 2018
Client	Toga Wicks Park Developments Pty Ltd	Box	1-2 of 2	Checked	DS	Date	31 / 1 / 2018

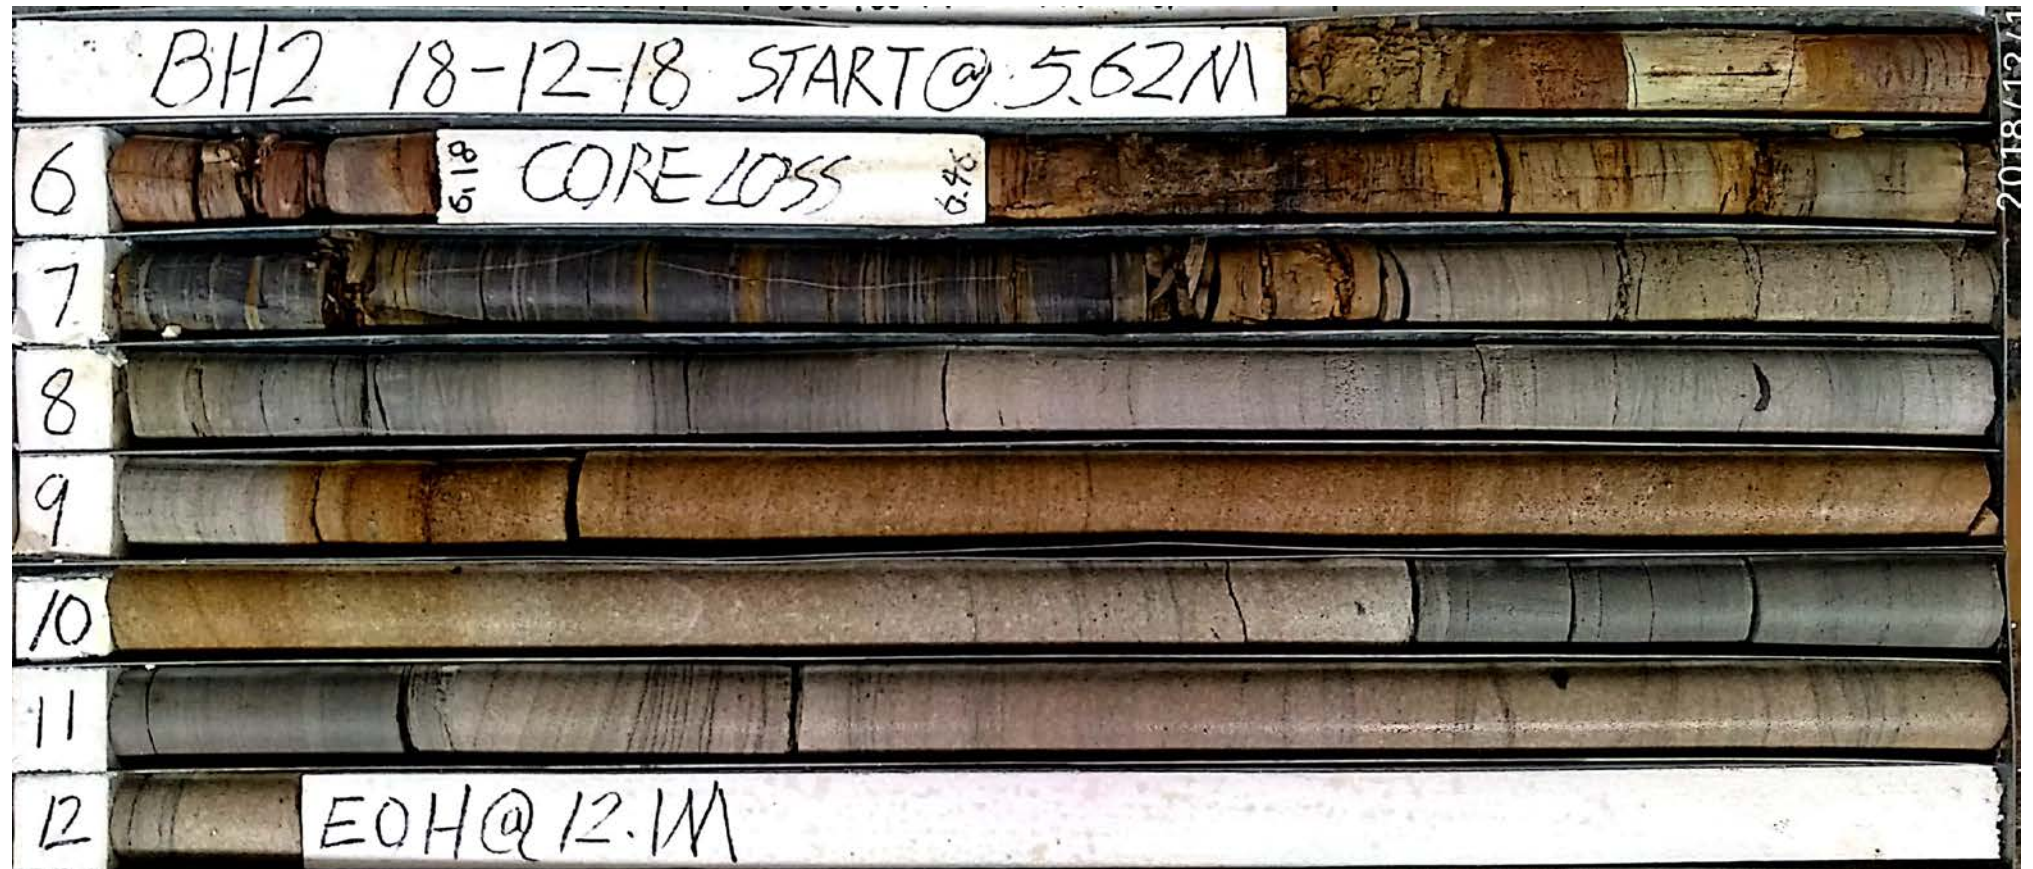
CORE PHOTOGRAPH OF BOREHOLE: BH2

Project	Proposed Development	East	330204.2	Depth Range	5.62m to 12.1m BEGL		
Location	182-198 Victoria Road & 28-30 Faversham Street, Marrickville, NSW	North	6246384.9	Contractor	BG Drilling Pty Ltd		
Position	See Figure 2	Surface RL	≈ 2.6m	Drill Rig	Rig 7		
Job No.	E24098.G03	Inclination	-90°	Logged	FY	Date	17 / 12 / 2018
Client	Toga Wicks Park Developments Pty Ltd	Box	1-2 of 2	Checked	DS	Date	31 / 1 / 2018

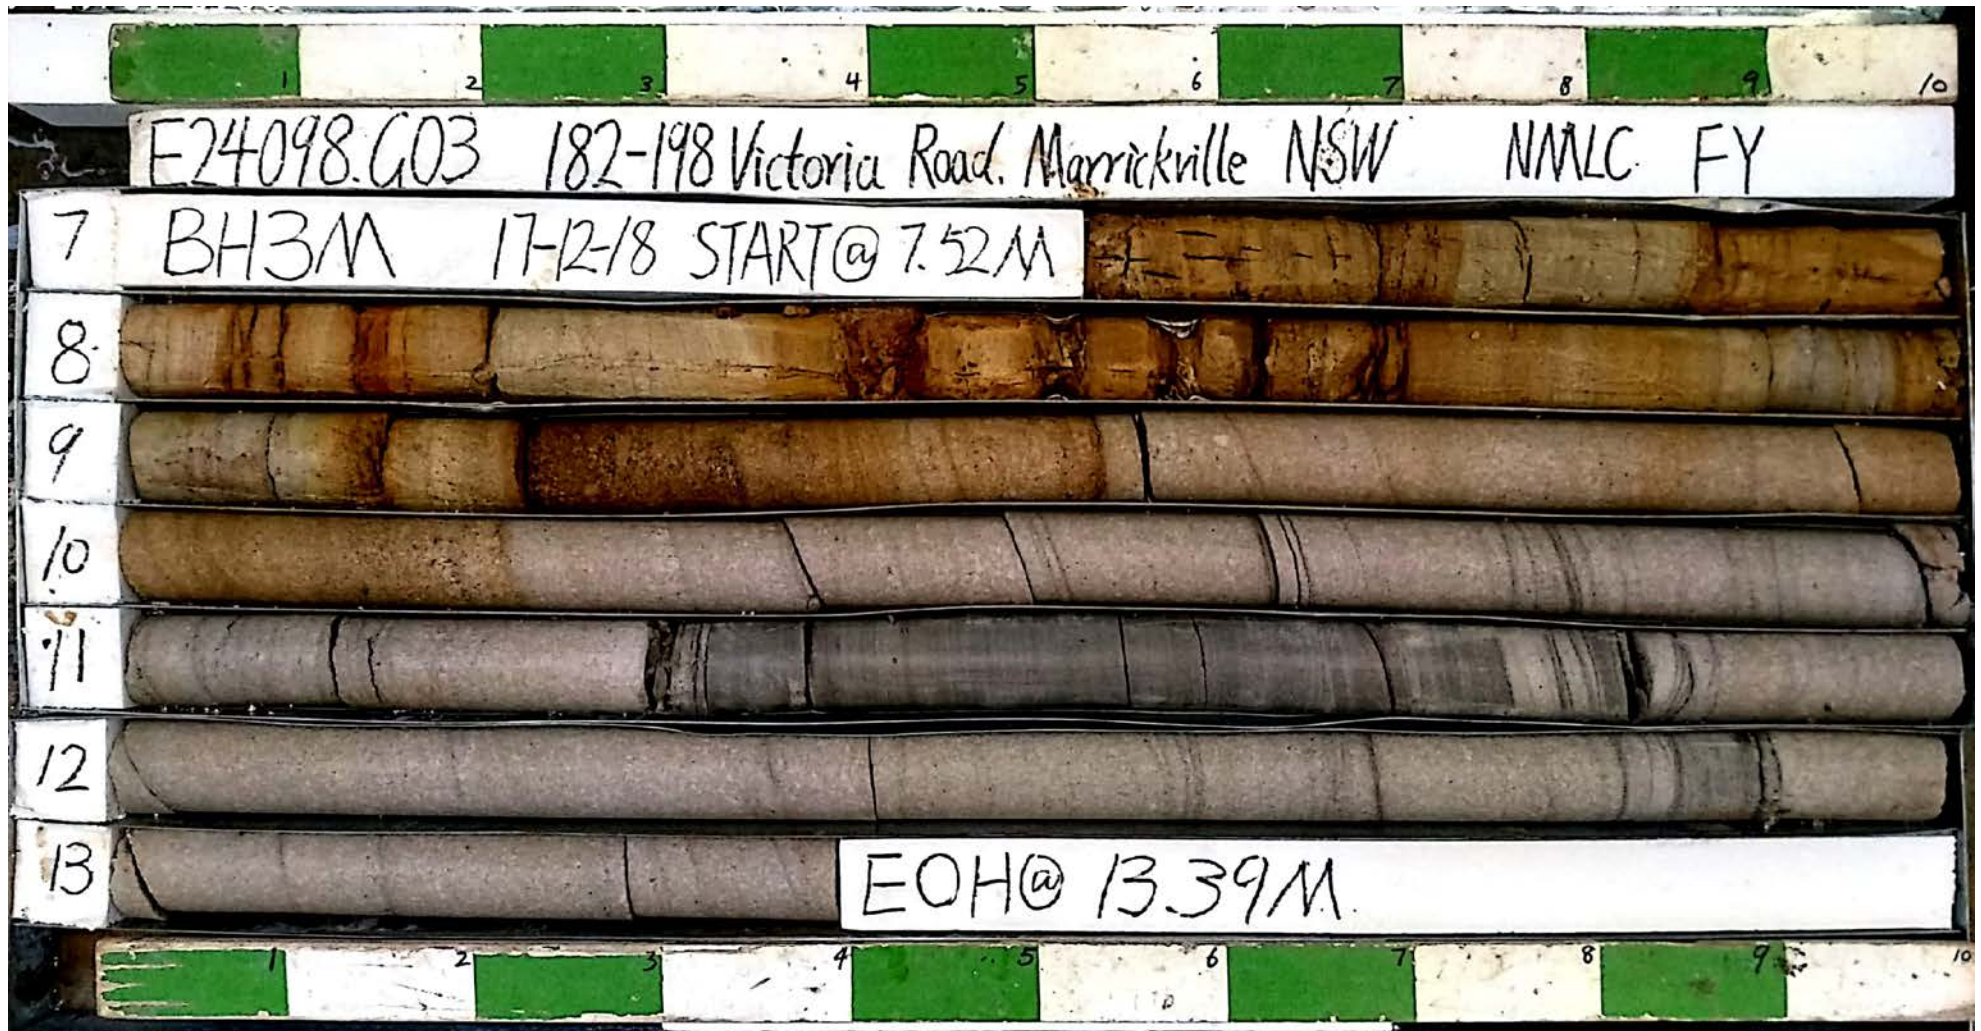
CORE PHOTOGRAPH OF BOREHOLE: BH3M

Project	Proposed Development	East	330238.4	Depth Range	7.52m to 13.39m BEGL		
Location	182-198 Victoria Road & 28-30 Faversham Street, Marrickville, NSW	North	6246363.2	Contractor	BG Drilling Pty Ltd		
Position	See Figure 2	Surface RL	≈ 2.6m	Drill Rig	Rig 7		
Job No.	E24098.G03	Inclination	-90°	Logged	FY	Date	17 / 12 / 2018
Client	Toga Wicks Park Developments Pty Ltd	Box	1-2 of 2	Checked	DS	Date	31 / 1 / 2018

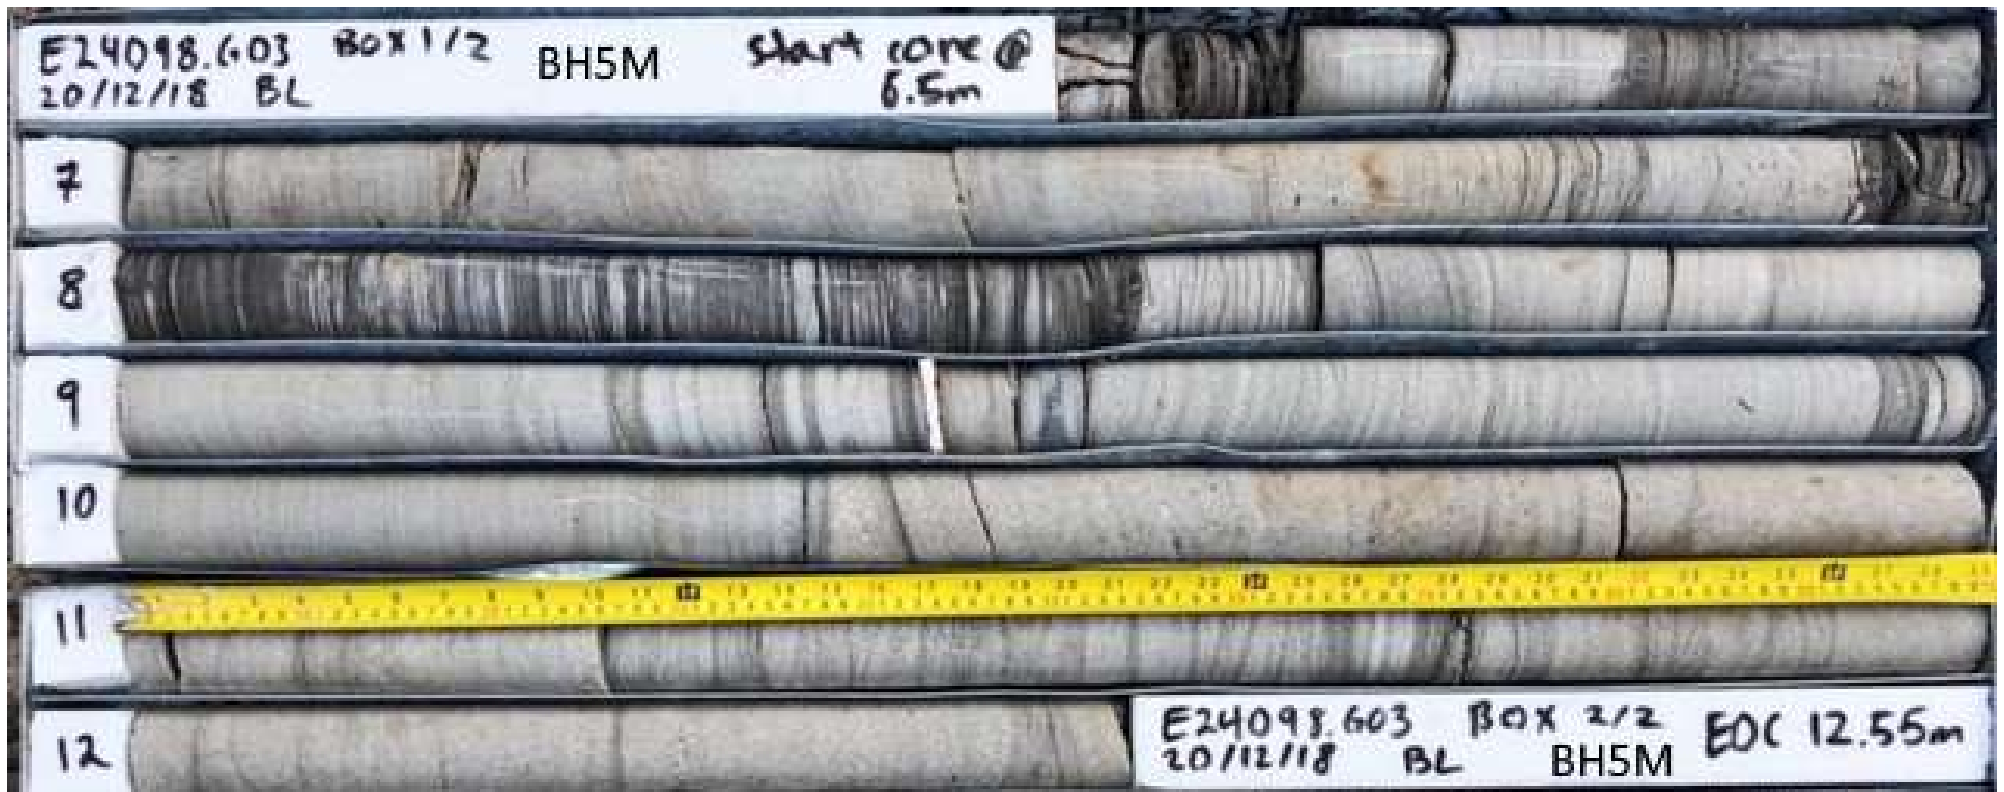
CORE PHOTOGRAPH OF BOREHOLE: BH5M

Project	Proposed Development	East	330179.4	Depth Range	6.5m to 12.55m BEGL	
Location	182-198 Victoria Road & 28-30 Faversham Street, Marrickville, NSW	North	6246439.0	Contractor	Geosense Drilling Engineers Pty Ltd	
Position	See Figure 2	Surface RL	≈ 3.1m	Drill Rig	Hanjin D&B 8D	
Job No.	E24098.G03	Inclination	-90°	Logged	BL	Date 20 / 12 / 2018
Client	Toga Wicks Park Developments Pty Ltd	Box	1-2 of 2	Checked	DS	Date 31 / 1 / 2018

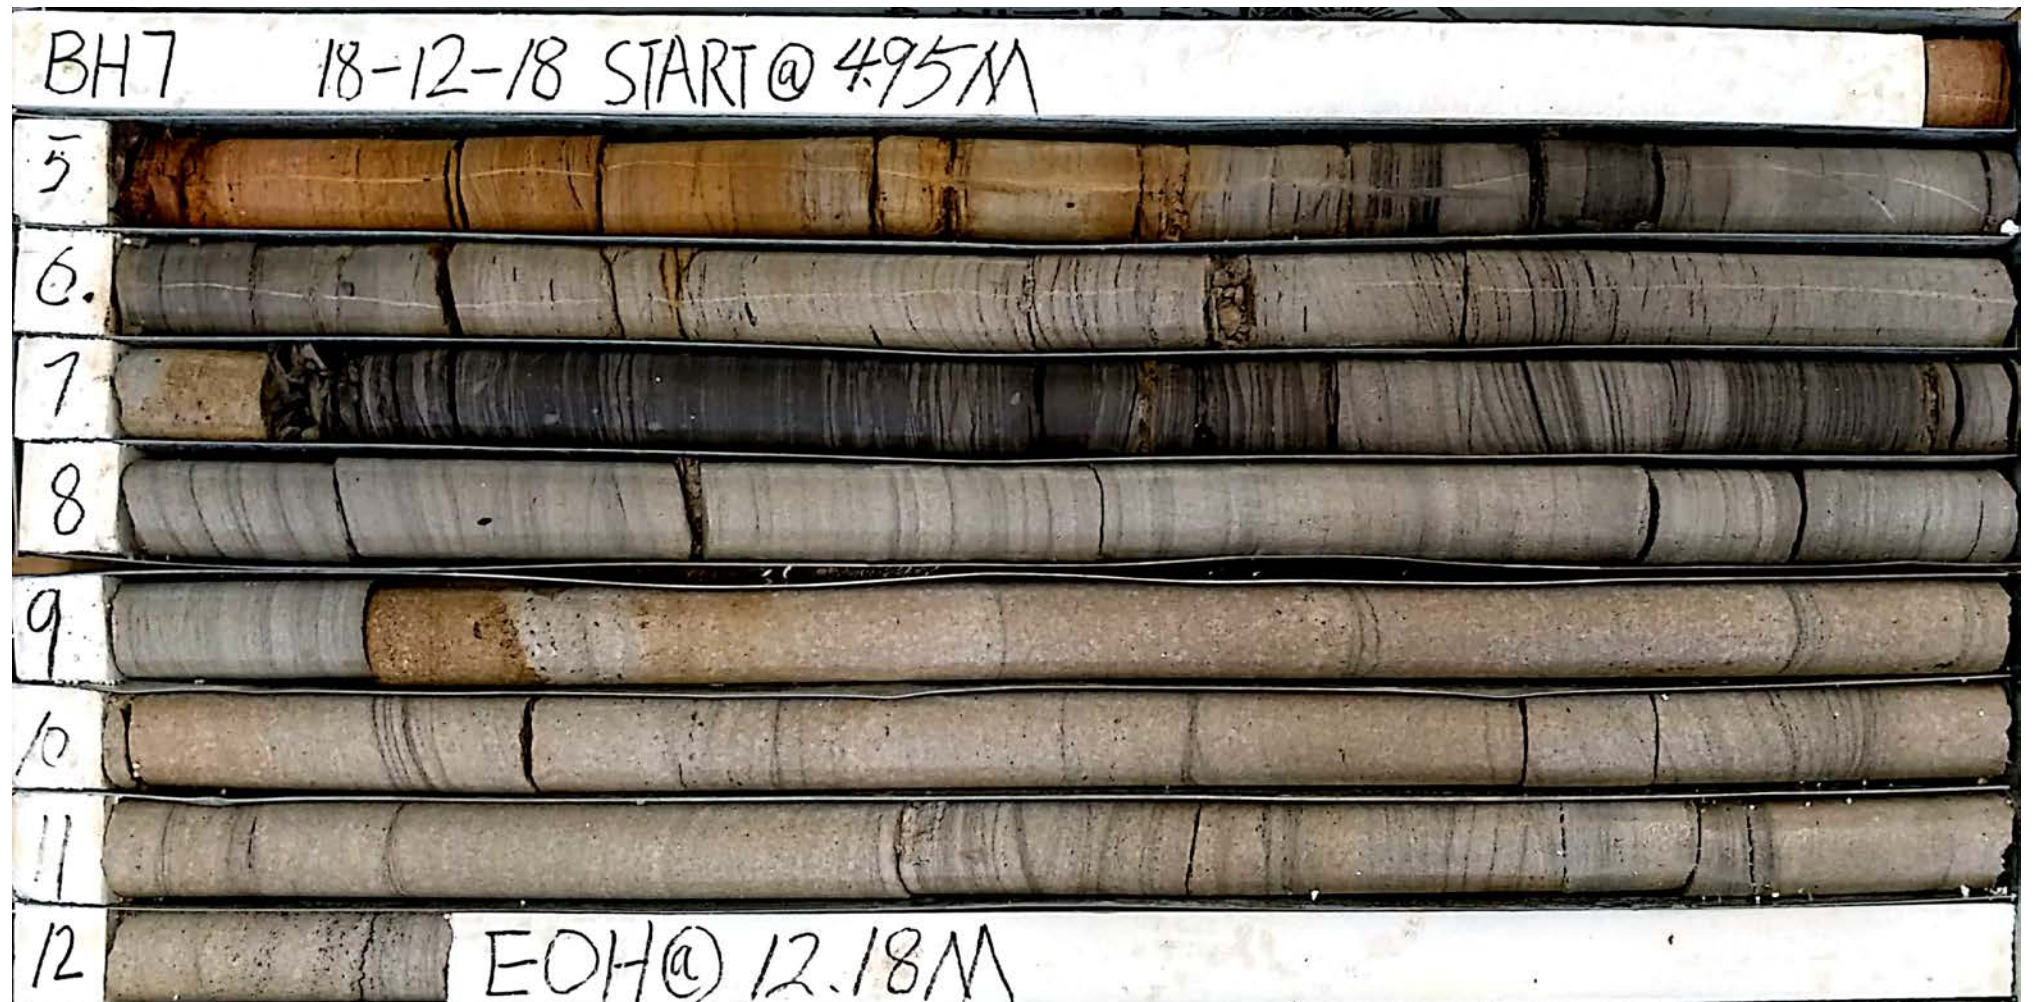
CORE PHOTOGRAPH OF BOREHOLE: BH7

Project	Proposed Development	East	330216.3	Depth Range	4.95m to 12.18m BEGL		
Location	182-198 Victoria Road & 28-30 Faversham Street, Marrickville, NSW	North	6246411.2	Contractor	BG Drilling Pty Ltd		
Position	See Figure 2	Surface RL	≈ 2.6m	Drill Rig	Rig 7		
Job No.	E24098.G03	Inclination	-90°	Logged	FY	Date	18 / 12 / 2018
Client	Toga Wicks Park Developments Pty Ltd	Box	1-2 of 2	Checked	DS	Date	31 / 1 / 2018

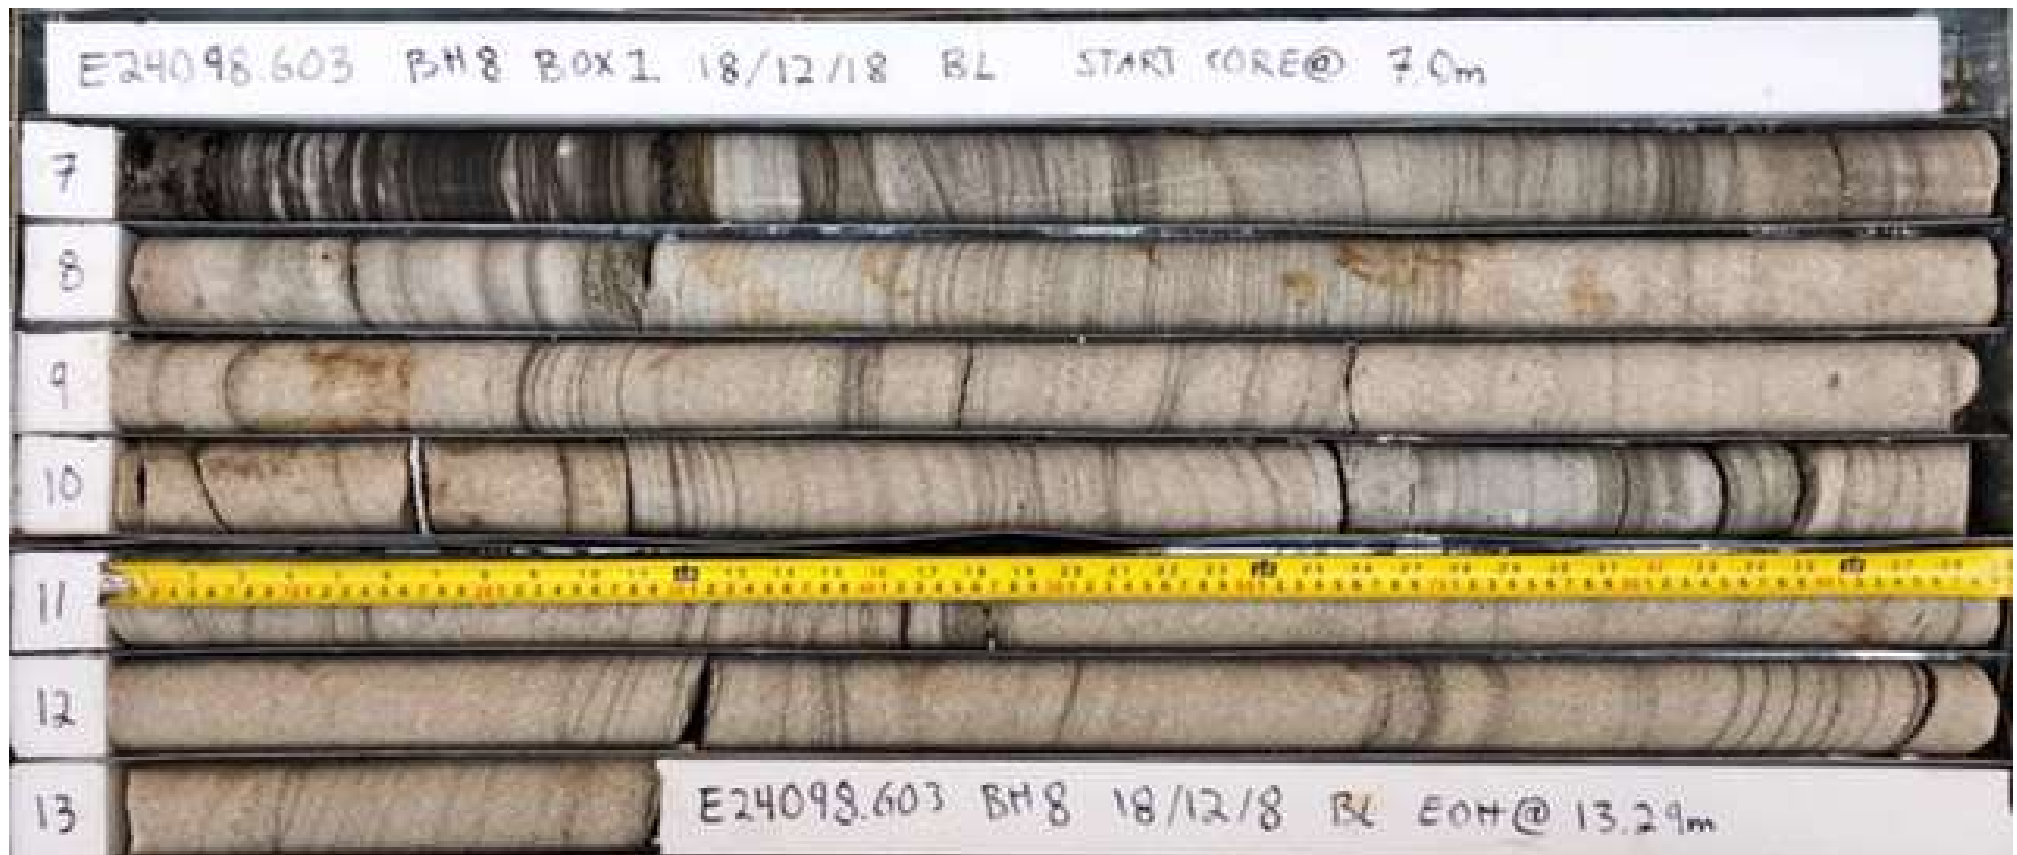
CORE PHOTOGRAPH OF BOREHOLE: BH8

Project	Proposed Development	East	330264.8	Depth Range	7.0m to 13.29m BEGL	
Location	182-198 Victoria Road & 28-30 Faversham Street, Marrickville, NSW	North	6246400.6	Contractor	Geosense Drilling Engineers Pty Ltd	
Position	See Figure 2	Surface RL	≈ 1.9m	Drill Rig	Hanjin D&B 8D	
Job No.	E24098.G03	Inclination	-90°	Logged	BL	Date 18 / 12 / 2018
Client	Toga Wicks Park Developments Pty Ltd	Box	1-2 of 2	Checked	DS	Date 31 / 1 / 2018

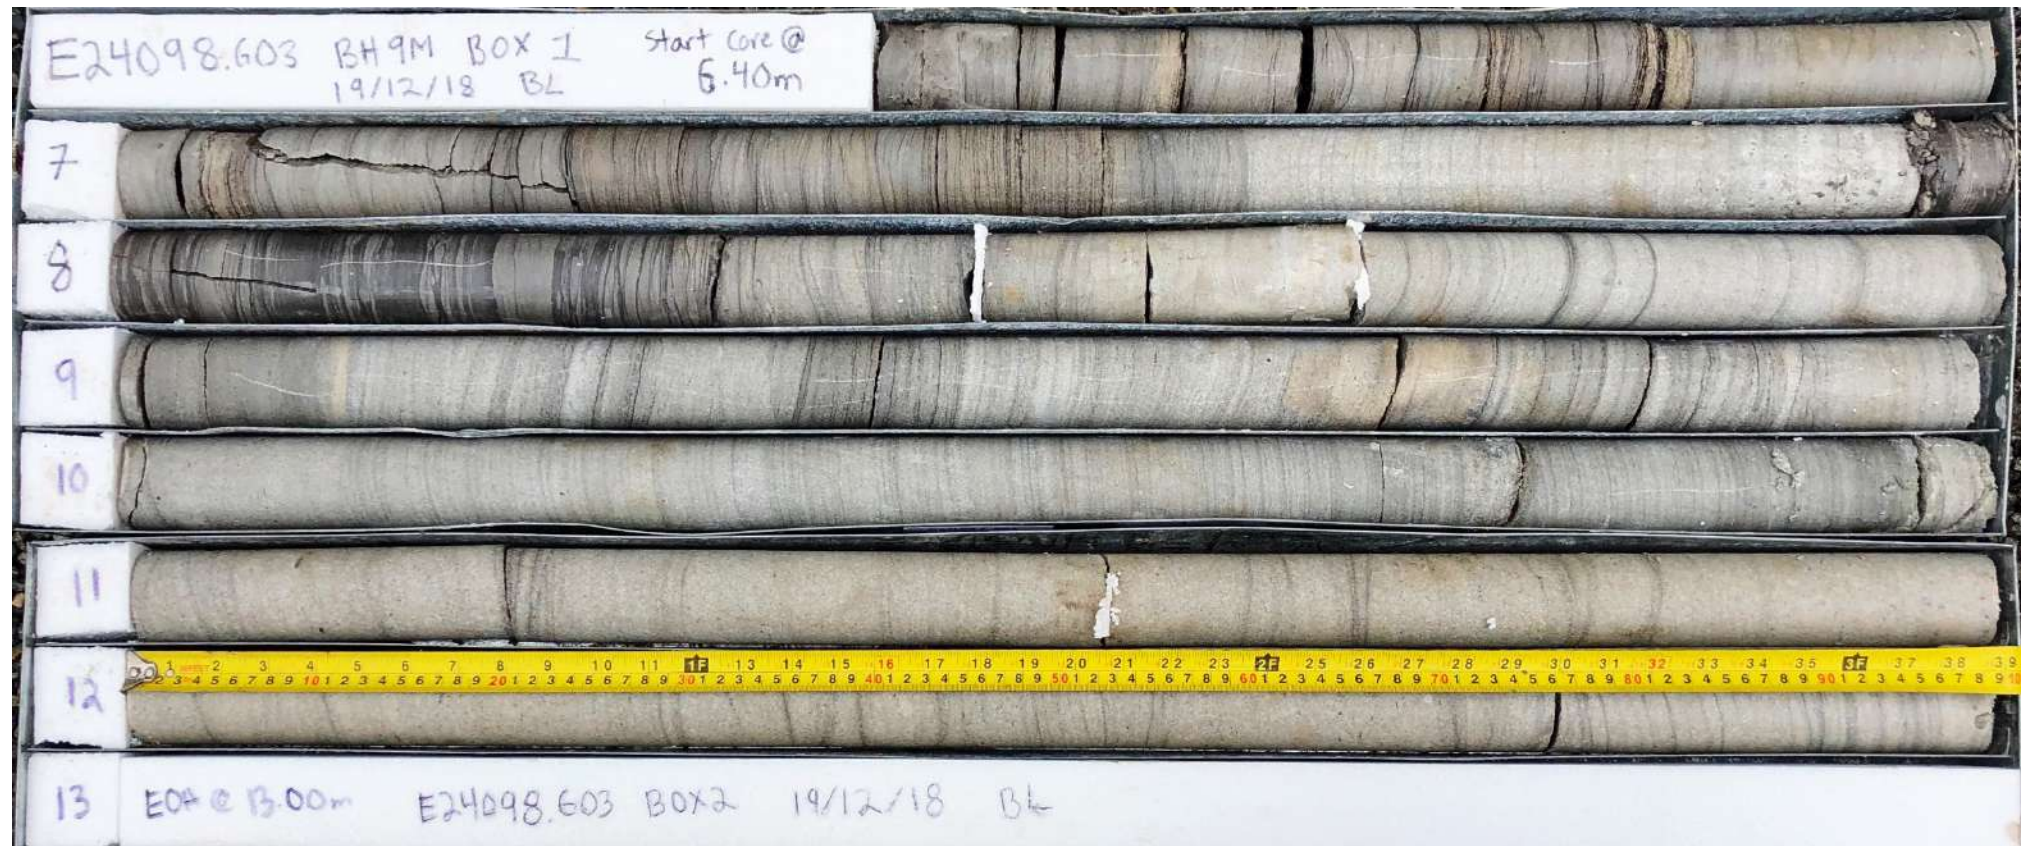
CORE PHOTOGRAPH OF BOREHOLE: BH9M

Project	Proposed Development	East	330202.4	Depth Range	6.4m to 13.0m BEGL		
Location	182-198 Victoria Road & 28-30 Faversham Street, Marrickville, NSW	North	6246462.3	Contractor	Geosense Drilling Engineers Pty Ltd		
Position	See Figure 2	Surface RL	≈ 3.3m	Drill Rig	Hanjin D&B 8D		
Job No.	E24098.G03	Inclination	-90°	Logged	BL	Date	19 / 12 / 2018
Client	Toga Wicks Park Developments Pty Ltd	Box	1-2 of 2	Checked	DS	Date	31 / 1 / 2018

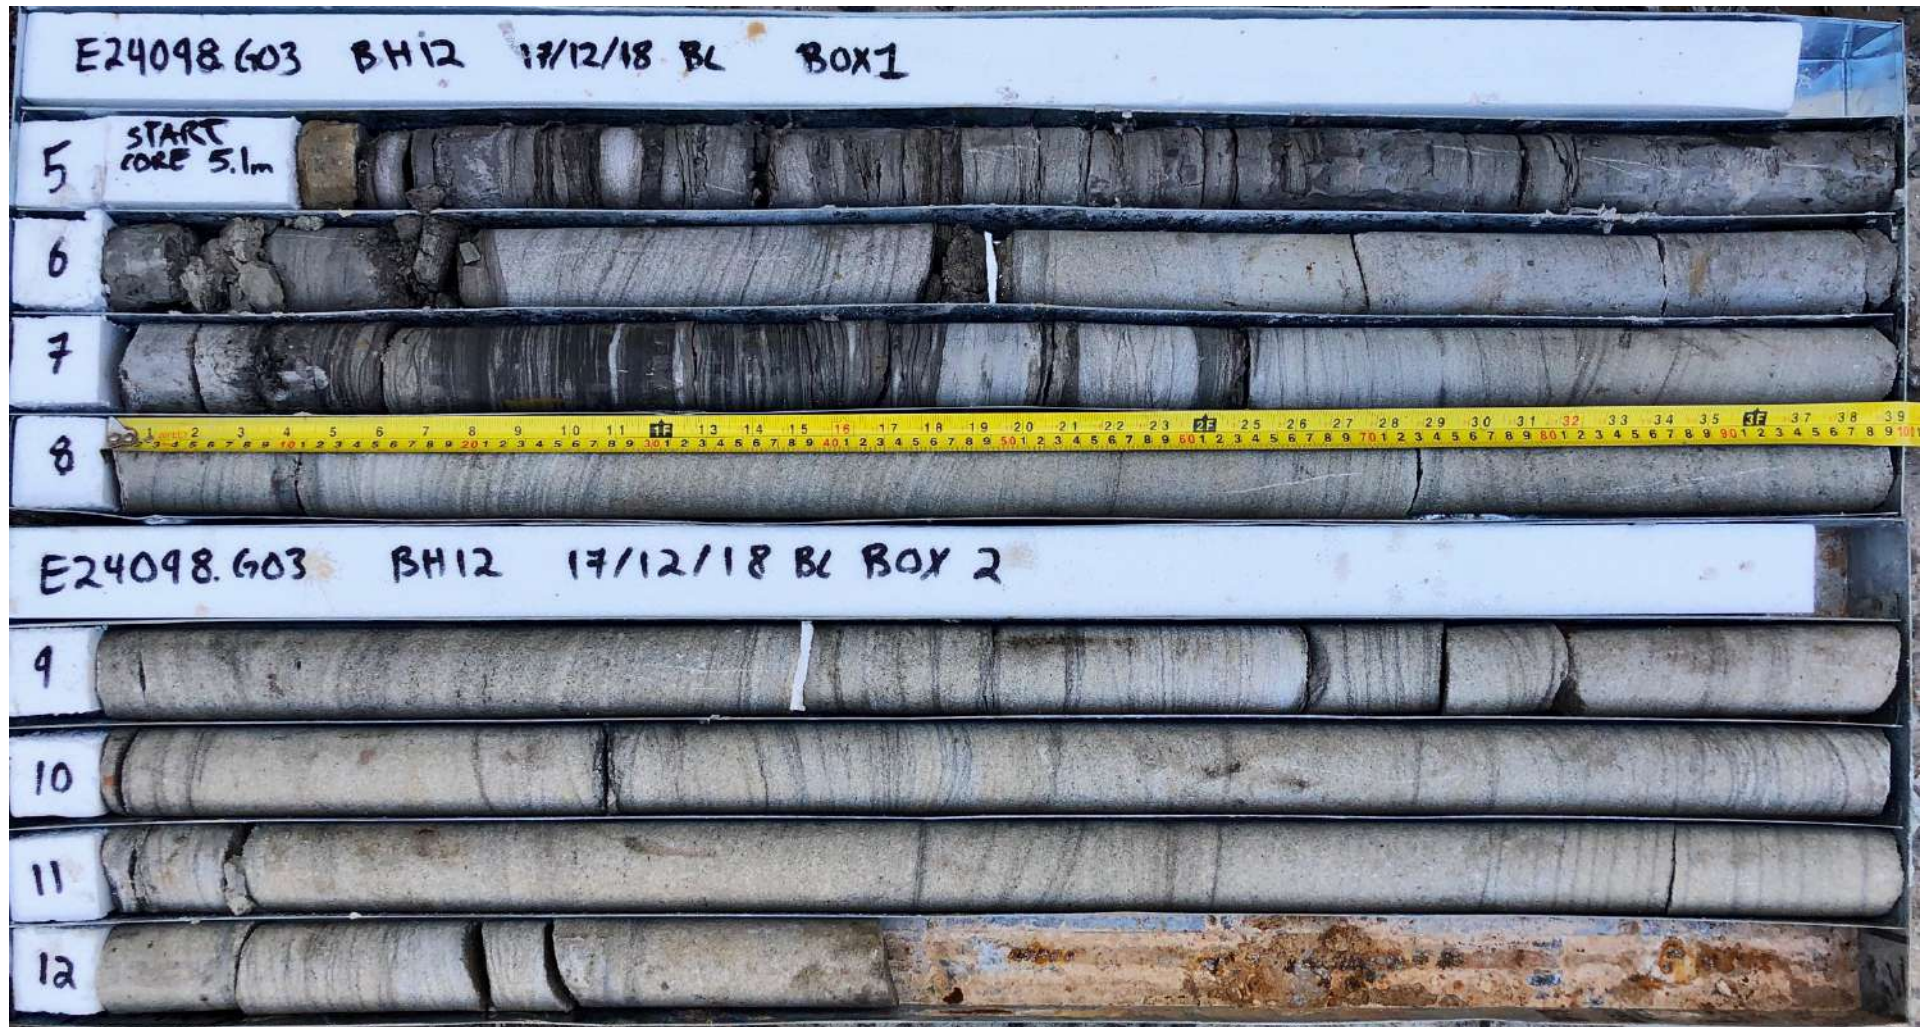
CORE PHOTOGRAPH OF BOREHOLE: BH12

Project	Proposed Development	East	330241.7	Depth Range	5.1m to 12.45m BEGL	
Location	182-198 Victoria Road & 28-30 Faversham Street, Marrickville, NSW	North	6246439.9	Contractor	Geosense Drilling Engineers Pty Ltd	
Position	See Figure 2	Surface RL	≈ 2.1m	Drill Rig	Hanjin D&B 8D	
Job No.	E24098.G03	Inclination	-90°	Logged	BL	Date 17 / 12 / 2018
Client	Toga Wicks Park Developments Pty Ltd	Box	1-2 of 2	Checked	DS	Date 31 / 1 / 2018

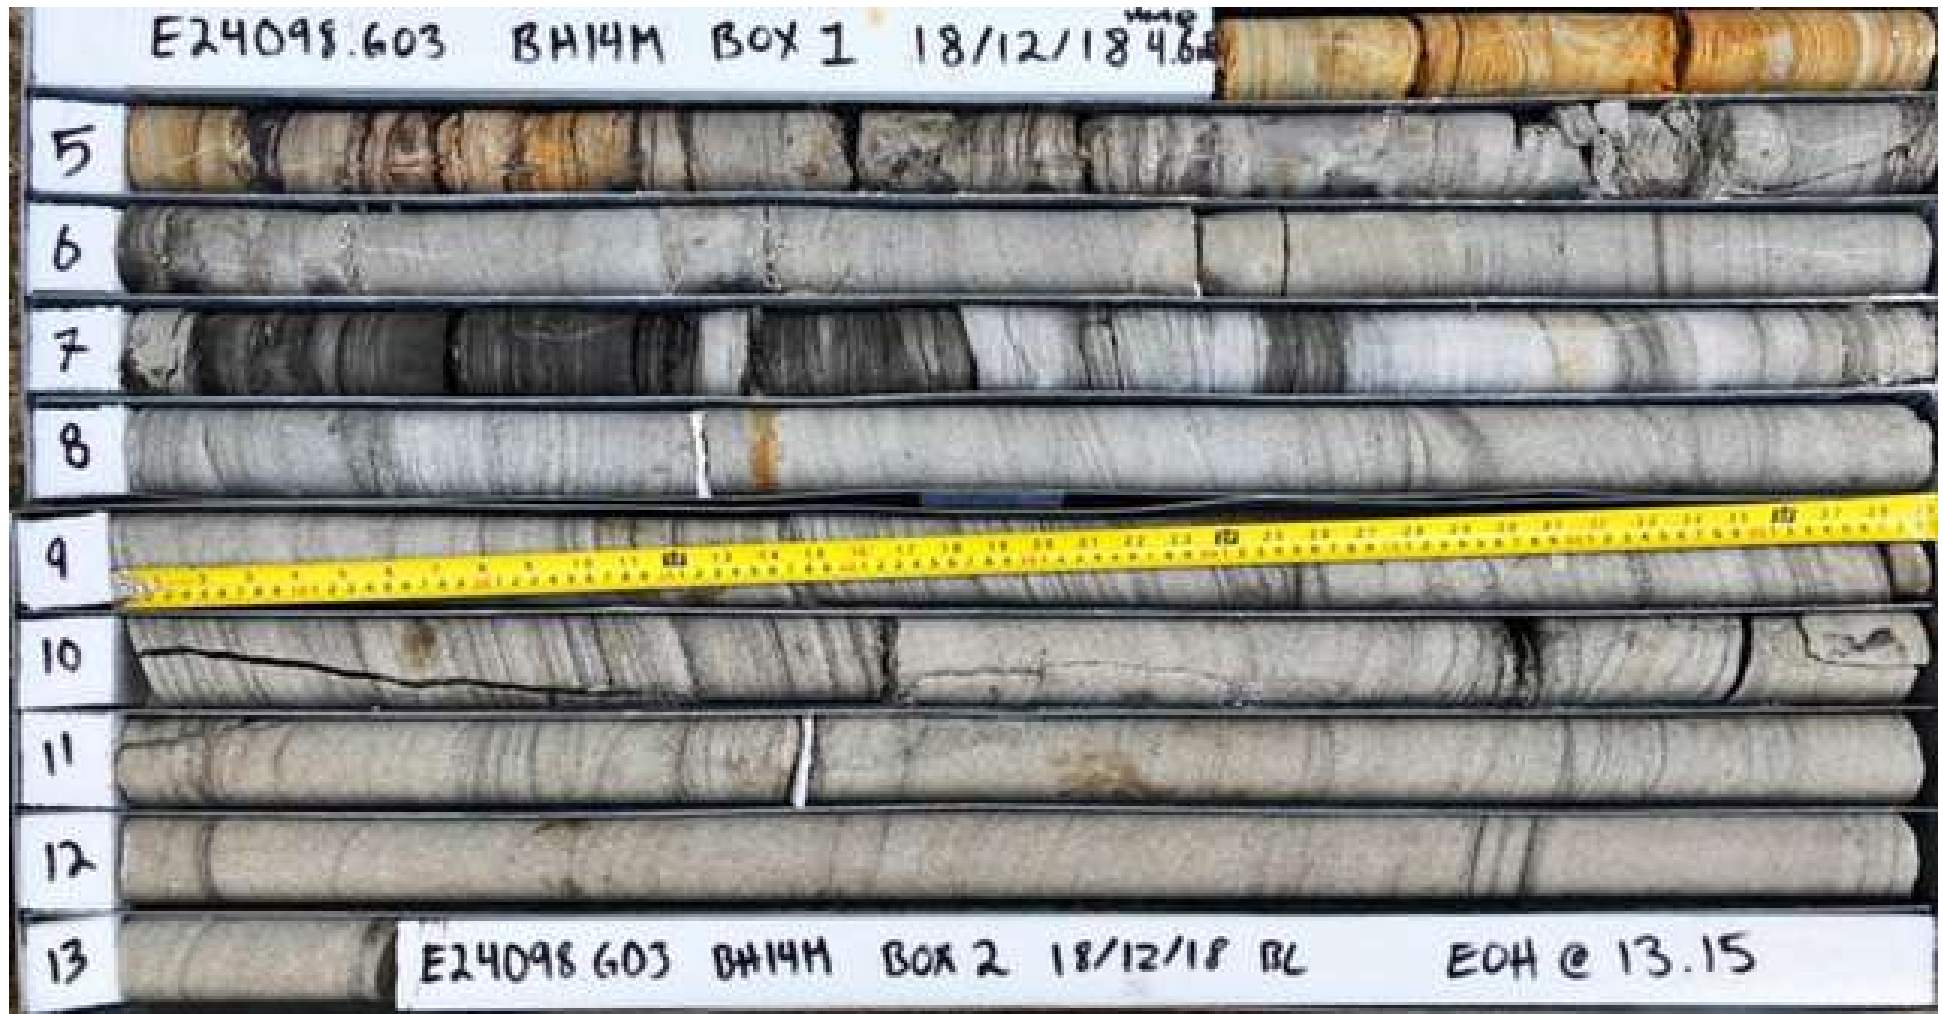
CORE PHOTOGRAPH OF BOREHOLE: BH14M

Project	Proposed Development	East	330271.9	Depth Range	4.6m to 13.15m BEGL		
Location	182-198 Victoria Road & 28-30 Faversham Street, Marrickville, NSW	North	6246420.8	Contractor	Geosense Drilling Engineers Pty Ltd		
Position	See Figure 2	Surface RL	≈ 2.0m	Drill Rig	Hanjin D&B 8D		
Job No.	E24098.G03	Inclination	-90°	Logged	BL	Date	18 / 12 / 2018
Client	Toga Wicks Park Developments Pty Ltd	Box	1-2 of 2	Checked	DS	Date	31 / 1 / 2018
