**MINE SUBSIDENCE &  
MINING ENGINEERING**

Crescent Newcastle Pty Ltd  
Proposed Development 11-17 Mosbri Crescent, The Hill

**MINE SUBSIDENCE REPORT**

6 May 2021

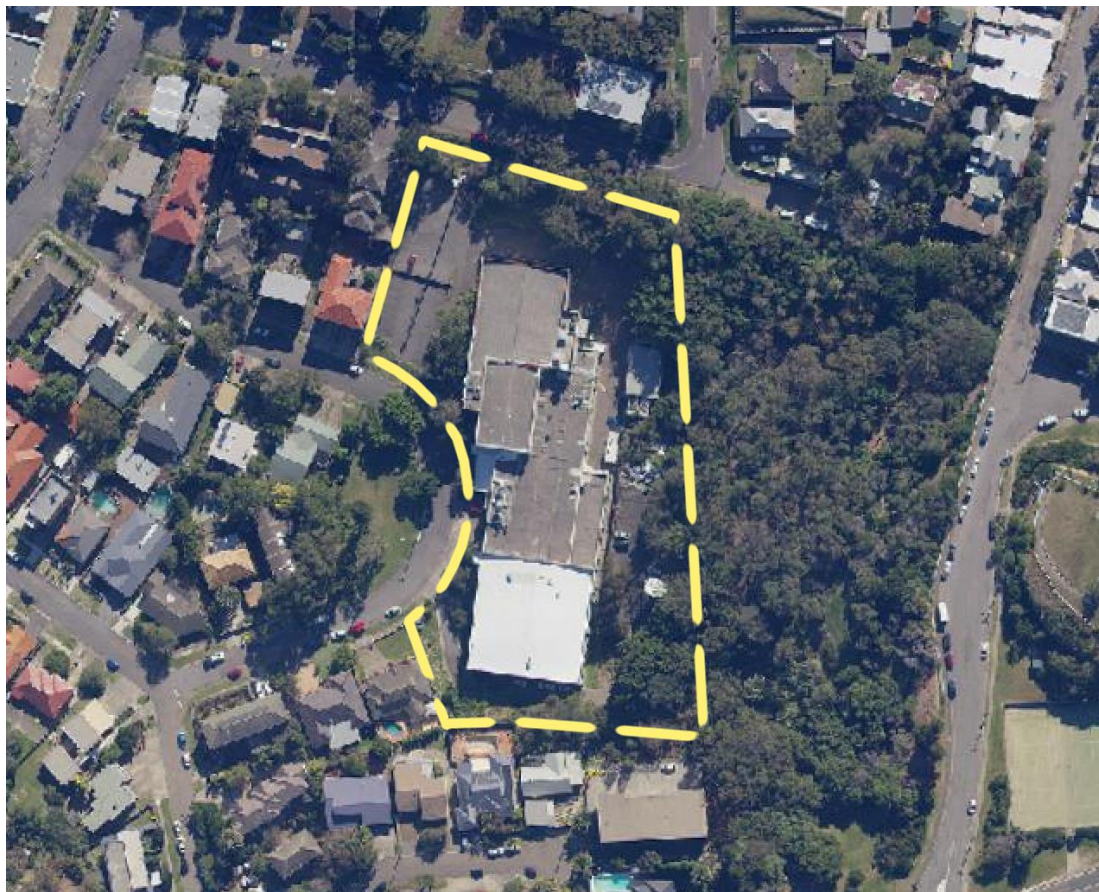
**FIG 1: Existing surface development and Lot 1 DP204007**

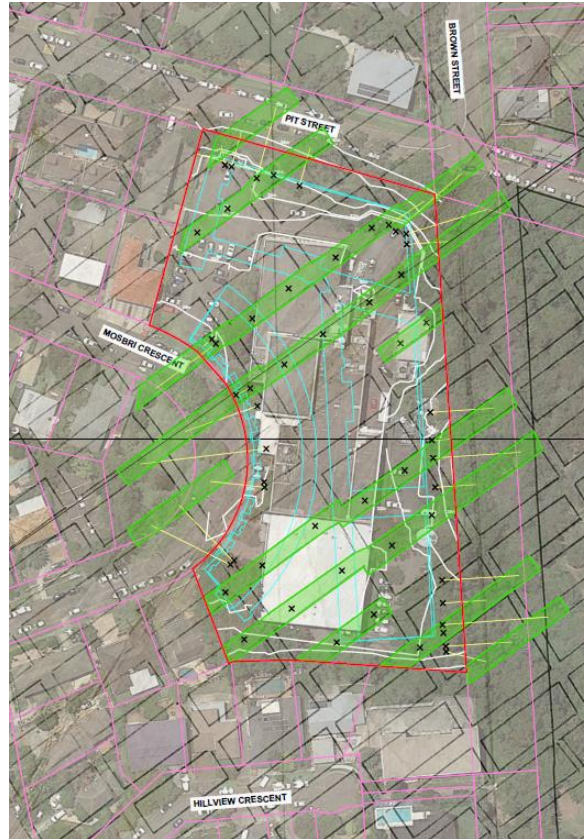
**FIG 2:** Borehole location for grouting the Borehole Seam.

The proposed location of boreholes is shown in FIG 2.

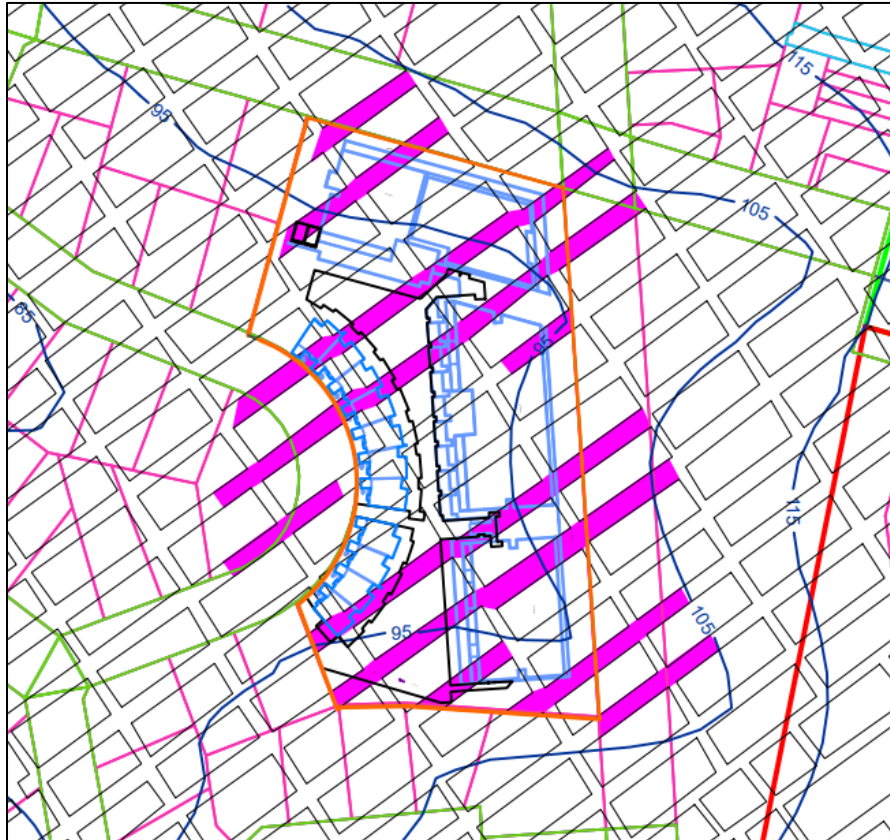
**FIG 3:** – 'Lot Boundaries and Proposed Grout in the Borehole Seam: Preferred Option 2, DgS Report No. COF-009/2 prepared by Ditton Geotechnical Services dated 22 August 2020

Figure 3 illustrates the grouting proposed as part of the Current Mine Grouting Strategy.

The modelling completed by DgS, and reviewed by GAPL, does not require the grout in the Boreholes Seam to be "*hard up against the roof*" in all mine headings, as the requirement is to strengthen the sides of the coal pillars, and not hold up the roof. For the Borehole Seam in the Current Mine Grouting Strategy, modelling utilises a conservative grout angle of repose of 1V:6H along the bords and 1V:10H across the bord assuming the more conservative 6m seam height with grout at the borehole taken to the roof.

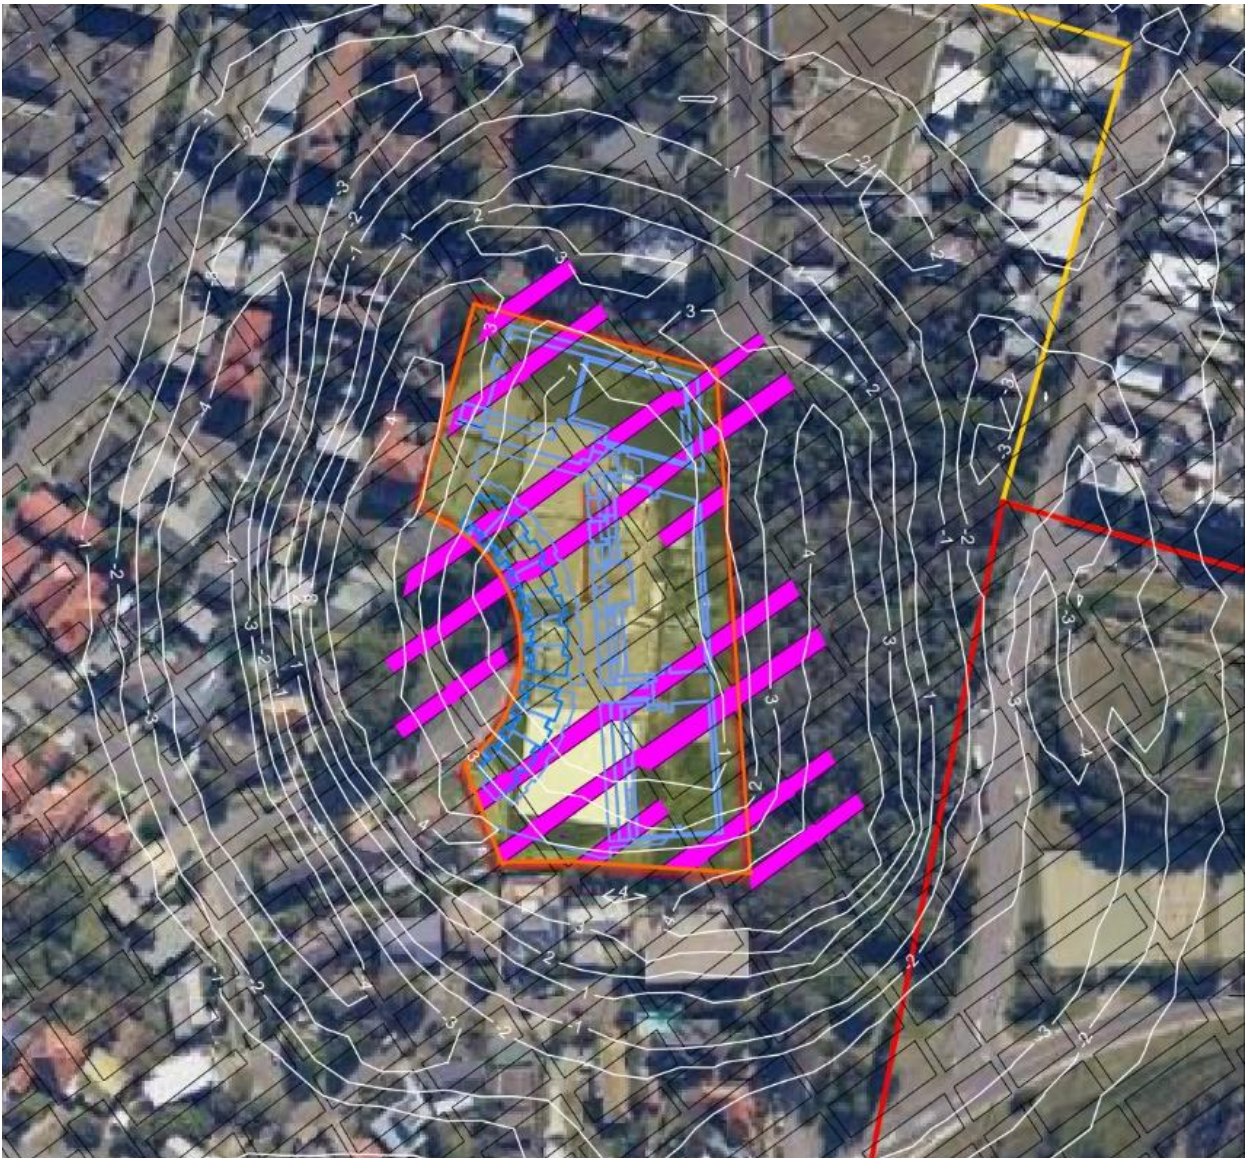
**Fig 4:** Predicted Final Horizontal Strain Contours with Aerial Photo and Proposed Grout in the Borehole Seam: Preferred Option 2 prepared by Ditton Geotechnical Services

In undertaking modelling DGS considered the possibility for a mine subsidence event to be initiated from a particular direction were considered. DgS had to model a credible worst-case scenario that this could occur from any direction and include that in the contour plans – see Figure 4. In reality, a mine subsidence event is expected to be initiated from a particular area.

Depending upon the behaviour of the subsidence event, existing structures could be subject to the same maximum predicted subsidence parameters calculated by DGS as illustrated in the subsidence contour plans as the subsidence 'wave' passed beneath the area. It is my observation after inspecting buildings damaged by subsidence over a period exceeding 20 years that not all residential structures are damaged following mine subsidence after undermining and that mine subsidence strains are not uniform in nature. There is a low risk the maximum predicted subsidence parameters would be exceeded. If a subsidence event were to occur today there can be no assurance where the subsidence effects will stop (as occurred with the original creeps to the east) and some structures will be subject to similar residual subsidence parameters as detailed in the DGS subsidence contour plan (Figure 4 below) attached as Appendix B to the Current Mine Grouting Strategy.

It can be seen from Figure 3 that in the area covered by the strain contours, the 4mm/m zone only makes up a portion of the area and in some cases is located where there are no surface structures. The majority of the area has strains of less than 4mm/m. It is also clear that strains will affect the Subject Site and grouting therefore was not intended to prevent any subsidence related ground movement.

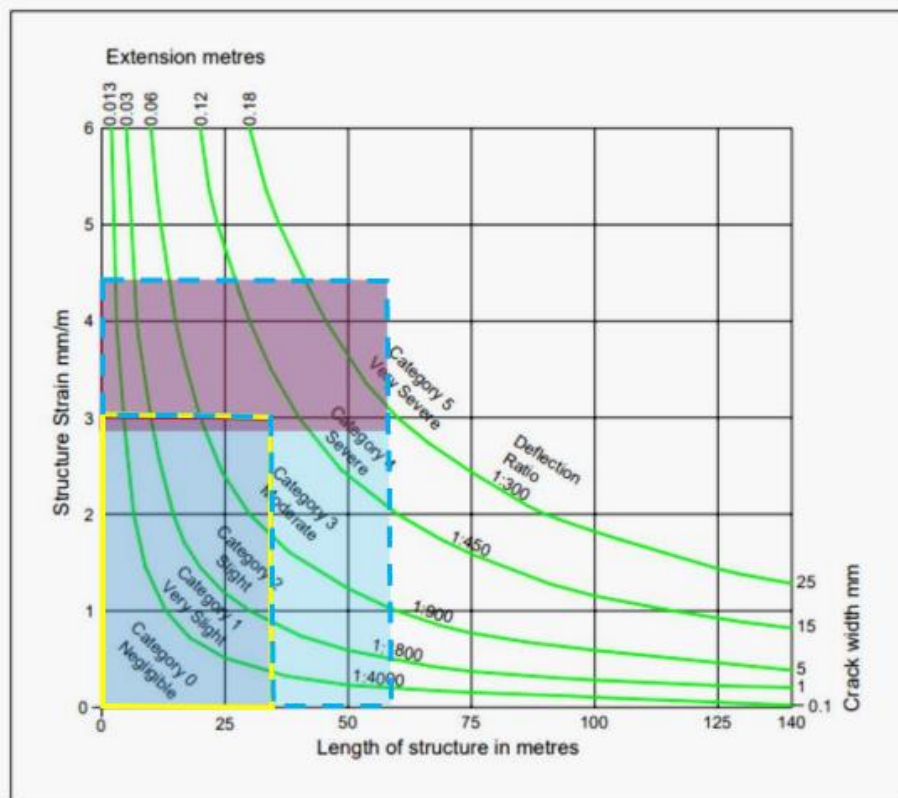
**FIG 5:** Impact Classification with Deflection Ratios for Two Storey Brick Structures [1]

**Fig. 1.2** Impact Classification with Deflection Ratios for Two Storey Brick Structures

The zone enclosed by the yellow dashed line added by the author shows the possible damage category for 2-storey brick structures if the strains were  $<3\text{mm/m}$  and the building length  $<35\text{m}$ .

The following diagram from the 1975 National Coal Board Engineer Handbook [1] was for 2 storey brick structures and therefore doesn't provide for different types of construction. Modern structures are more flexible and therefore have a greater level of tolerance to ground movement. Based on available aerial information it appears many structures would be less than 30m in length. For the purpose of conservatism, I have used 35m.

Based on Figure 5, it is expected most 2-storey brick structures would be in the "very slight to moderate" category.
