# Rehabilitation Plan

**Rehabilitation Plan  
for:  
Andersons Clay Mine  
Environmental Impact Statement  
November 2018**

Prepared by:  
**VGT Environmental  
Compliance Solutions Pty Ltd**

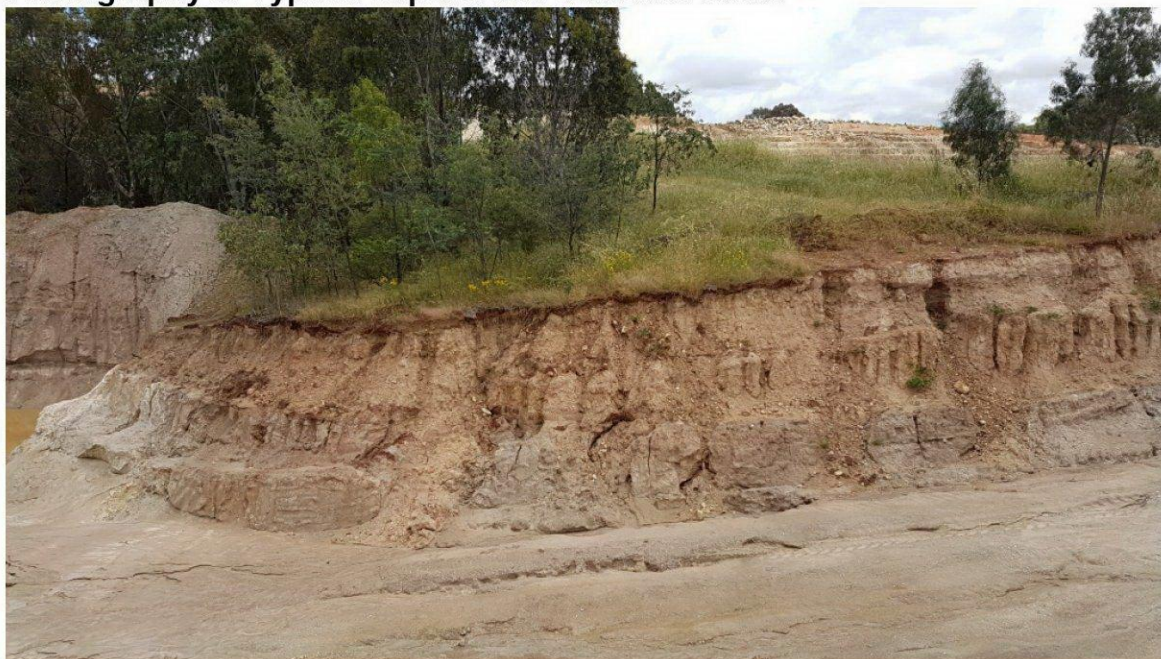
**Photography 6: Typical Topsoil and Subsoil Profile**

The topsoil in the extension area is quite thin (approximately 10 to 20cm in depth) overlaying the very hard weathered Shale shown as the 'C' Horizon in the table above and Photography 6 below. The soils are slightly acidic and have low to moderate conductivities.

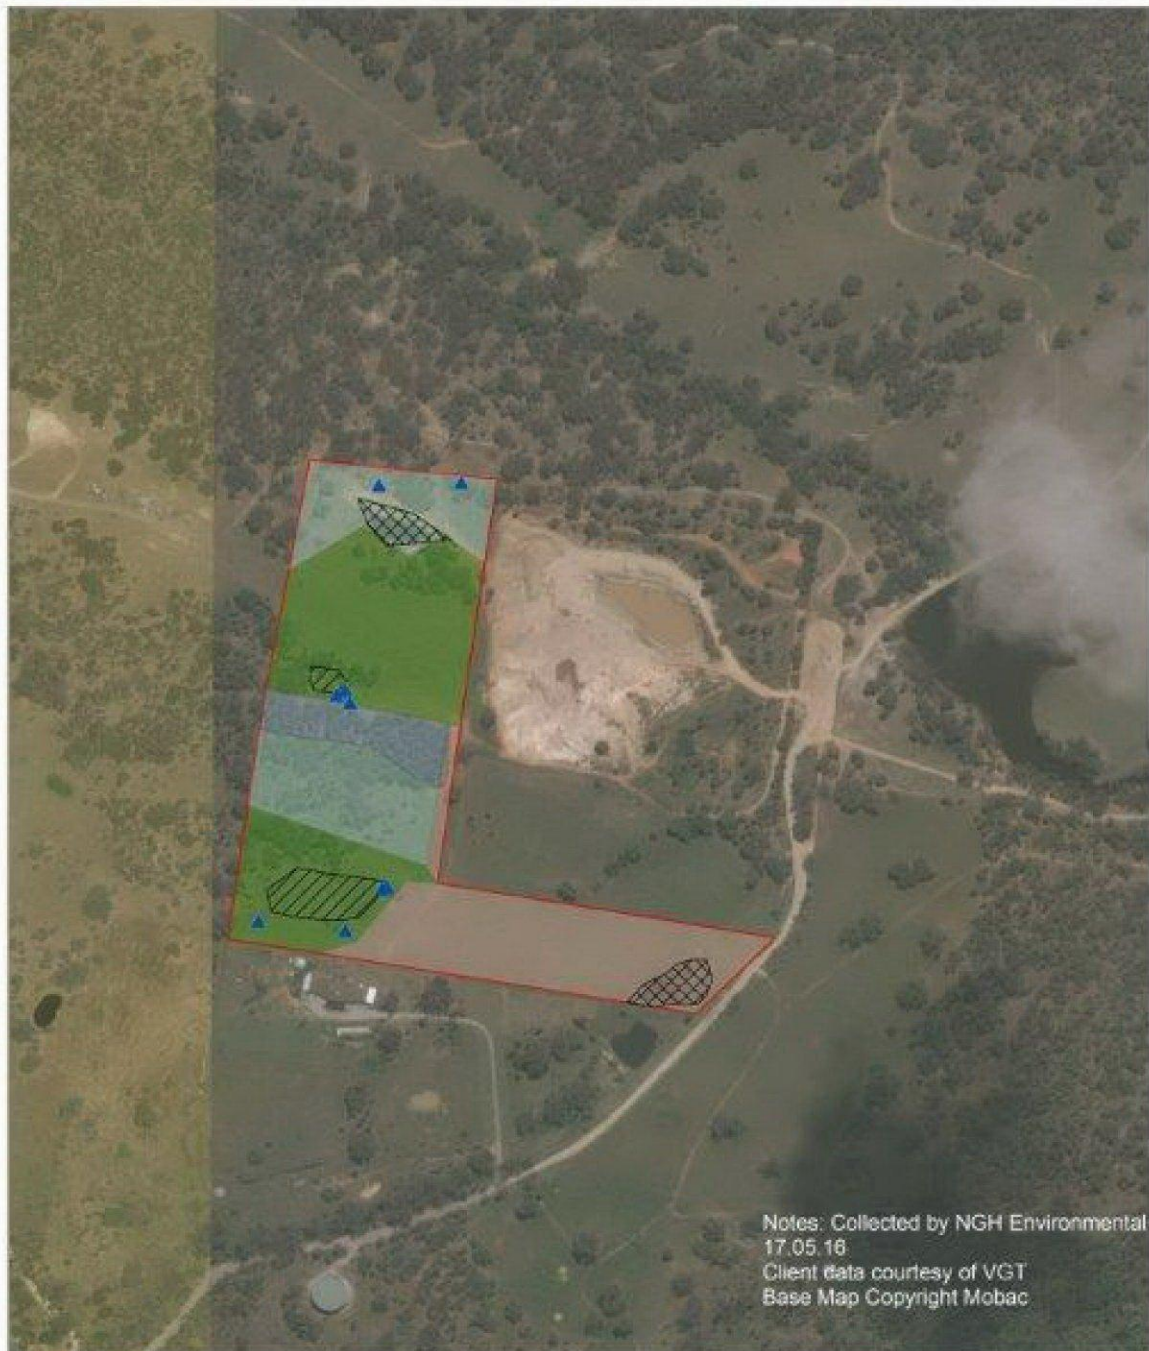
# Vegetation Communities and Threatened Species within the proposal

- Anderson's Quarry Proposal Site Boundary
- Hollow Bearing Tree

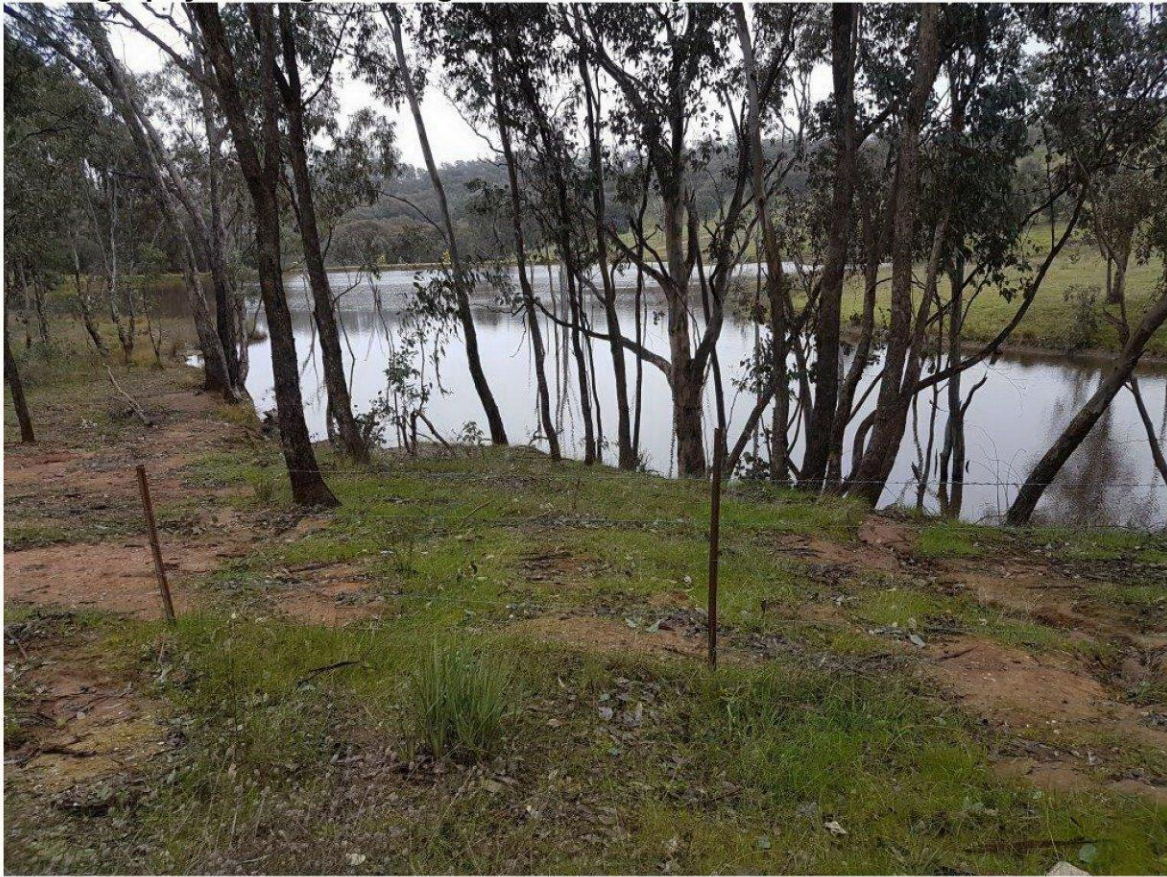
**Photography 7: Neighbouring Former Quarry Dam**

The final water body will not be out of character for the area given the former quarry dam located in Humbug Gully, less than 100m to the east of the site and other farm dams located in the area.

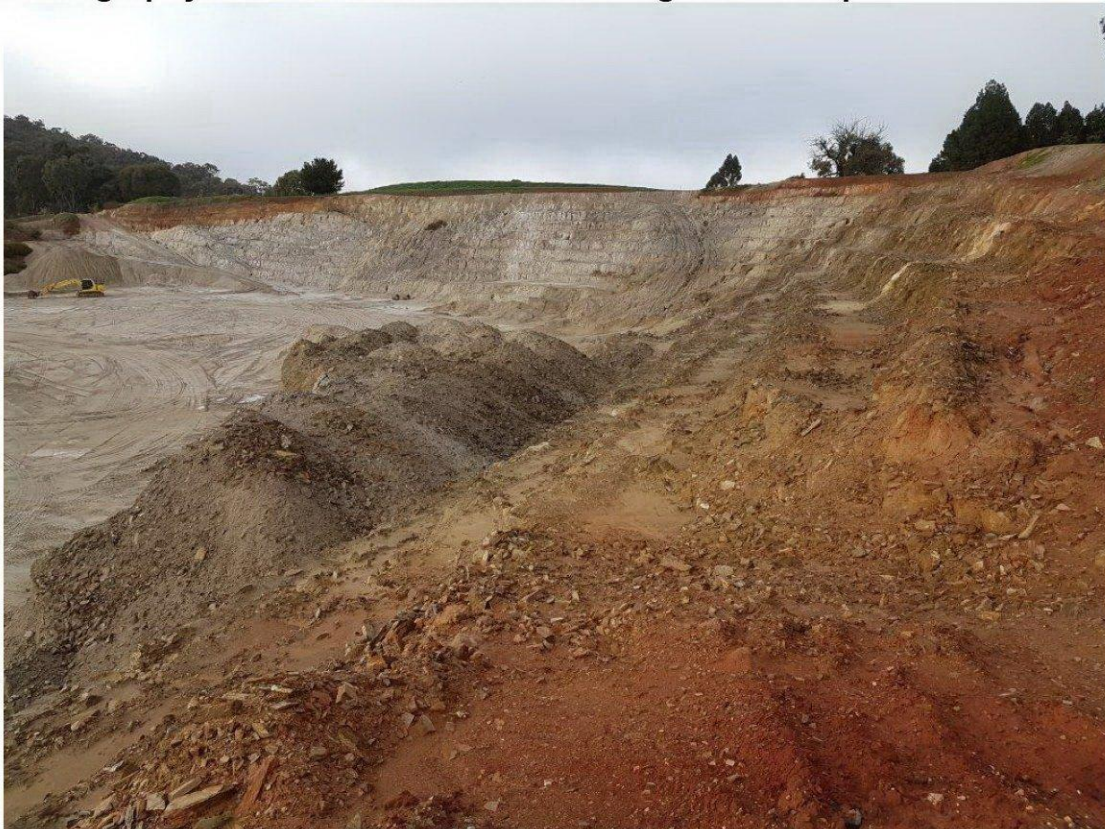
**Photography 8: Stable batters and benching in current pit**

The weathered Shale and Clay material remaining the final landform is geotechnical and chemically stable and is unlikely to fail at the proposed batter angles. Current faces at much steeper slopes have proved resistant to failure over the life of the operation and the risk of failure of the final landform is considered to be minimal. Additionally, previously rehabilitated slopes have proven to be stable as shown in *Photography 9* below.

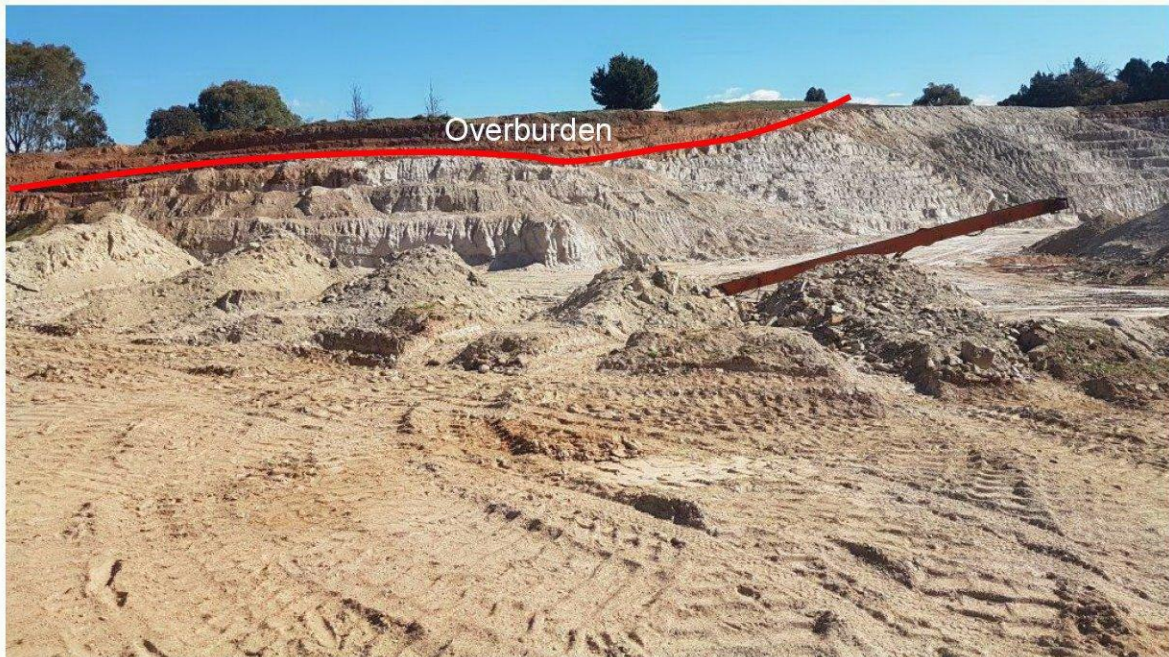
Photography 11: Subsoils and Overburden in the East

The 3-4 Horizontal to 1 Vertical mine final face batters will provide gentler slopes and the requirement for overburden to batter final slopes will be reduced. Further exploration activities will identify the volumes, if any, of overburden material expected.

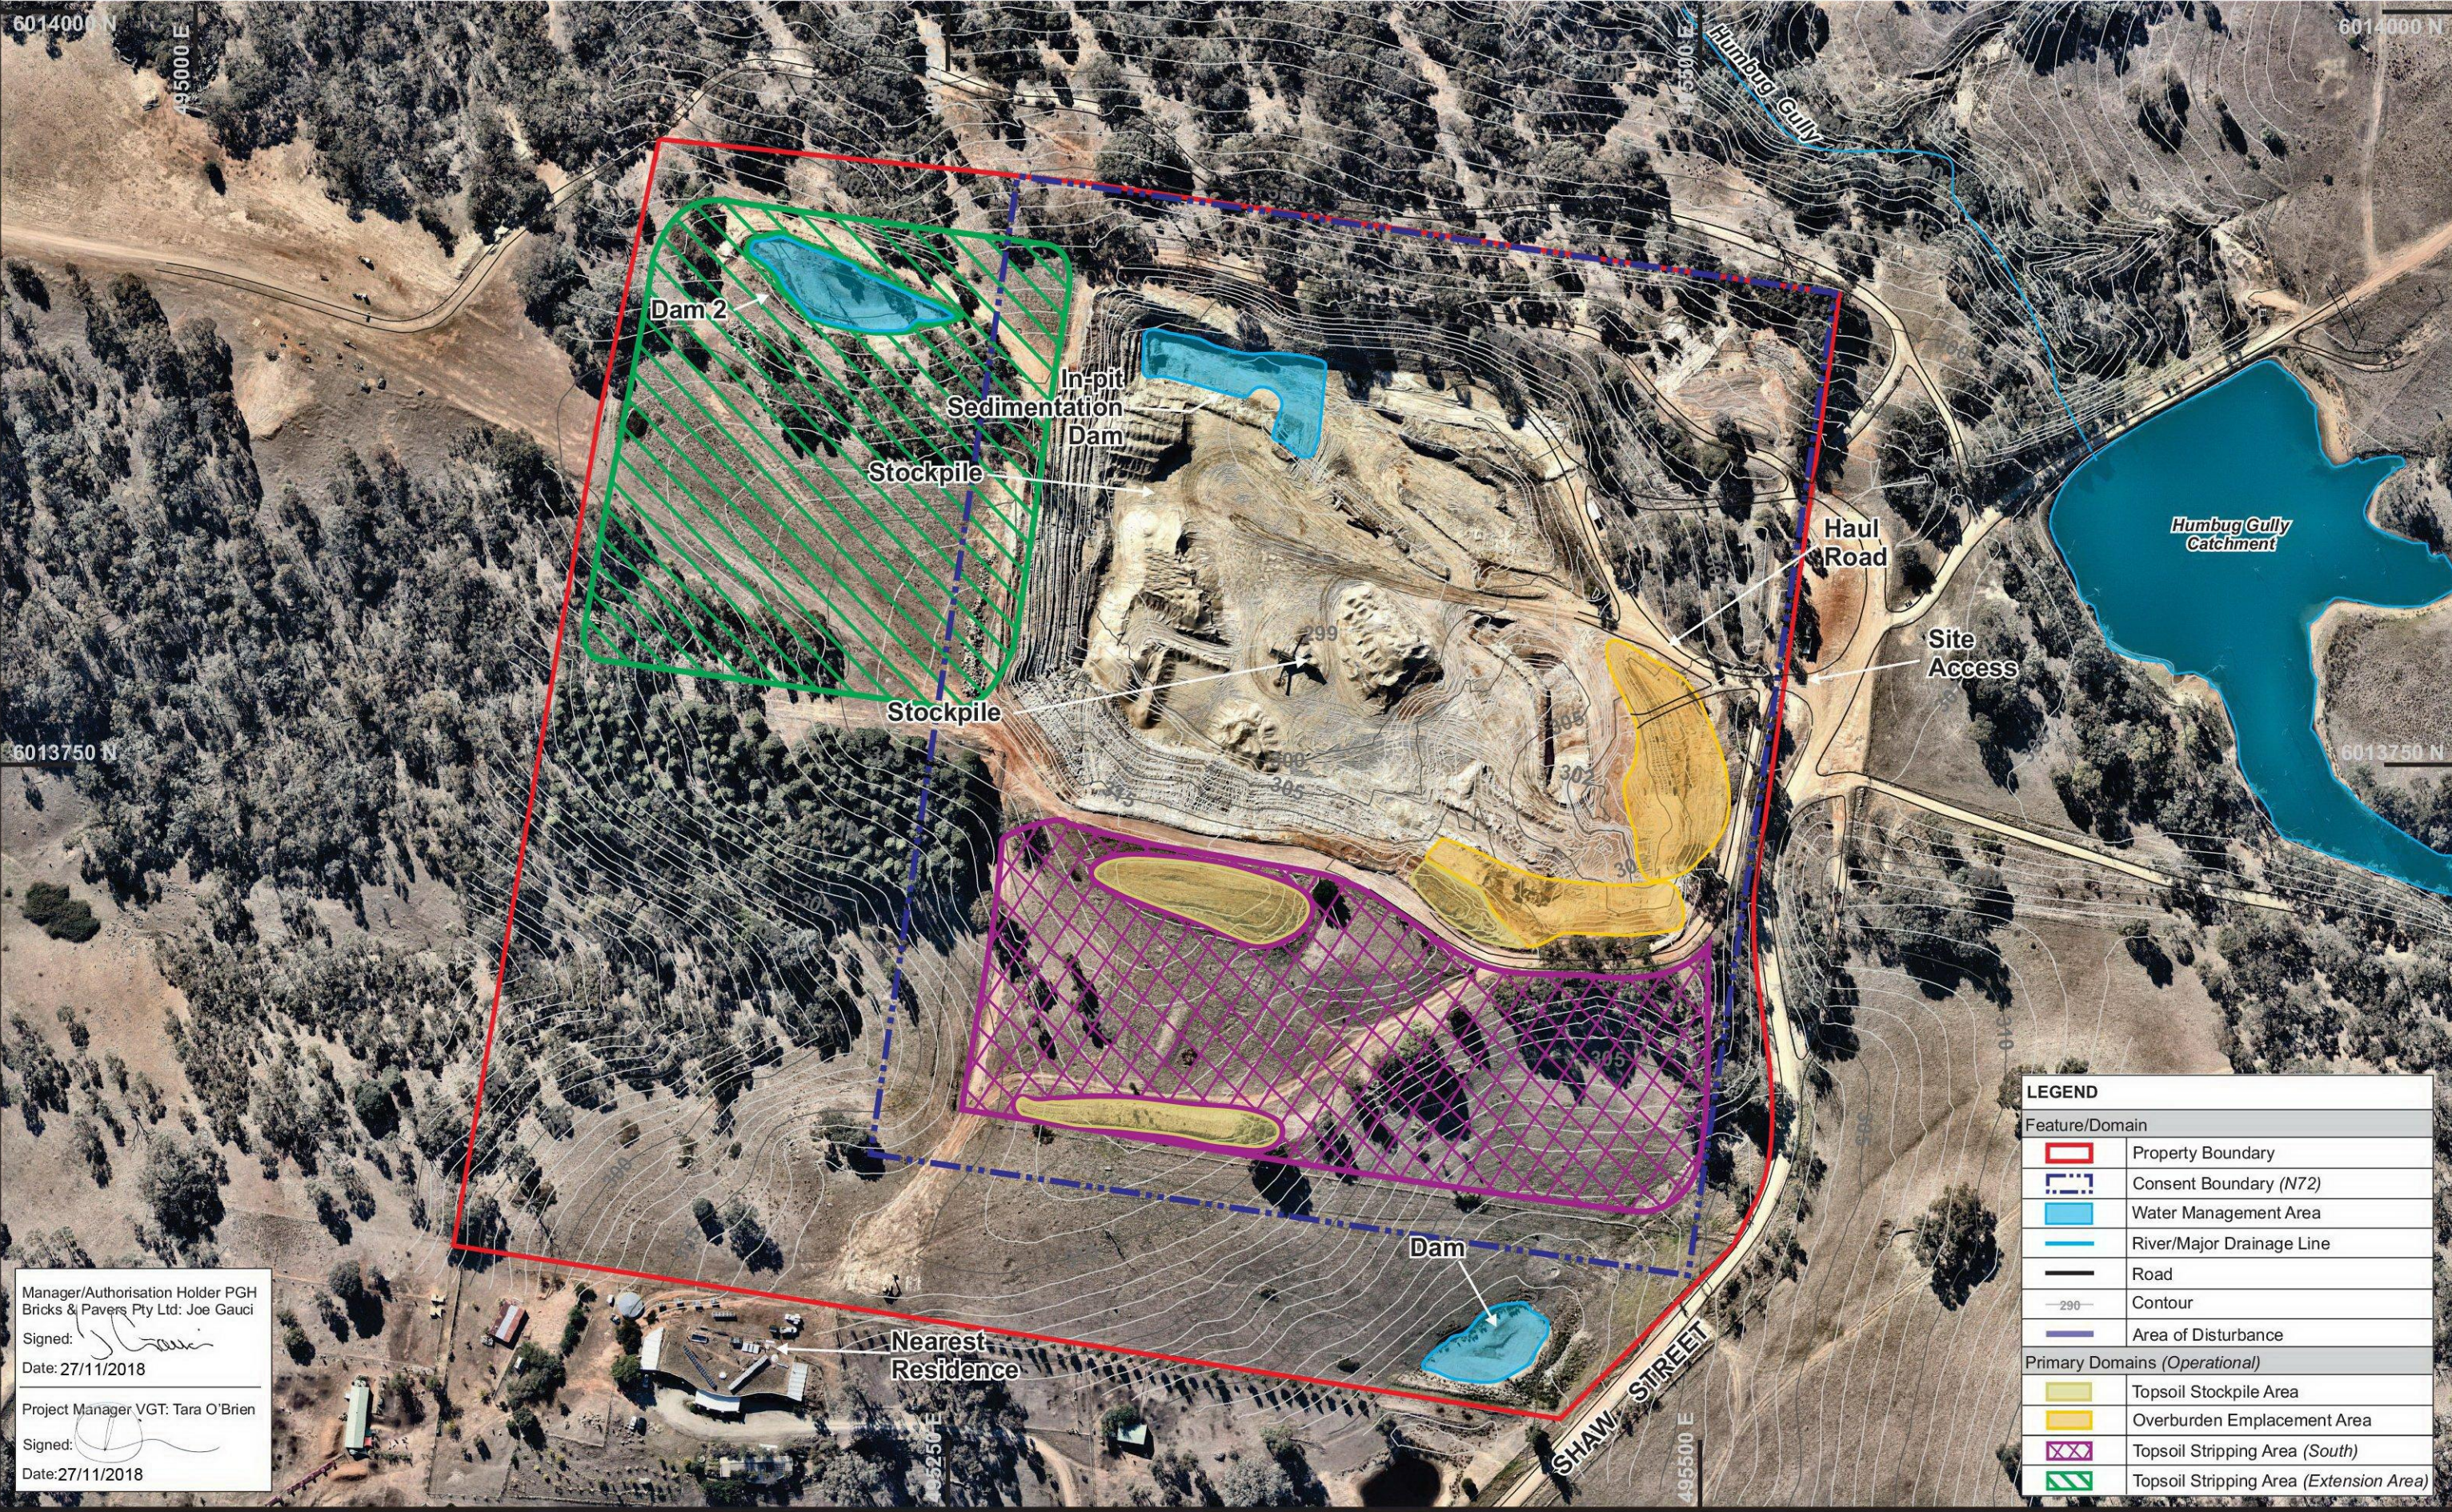
| <b>Plan of:</b> | Rehabilitation Plan for Andersons Clay Mine Environmental Impact Statement 2018 - Soil Resources | <b>Location:</b> | 253 Shaw Street, Springdale Heights, NSW | <b>Source:</b> | nearmap - Image Date 01/05/2018 & Landair Surveys | <b>Our Ref:</b> | 3618_BAN_RP_DA17_C009_V0_F9.cdr |
