Report on  
Geotechnical Investigation

School Upgrades  
Irrawang High School, 80 Mount Hall Rd, Raymond Terrace

Prepared for  
NSW Department of Education

Project 216008.00  
August 2022

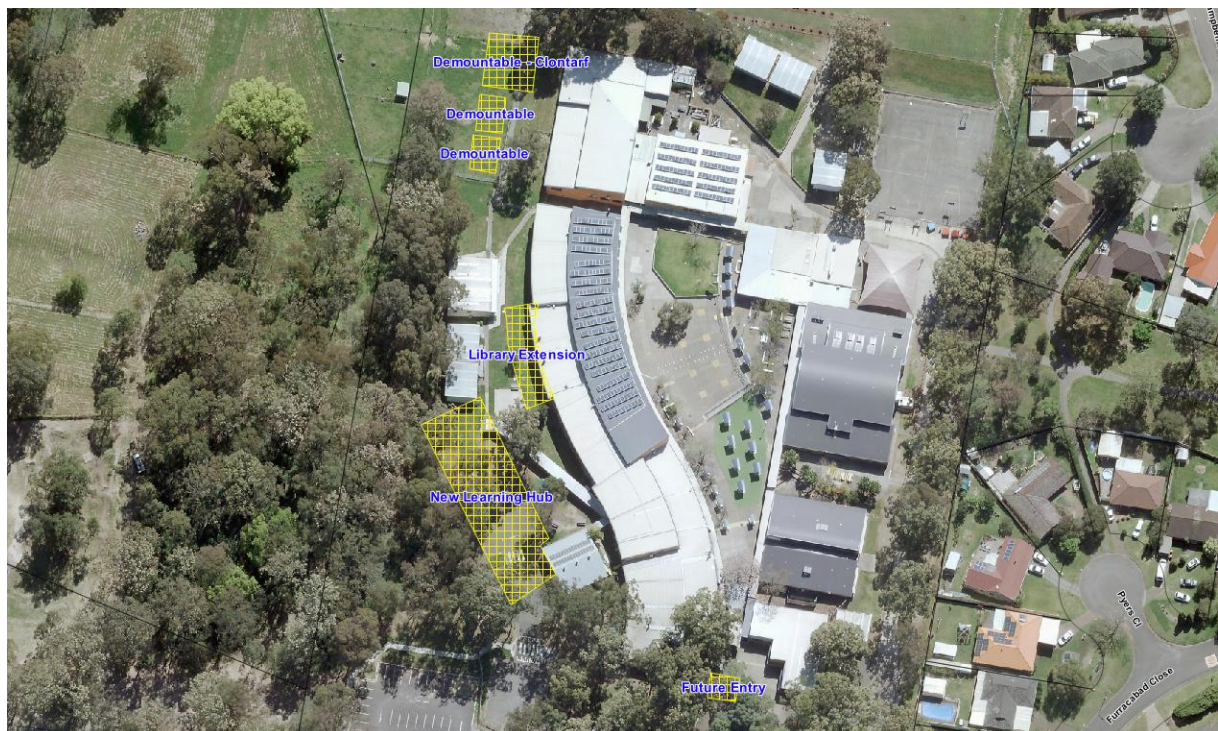
**Figure 2: Aerial photo of the site, proposed building footprints in yellow. Source – Metromap (19 September 2021).**

The site is situated within the western grounds of the Irrawang High School campus, located at 80 Mount Hall Road, Raymond Terrace. The site is bordered to the south by an existing car park and Mount Hall Road, to the east by existing one and two storey school buildings, to the north and west by agricultural land (refer to Figure 2 below and Drawing R.002.D.001 in Appendix D).

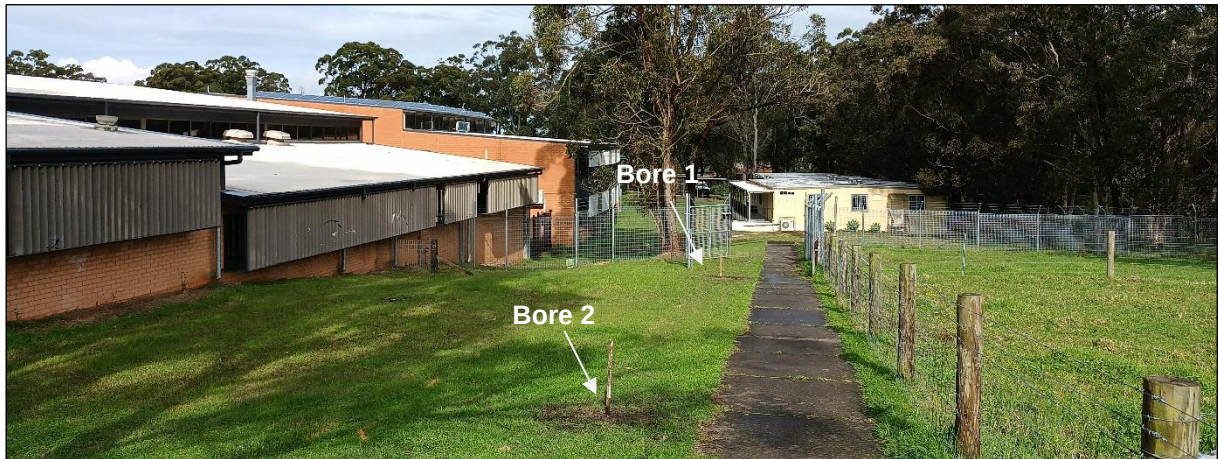
**Figure 3: Proposed location of demountable classrooms, looking approximately south.**

Parts of the proposed locations for the demountable classrooms, library extension and new learning hub and surrounds at the time of the investigation are shown in Figure 3 to Figure 5.

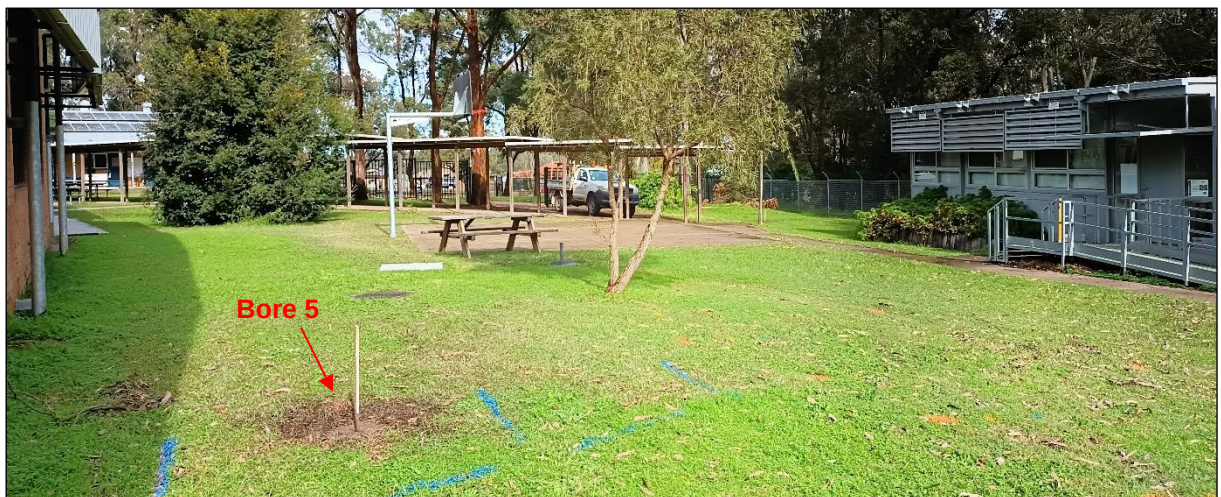
**Figure 4: Proposed location of library extension, looking south-west.**

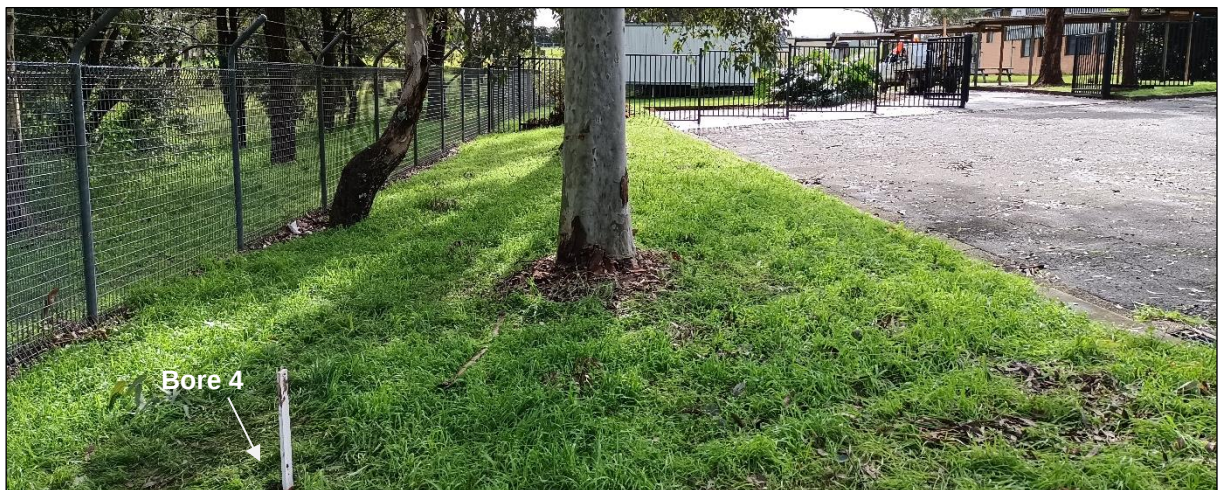
**Figure 5: Proposed location of new learning hub, looking north.**
