Pacific Highway / Italia Road Intersection

Preliminary Site Investigation

Boral Resources (NSW) Pty Ltd

09 August 2023

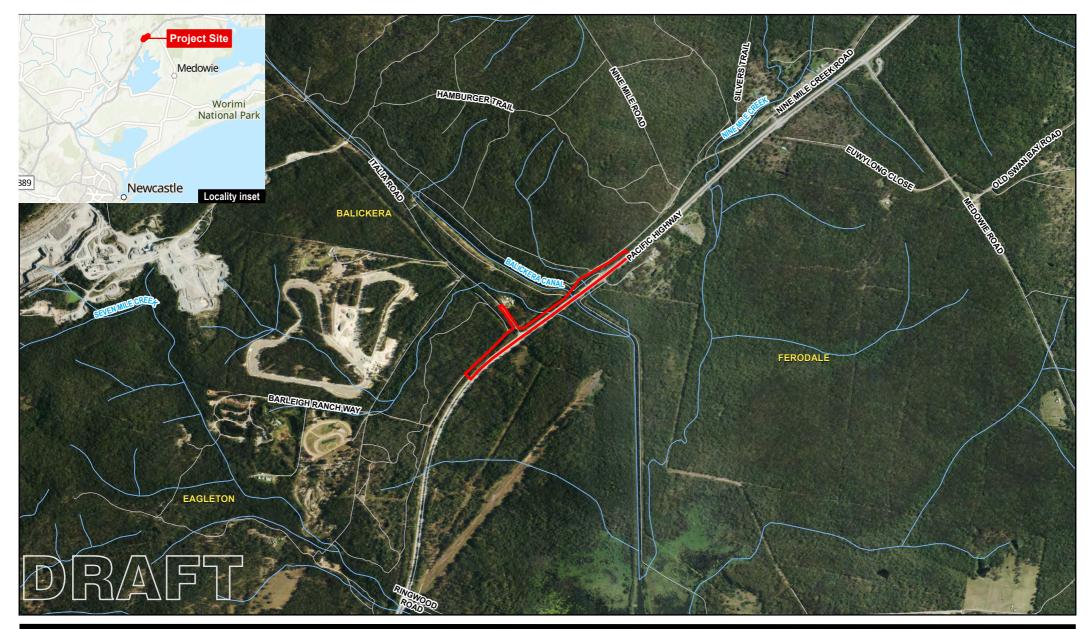
FIGURE 1

Site boundary

GHD Pty Ltd (GHD) was engaged by Boral to complete a Preliminary Site Investigation (PSI) to assess potential contamination at the Italia Road and Pacific Highway intersection, Balickera, NSW, 2324 (referred to as the Site). The site location is shown on Figure 1, Appendix A. The 'Site' refers to the site area as shown in Figure 2, Appendix A.

A summary of identification details for the Site are provided in Table 2.1. The Site location is shown on Figure 1 in Appendix A.

Setting	Site conditions
Topography	The Site has an elevation of approximately 20-30m Australian Height Datum (AHD), with a gentle downward slope to the north in the direction of the Balickera Canal adjacent to Wallaroo State Forest.
Hydrology	Grahamstown Dam is located approximately 1.5km to the Southeast of the area.
	Balickera Canal starts approximately 950 m west of site from the Balickera Canal Tunnel which flows from the Williams River to the Dam.
	The Site consists of both sealed and unsealed areas. Surface runoff is expected to follow stormwater diversion pathways that are located in the median strip, as well as drainage which directly leads to the canal.
	For unsealed areas surface water runoff is expected to either infiltrate into surface soils or run off to the north to northeast towards Balickera Canal.
	As seen in Figure 1 and 2, two unnamed creeks are present which flow into Balickera Canal.
