Project 49737.06
8 November 2021
R.001.Rev0
CB:kd

**Proposed Rainwater Tank
Newcastle Art Gallery - Proposed Alterations and Additions
1 Laman Street, Newcastle**

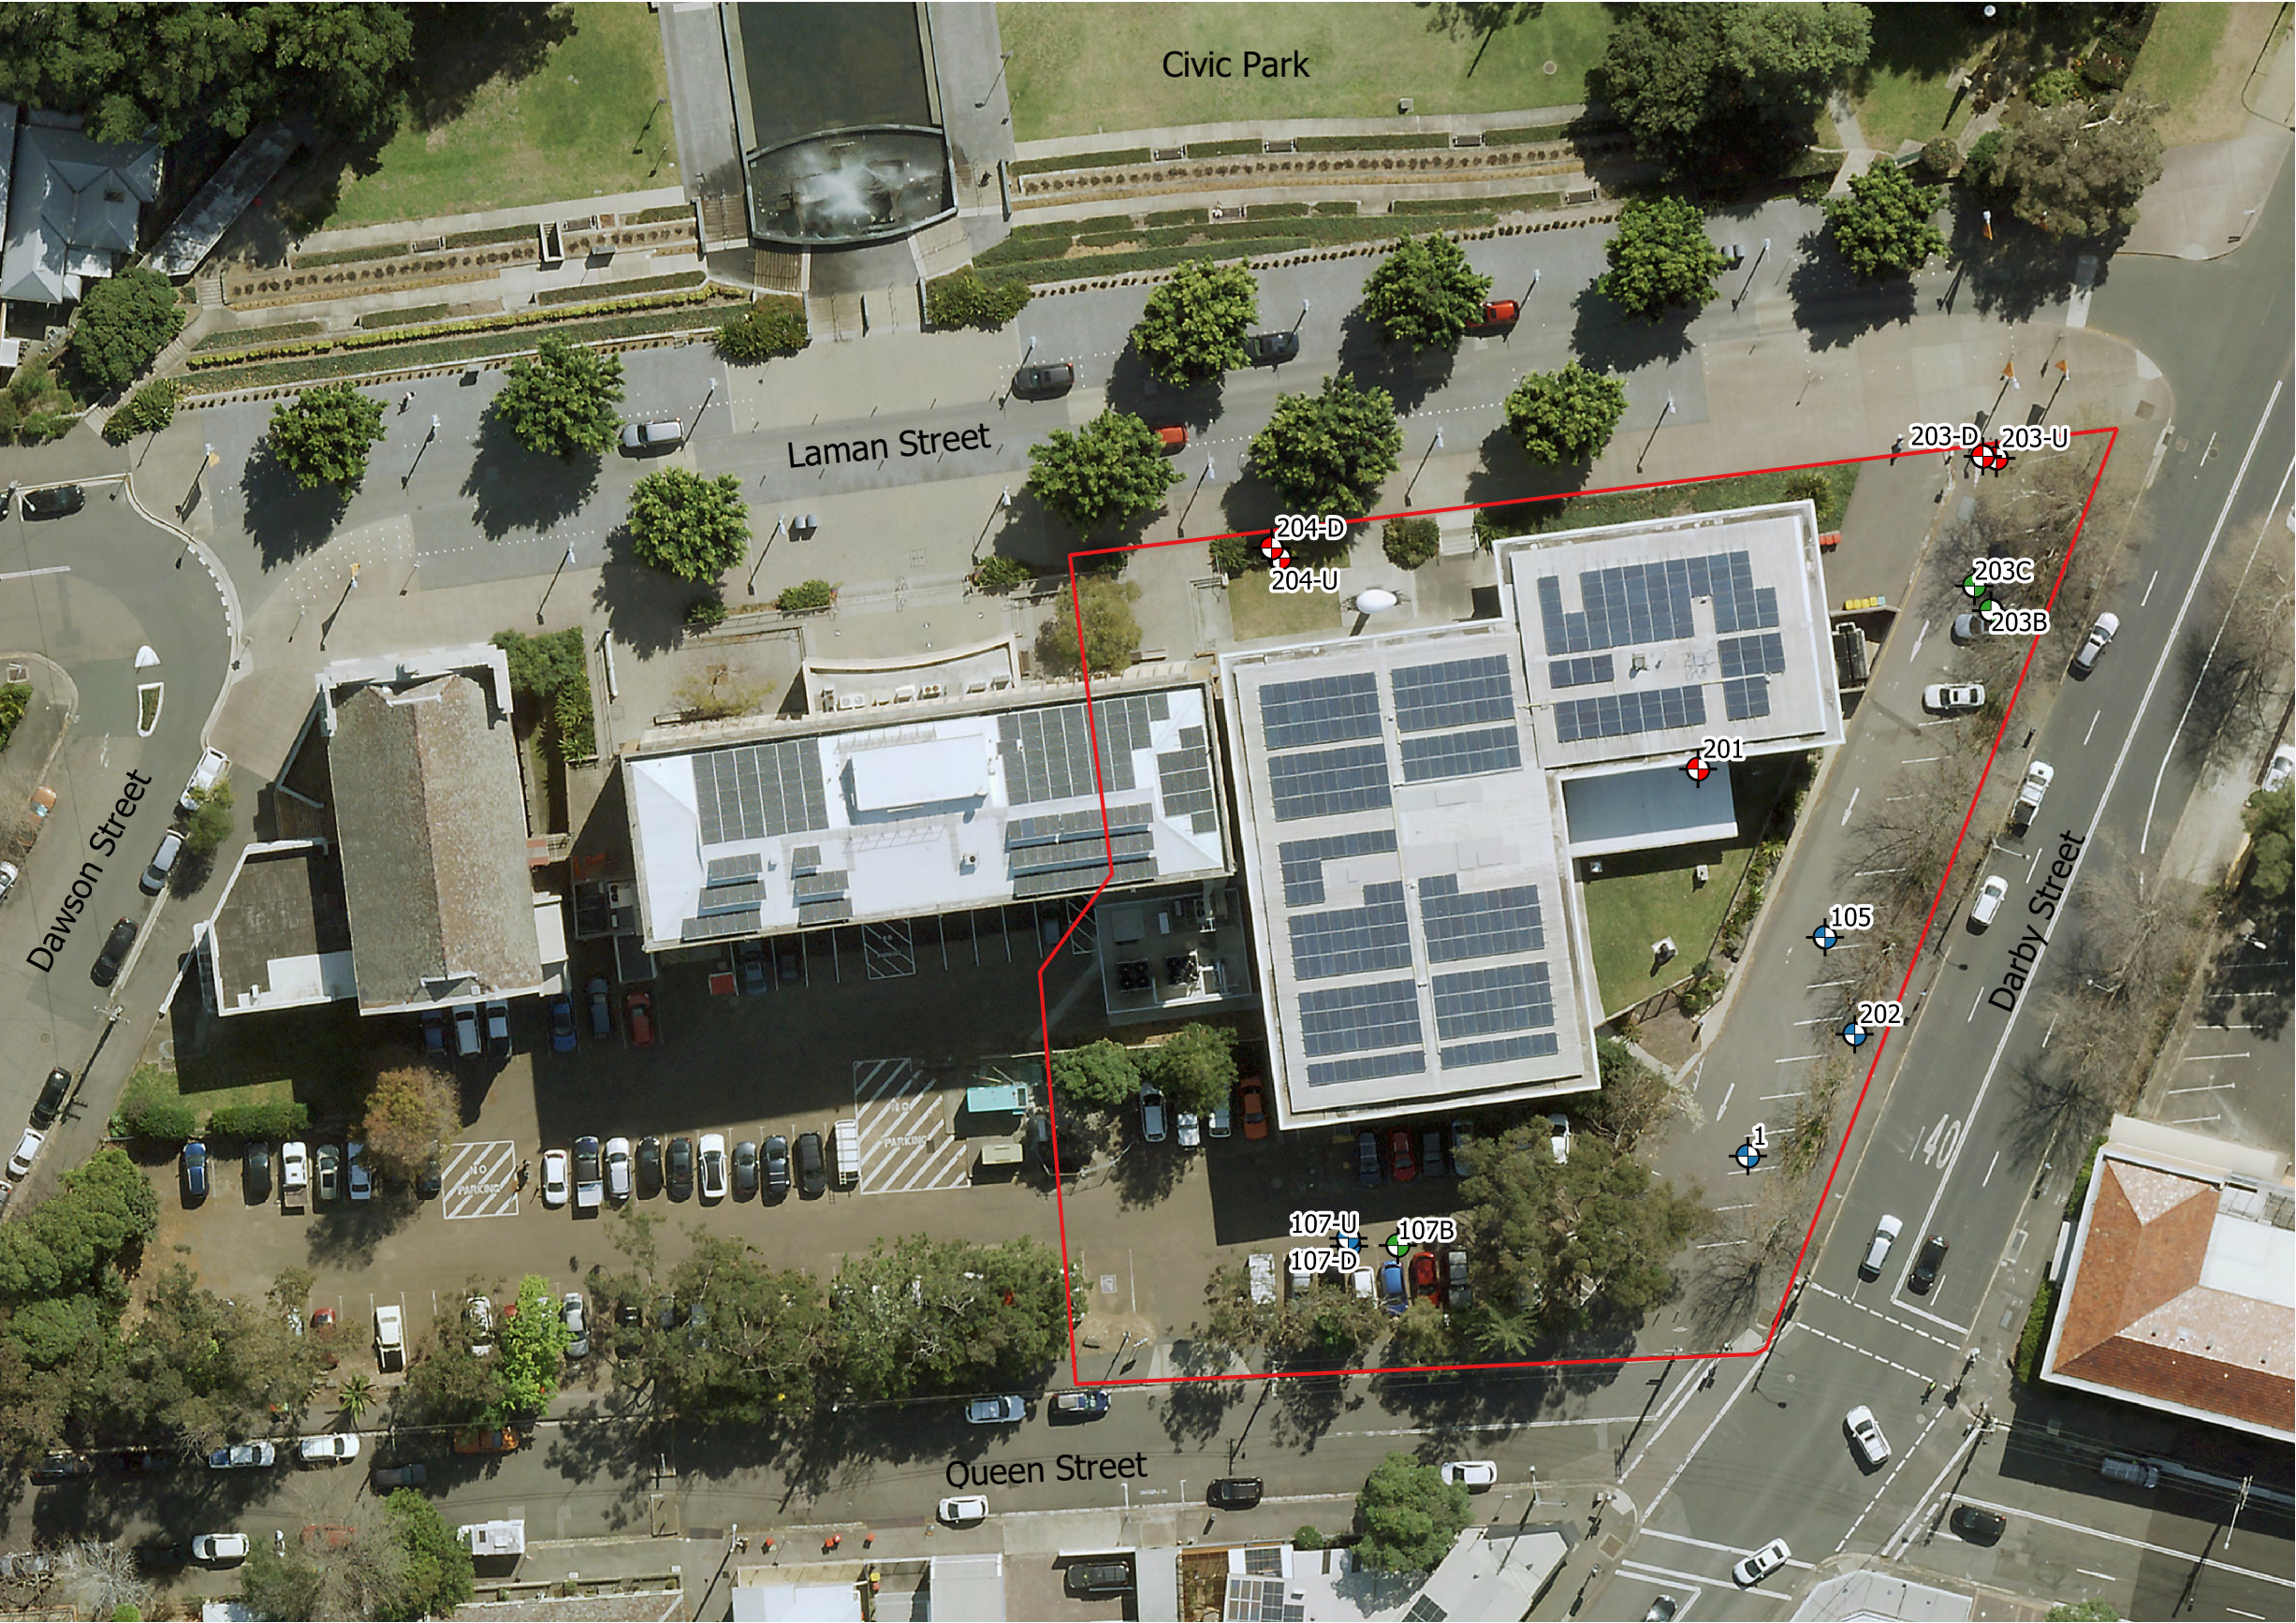
- Existing Groundwater Wells
- Missing Groundwater Wells
- Additional Wells (Not DP)
- Approximate Site Boundary
