Project 85348.00
4 March 2016
R.001.Rev0
PAV:dh

**Geotechnical Assessment of Nominal Absorption Rate
Proposed Residential Aged Care Development
119 Barton Street, Monterey**

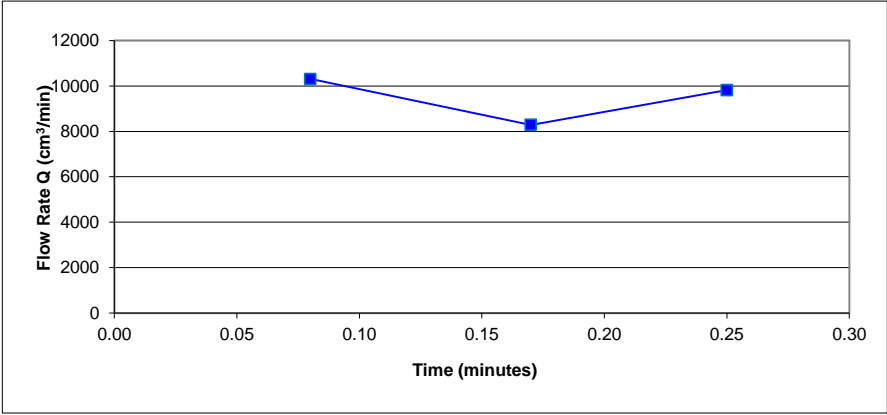
<table><tr> <th>Time (minutes)</th> <th>Level below top (mm)</th> <th>Flow Volume (cm³)</th> <th>Rate of Loss [Q] (cm³/min)</th> </tr><tr> <td colspan="2" style="text-align: center;">Average</td> <td style="text-align: center;">785</td> <td style="text-align: center;">9472</td> </tr></table>

</div>		Time (minutes)	Level below top (mm)	Flow Volume (cm ³)	Rate of Loss [Q] (cm ³ /min)	0.00	300			0.08	195	825	10308	0.17	100	746	8290	0.25	0	785	9817																													Average		785	9472
Time (minutes)	Level below top (mm)	Flow Volume (cm ³)	Rate of Loss [Q] (cm ³ /min)																																																		
0.00	300																																																				
0.08	195	825	10308																																																		
0.17	100	746	8290																																																		
0.25	0	785	9817																																																		
Average		785	9472																																																		
Saturated Hydraulic Conductivity - Over total duration of test <div style="display: flex; justify-content: space-between;"> <div> k = 4.20E+00 cm/min = 7.01E-04 m/sec = 60.53 m/day </div> <div> where $K = 4.4Q[0.5 \sinh^{-1}(H/2r) - \sqrt{(r/H^2) + 0.25}] + r/H / 2\pi H^2$ ref. AS1547-2012 App G </div> </div>
