Bronte SLSC Redevelopment Seawall and Related Elements Detailed Design

Concept Design and Coastal Engineering Assessment
Report

Reference: PA3572-RHDHV-RP-S1-RP-FC-0001

Date: 5 December 2023

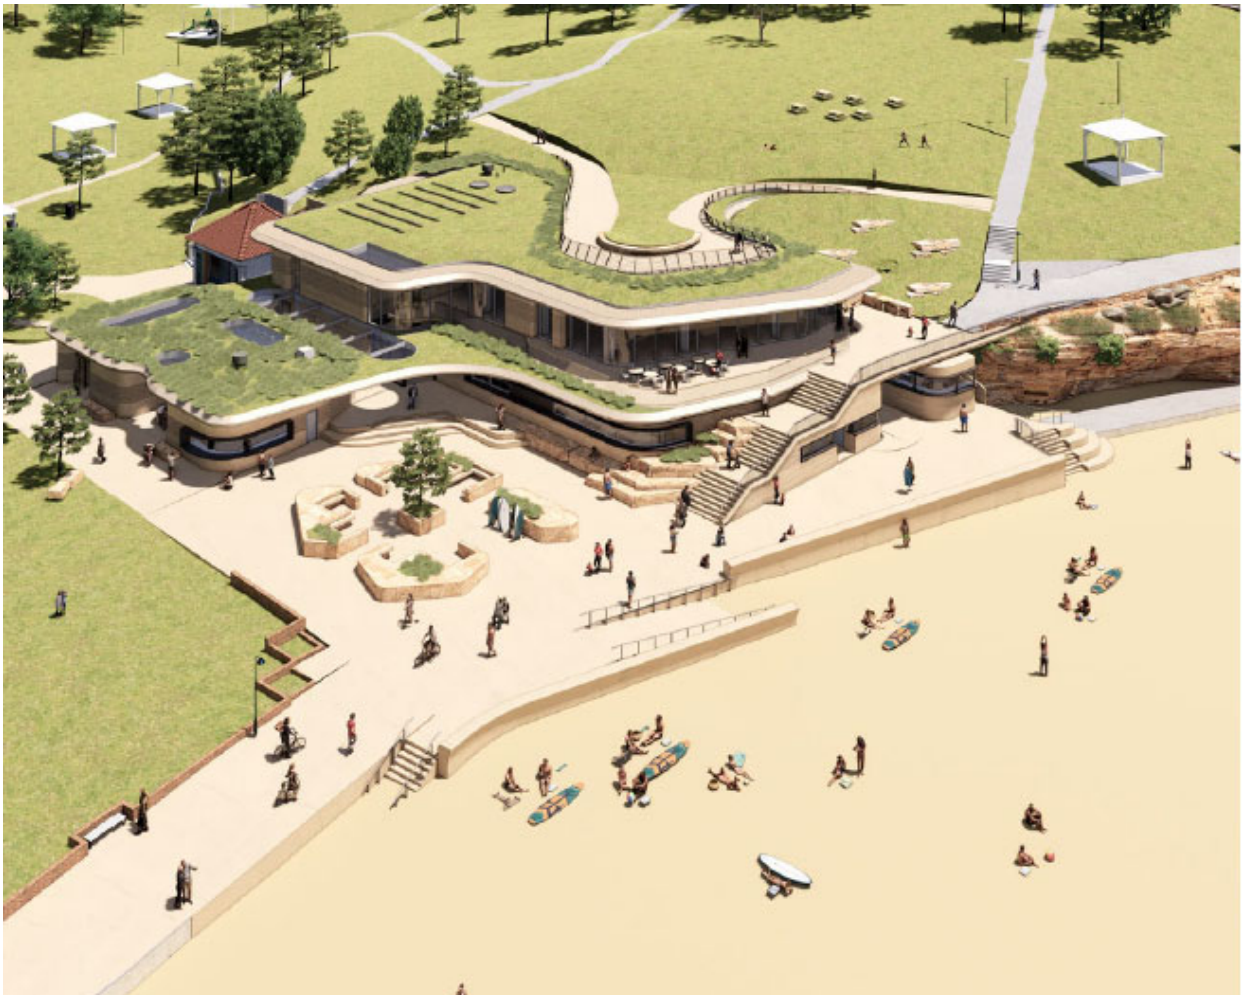
Figure 1-1 Photo montage for revised DA showing seawall and related elements. Subject to design development

Architects Warren and Mahoney (W&M) have recently resubmitted a revised Development Application (DA) for the redevelopment of the Bronte Surf Lifesaving Club (SLSC), refer to **Figure 1-1** and **Figure 1-2**. The design of the seawall and its related elements were originally to be run internally within Waverly Council (hereafter referred to as the Council), but it was decided that it would be preferable to extract the documentation into W&M's scope so that it could be run concurrently with the SLSC upgrade.

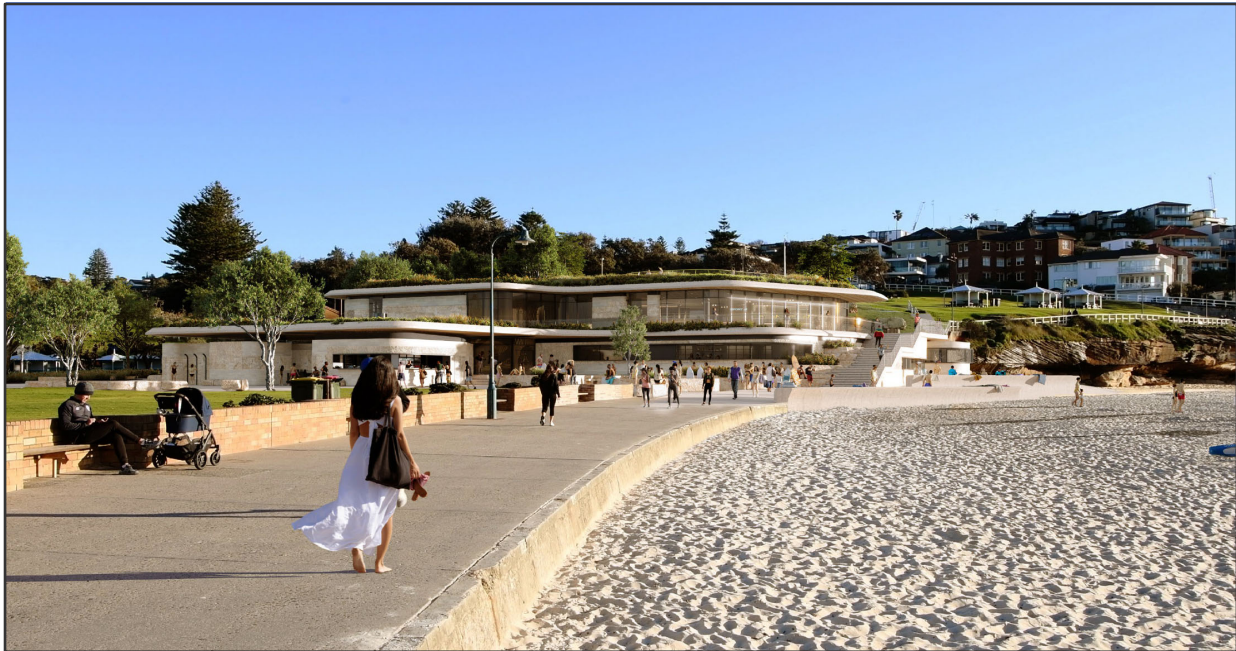
Figure 1-2 Architectural visualisations for general arrangement for revised DA showing seawall and related elements. Subject to design development

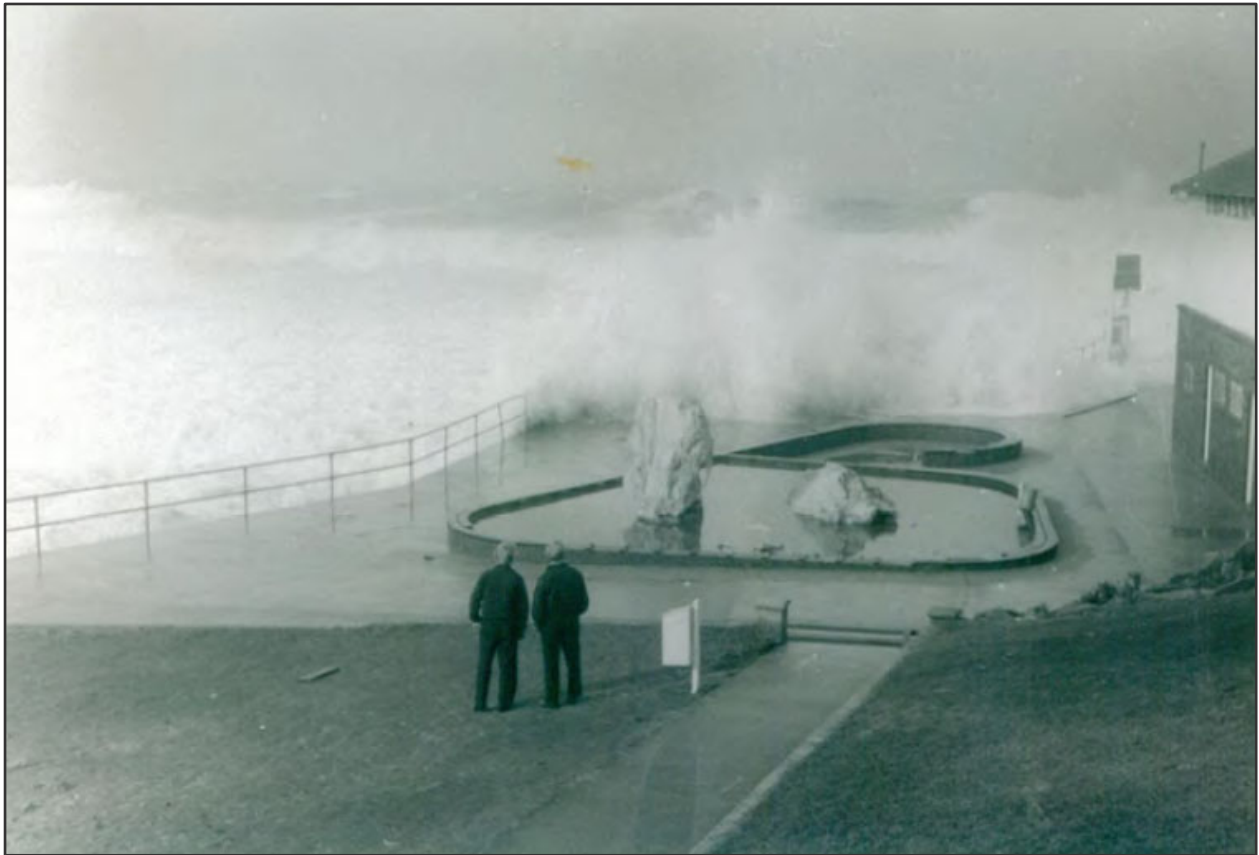
Figure 2-2 Overtopping at Bronte, 1974 (source: Waverley Council)

According to the WorleyParsons report (WorleyParsons, 2011), the crest level of the Bronte seawall varies from around 3.9m AHD in the south to 4.8m AHD in the centre of the beach in front of the amenity block. These levels are considerably below potential runup levels, and overtopping would be anticipated during extreme events. As per this report, this aligns with comments recorded in news reports during previous storm events in 1948 and 1959. However, there is no mention of damage to the seawall, and it is not known what (if any) repair works have been undertaken to the seawall since its construction. Overtopping was also documented in photographs taken during the 1974 storms (refer to **Figure 2-2**).

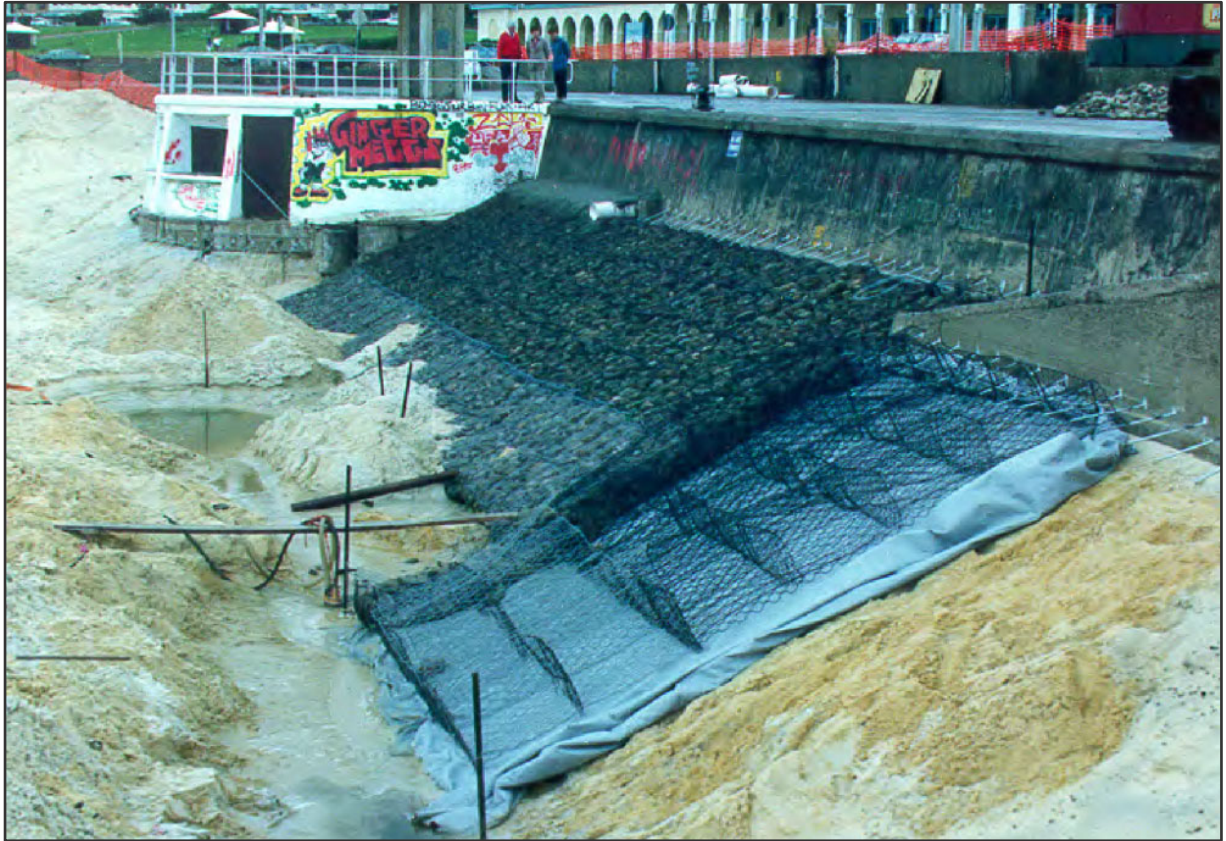
Figure 2-5 Construction of Bondi seawall reno-mattress toe protection 1987 ((WorleyParsons, 2011))

ARUP have run stability assessments for the wall, including gross stability, overturning, sliding, and bearing. While acceptable gross stability is reported for all test cases, this is found to be unacceptable for extreme coastal loads, and strengthening is required. ARUP present several options to strengthen the existing seawall including rock or grout bag mattress, cut-off sheetpile, underpinning, modified geometry (including widening landwards), and replenishment of backfill. Bullnose and/ or parapet at the top of the wall to reduce overtopping is recommended. The mattress was ARUP's preferred option. RHDHV note that the seawall at Bondi Beach which is of similar vintage and design to the Bronte seawall, was protected by a reno-mattress apron 36 years ago, probably for similar reasons (refer to **Figure 2-5**).

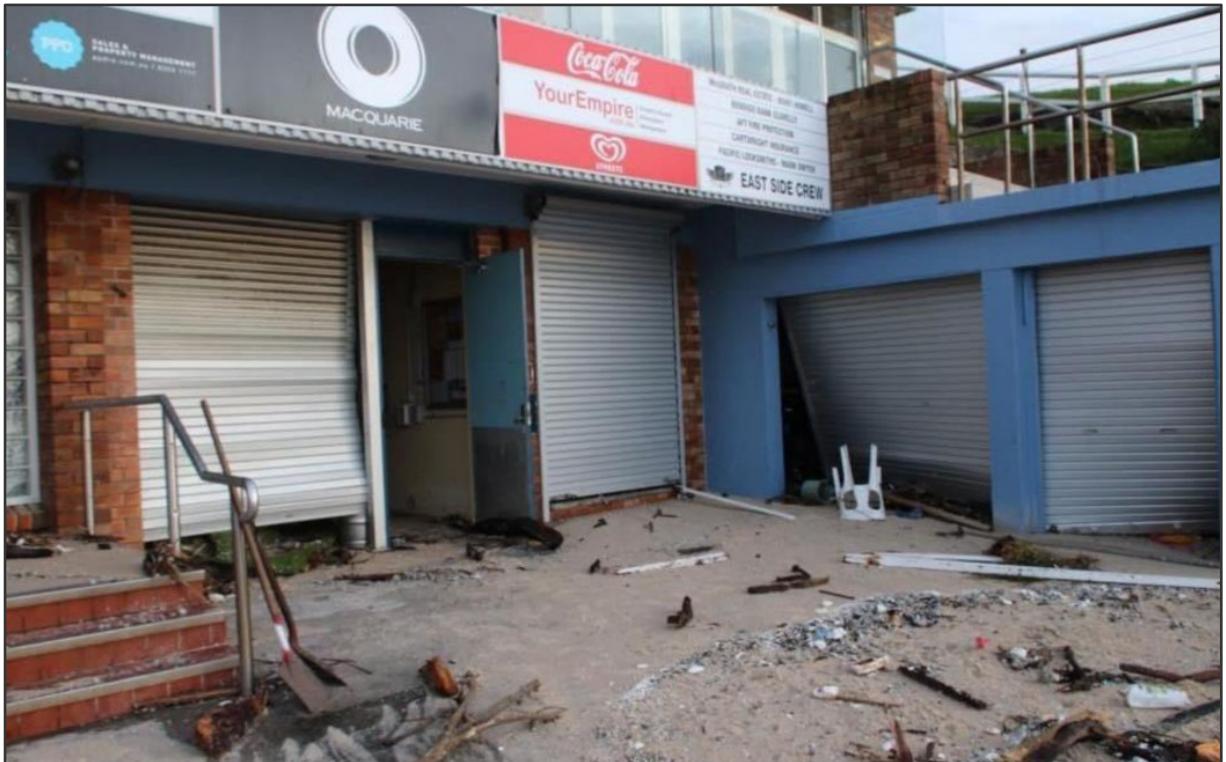
Figure 2-6 Damage to roller doors at Bronte SLSC in June 2016

The promenade and club, as they are currently situated, are exposed to wave runup, and overtopping in storms. Impacts from the June 2016 event (refer to **Figure 2-6**), nominally regarded as about a 30-year ARI event for east facing shorelines in and around Sydney, aptly demonstrate this exposure which could be expected to worsen significantly under sea level rise over the life of the development.

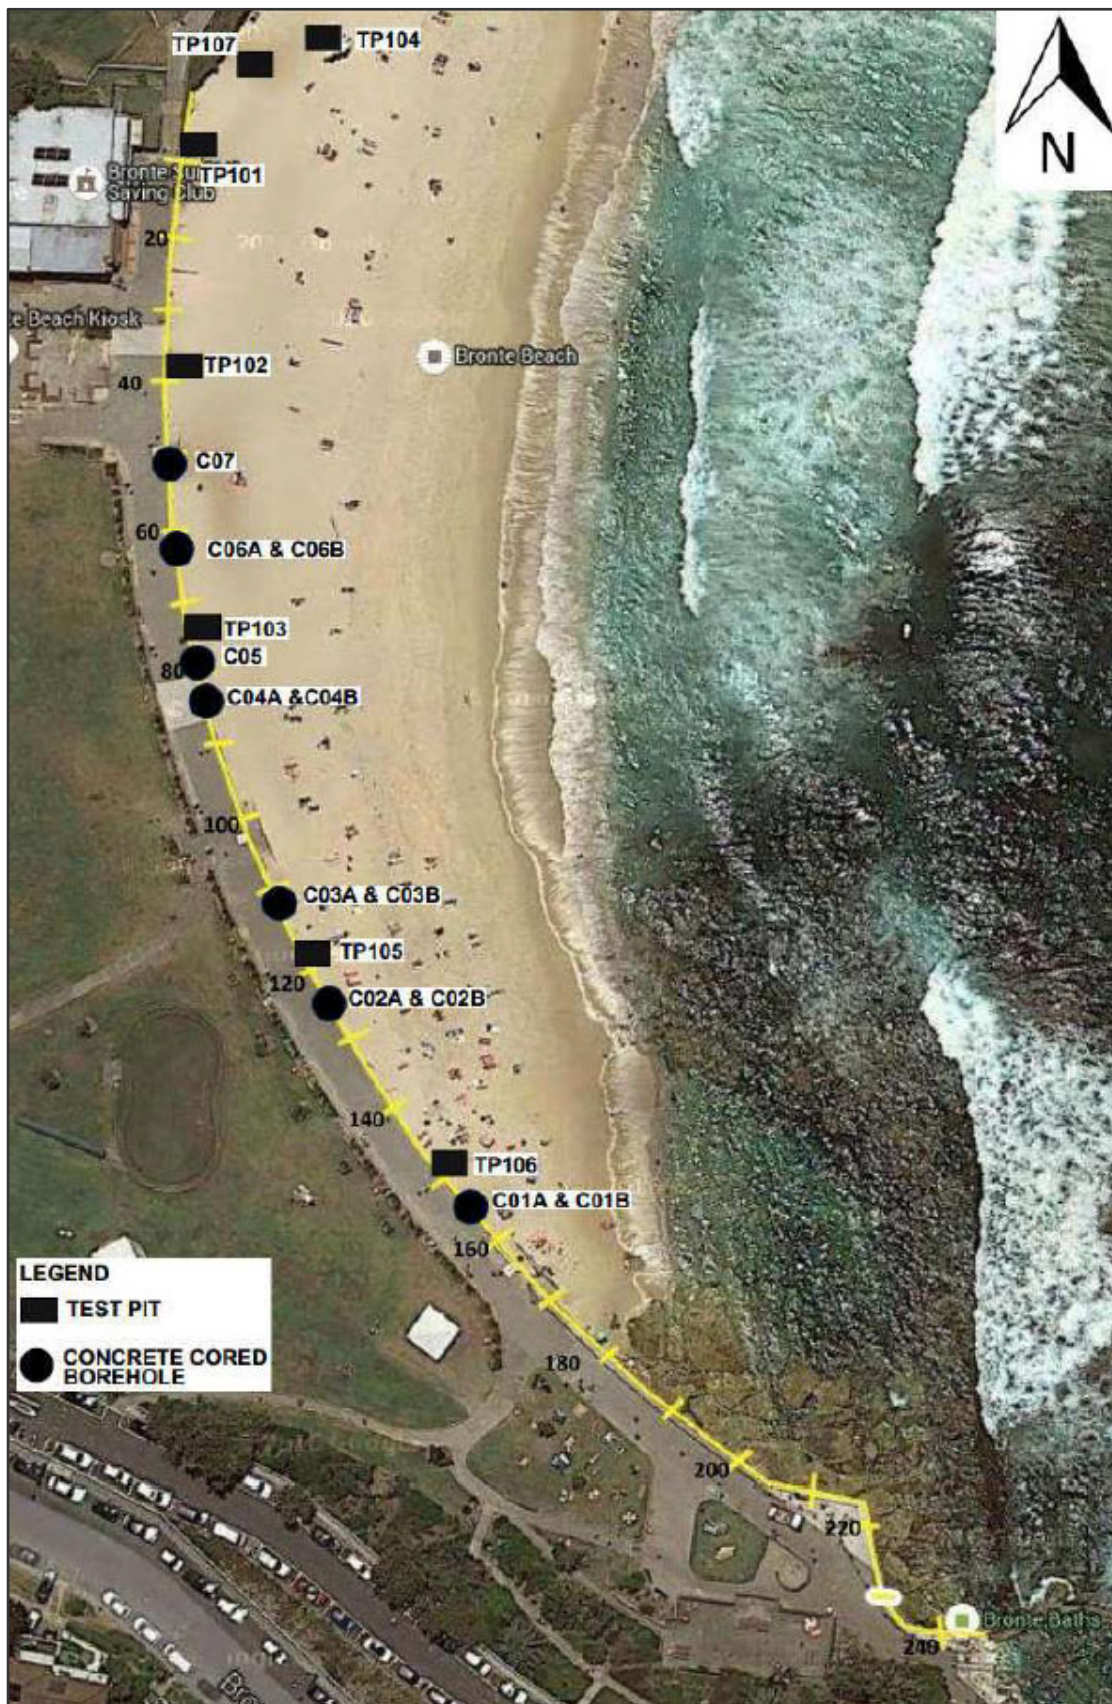
Figure 4-3 Seawall chainages and test pit and seawall coring locations (ARUP, 2016)

The selection of test pit locations aimed to cover the extremities of the seawall, providing a comprehensive understanding of the ground conditions and the seawall itself. Test pit and concrete core locations can be seen in **Figure 4-3**.

A summary of the approximate reduced levels of the test pit locations and subsurface conditions encountered at the three sites is provided in **Table 4-1** and **Table 4-2** based on ARUP's report (ARUP, 2016). The test pits successfully revealed the type and depth of the seawall foundation. In the southern region, the wall appears to be founded on Hawkesbury Sandstone. TP103 exposed the wall sitting on a brick pier. The geotechnical investigation uncovered a subsurface profile characterised by medium- to coarse-grained beach sands overlaying medium- to coarse-grained sandstones. Observations indicated the presence of sandstone outcrops at both the north and southern ends of the seawall.

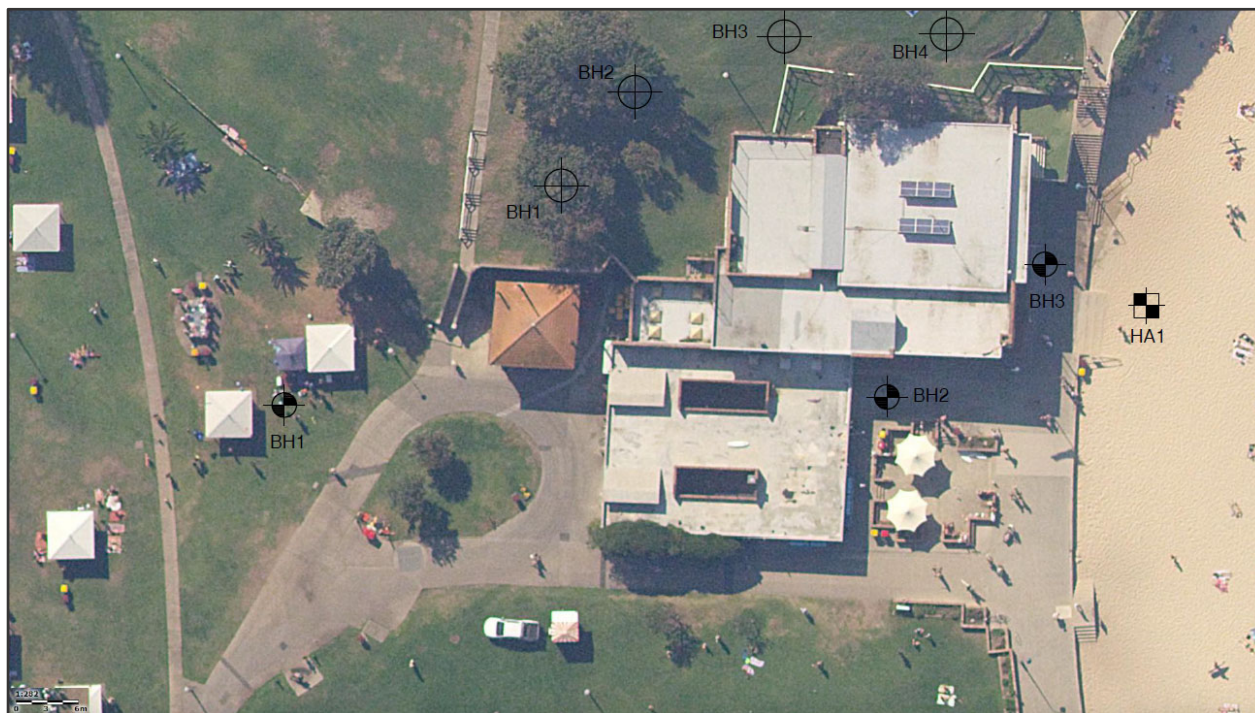
Figure 4-4 Borehole location (AssetGeoEnviro, 2022)

Geotechnical investigations at the subject site have been carried out by AssetGeoEnviro (AGE) in 2020 (AssetGeoEnviro, 2020) and 2022 (AssetGeoEnviro, 2022). The 2020 study involved drilling three boreholes (BH1, BH2, and BH3) at the landward, centre, and seaward edges of the development area, respectively (refer to **Figure 4-4**).

The back beach in **Figure 4-4** falls in the active coastal zone, where erosion would typically be expected down to -1m AHD on a sandy beach. It is likely that the bedrock surface along the face of the seawall seaward of the SLSC is higher than typical back beach scour levels.

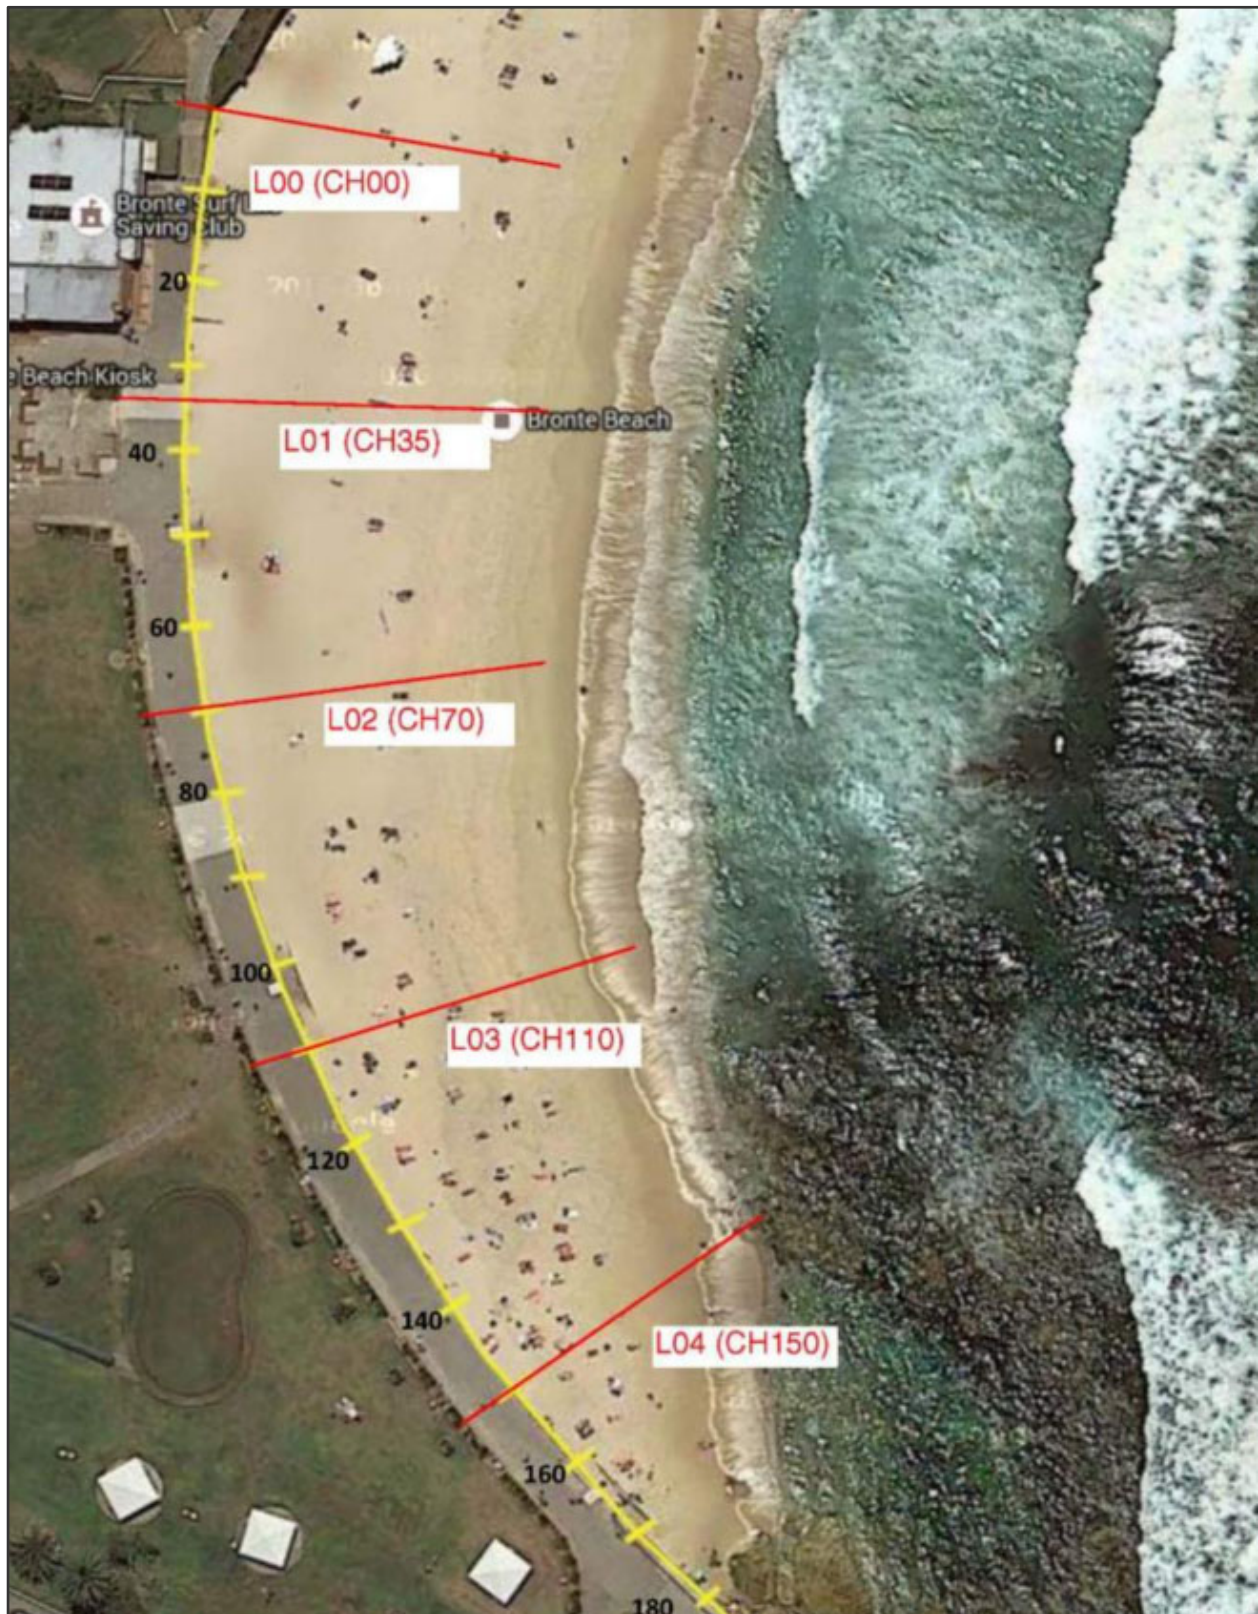
Figure 5-2 Location of photogrammetric profiles

As Bronte Beach was not captured by the NSW Coastal Profile Database, Baird (2016) completed a photogrammetric assessment of available aerial photography for the beach. Ten dates were analysed from 1970 to 2006 with five profiles extracted along the beach for each date as shown in **Figure 5-2**. Profiles L00 and L01 are located approximately in the middle of the beach, fronting the SLSC redeveloped. The terrestrial survey undertaken on June 12, 2016, within one week of the June 2016 storm event, is added to the profiles. The average profile is also shown, adopted by Baird as the prestorm profile for their beach erosion modelling. The extracted profiles are shown in **Figure 5-3** and **Figure 5-4**.

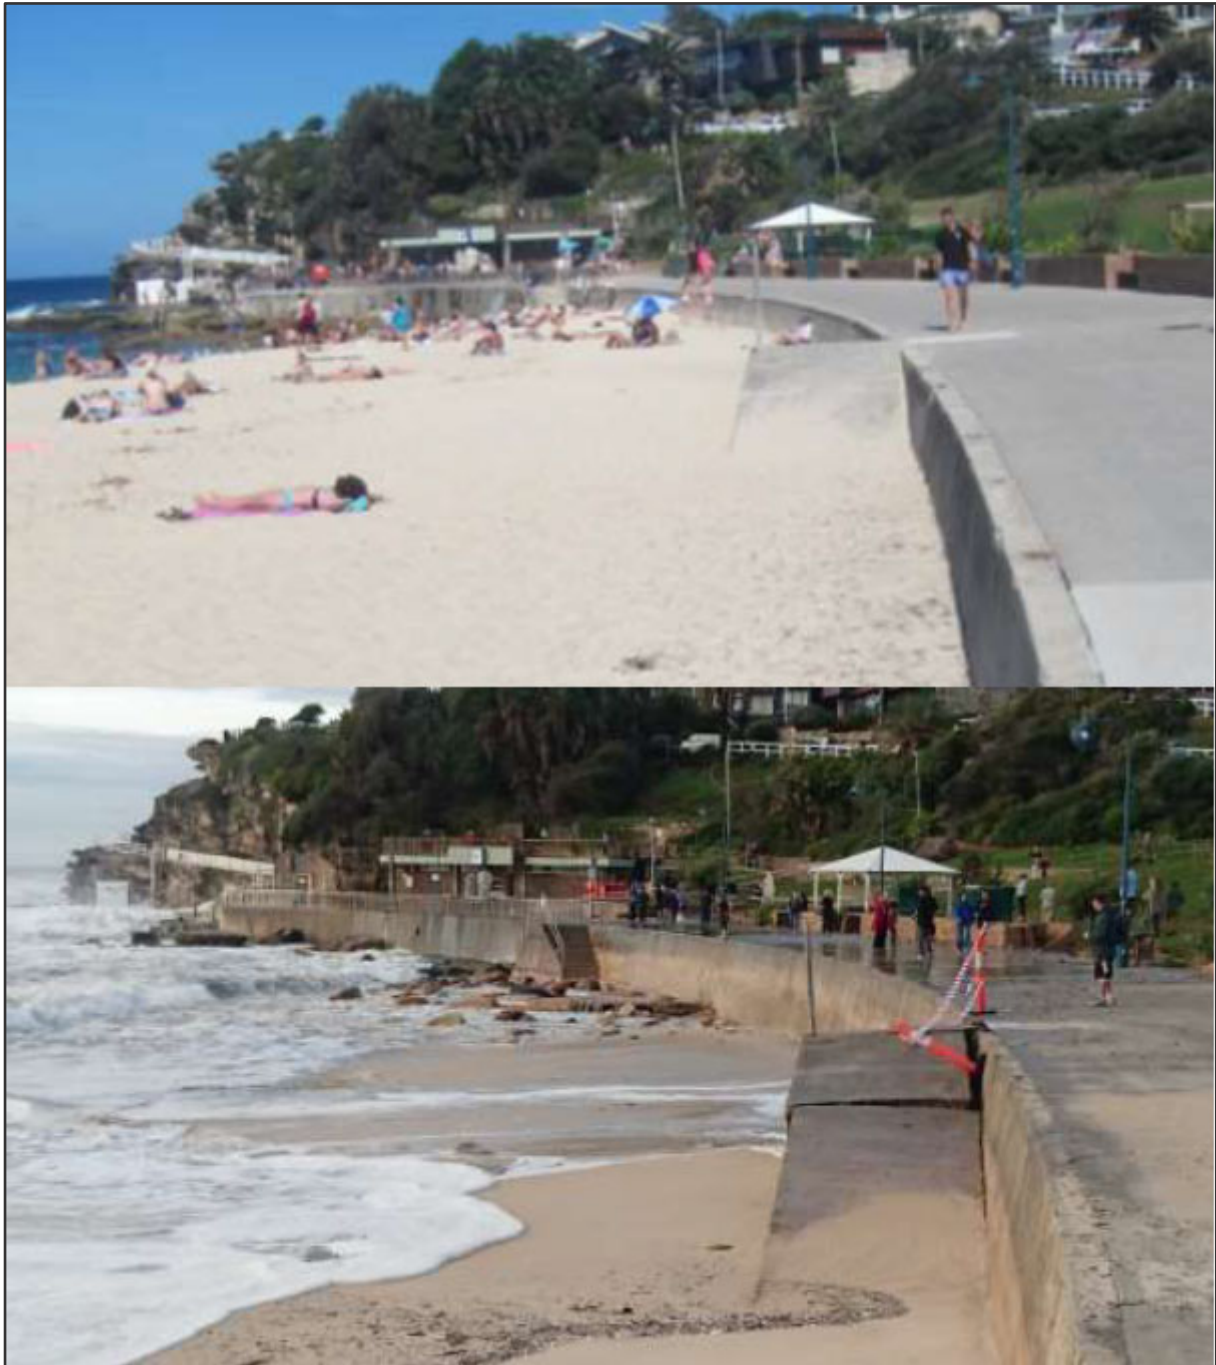
Figure 5-8 View of southern length of Bronte Beach and seawall showing differences in beach profile before (top image, 1 April 2016) and immediately after (bottom image, 6 June 2016) the East Coast Low storm event (source: (ARUP, 2016) (top), (Baird, 2016) (bottom)).

1970s. The event was unique in that it featured some of the largest wave heights ever recorded off Sydney from north-east to east. Despite the offshore wave height during the event being equivalent to less than an omnidirectional 10-year ARI, the consideration of specific wave direction revealed a much higher ARI for the north-east sector. The storm provided a rare opportunity to observe how the beach responds to large storm wave conditions. ARUP study (ARUP, 2016) incorporates valuable pre- and post-storm beach survey data, along with post-storm observations. **Figure 5-8** illustrates the southern portion of Bronte Beach, showing a notable change in the beach profile before and immediately after the storm.

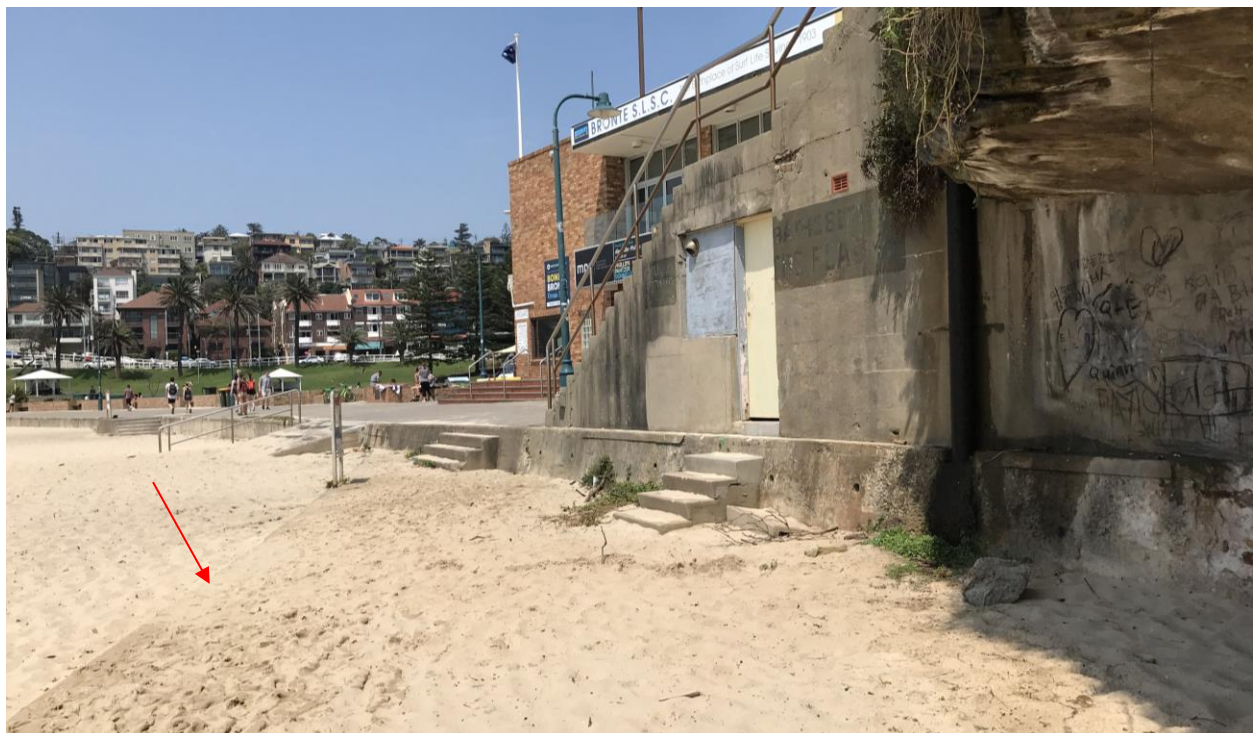
Figure 2: View of Bronte SLSC from Bronte Beach on 4 February 2020, facing SW (note seaward edge of culvert at arrow)

A culvert is located under the promenade, that turns on to the beach adjacent to the northern end of the ramp (see Figure 2), and discharges on the beach about 130m to the NE (see Figure 4). The top surface of this culvert is at 4.1m AHD adjacent to the ramp ("I" in Figure 3).

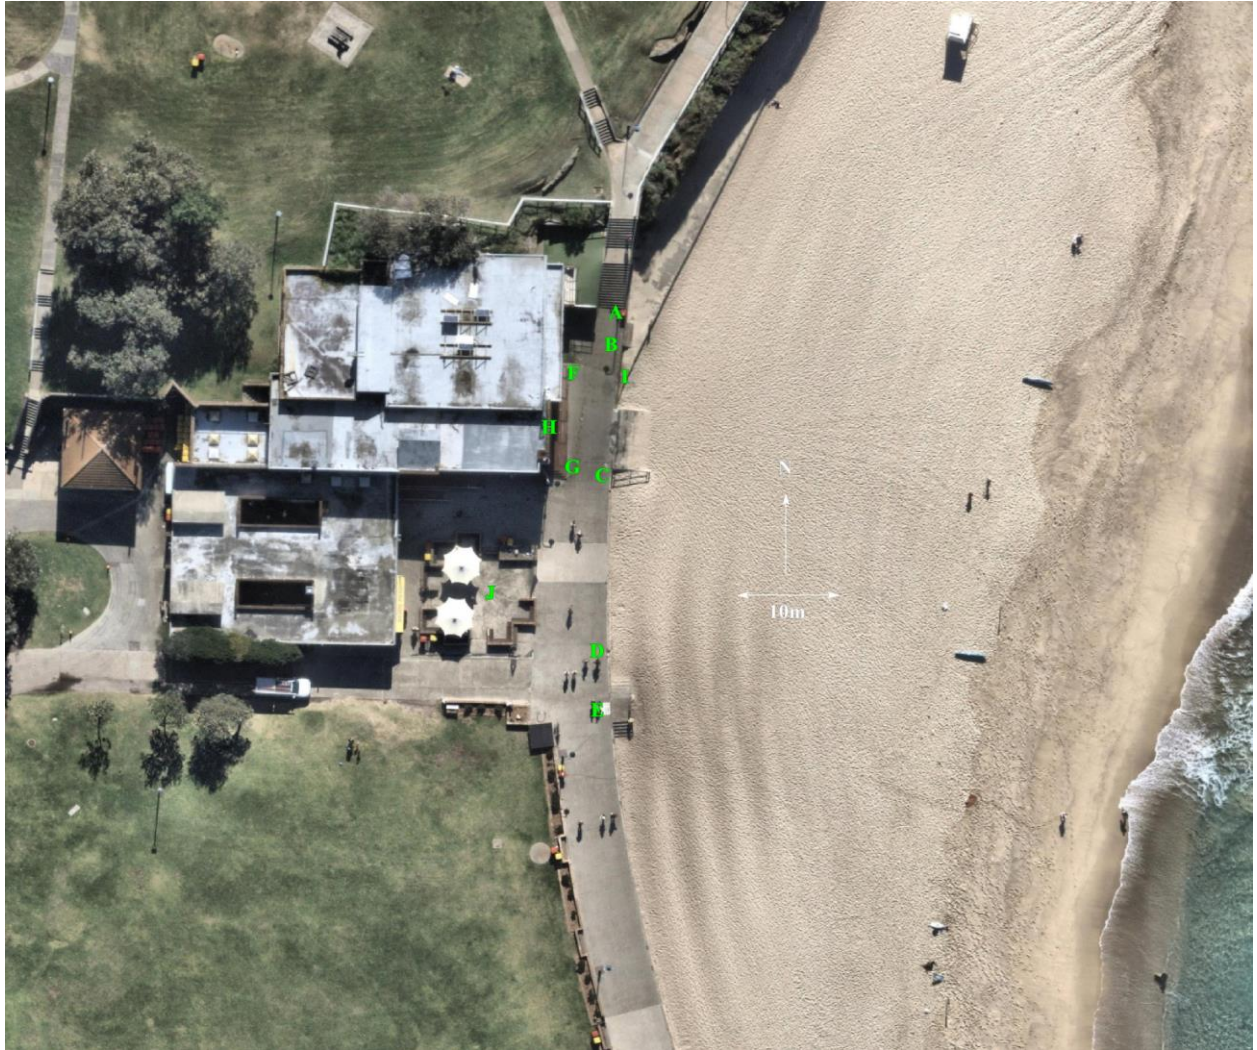
Figure 3: Vertical aerial view of Bronte SLSC on 1 May 2023

The seaward edge of the concrete pathway (promenade) seaward of Bronte SLSC (top of the seawall) has a level of about 4.9m AHD adjacent to the base of the steps heading north up the headland ("A" in Figure 3), reducing to 4.7m AHD at the southern edge of the steps to the beach about 1.4m south ("B" in Figure 3) and continuing at that level to the concrete ramp, then reducing to 4.6m AHD at the southern end of the ramp ("C" in Figure 3). This 4.6m AHD level continues to adjacent to the southern end of the SLSC ("D" in Figure 3), then reduces to 4.5m AHD at the double set of stairs located about 5m south of the SLSC ("E" in Figure 3).

The promenade level at the base of the stairs leading to the northern section of the SLSC varies from 5.2m AHD (northern end, "F" in Figure 3) to 5.0m AHD (southern end, "G" in Figure 3). The pathway at the top of these stairs is at 5.65m AHD ("H" in Figure 3).

The sunken courtyard at the SE corner of the clubhouse ("J" in Figure 3) has a minimum level of 4.5m AHD, with internal surrounds at about 4.6 to 4.7m AHD. The external surrounds are at about 4.8m AHD (southern and eastern side) and 5.0m to 5.2m AHD (northern and western side).

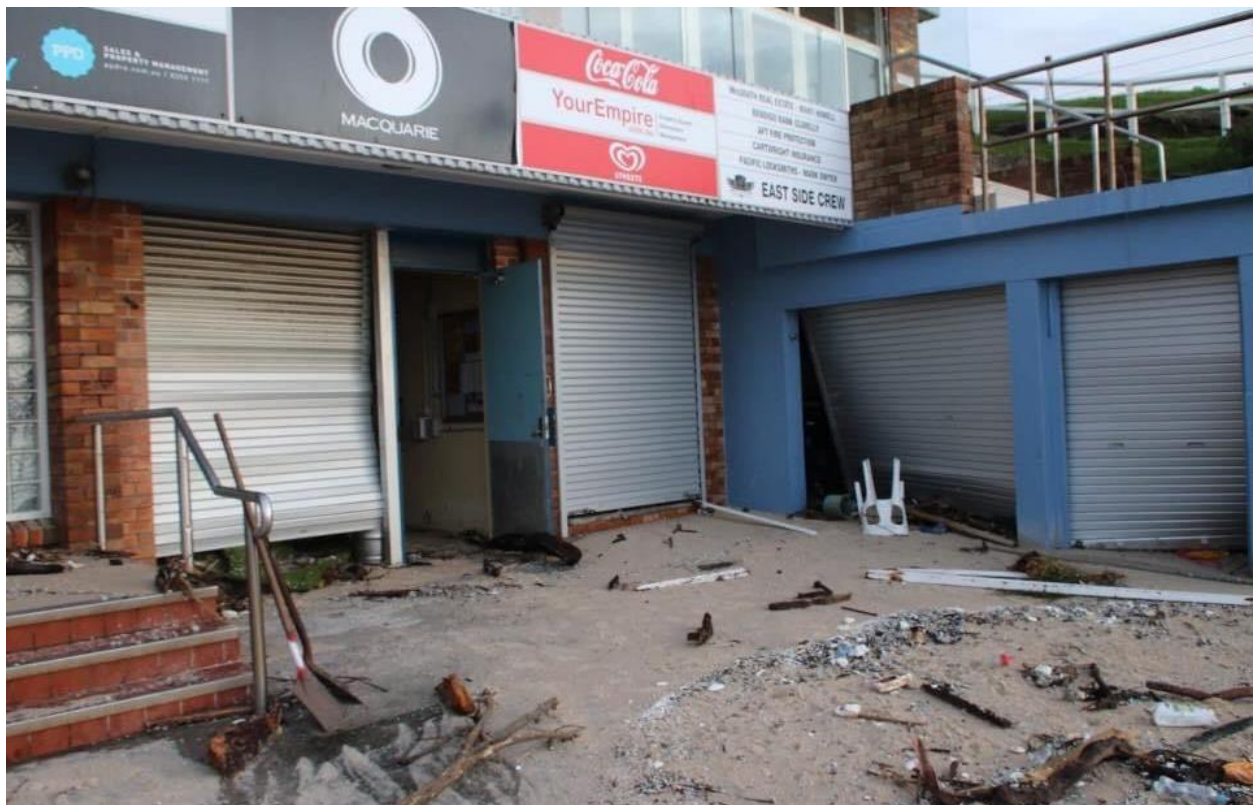
Figure 6: Damage to roller doors at clubhouse in June 2016

The most significant storm since 1974 was in June 2016. This caused damage to three of the SLSC roller doors (Figure 6), and water, sand and debris entered the building (Figure 7 and Figure 8) and the sunken courtyard (Figure 9). More widely in Bronte Park, brick walls were knocked over (Figure 10) and there was damage to the concrete ramp, South Bronte Amenity and Community Centre and pool at the southern end of the beach¹.

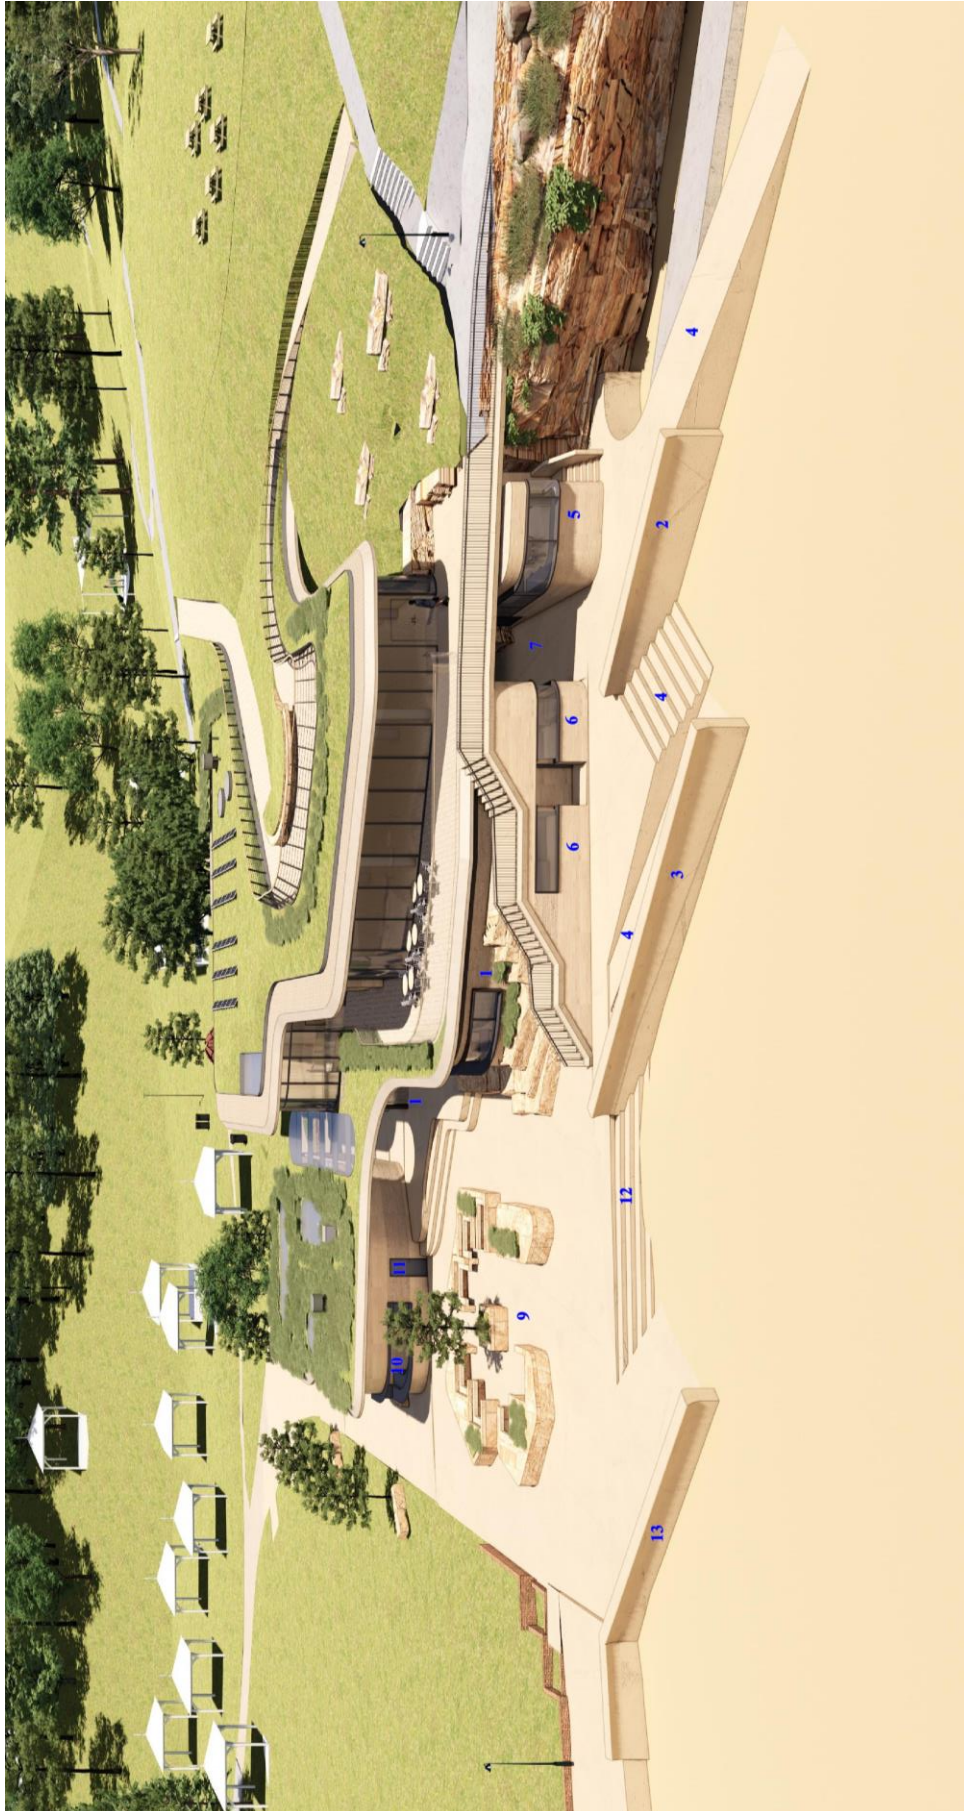
Figure 11: Features to reduce the risk of wave runup damage to SLSC clubhouse

The design of the clubhouse and seawall included iterative coastal engineering input to include features to reduce the risk of wave runup causing damage to the clubhouse in severe storms, as depicted in Figure 11. These features (numbered in Figure 11) include:

8. pump out pit in equipment storage area to be used in the unlikely event that there was overtopping of the wave barrier in the circulation area (not depicted in Figure 11);

It is intended that the seawall is rebuilt seaward of the SLSC clubhouse, comprising ramps and steps as depicted in Figure 11 (Items 2, 3, 4, 12 and 13). It is expected that the seawall would comprise:

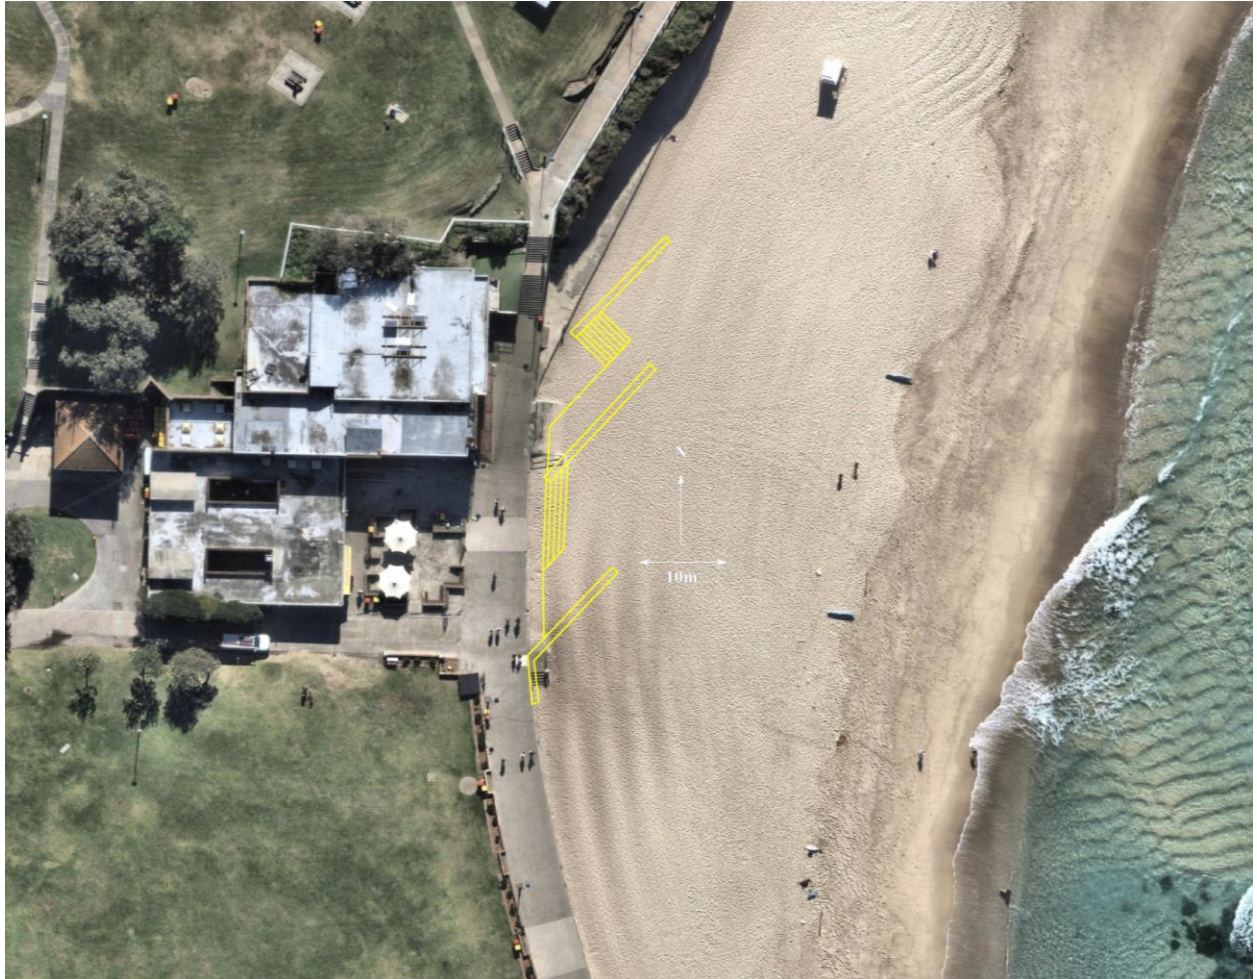
Figure 12: Alignment of proposed seawall, ramps and stairs at Bronte SLSC (aerial photograph taken 1 May 2023)

The alignment of the proposed seawall, ramps and stairs is depicted in Figure 12. This has the seaward edge of the promenade extending 2m seaward of its current position, with the steps and ramps extending further seaward. This proposed layout provides separation from the coastal walkway and surf lifesaving beach access activities (with access to and from the main storage not crossing the coastal walkway path), enhances access to the beach for lifesaving equipment (with an enhanced access ramp compared to the existing ramp), enhances public access to the beach (with enhanced stair and ramp access compared to the existing stairs and ramp), provides disabled access, and provides enhanced protection to the clubhouse from wave runup.

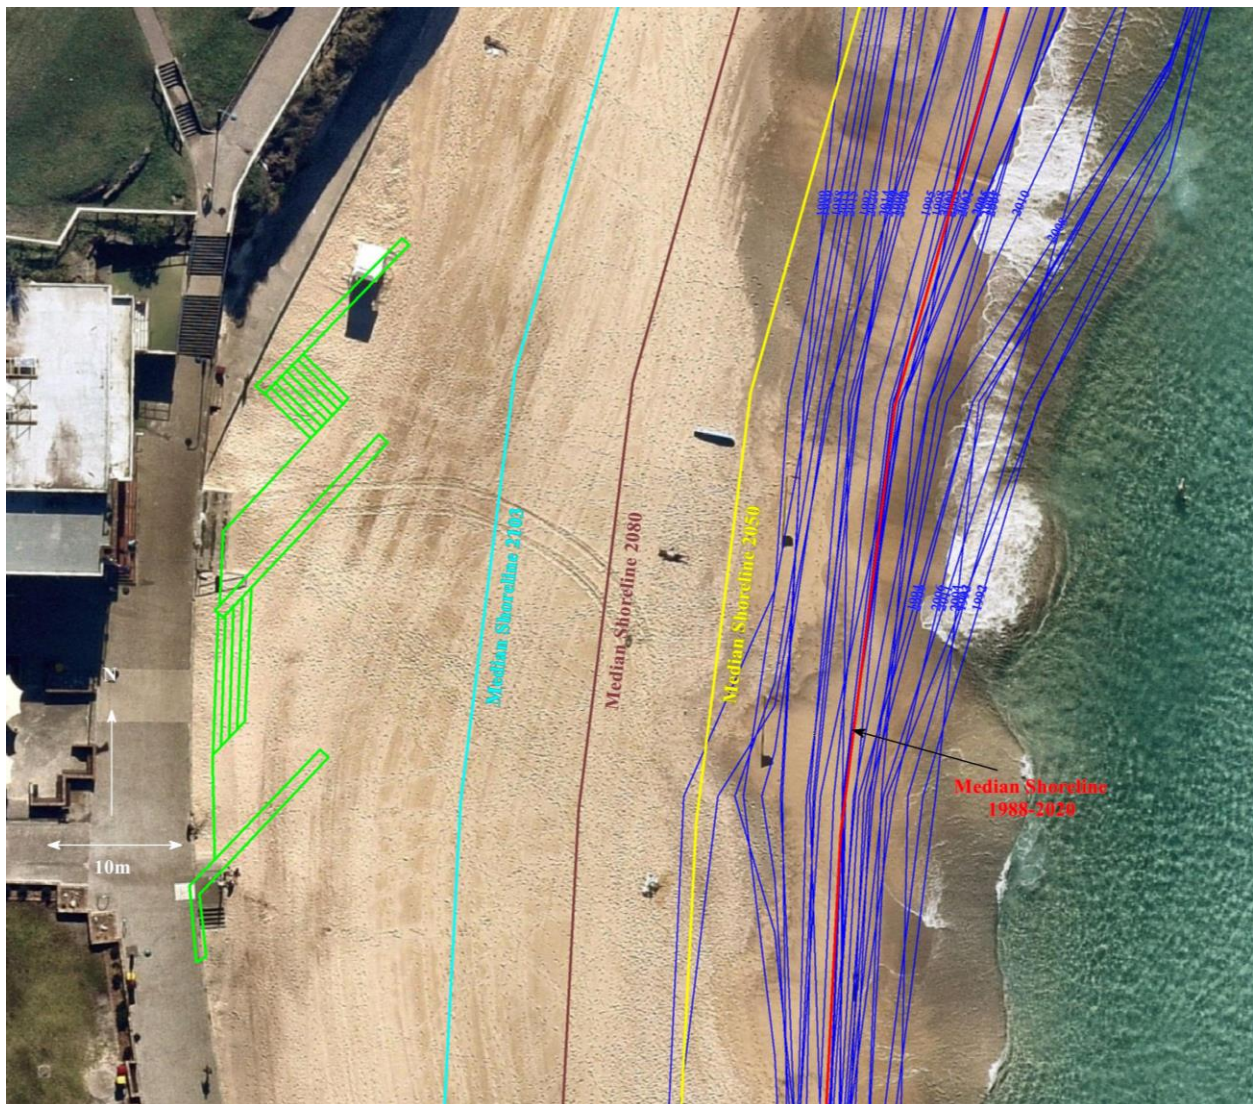
Figure 15: Median annual position of the shoreline at 0m AHD from 1988 to 2020 (blue lines) from DEA Coastlines, with median of these 33 years in red, receded 33-year median at 2050, 2080 and 2103 in yellow, brown and cyan respectively, and proposed seawall (plus ramp and stairs) shown in green

It is evident from Figure 15 that there would (on average) be the expectation of a useable beach width seaward of Bronte SLSC at 2103. If sea level continues to rise beyond the design life, and beach recession occurs as projected based on Bruun (1962), and there are no beach nourishment intervention works undertaken, there may be a point mid next century when there is insufficient beach width to maintain sandy beach activities, on average.
