# STATEMENT of HERITAGE IMPACT

UPGRADE OPTIONS ANALYSIS

***The Boot Factory*** 1892

27-33 SPRING STREET, BONDI JUNCTION NSW

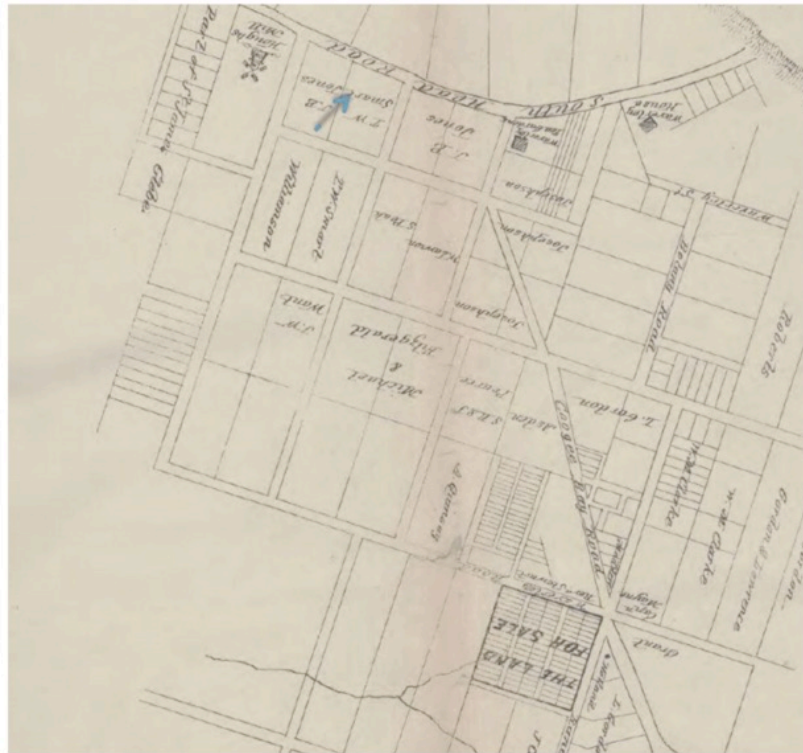
FIGURE 2: Plan of Canonbury, Waverley, 1857-69. Source: State Library of NSW, Map F762. Cited in Urbis, *Boot Factory History and Adaptive Reuse report*, 2015, p.11. The approximate site of the Boot Factory is indicated by the blue arrow. (N.B. The map has been rotated so that north is at the top, for ease of reference.)

The Boot Factory on Spring Street was constructed by William Sidaway in 1892. An early map of the area (the Plan of Canonbury, Waverley, produced between 1857 and 1869) shows that the site was part of land owned by either T.W.Smart or J.B.Jones. (See Figure 2.) Jones' and Smart's parcels were adjacent to each other and situated between what was then called South Head Road (Oxford Street) and Ebley Street. Spring Street was not yet constructed, so it is difficult to know on whose land the site was situated, or whether it straddled the two original titles.

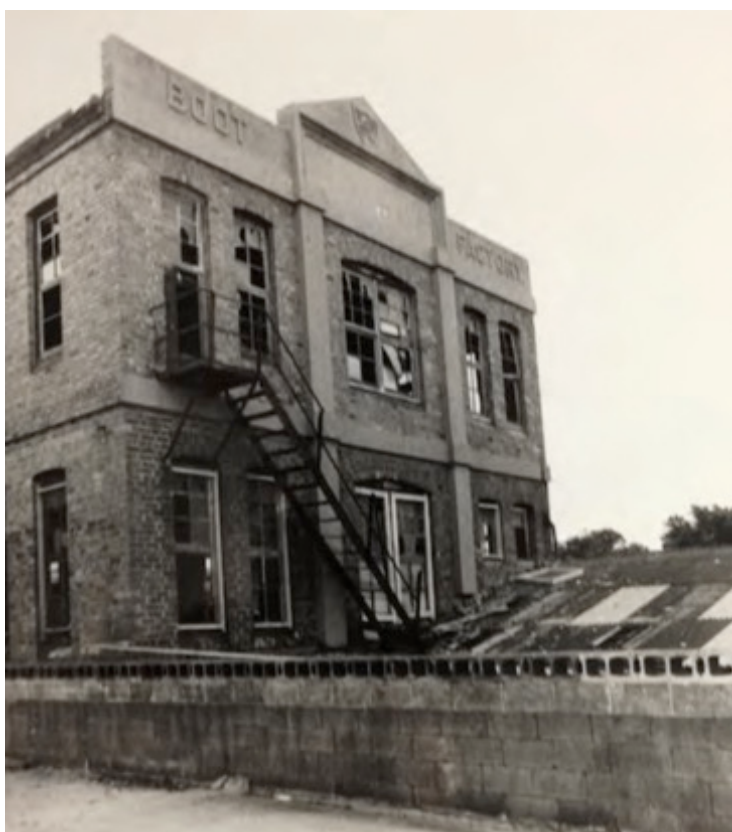
FIGURE 15: The building was in a dilapidated state in 1984 prior to restoration work being commenced. Source: Waverley Studies Collection.

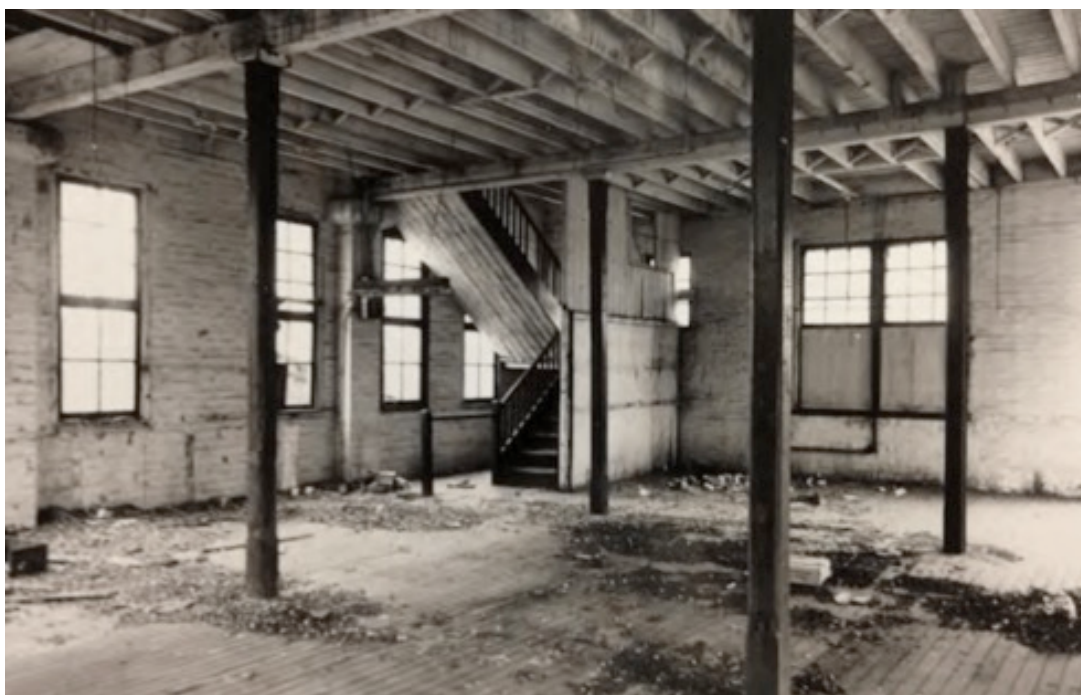
FIGURE 16: Interior view of the first floor of the factory in 1982, prior to renovation works. This photograph shows the original timber stair, now removed. Source: Waverley Local Studies Collection.

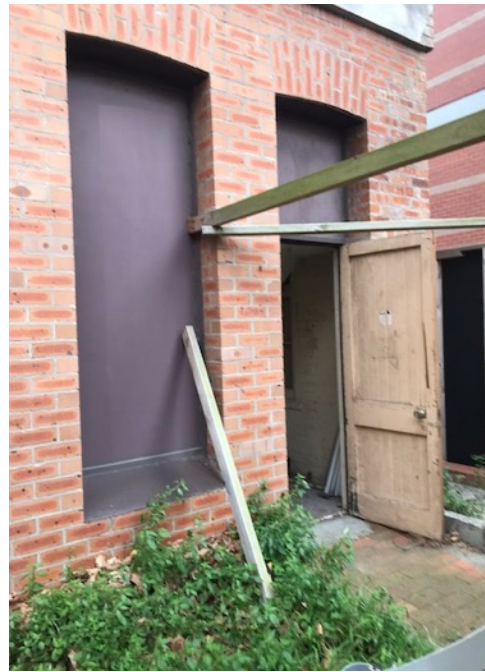
FIGURE 33: Ground floor, front façade, showing 1985 door to fire stair

A fire stair was installed in the north-west corner of the building as part of the repair works in 1984-5 and a window on the ground floor in that corner has been converted into a fire egress door. During these 1980s repair works the ground floor façade was partially reconstructed, with the window openings rebuilt using slightly different textured bricks.

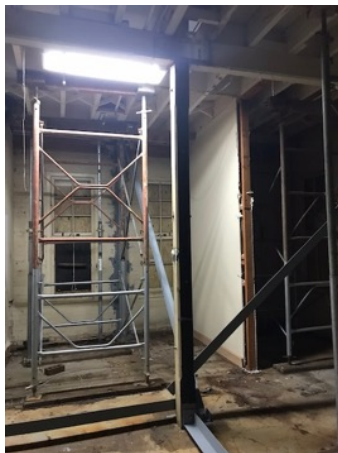
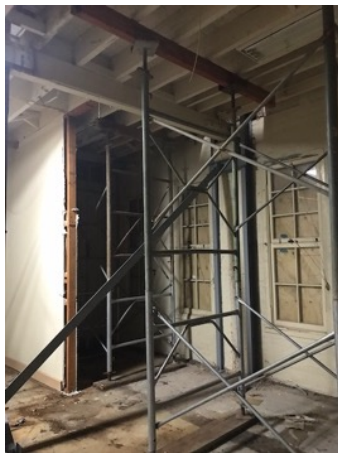
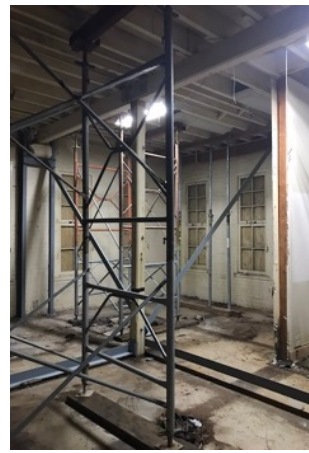
FIGURES 42, 43 & 44: Interior, ground floor

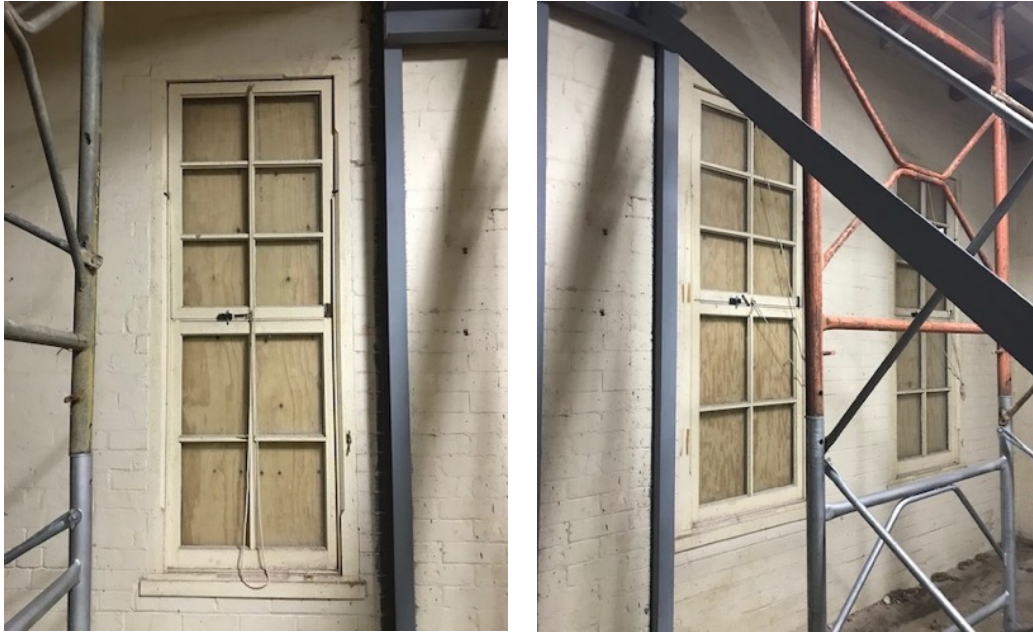
FIGURES 45 & 46: Typical windows

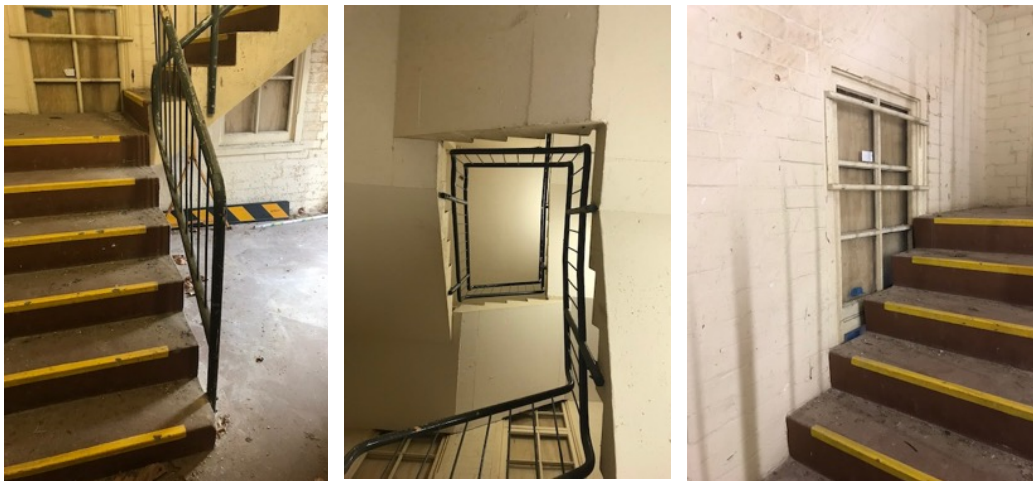
FIGURES 47, 48 & 49: Fire stair

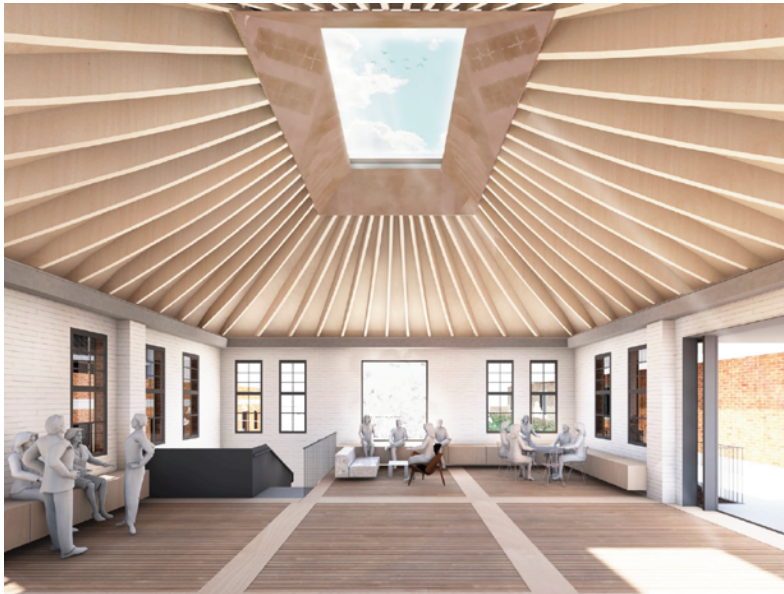
FIGURE 64: Roof option 1 – internal perspective. Archer Office.

While in some projects it would be an automatic decision to reconstruct the existing roof structure to match existing, in this project it was considered that as long as the external form from the public domain remained effectively the same, the new roof structure could be an innovative feature, linked to a large open space on the second floor. The introduction of a skylight increases the potential use of this space as well. The new structural system proposed is entirely supported on the exterior walls and therefore no internal columns are required. While this does impact upon the historic character of this floor (as a 3 x 3 grid), this grid will be interpreted in the new floor finish. The loss of the 3 x 3 grid on this floor does, however, provide an opportunity for a large and flexible open space that more than compensates for the loss of this original character.
