Address: 11/40 Drummoyne Avenue Site Visit: 2.30-2.40pm 27 August 2020

Document Set ID: 6762705 Version: 1, Version Date: 22/12/2020 Address: 13/40 Drummoyne Avenue Site Visit: 2.10-2.30pm 27 August 2020

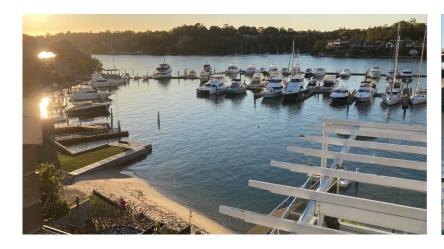
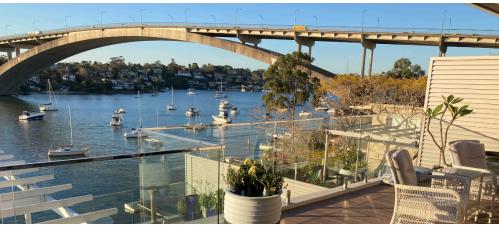
Terrace

Front –west side, facing north-west

Rear - west side, facing north west to bridge

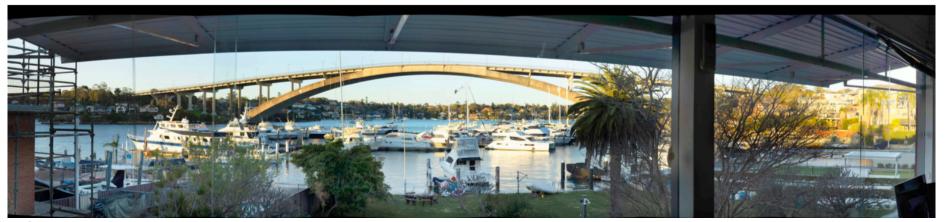
Office

Before

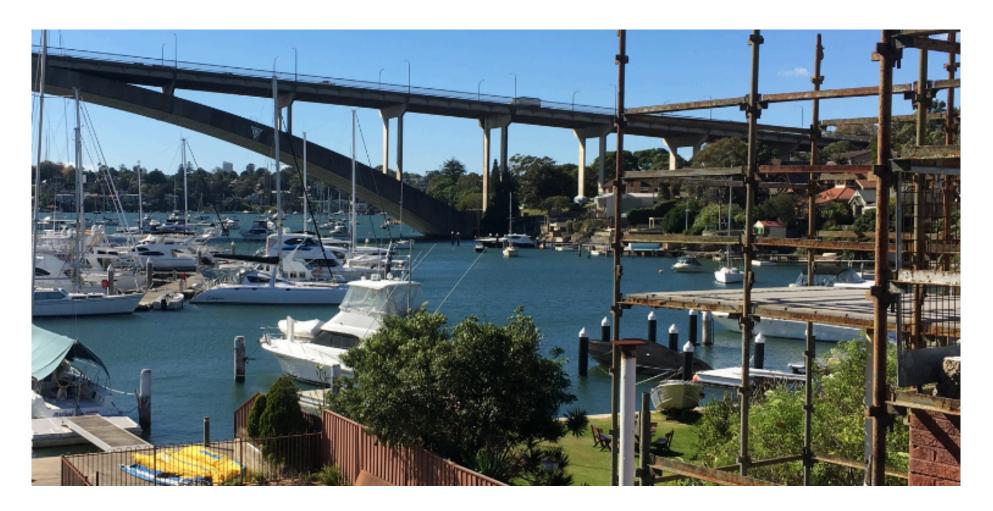
View from property to north of subject: Facing along the southern channel and foreshore, for evaluation purposes only - Not from No.376
