Your ref: Quotation Request Form from Slavco Bujaroski received on 08 Jan 25  
Our ref: 12660366

## Kurnell Revetment Wall Peer Review

DA for construction of the seawall and adjacent landscaping works (DA24/0290) was submitted to the Sutherland Shire Council (SSC) by the NSW National Parks & Wildlife Service on 13 September 2024.

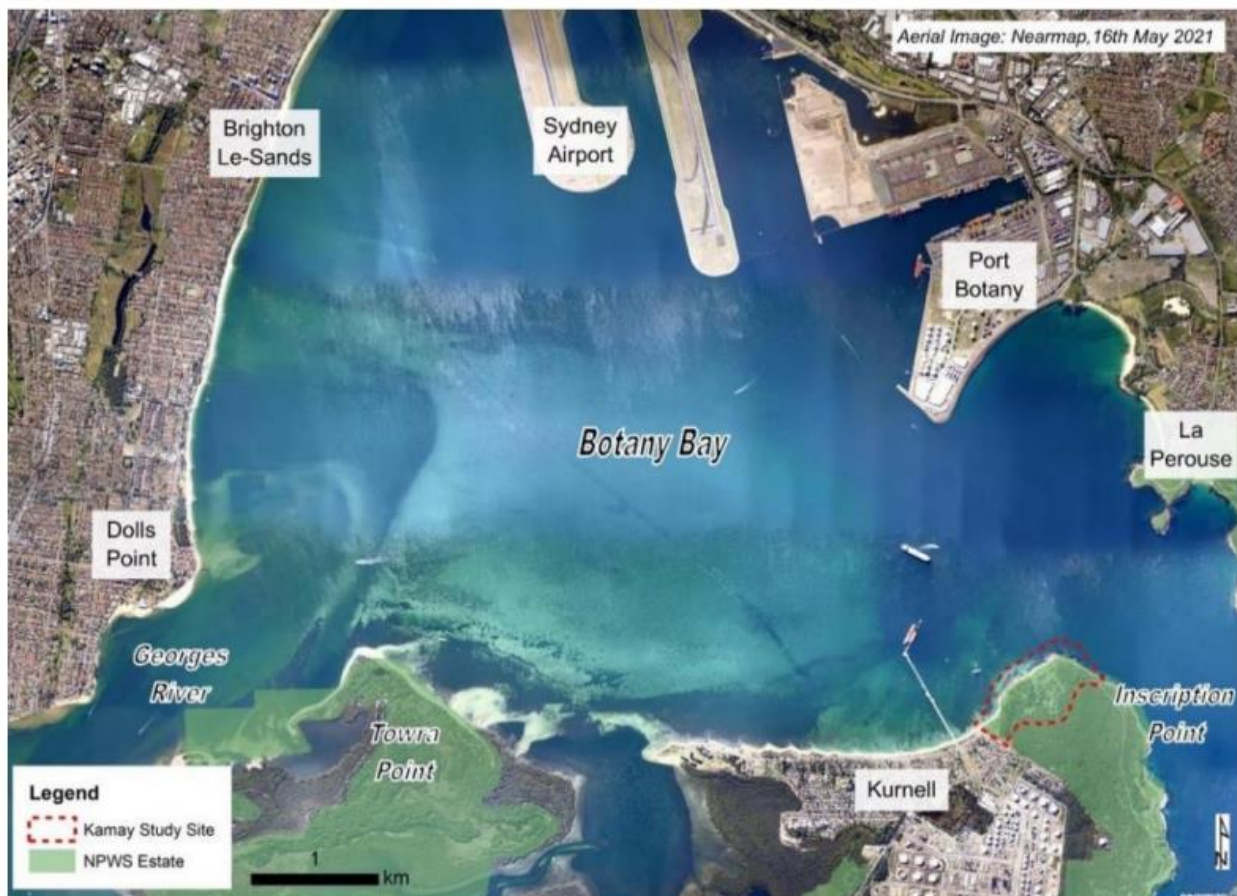
Figure 1 - Overview of Botany Bay showing the Kamay Study Site (BMT, 2024)

The Kamay Botany Bay National Park (KBBNP) is located on the southern foreshore of Botany Bay, covering an area of 492 hectares. The study area is a 220m length of foreshore on the southern peninsular of the entrance to Botany Bay (Figure 1).

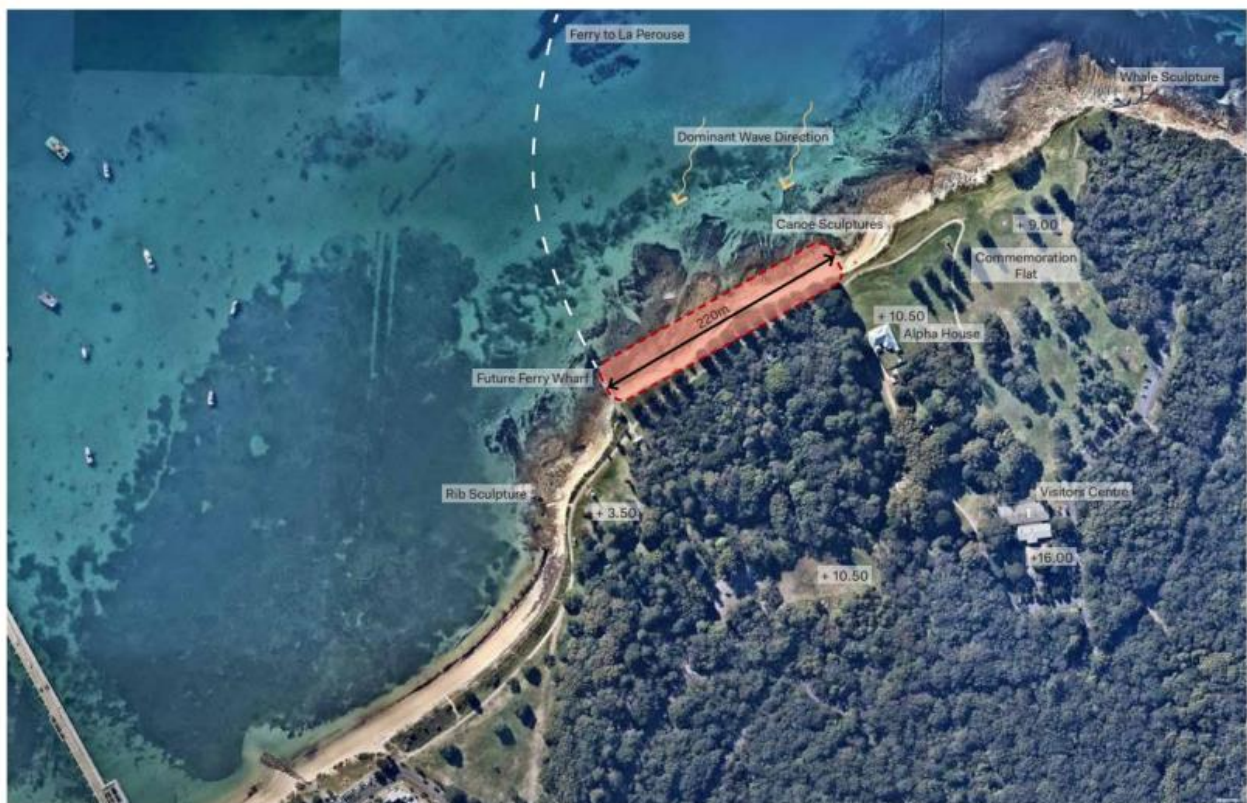
**Figure 2** Nearmap image showing the approximately 220 metres in length proposed seawall area on the seaward side of the Norfolk Island Pines (BMT, 2024)

The new stepped sandstone seawall was designed by Consult Marine, running from the recently constructed wharf to the edge of Commemoration Flat (Figure 2), in front of the existing sandbag wall. The topmost layer of sandbags will be removed, and the rest buried underneath sandstone blocks (Figure 4). These sandbags currently provide a temporary protection to the dune, mitigating the damages caused by the 2018 major storm event. Consult Marine's design drawing list has been documented in the *DA240290 Original Structural Design Drawings*.

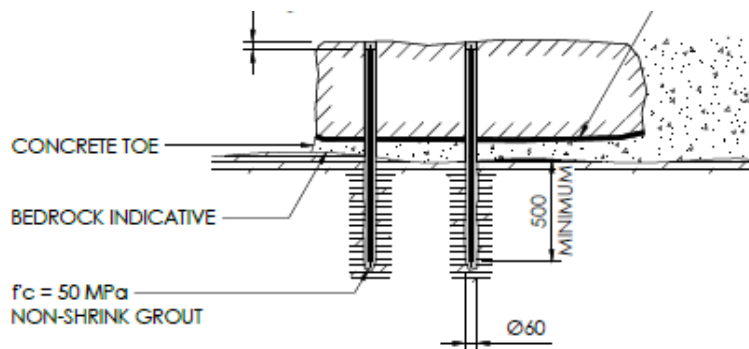
The design notes a concrete mass is to be cast over bedrock beneath the toe blocks to prevent undermining. Toe block anchors are to be installed at every fourth block along the length of the structure, with two anchors per block, as shown in Figure 5.

Figure 5 Toe block anchor detail

It is expected that the core drilling of anchor holes will be undertaken once the blocks are placed. The specifications do not include any requirement for the contractor to minimise the risk of cracking of the sandstone blocks during coring. The 25 MPa UCS is roughly in the range of a medium-strength rock which, while it can be drilled, may require special methods including low-pressure drilling to minimise cracking especially for a drill hole of 60mm. The risk is also increased when drilling through thinner sandstone blocks (as shown in some areas) or thin layers of insitu placed concrete.

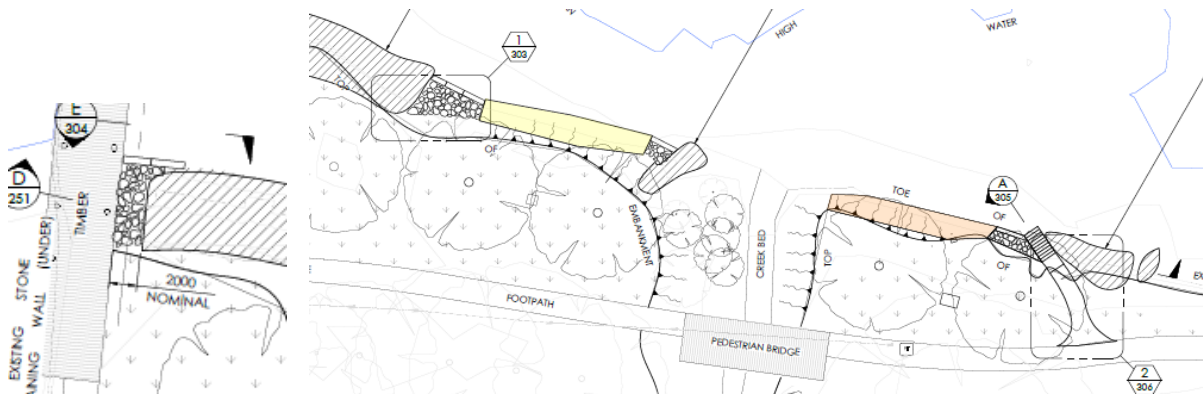
- Kamay Ferry Wharf to transition revetment structure (west)
- Transition revetment structure to blockwork wall

- Transition revetment structure to existing sloped rock wall
- Transition revetment structure to existing sloped sandstone wall
- Transition revetment structure to blockwork staircase
- Blockwork staircase to blockwork wall

**Figure 6** Interfaces between structure types

The interfaces appear to have been considered by Consult Marine and are documented by several detailed sections in Drawings 303 and 304. The proposed approach generally aligns with typical industry practice and appears appropriate given the site constraints. GHD recommends the interfaces between the existing and proposed shoreline protection be monitored over the design life and maintenance be undertaken when required to ensure the structure performs as intended over the design life.

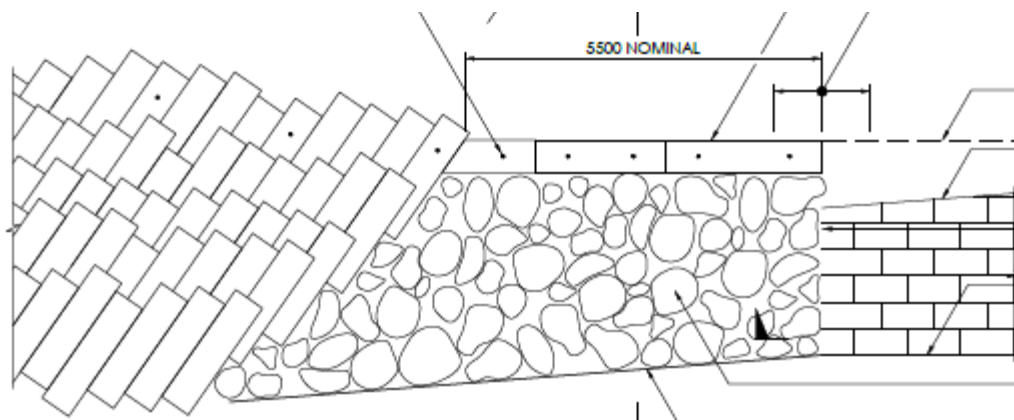
Consult Marine specified the transition plan from the blockwork structure to the existing block wall, comprising a transition structure of rock armour revetment and toe blocks. The rock revetment will align with each side, transitioning linearly from the proposed structure to the existing block wall, and the toe will align with the existing wall, with two anchors per block (Figure 7).

**Figure 7** Transition plan detail (east)

Whilst the proposed structure would typically extend beyond the area's most at risk to reduce potential for outflanking, it is understood BMT and Consult Marine have taken into consideration the aesthetic and heritage aspects of the site by preserving existing shoreline protection. This is documented in response to SSPP RFI 2, "An assessment of the proposal under Part 2.2, Division 2 - Coastal Vulnerability of the SEPP, to ensure that the works are engineered to withstand current and projected coastal hazards for the design life of the works", where BMT have outlined that, "The revetment transition structure should ideally continue from the existing wall into the western bank of the stream mouth. The adopted position was to retain the blockwork structure at the stream mouth for aesthetic reasons, primarily to preserve the heritage value of the adjoining stone block seawall structures. This approach involves accepting the risk later in the structure's life, with repairs and maintenance to be undertaken locally as required".

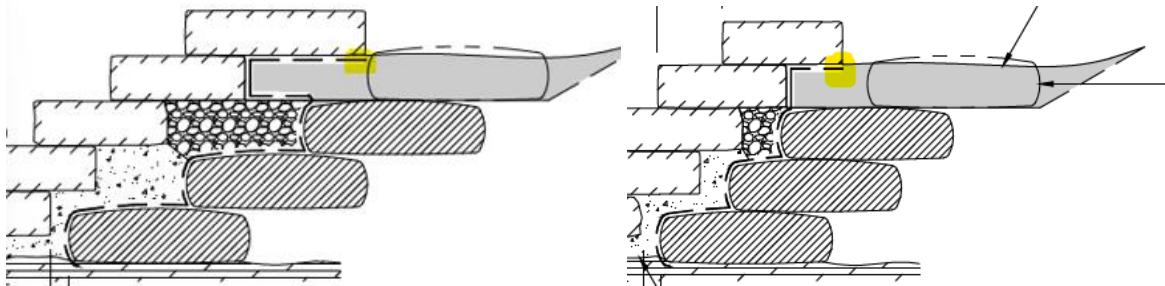
The proposed geotextile Texcel 400R is a non-woven geotextile designed for coastal applications, with a resistance to environmental factors such as saltwater. It restricts the migration of fine soil particles while remaining permeable to water, thereby preventing fines washout. Along the length of the structure, the geotextile is to be cut in line with the top block and consideration has been given to its exposure to erosion and overtopping. However, given the low frequency and magnitude of overtopping rates, GHD would consider this to be a reasonable approach.

Figure 8 Geotextile ends in Type 1 and Type 2 structure sections

to overlying sands. The underlayers are to be comprised of concrete, backfill and drainage material made of ballast or aggregate, placed over the existing sandbags (refer Figure 8).

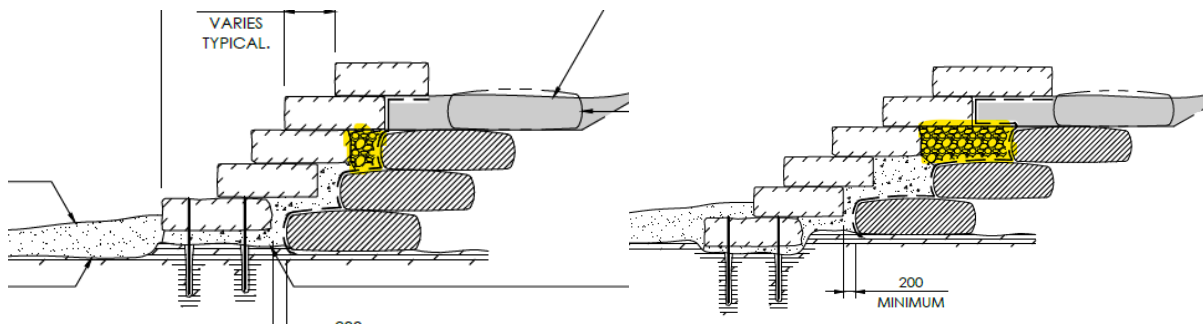
Considering the predicted maximum wave runup levels over the lifespan of the structure, the proposed crest height will reduce overtopping under current conditions. Towards the end of the design life, the

structure may have overtopping in some areas, similar to current conditions. Whilst overtopping may occur in extreme weather events, the inclusion of the drainage layer may reduce the impacts on landside assets.

**Figure 9** Drainage layer

The proposed design includes a drainage layer as shown in Figure 9 however there is no drainage behind the concrete footing (up to +2.1 mAHD) resulting in potential increases in groundwater levels which may cause potential impacts to slope stability and nearby trees, and create unintended flow paths (Figure 10).

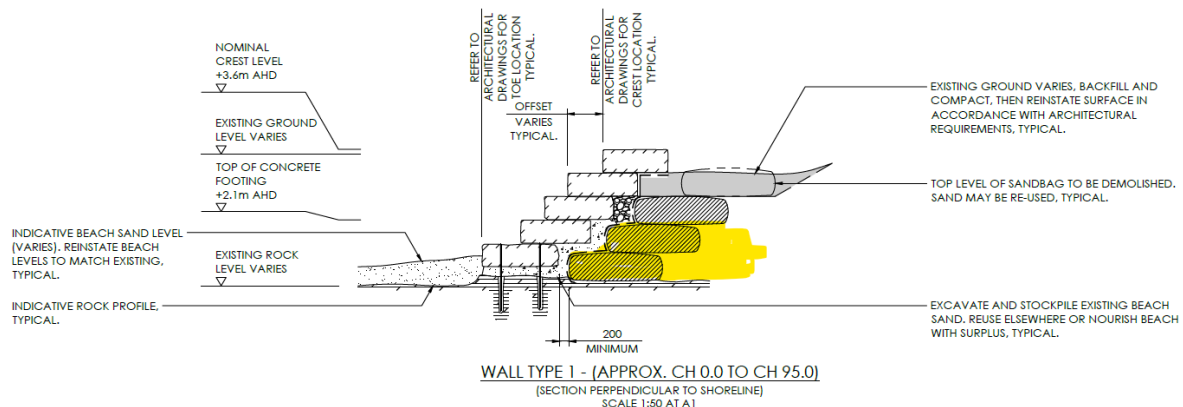
**Figure 10** No drainage outlet behind concrete footing leading to increases in groundwater levels

The concrete stair area, as detailed in Section A, Drawing 305, shows consideration of a drainage pipe and rock profile. However, the rock profile is not extended to the level of pavement. The type and permeability of the underlying material are unknown. We would recommend that the drainage design be reviewed and full continuity of drainage pathways to the open water or adjacent drainage system be confirmed.

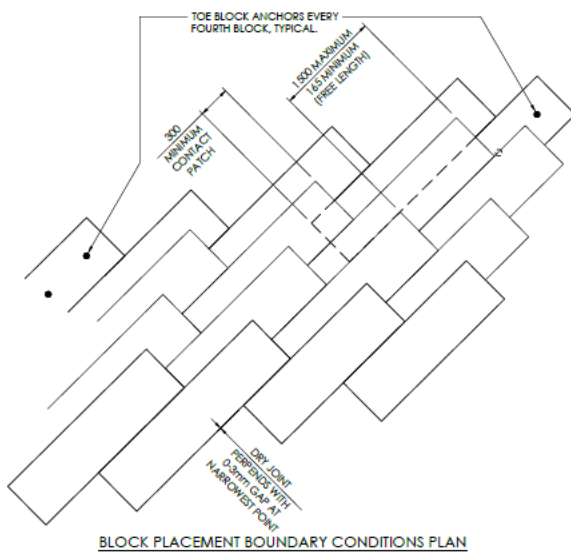
The weight of the sandstone blocks has potential to cause the sandbags to compress, which, combined with potential degradation of sandbags, may lead to uneven settling. However, the design has arranged blocks in an interlocking placement that will distribute the weight and may reduce potential movement.

**Figure 11** Interlocking placement of sandstone blocks

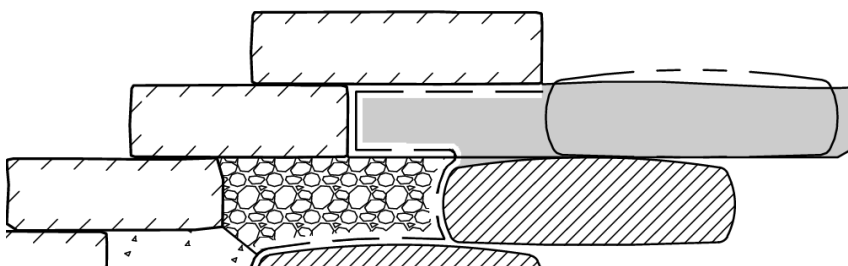
There is also a risk that the top sandstone block may be subject to uneven settlement when placed on the compacted backfill (Figure 12). However, Consult Marine has proposed that the fill material is subject to 95% compaction and as a result, any settlement is expected to be minimal and gradual over the design life.

**Figure 12** Settlement risk of top sandstone block

GHD recommends periodic monitoring of the top sandstone block and fill layer and undertaking maintenance if any issues are identified.
